**Observations on wall repairs at Woodspring Priory, Kewstoke, North Somerset**

**YATTON, CONGRESBURY, CLAVERHAM AND CLEEVE ARCHAEOLOGICAL  
RESEARCH TEAM (YCCCART)**

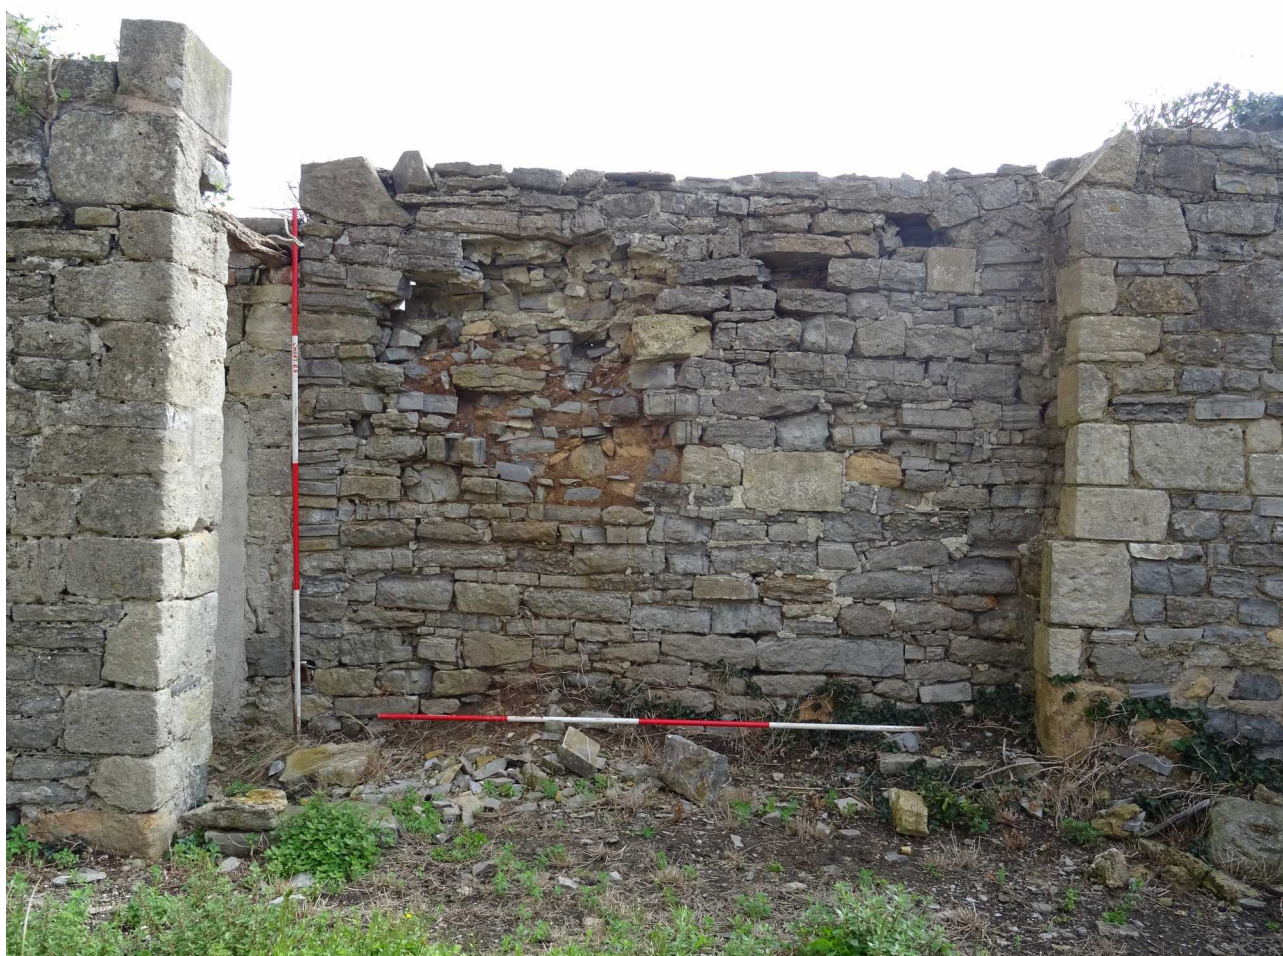
*Collapsed section of wall on east side of cloister, Woodspring Priory*

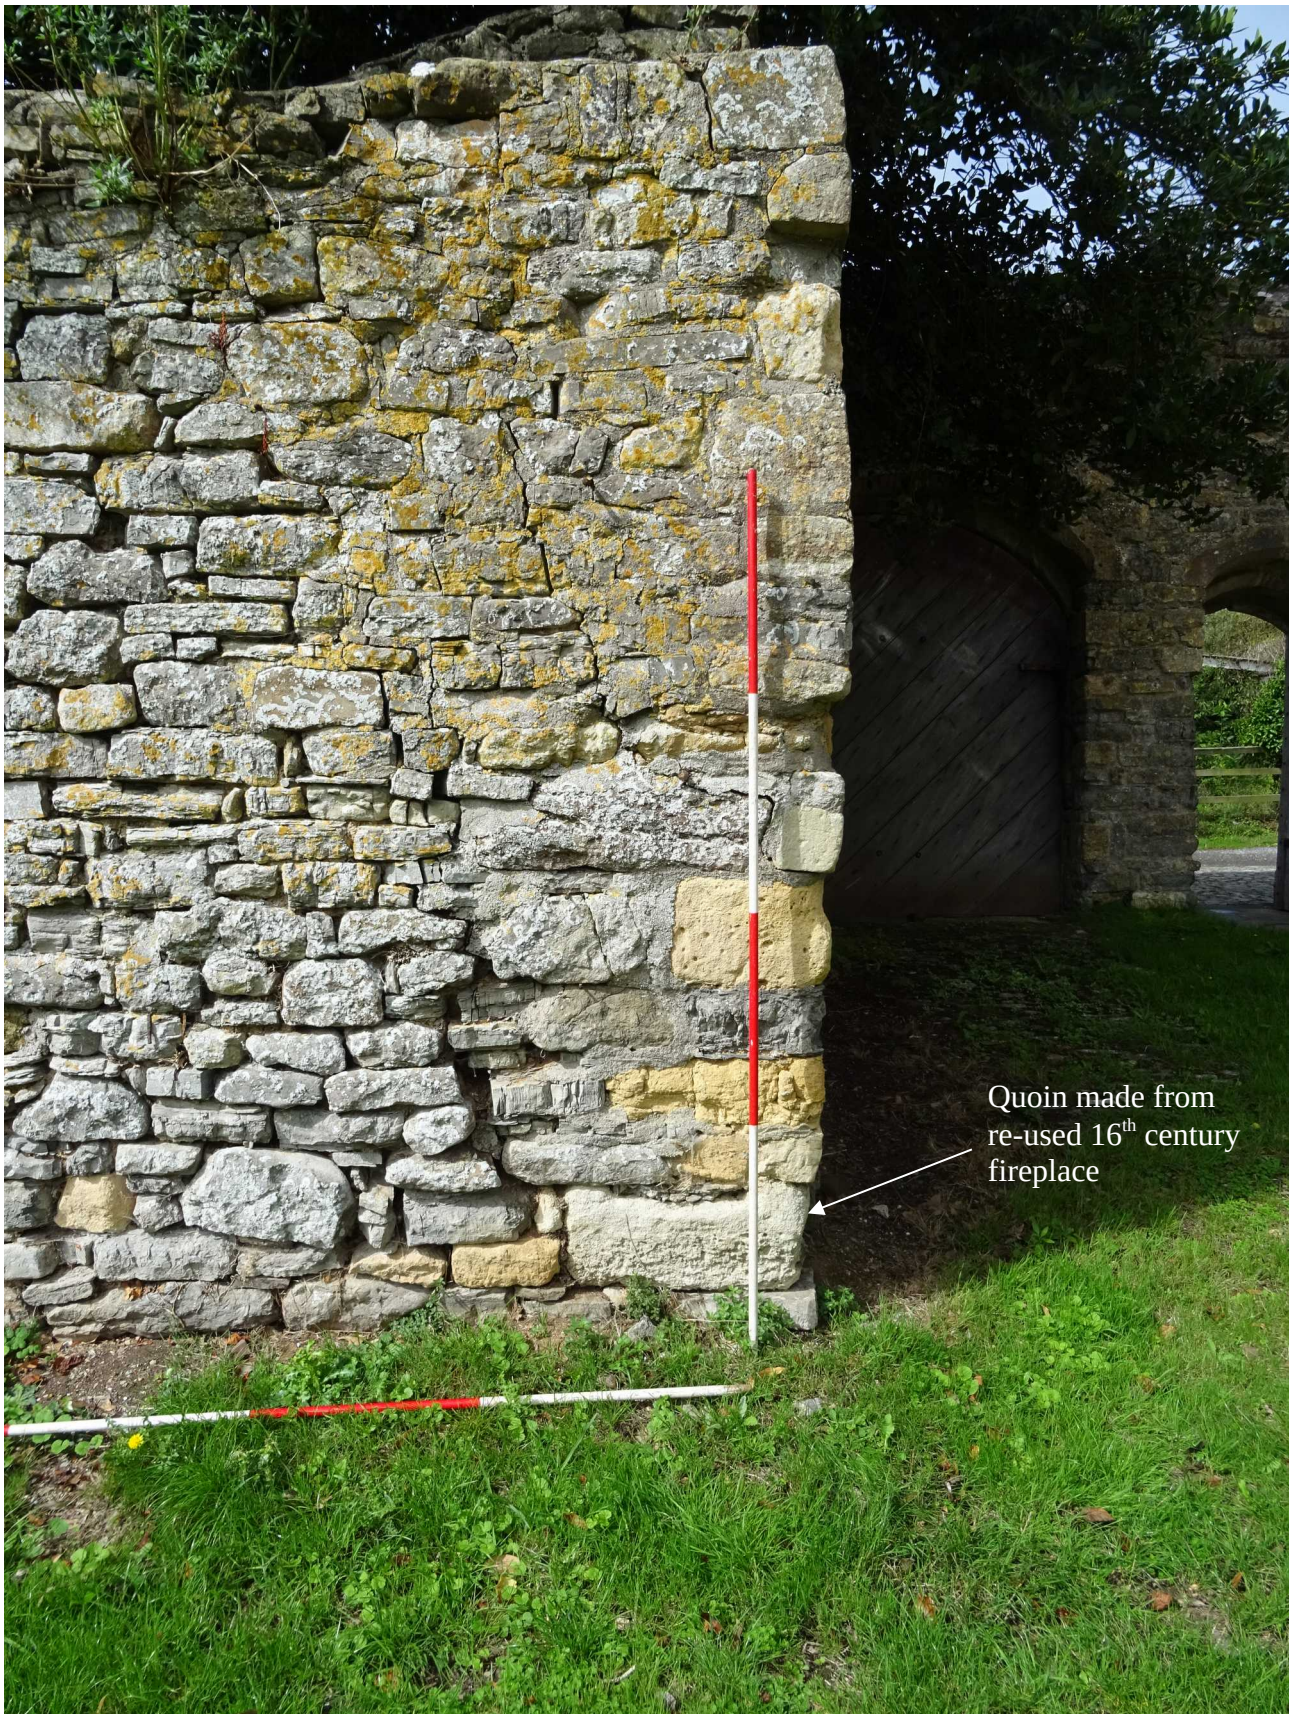
Evidence during the demolition revealed that root and water penetration had largely washed away the mortar from the top 1.5m of the wall, leaving loose stones in a matrix of dry brown dust, which could be picked out by hand.

The wall in general is a coursed and random rubble structure, largely of Blue Lias, with the use of freestone quoins, but also including small amounts of Pennant Sandstone. The wall has been repointed so thoroughly that nothing of the original mortar can be seen.

*Fig 8: Repair 2 site, section east-facing, August 2020*

The stonemasons made a rough tracing of the stones in their current positions, so they could be replaced as closely as possible to the present arrangement.

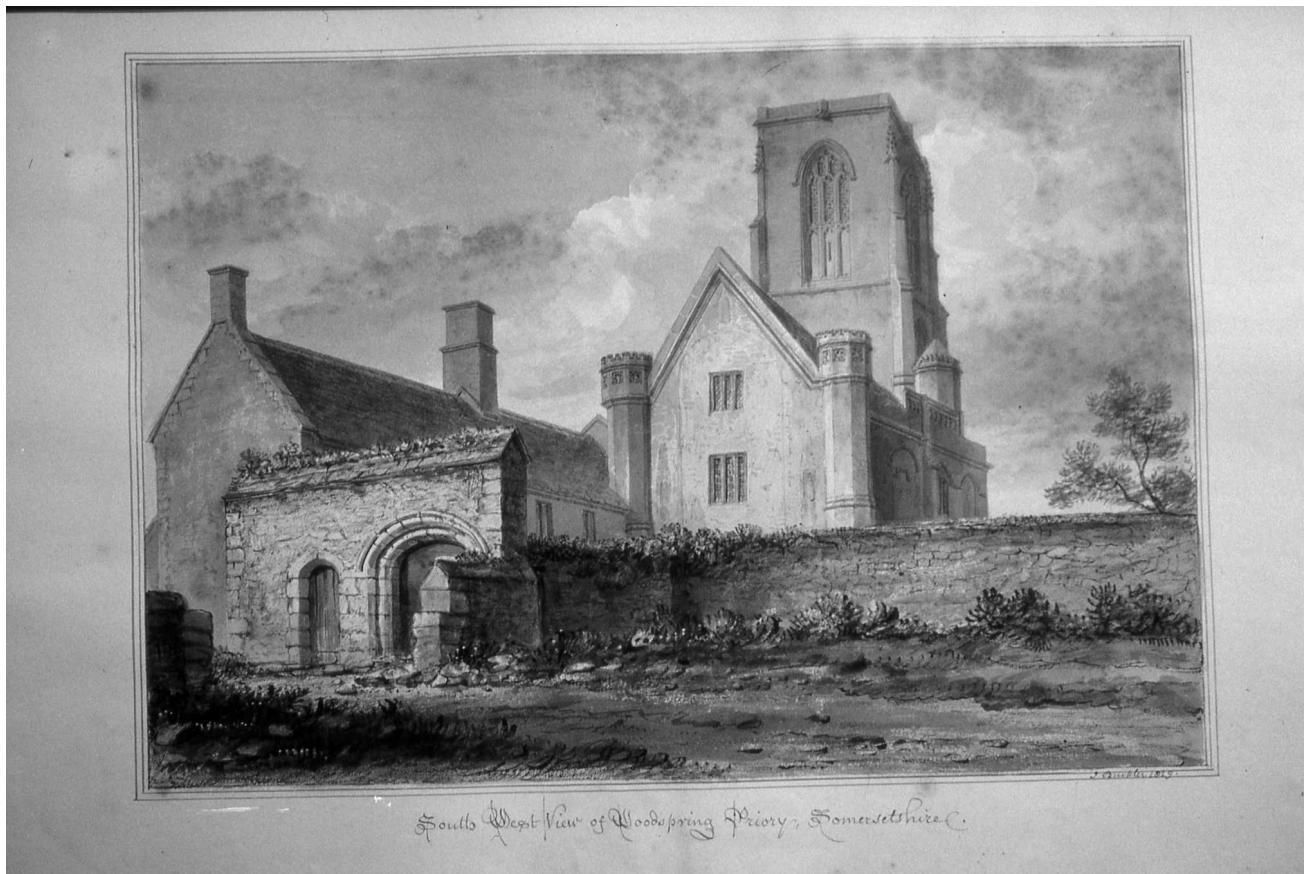
It was clear the wall had a complex history. Buckler's drawing of 1829 shows it as much lower (Fig 10 below): assuming this is not artistic licence to make features of the church and farmhouse visible, the wall has at some point been raised by at least a metre. Buckler's drawings are meticulous and correct: his interest in the site led to his being the architect for its restoration in the 1820s and 1830s.

*Fig 9: Buckler's drawing of 1829, showing a much lower wall at the site of repair 2 than today*

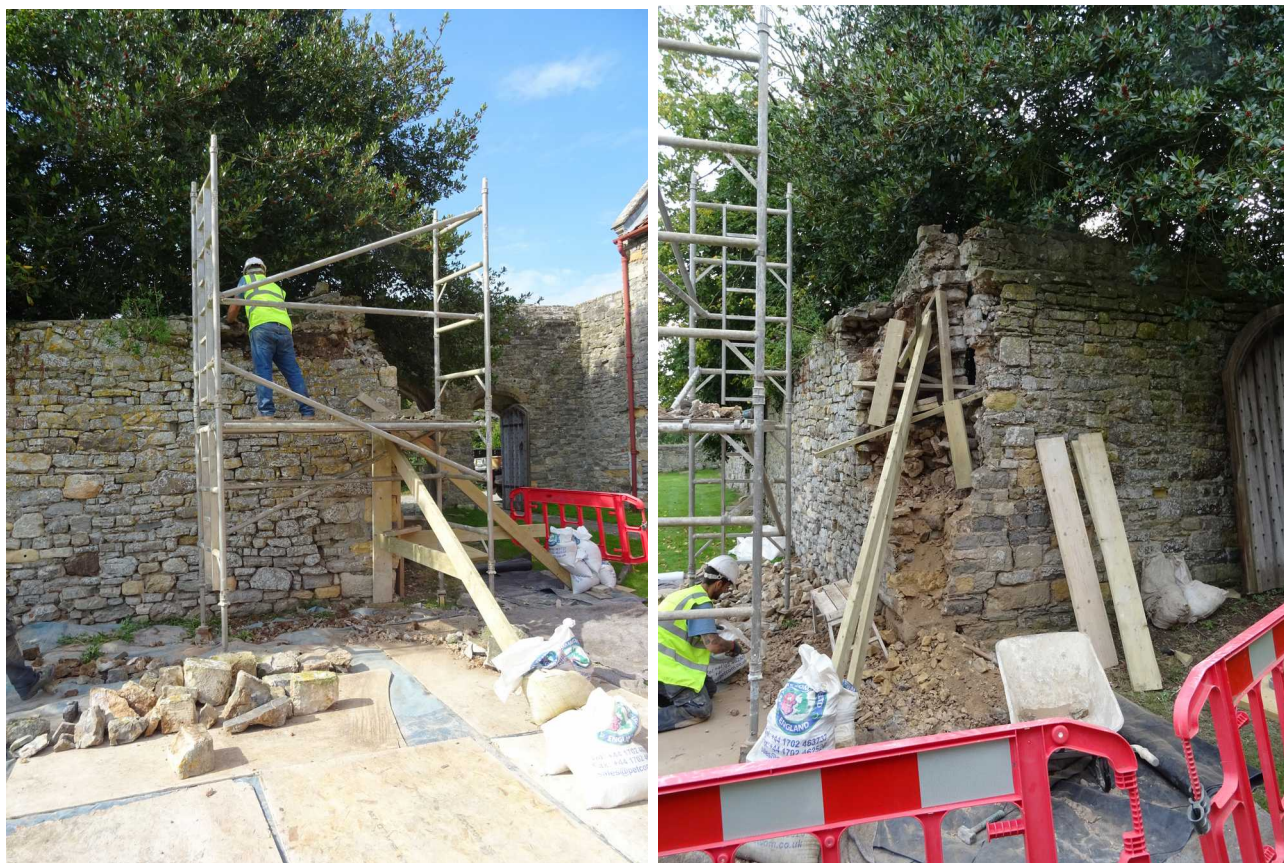
*Fig 10: Increasingly complex propping as demolition proceeds*

The demolition began by propping of the lower part of the wall to prevent collapse during demolition, and a more and more complex succession of internal props to hold the sound pieces of wall until the rebuilding.

The corner of the walls was demolished completely to ground level, and the rest back to sound structure before rebuilding (Fig 10).

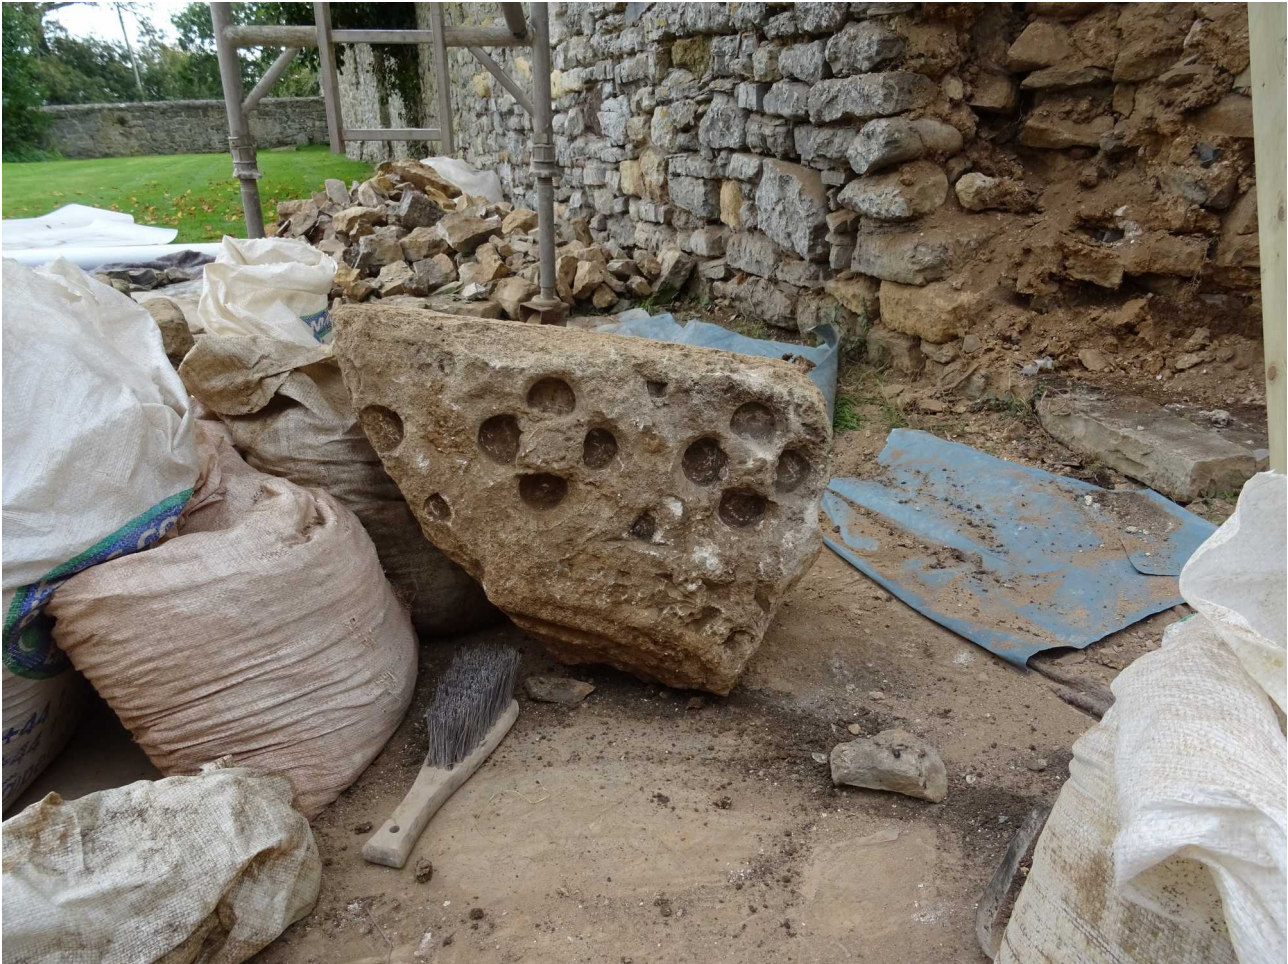
*Fig 13: Upper right corner of Tudor fireplace, with quatrefoil settings, corner vegetative spandrel and apparent 4-centred mouldings. Re-used as lowest quoin in the corner of the wall, where it can be clearly seen in Figs 8 and 9*

The stone is very worn, and may have been exposed to the weather, or even adapted for a different use subsequent to being a fireplace, as its back has been chiselled hollow (see Fig 17), possibly for use as a surface drain.

The stone is a maximum of 58cm across, 43cm high and 28cm deep. Some mortar is retained in the photographs, because (ironically) this was concrete hard and was deliberately not removed for fear of damaging the stone further.

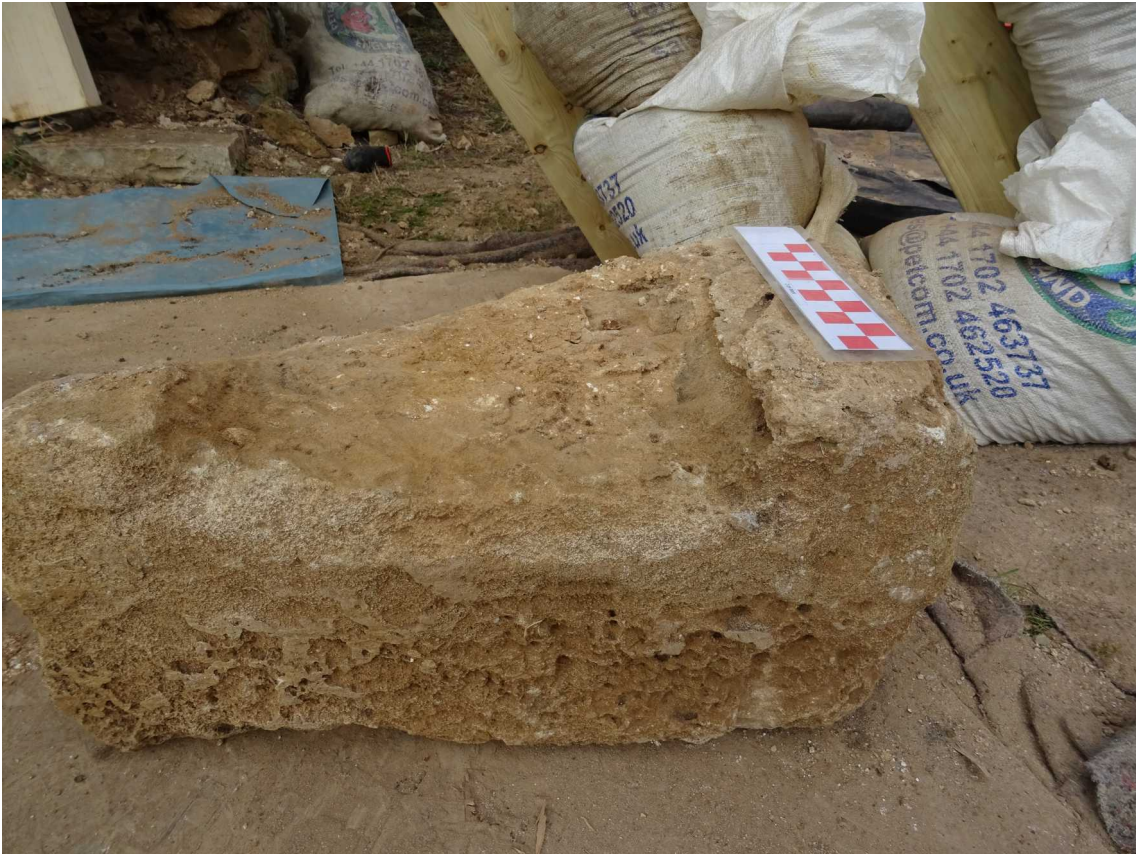
*Fig 17: Crudely hollowed out back face of stone.*

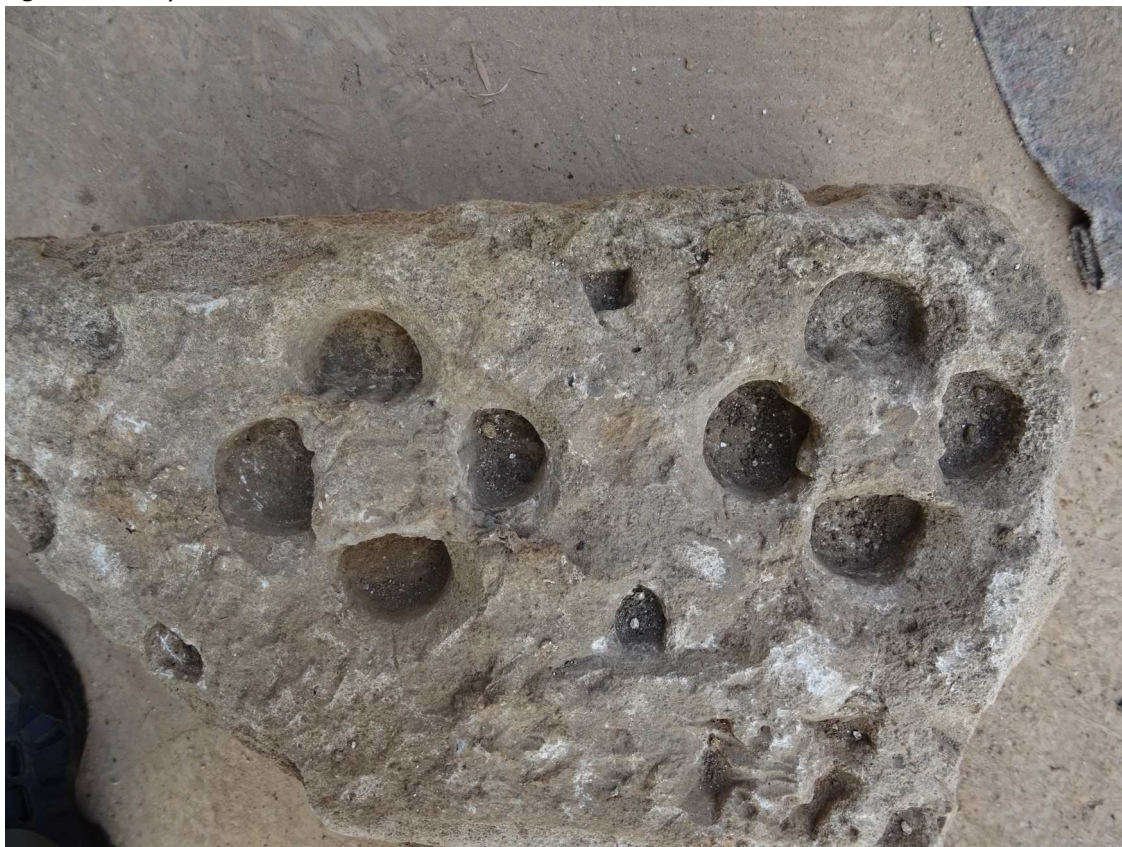
*Fig 18: Close-up of quatrefoils and damage to face of stone*

The quatrefoils have deep hollows with flared rims: could these have held affixes? There seems from the faint marks on the lower edge of the face, some attempt to either mutilate the stone, or possibly, to prepare it for plastering over.
