Observations on wall repairs at Woodspring Priory, Kewstoke, North Somerset

**YATTON, CONGRESBURY, CLAVERHAM AND CLEEVE ARCHAEOLOGICAL
RESEARCH TEAM (YCCCART)**

Collapsed section of wall on east side of cloister, Woodspring Priory

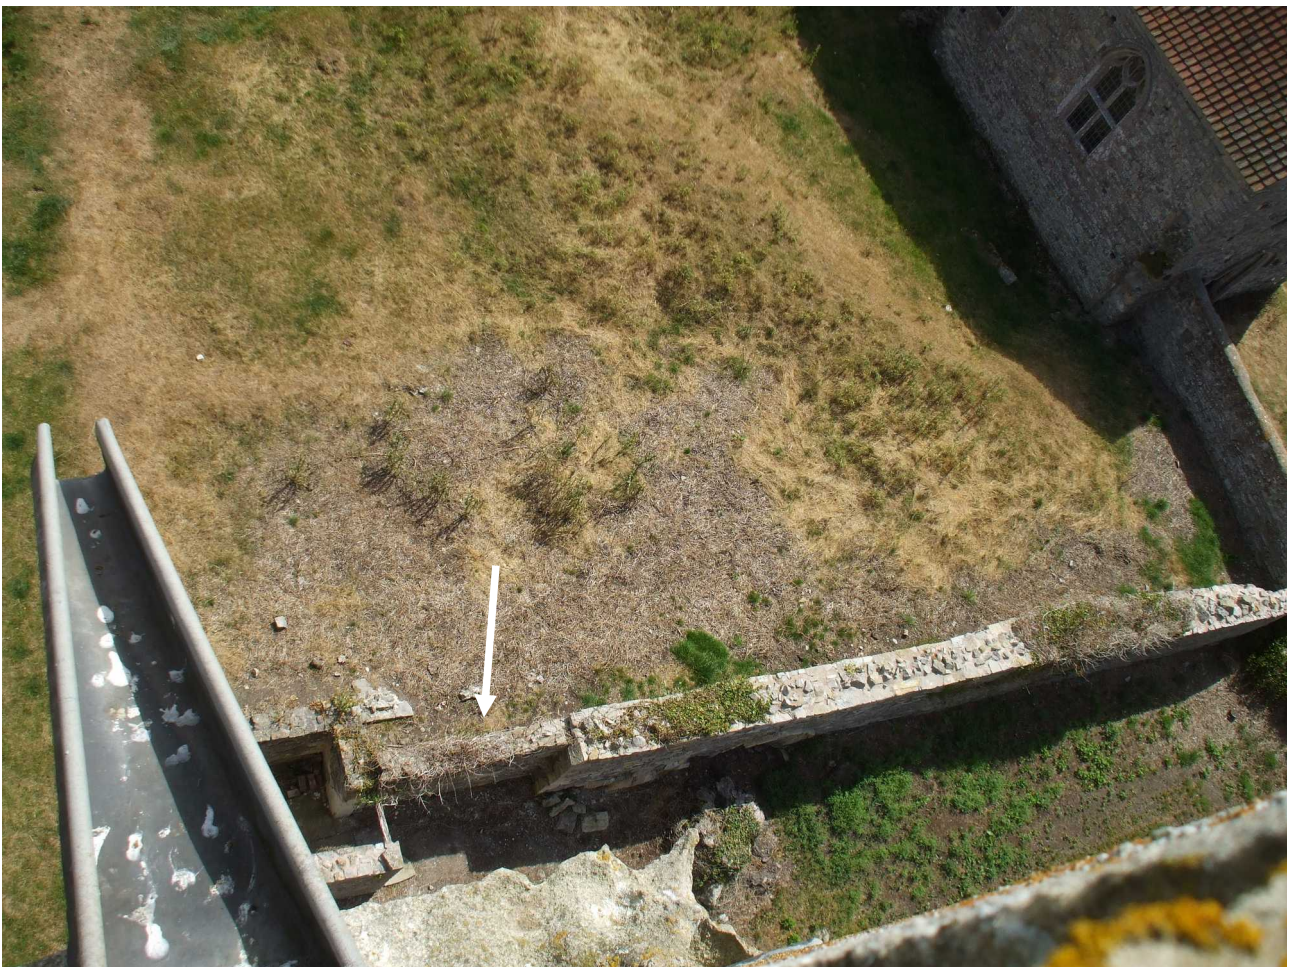
The first was a section of wall on the north-east side of the cloister, where a section of wall had collapsed, almost to the full width of the wall. The wall seems to have been tacitly assumed to be of medieval origin in the past. The view from the church tower in 2013, however, shows it to be different in width from the adjacent chapter-house wall (Fig 3).

Fig 3: Wall repair 1: Photograph taken in 2013 from church tower

On the ground, it can be clearly seen to be butted up against the two adjoining buildings, including the Chapter house wall on its south.

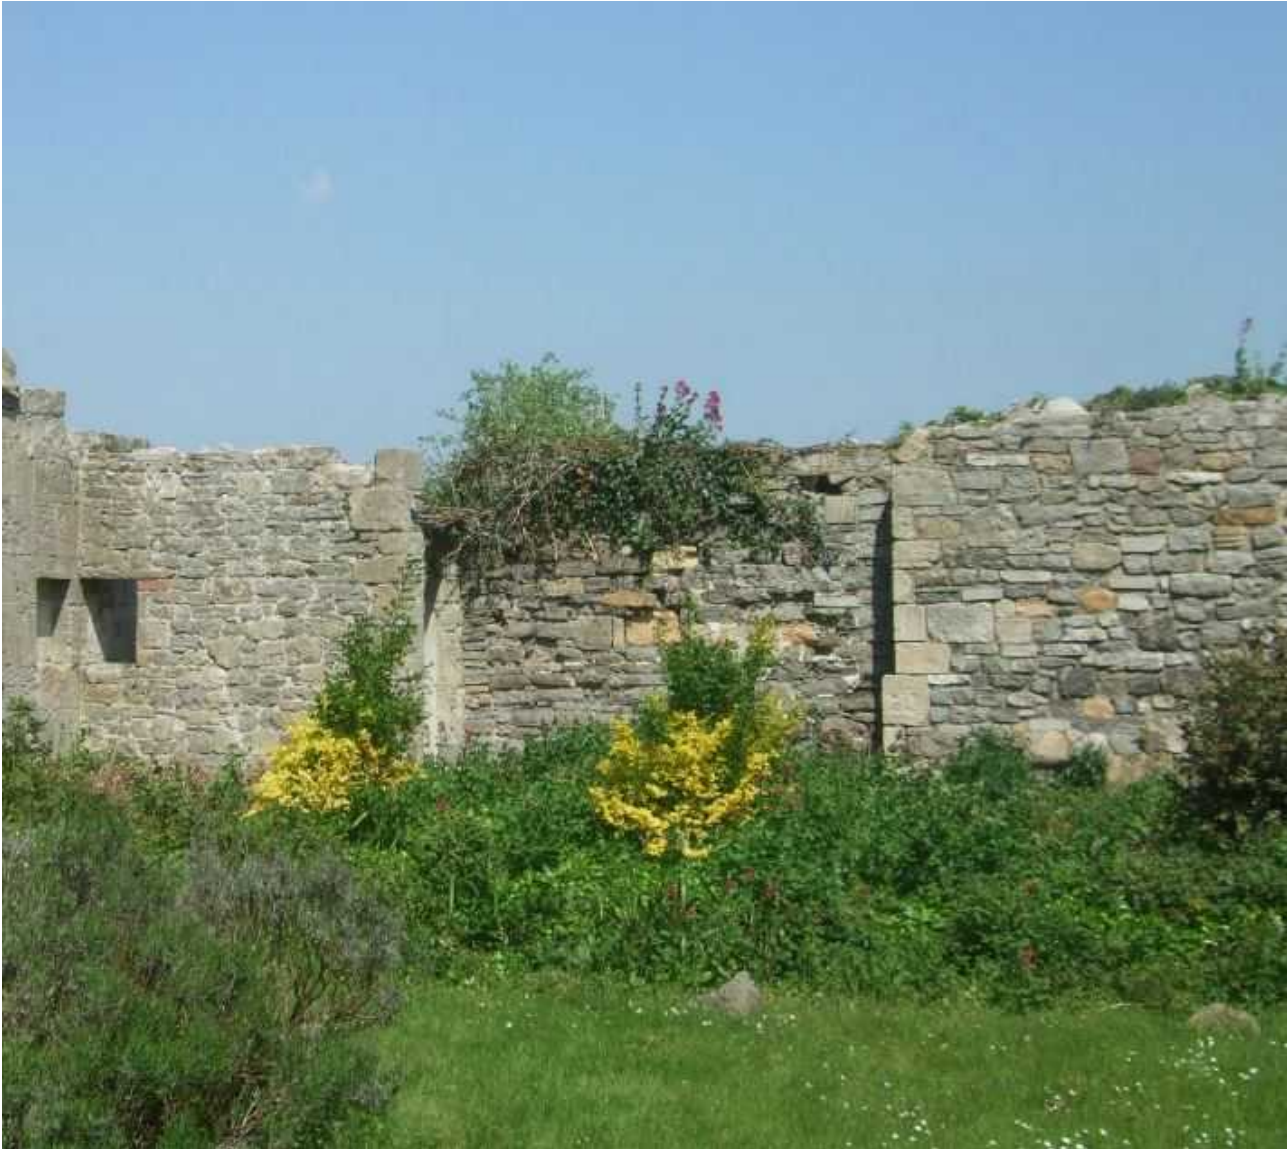
The top of the wall was quite heavily vegetated at the time, as can also be seen from a ground photograph of 2012 (Fig 4).

Fig 4: Wall 1 in 2012, vegetated, but pre-collapse

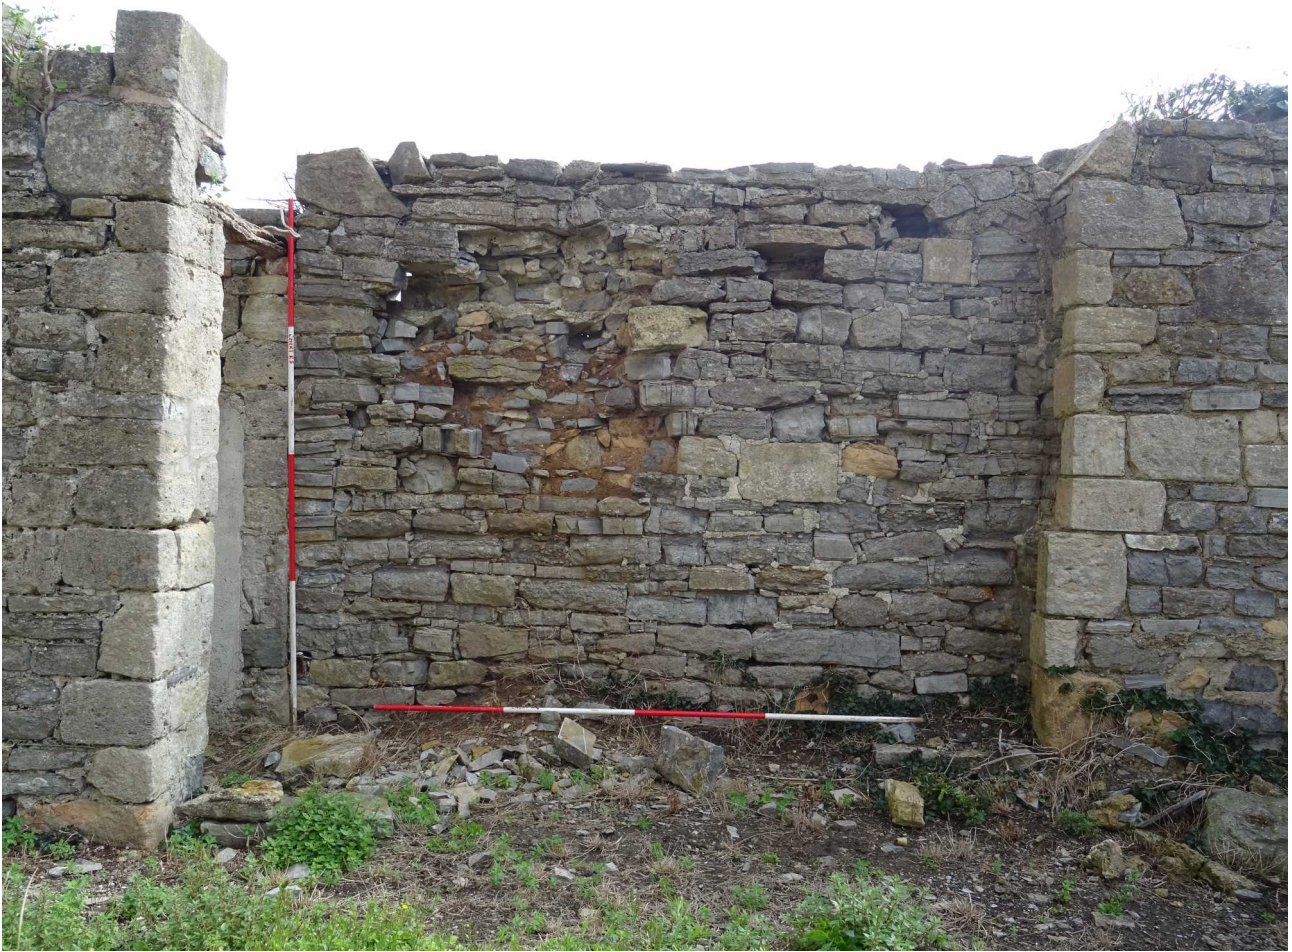
By 2020, however, a collapse of the face of the wall had occurred.

On close examination, it was clear that the wall was not of the same age as the adjoining chapter house wall, but seems to have been created to stop up a gap in the wall where the sacristy had once stood, something understood to have been demolished at, or soon after, the Reformation (Tomalin and Crook 2007: 38).

On closer examination (Fig 5-6), the wall can be seen to butt against the buildings on either side. It's lower part is bonded with a yellowish-red (5YR 5/6) earth, with occasional lime flecks. The upper third, however, consists of an initial pour of a white hard mortar (Gley 1 8/N), and the stones above are bound with the same mortar.

Fig 5: Collapsed face of wall, August 2020

After discussions with Landmark Trust and Orchard Stonemasons, it was agreed that the wall would be subject to repair and building up only, with no associated demolition.

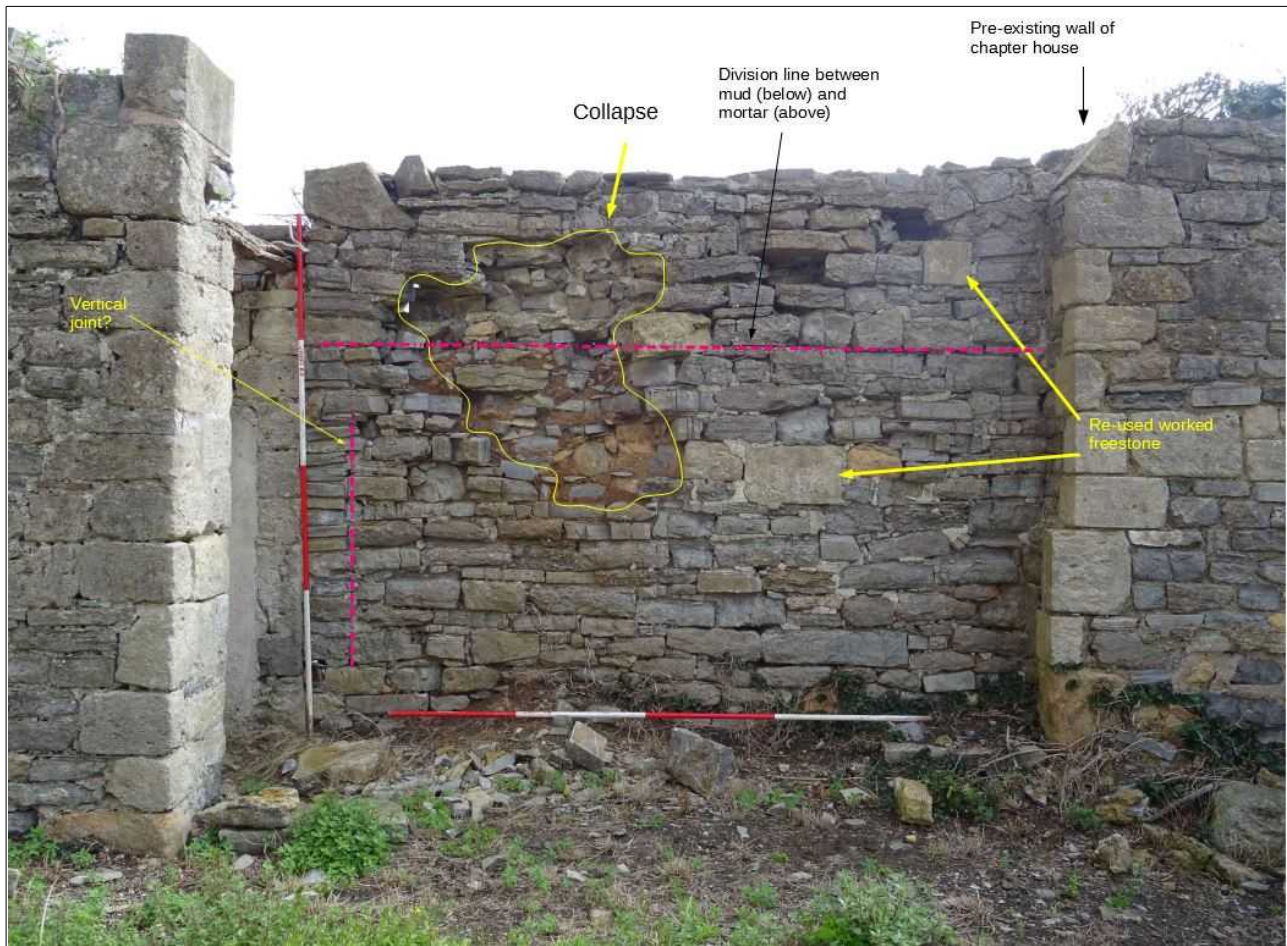
The radical difference in the bonding of the two sections of wall may imply some passing of time between them, but the hard mortar is not intrinsically datable, other than to say it does not seem to appear elsewhere in the Priory.

Fig 6: Analysis of wall and collapse

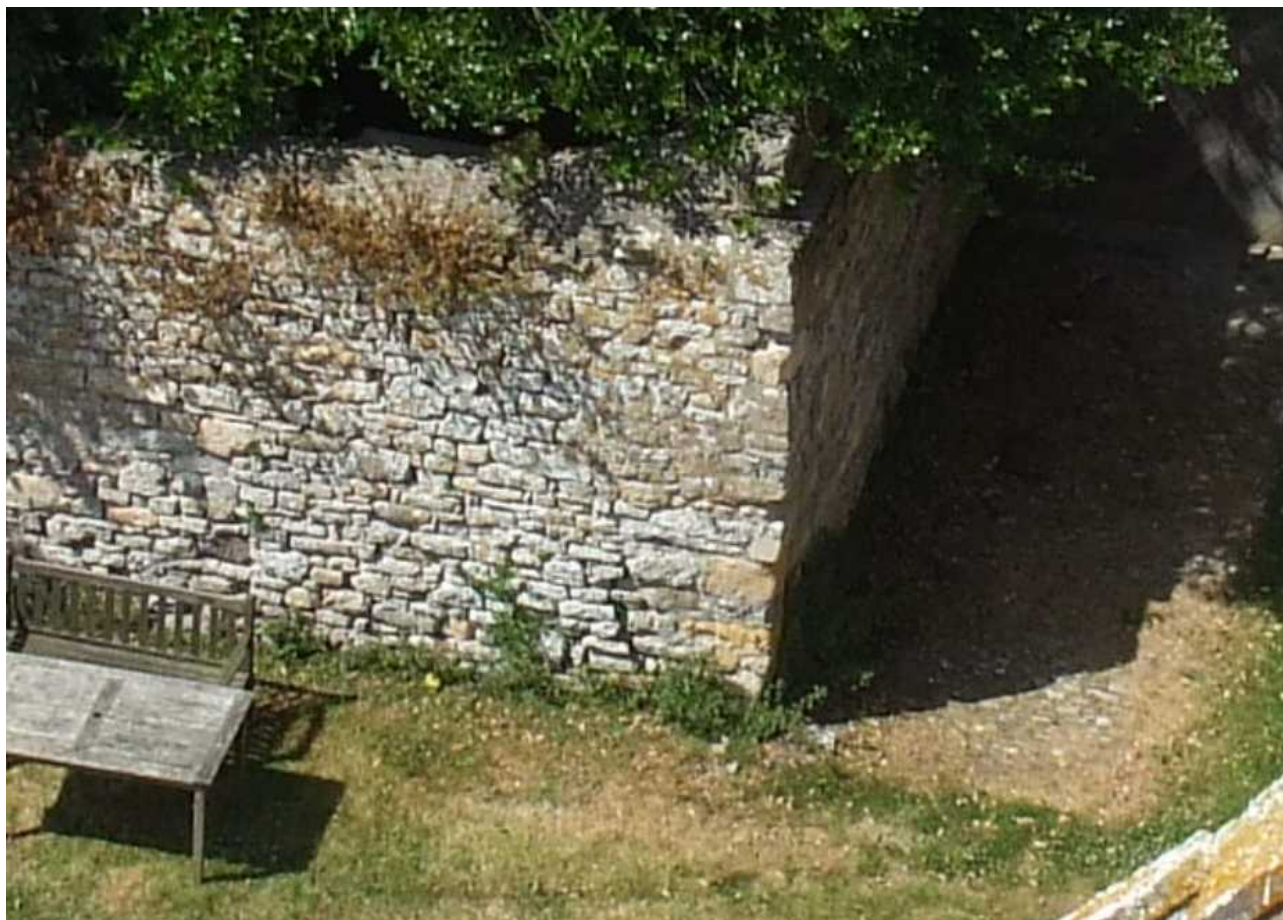
Cracks in this wall corner were already evident in 2013 (Fig 7)

Fig 7: Site of repair 2 from church tower, 2013

The alarming crack on both sides of the corner were beginning to cause serious fears of collapse by 2020, and a programme of controlled demolition and rebuilding of the corner, including internal steel clamps to prevent recurrence of the problem was agreed.

The demolition (entirely by hand) was to remove the corner loose stones back to solid surface, and prop this until the corner could be rebuilt.

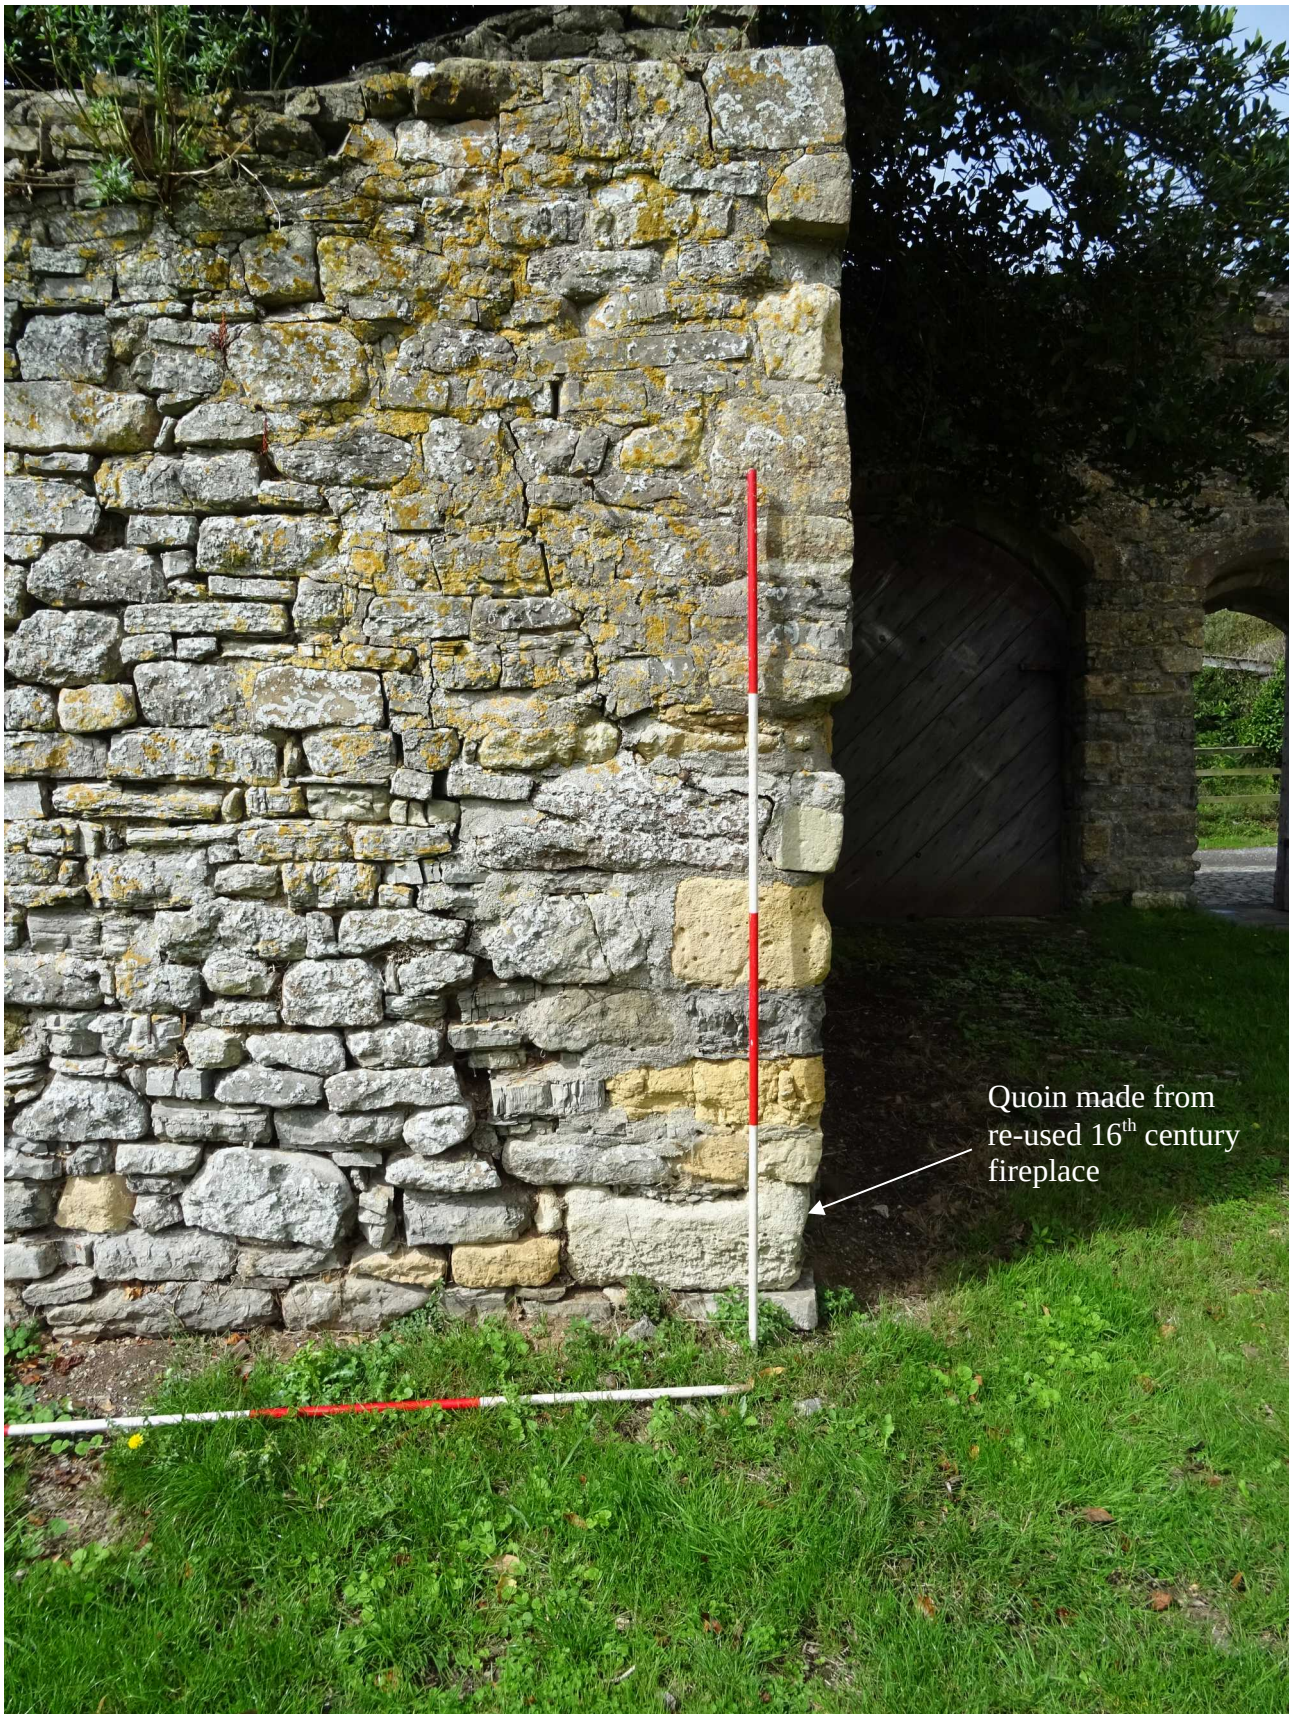
Evidence during the demolition revealed that root and water penetration had largely washed away the mortar from the top 1.5m of the wall, leaving loose stones in a matrix of dry brown dust, which could be picked out by hand.

The wall in general is a coursed and random rubble structure, largely of Blue Lias, with the use of freestone quoins, but also including small amounts of Pennant Sandstone. The wall has been repointed so thoroughly that nothing of the original mortar can be seen.

Fig 8: Repair 2 site, section east-facing, August 2020

The stonemasons made a rough tracing of the stones in their current positions, so they could be replaced as closely as possible to the present arrangement.

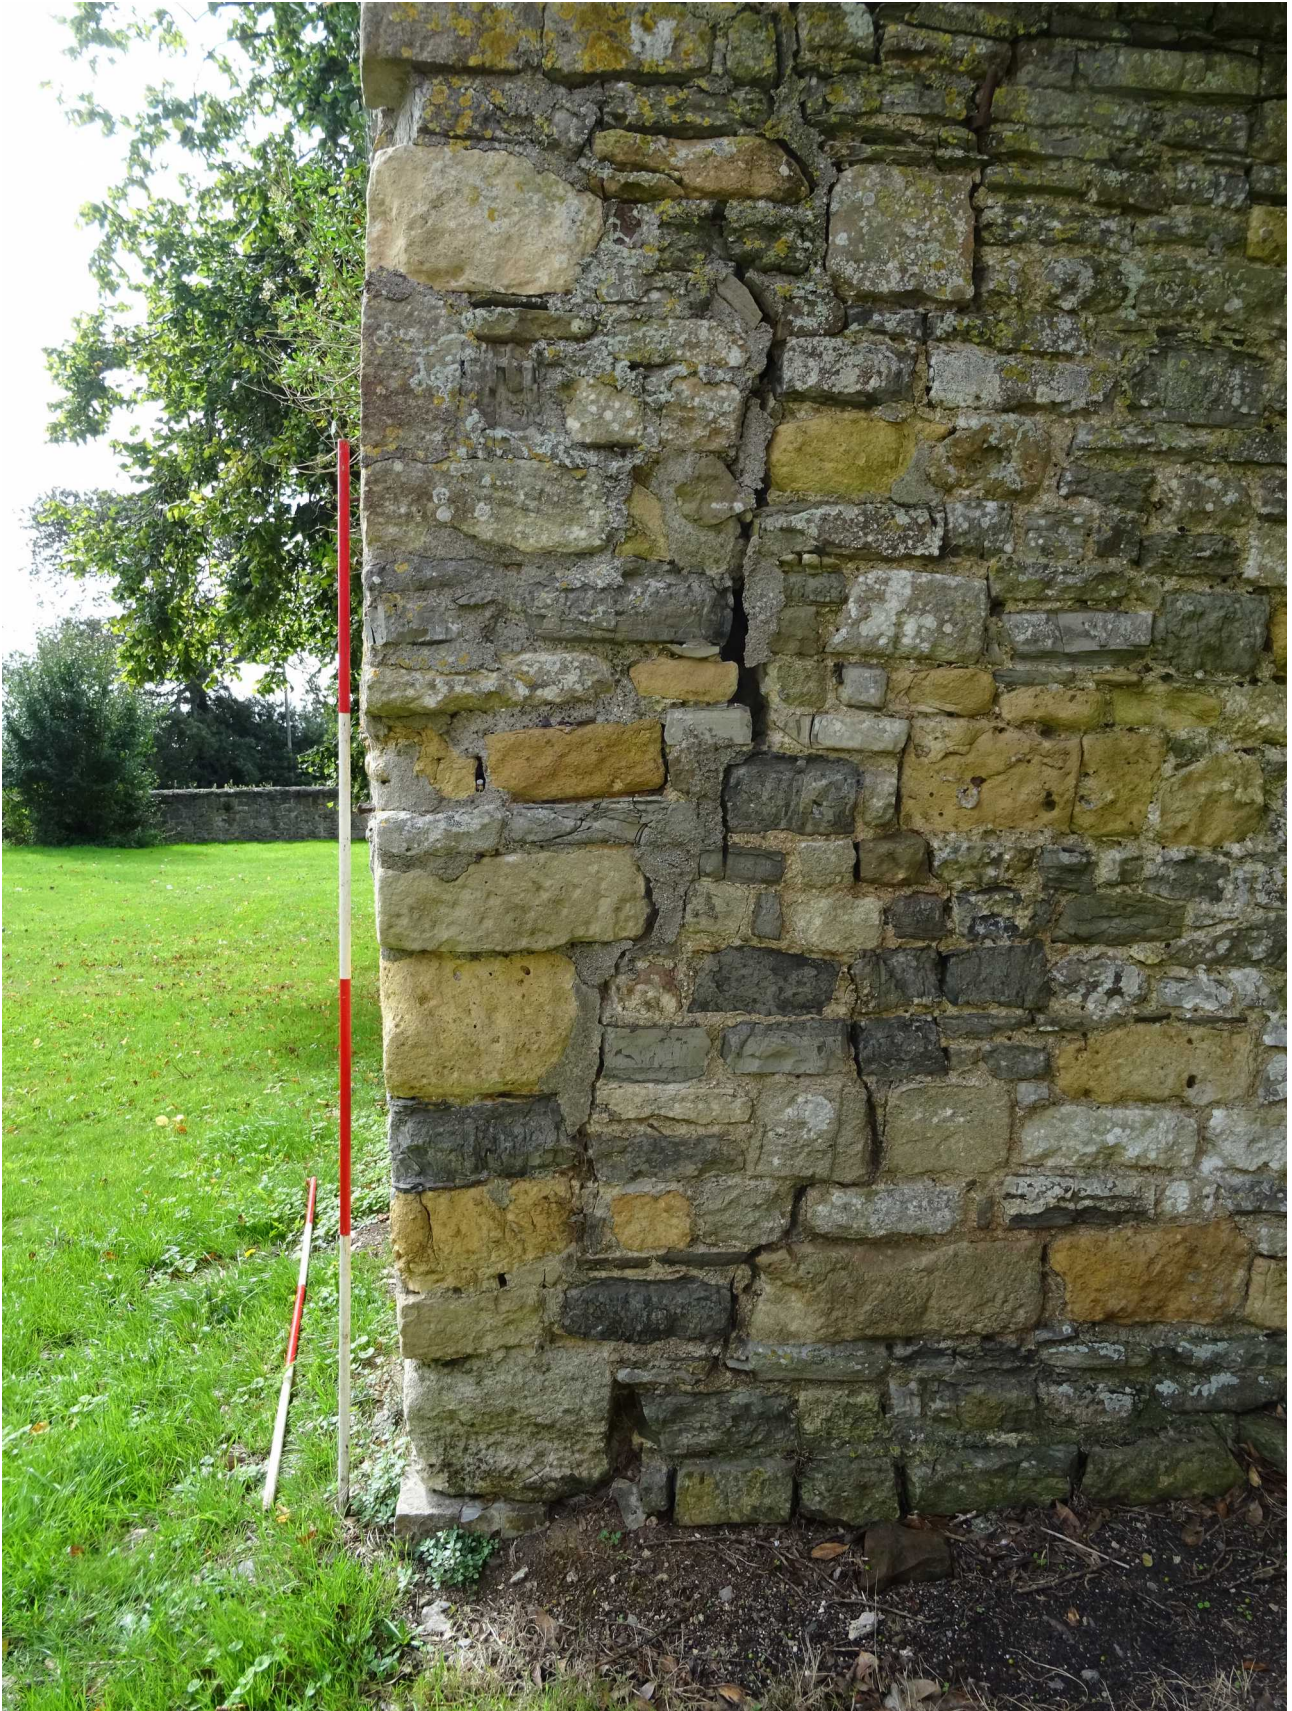
Fig 9: Repair 2 site, north-facing section, August 2020

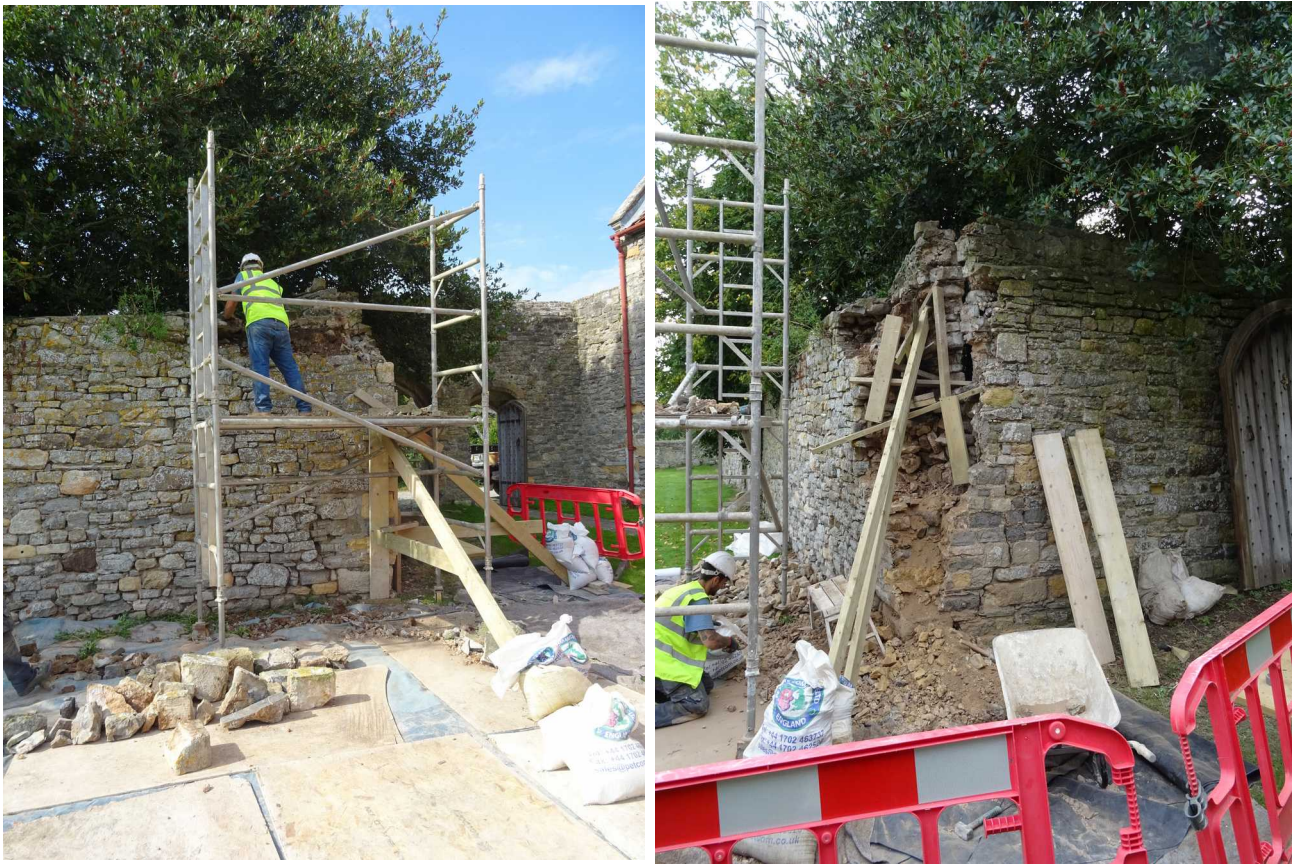
Fig 10: Increasingly complex propping as demolition proceeds

The demolition began by propping of the lower part of the wall to prevent collapse during demolition, and a more and more complex succession of internal props to hold the sound pieces of wall until the rebuilding.

The corner of the walls was demolished completely to ground level, and the rest back to sound structure before rebuilding (Fig 10).

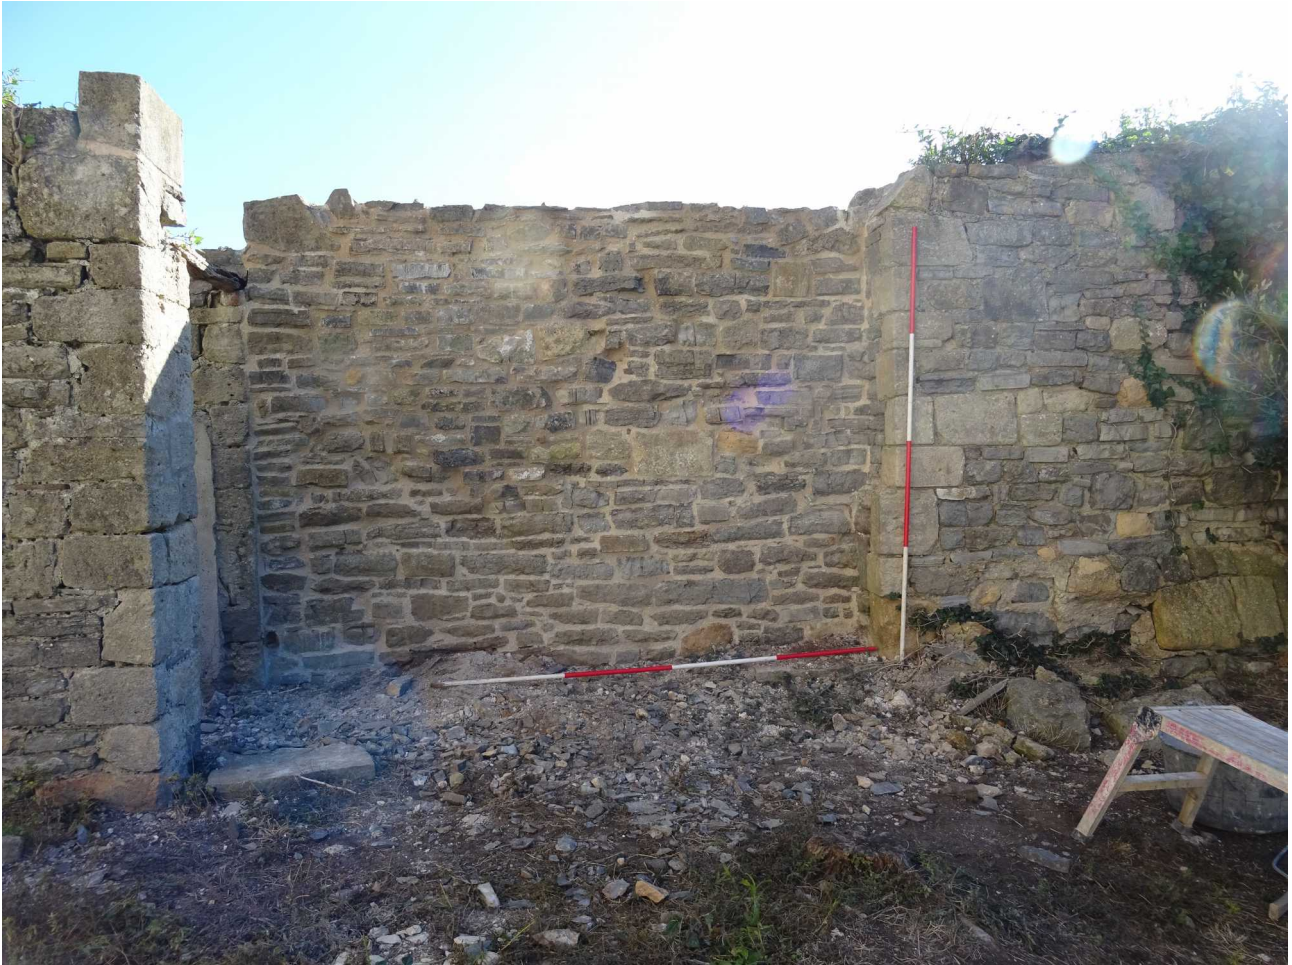
Fig 19: Wall 1 repaired

As expected, the finished result at this site has restored it to the condition seen in 2012 (Fig 4 above), although the difference between the two mortars seen in August 2020 is no longer visible.

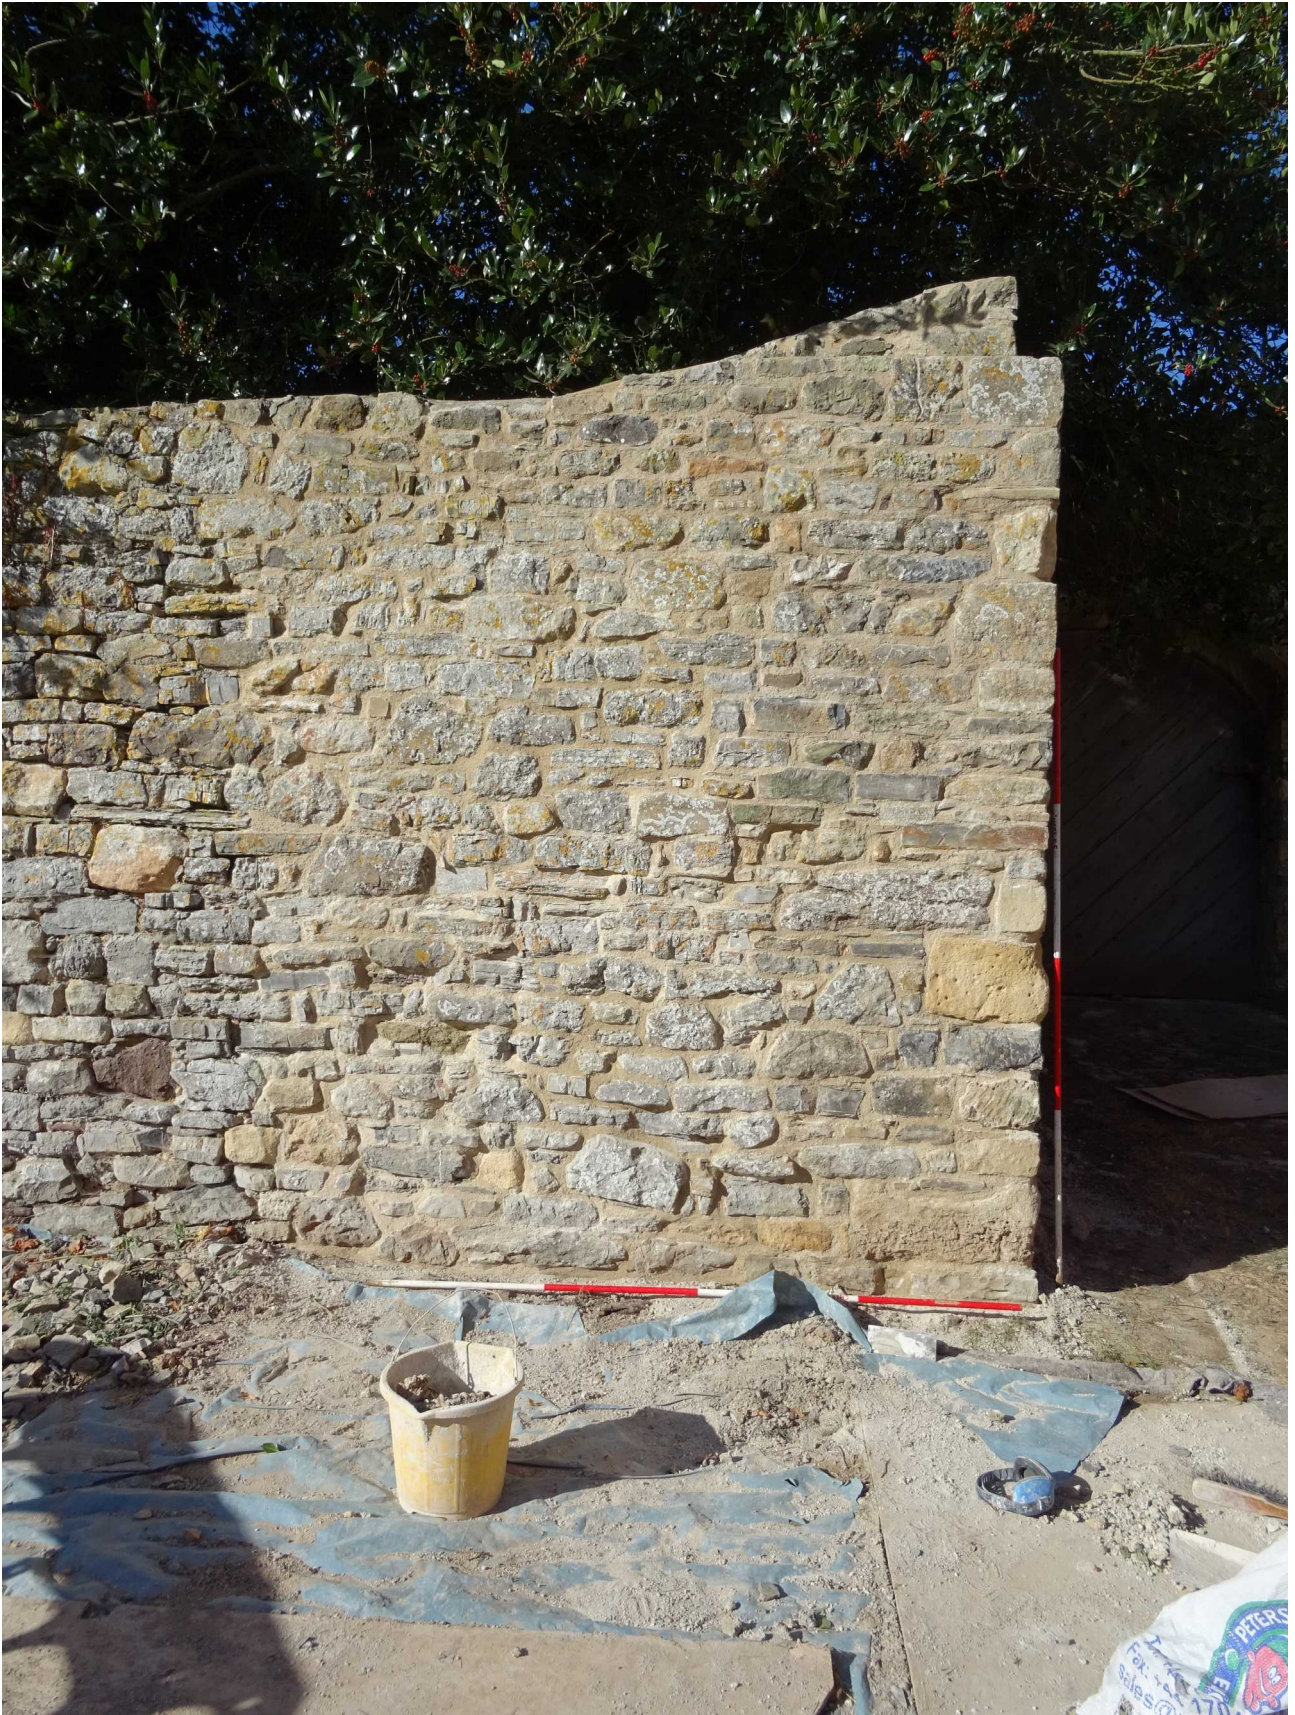
Fig 20: Wall 2 east-facing section repair

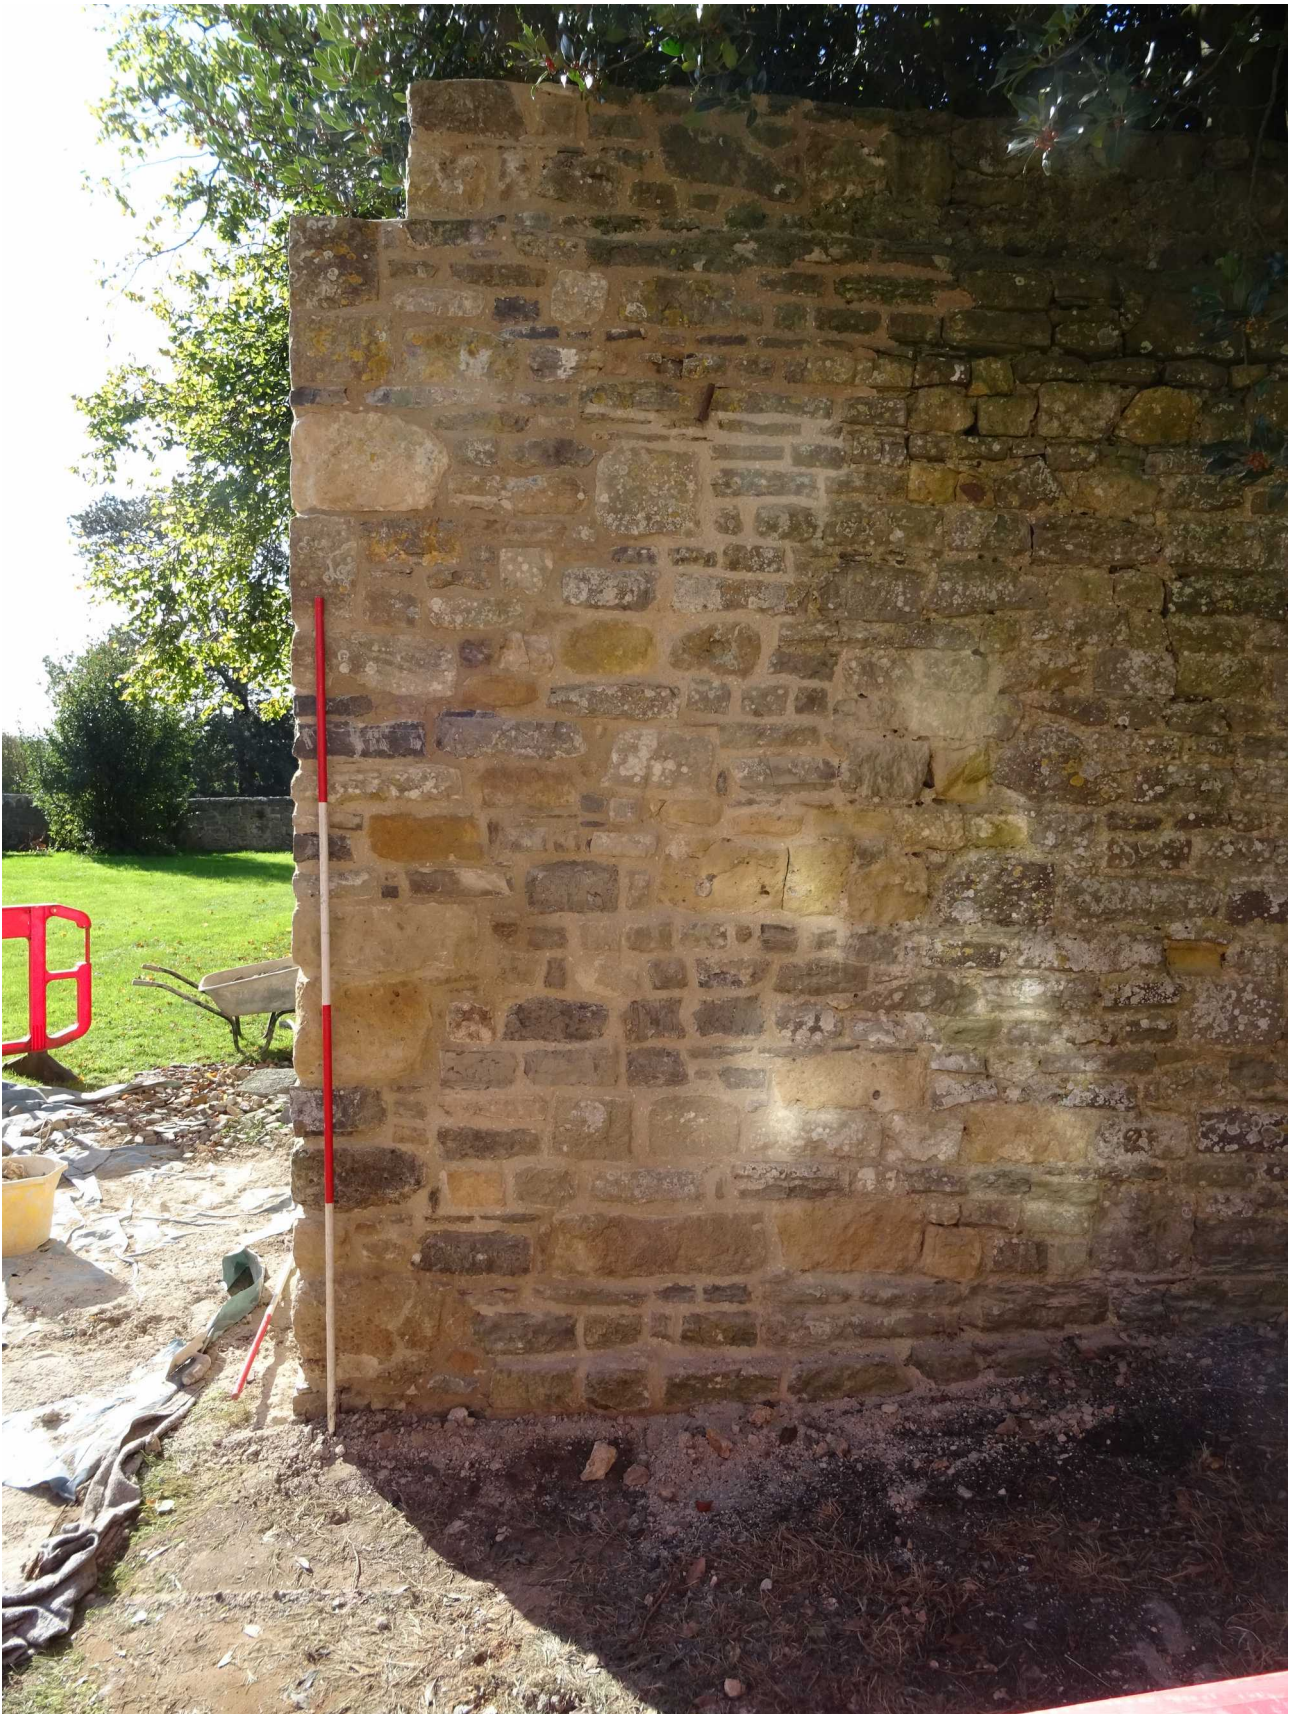
Fig 21: Wall 2 north-facing section repair (the spots of light are due to reflection from the farmhouse windows)
