YCCCART 2022/Y11

**Watching brief for Landmark Trust on wall repairs at Woodspring Priory
2021-2022 Reports: PART 1 Introduction and walls 1 - 7**

**YATTON, CONGRESBURY, CLAVERHAM AND CLEEVE ARCHAEOLOGICAL
RESEARCH TEAM (YCCCART)**

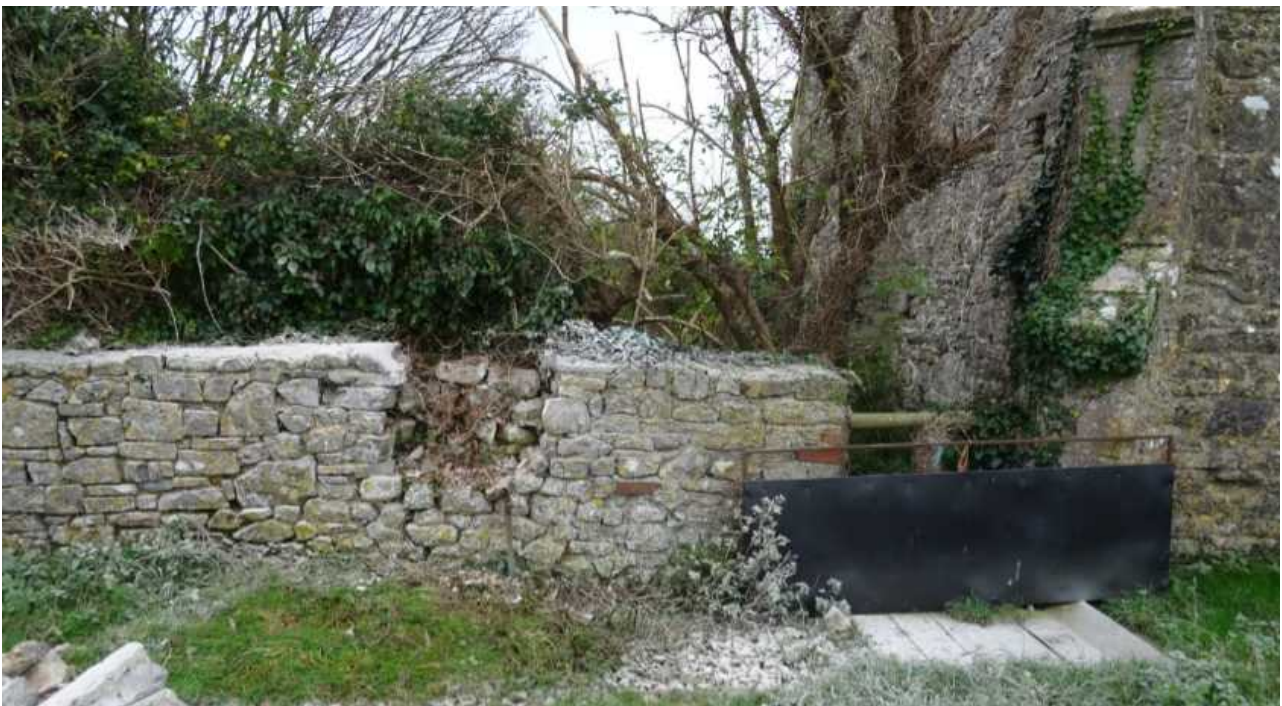
Only one major repair was carried out on this wall: a roughly square area in elevation, approximately 1.8m from the wall's western end. This was cleared and repointed (see Figs 9 and 10 below).

Fig 9: Defect in wall 1, November 2021

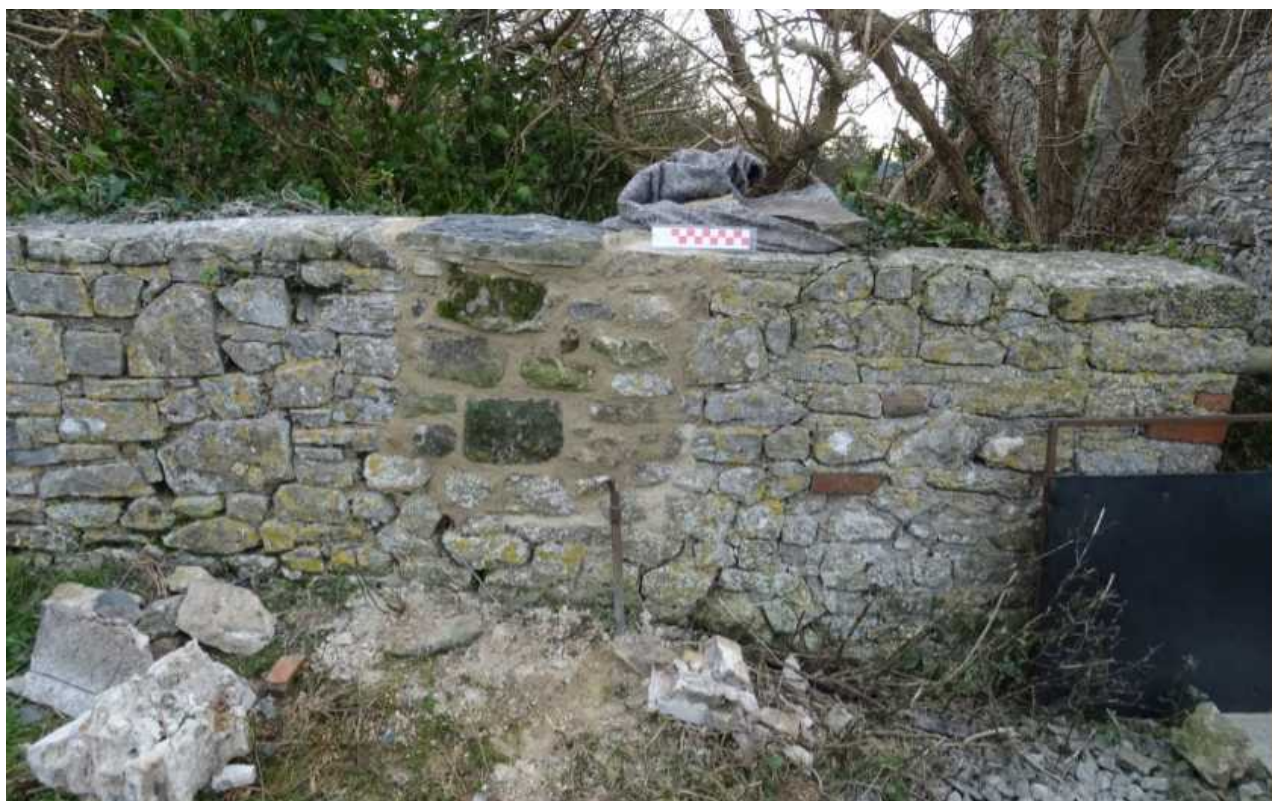
Fig 10: Wall defect as repaired November 2021

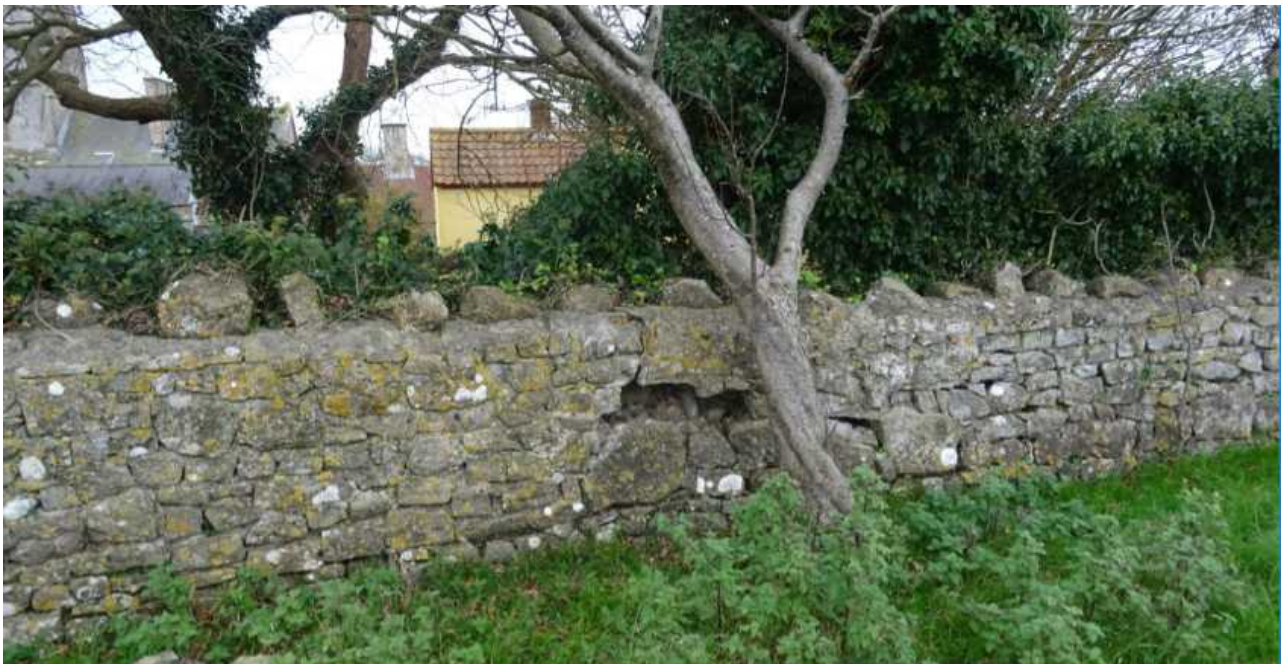
A single defect in this wall was rebuilt and repointed.

Fig 12: Defect in wall 2 (Woodspring Cottage is yellow building)

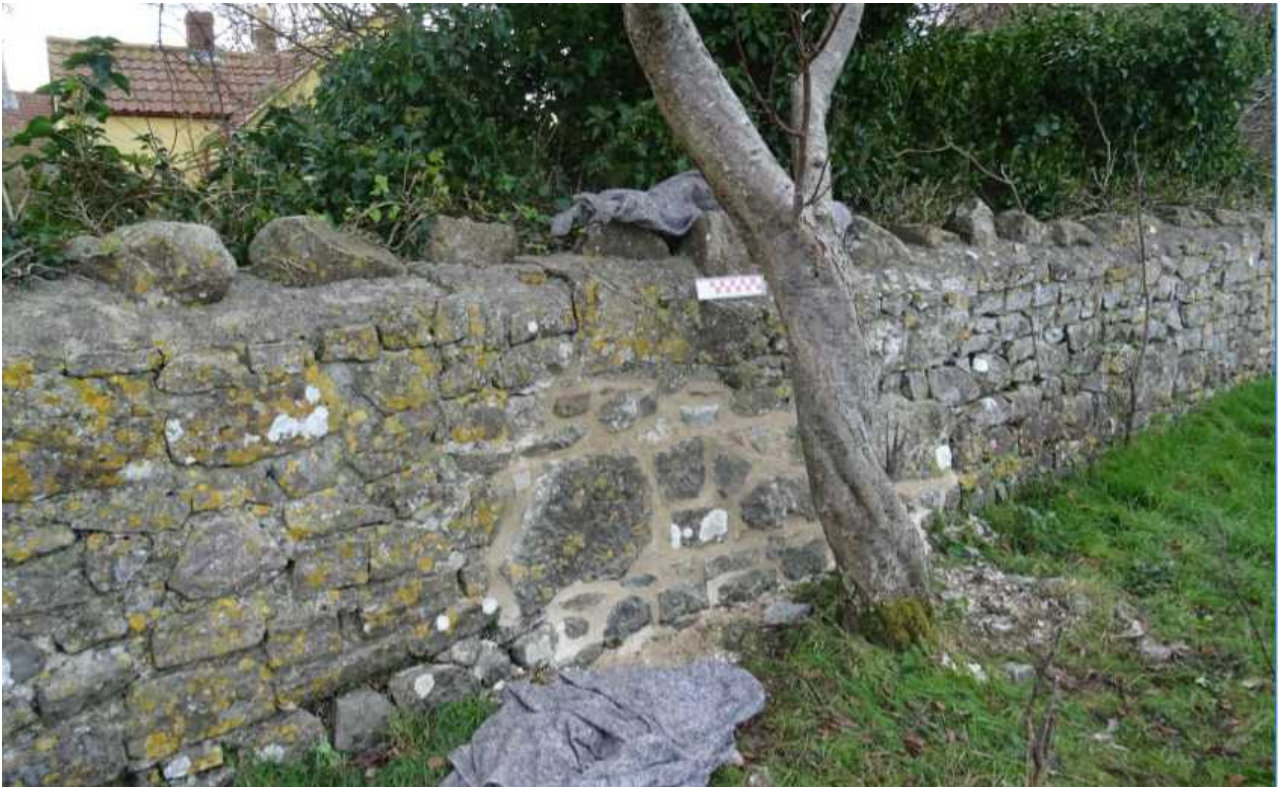
Fig 13: Wall 2 defect as repaired

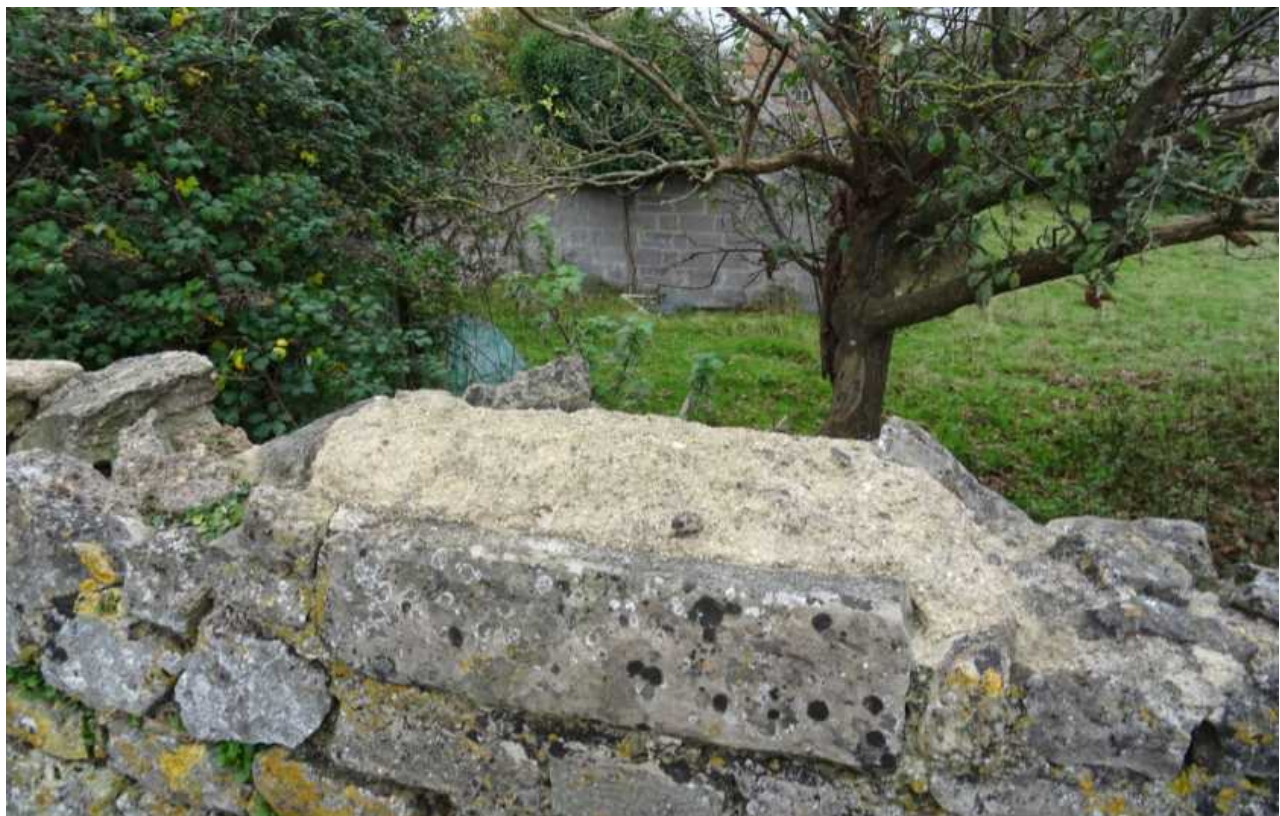
In addition, a section of wall approximately 1m long was recorded, where a squared freestone block with bevelled edges was laid along the top of the wall and capped with a semi-cylindrical mortar topping (Fig 14 below).

Fig 14: Unusual block-and-mortar structure in top of wall 2

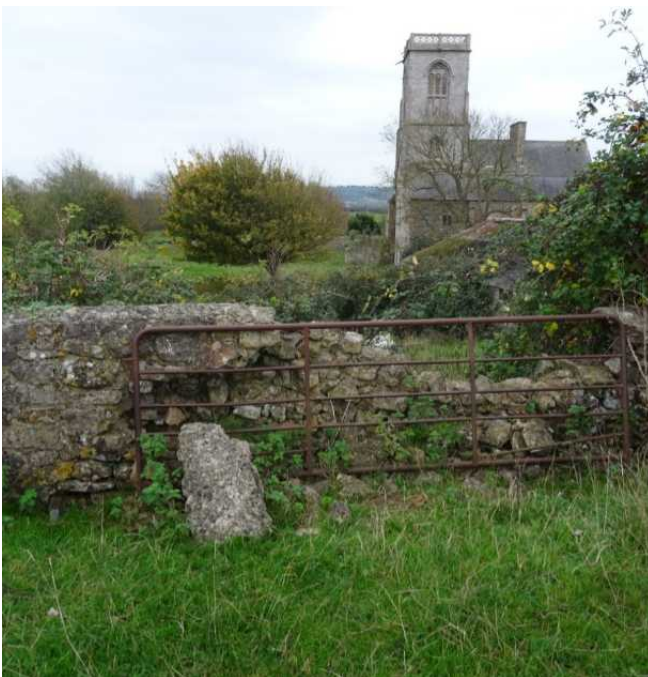
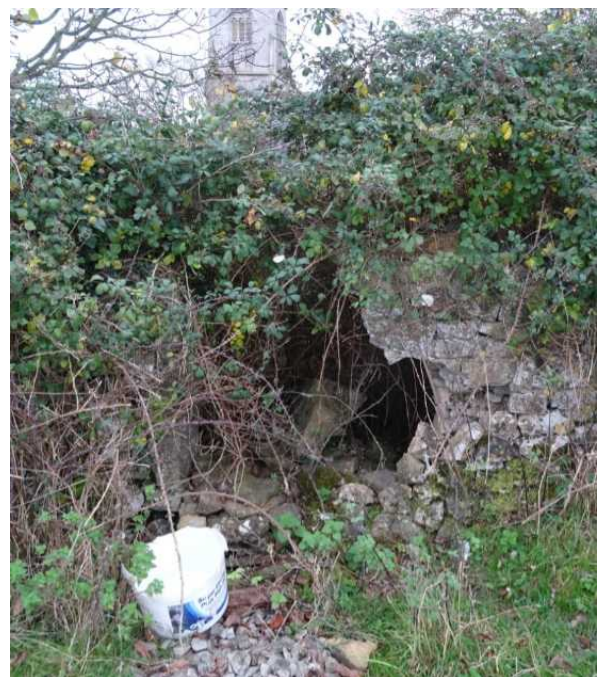
Defects to wall 3 were largely loss of surface mortars, repaired by repointing: two larger defects (Fig 16 below) also occurred.

Fig 16: Two major defects in wall 3

These were repaired during winter 2021-2022.

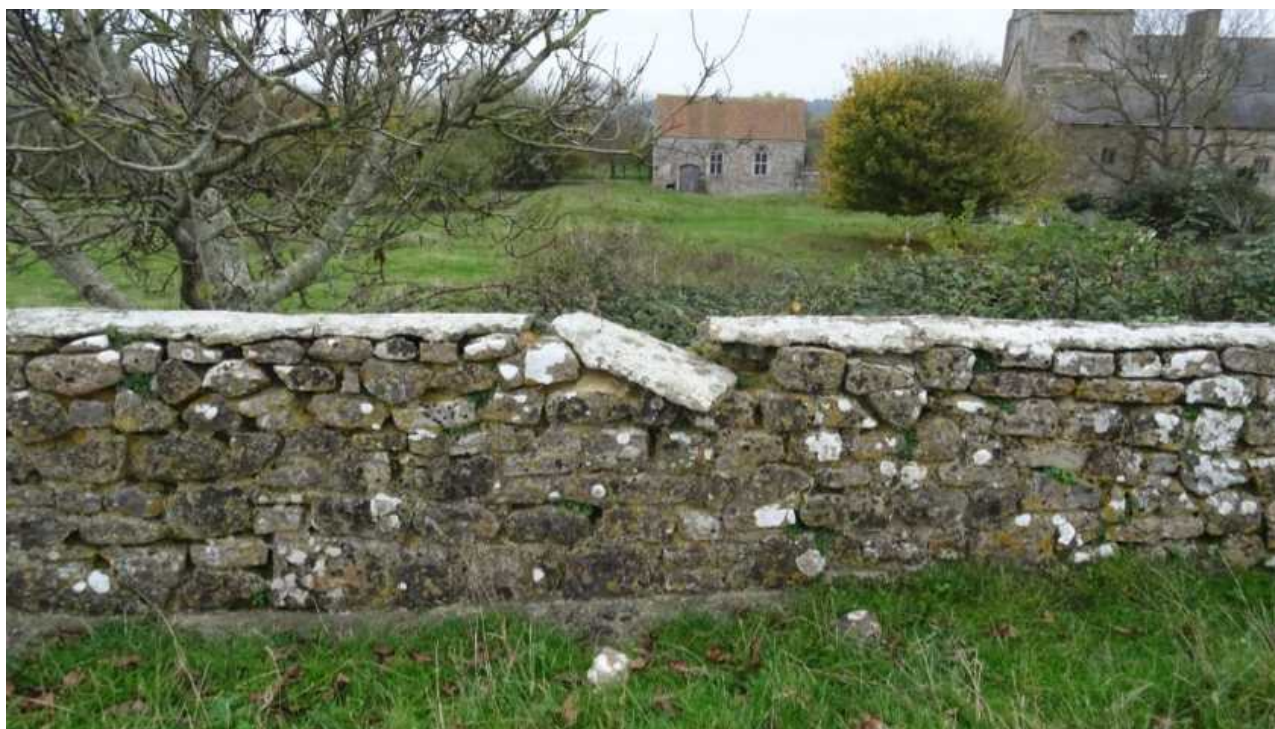
Fig 17: Minor defect in wall 3

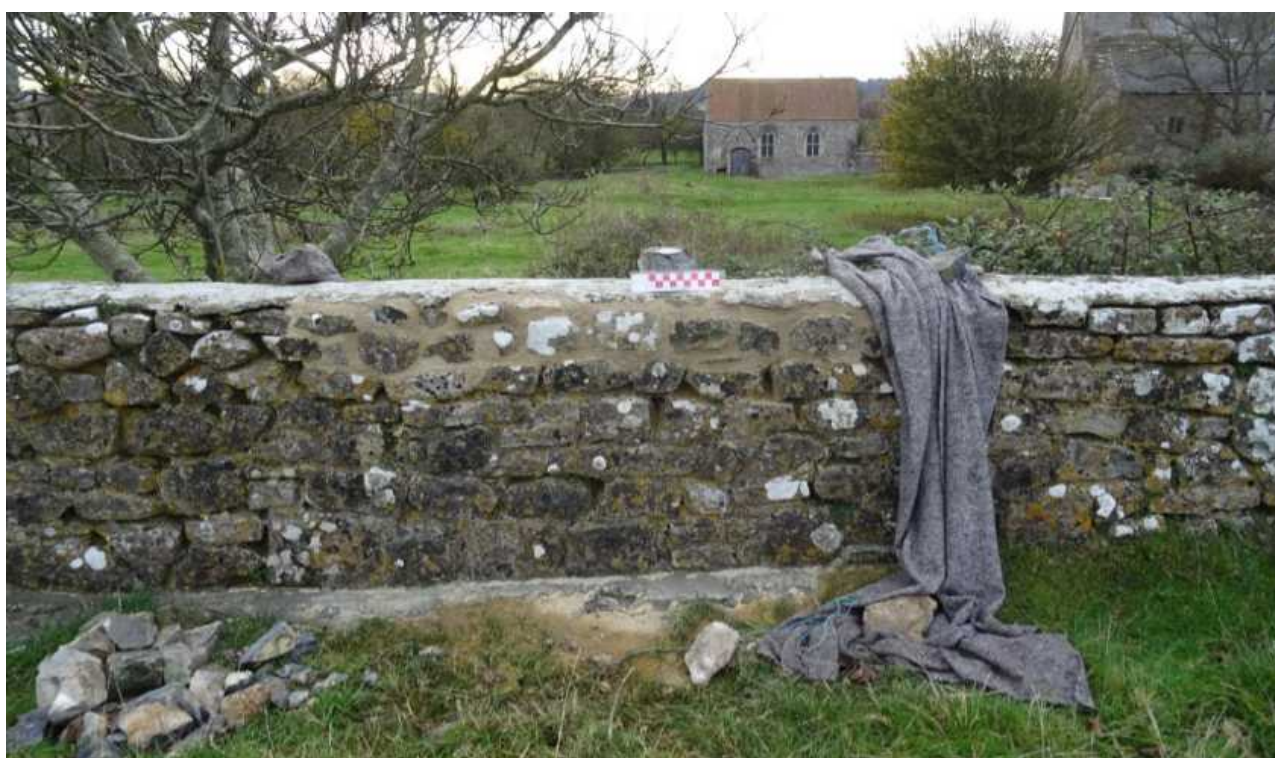
Fig 18: Minor defect as repaired and repointed November 2021

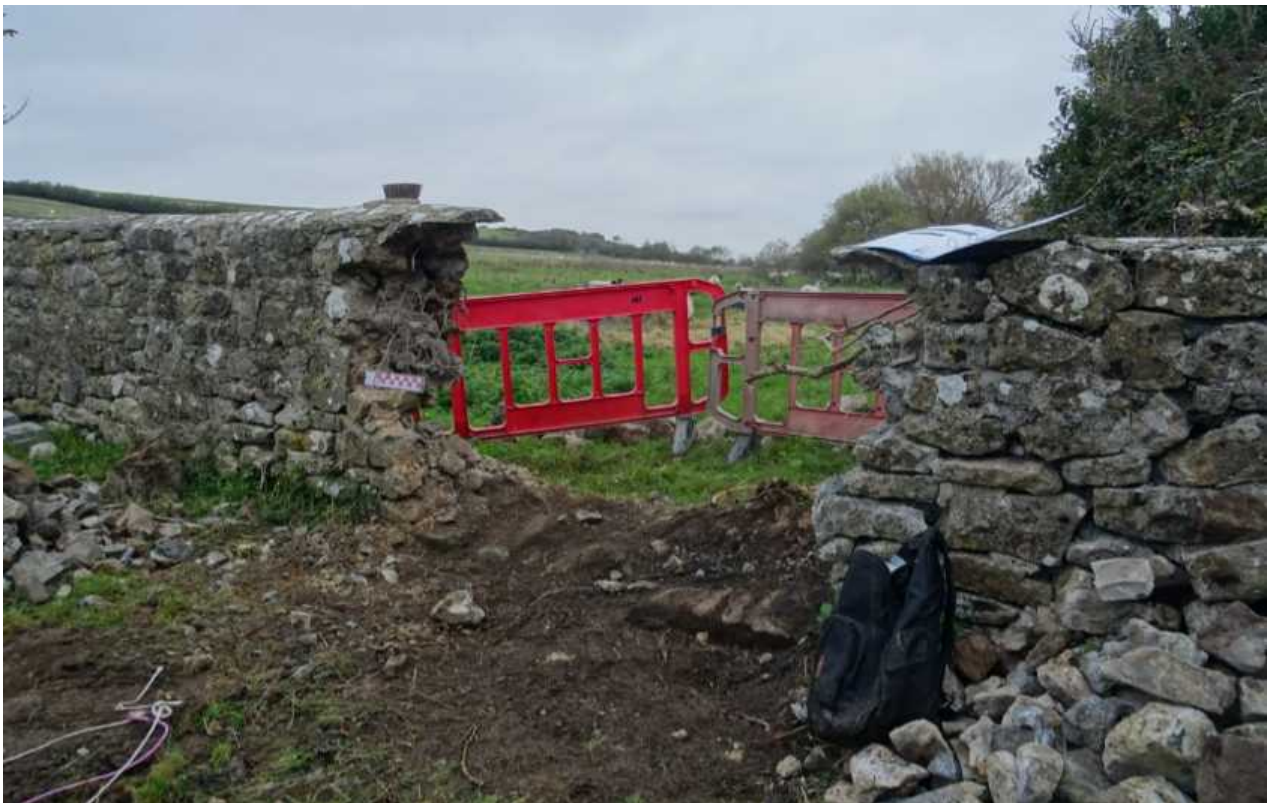
Fig 23: Repairs to southern defect of wall 4 north of junction with exterior wall

Unfortunately, work began on the collapsed area in Fig 23 before recording began, but in recompense, the area yielded several worked freestone fragments (Fig 24).

Two major defects in wall 4 were recorded and corrected in late 2021.

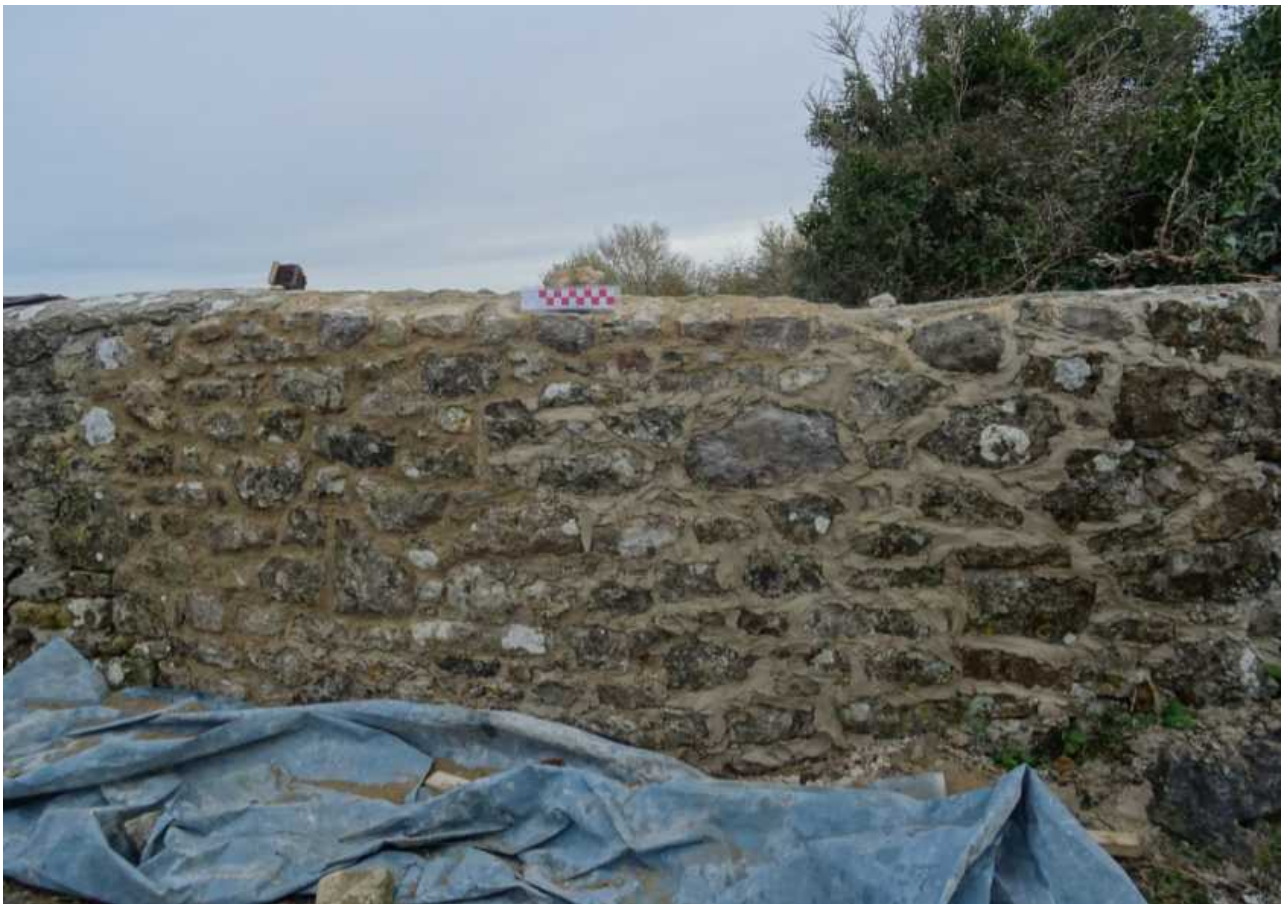
Fig 25: Wall 4 southern defect repaired and repointed

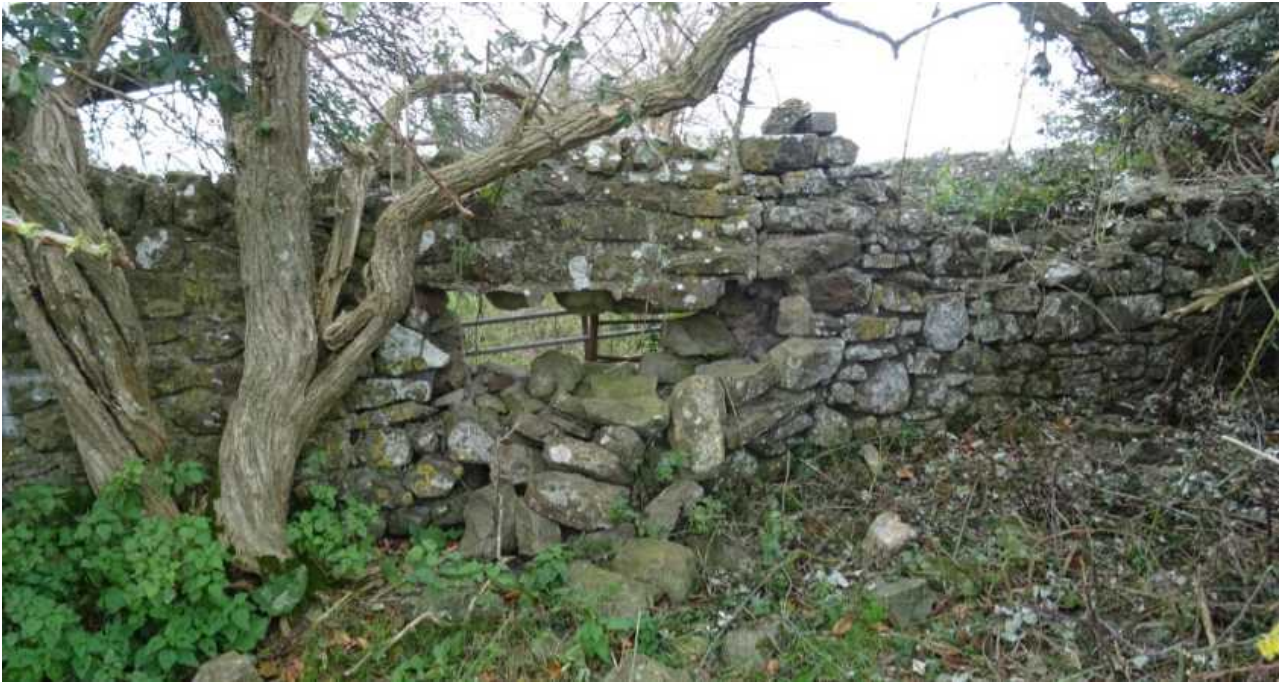
Further north in wall 4, only 8-10m south of its junction with wall 3, an overgrown section of wall proved, when cleared of undergrowth, to have the second defective wall area (Fig 26).

Fig 26: Collapse of wall in northern defect of Wall 4 (external view)

This was repaired, and major repointing to the exterior surface of the wall followed.

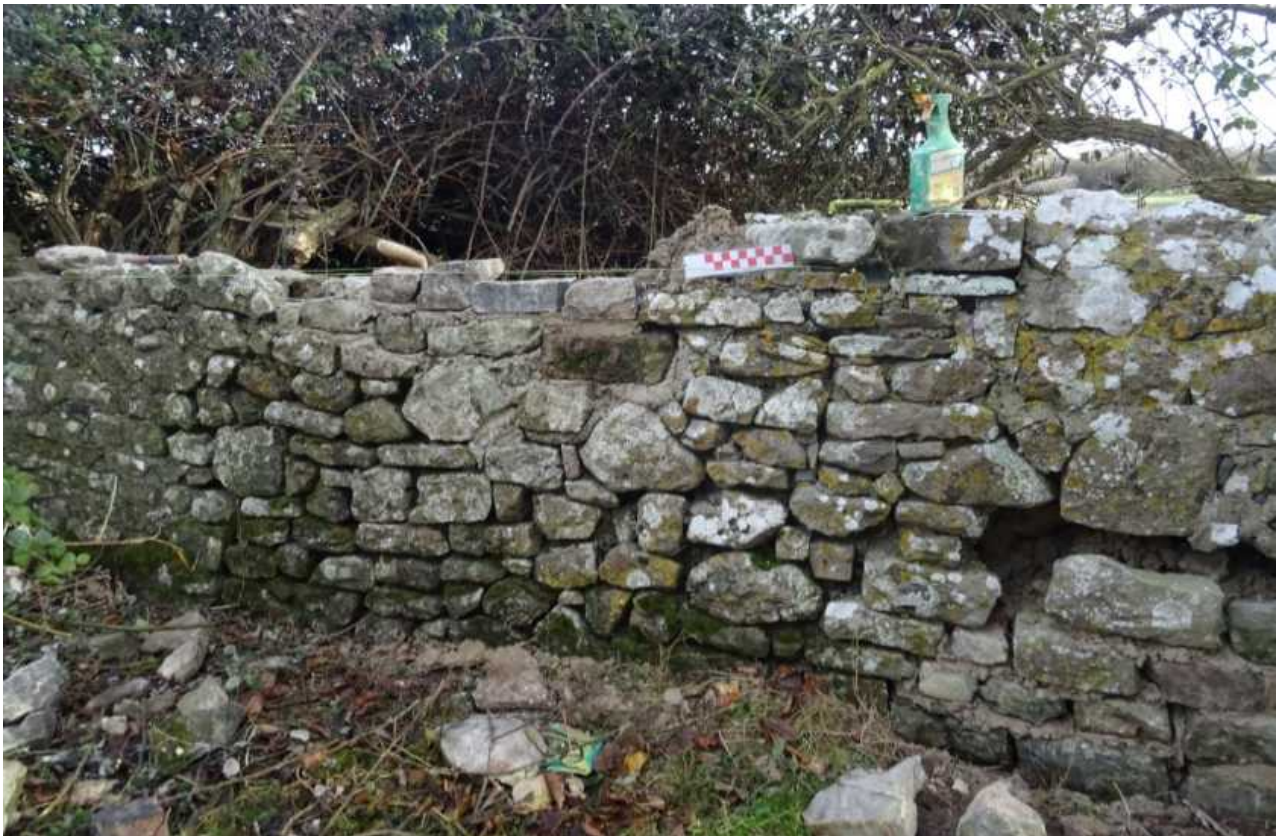
Fig 27: Formerly overgrown collapse of wall 4 close to junction with wall 3 under repair

Both areas were repaired (Fig 27 below), and the exterior face of wall 4 extensively repointed (Fig 28 below). Some repointing of the inner face also took place, but owing to the better conditions of this face, this was largely confined to the areas of repair.

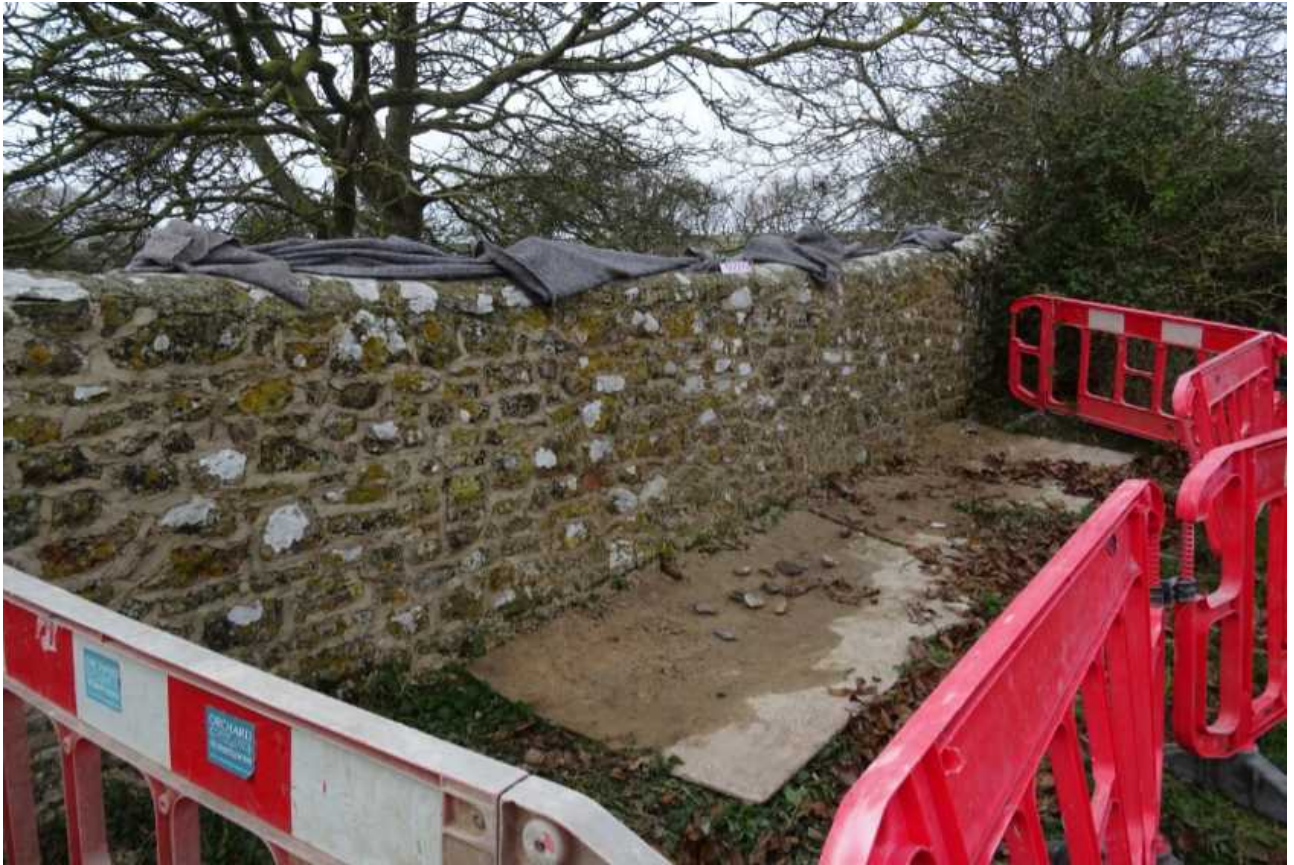
Fig 28: Subsequent repointing of exterior surface of wall 4

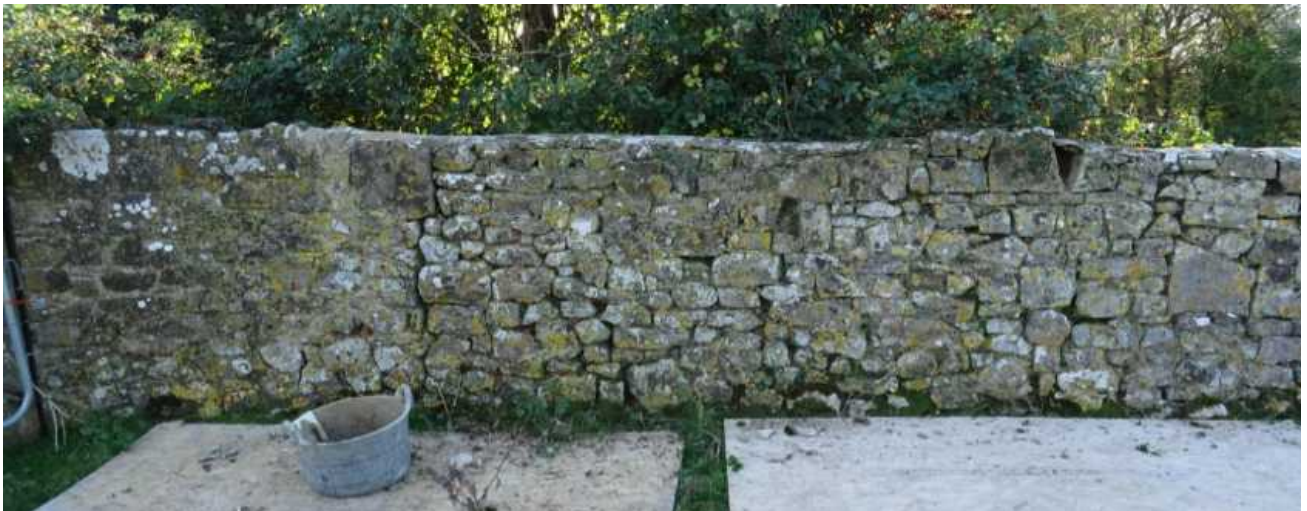
Fig 30: Typical weathered section of wall 5 (close to junction with wall 4)

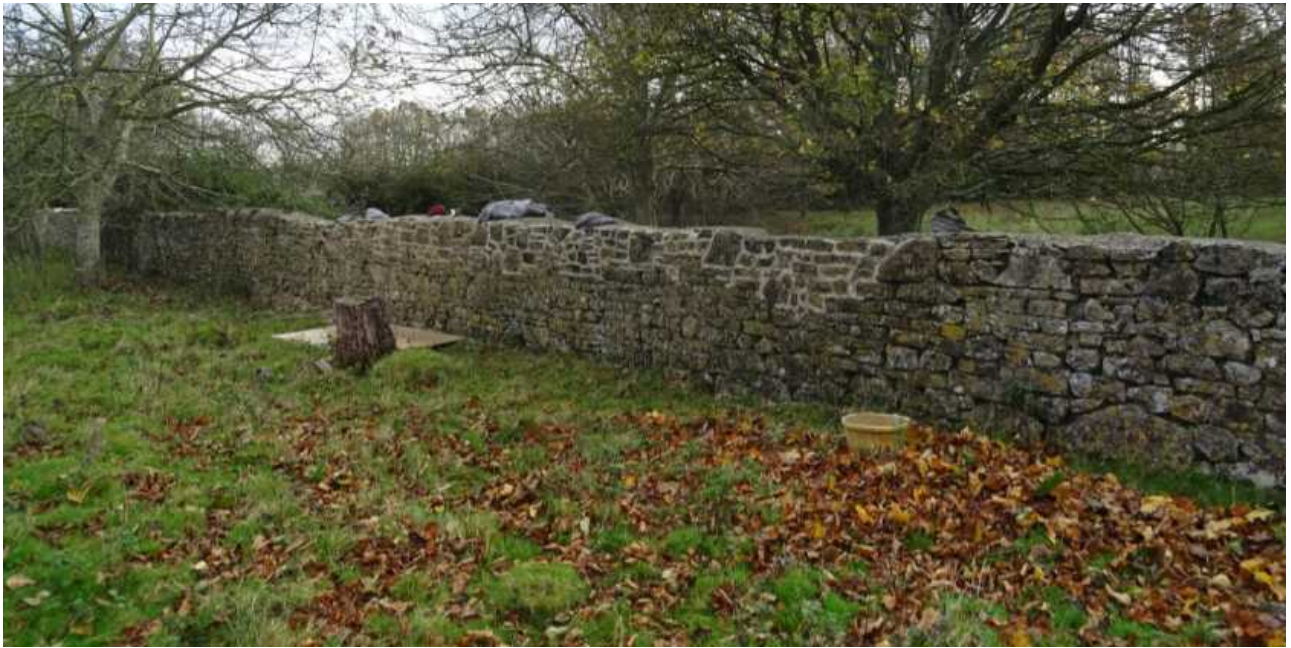
Fig 31: Section of wall as seen in Fig 30 (above) after repointing

Apart from the repair of one very minor collapse, this response to the wall was largely repointing of areas where surface mortars had weathered out.

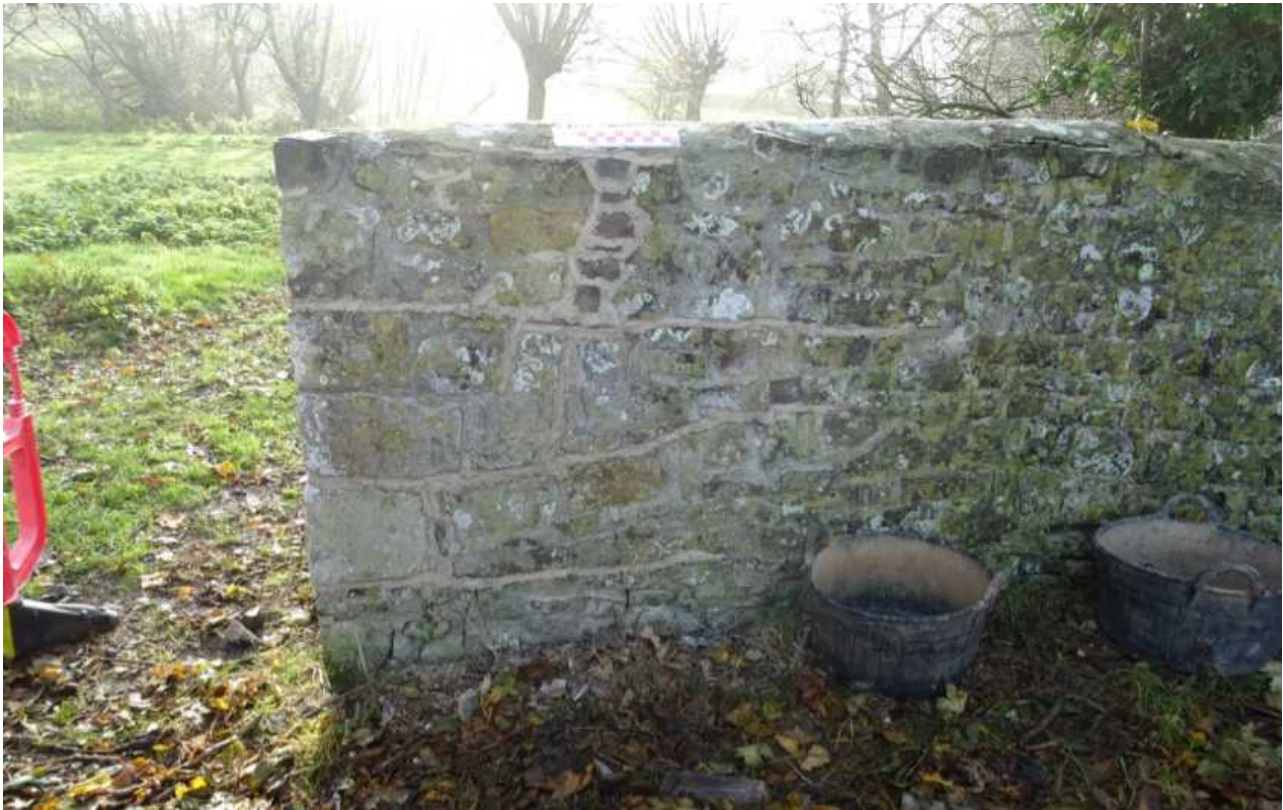
Fig 33: Wall 5: repointing of west jamb of field gate between orchard and outer fields

Some repointing was also carried out around the openings in the wall (Fig 33 below).

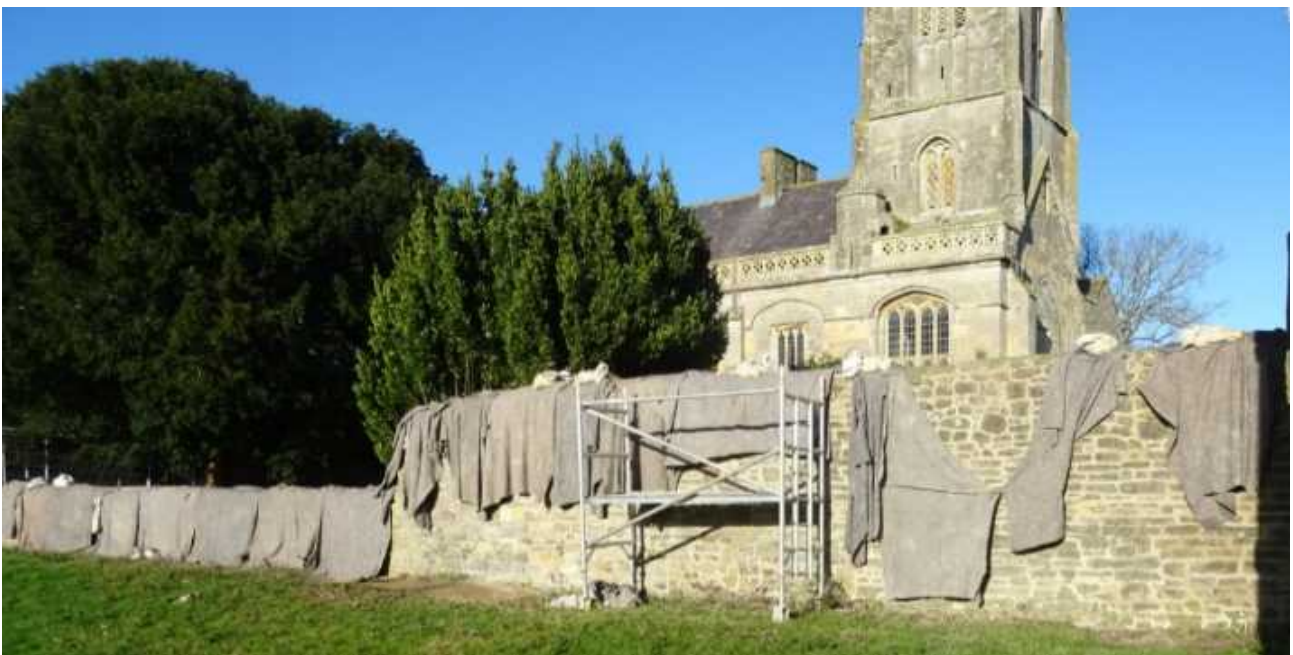
Fig 39: Wall 6 during repointing works, 2022

Most of the works to this wall were limited to repointing.
