PART 2: Walls 9 - 19 and endrefs

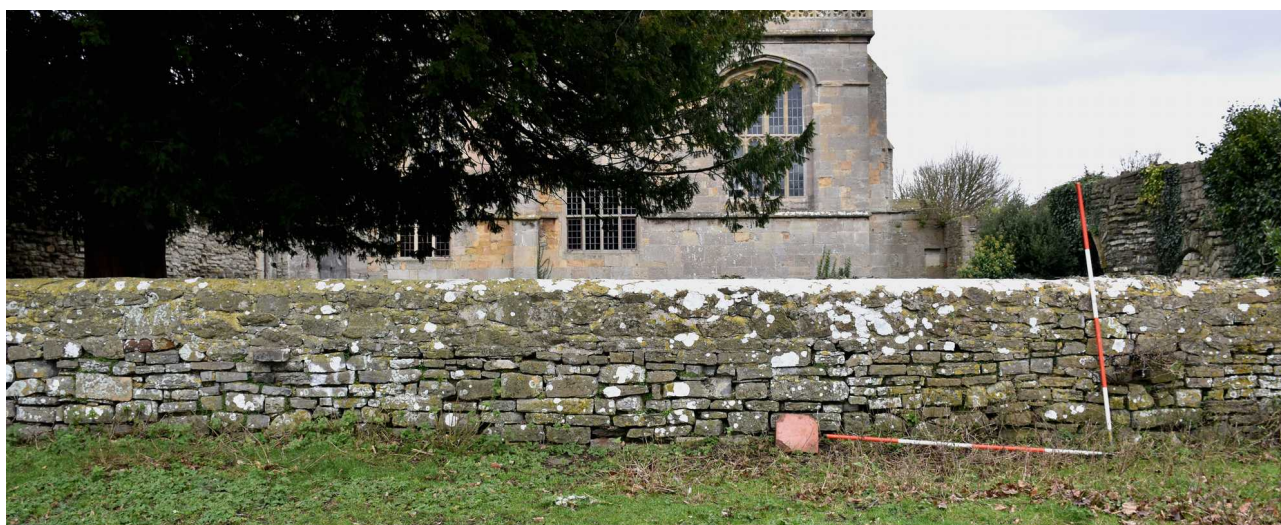
Fig 54: Wall 9 from south, 2020

Before repairs in 2022, wall 9 was lacking any major defects, but required repointing to replace lost surface mortar.

Repointing (Fig 58 below) was interrupted by frosts in February 2022, but successfully protected and is now sound.

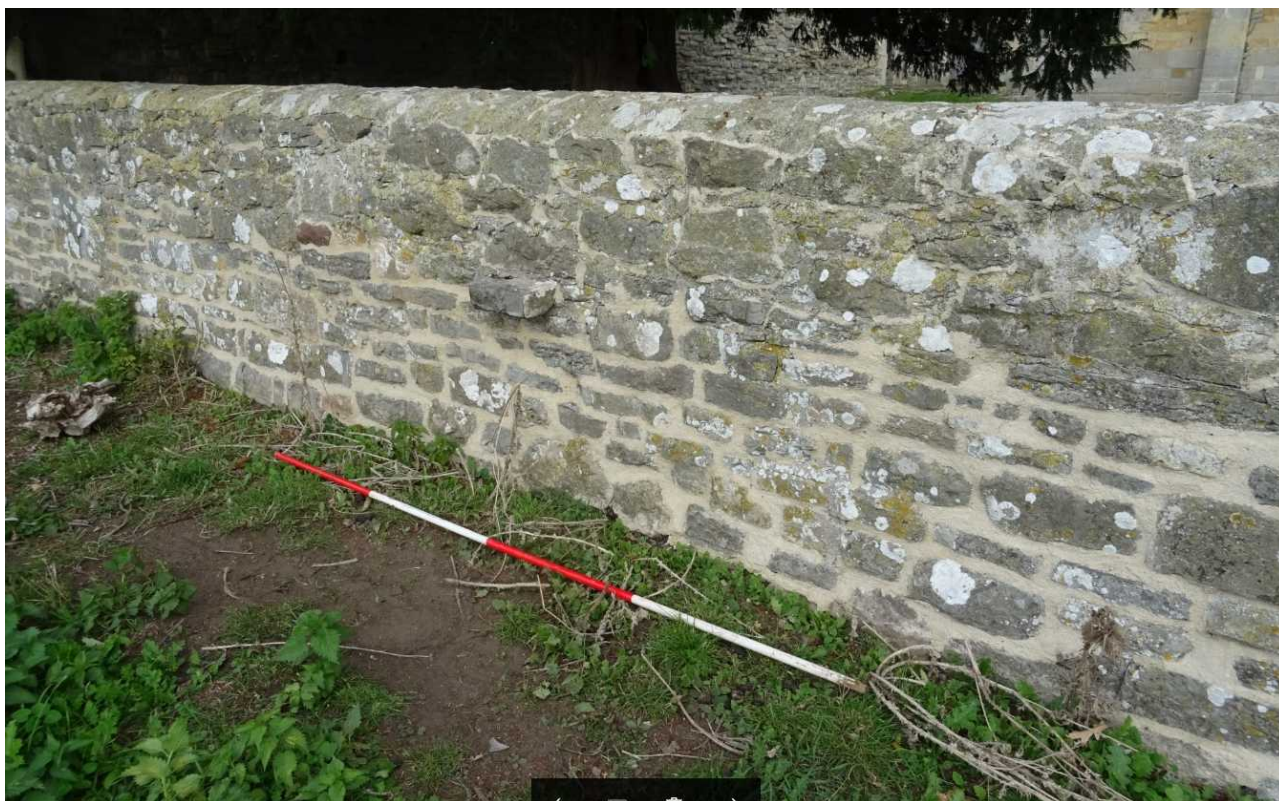
The projecting stone in Fig 58 is likely a domestic insertion, to simplify movement between the garden (cloister) area and the paddock to its south, and of no great age.

Fig 58: Wall 9 after repointing in 2022

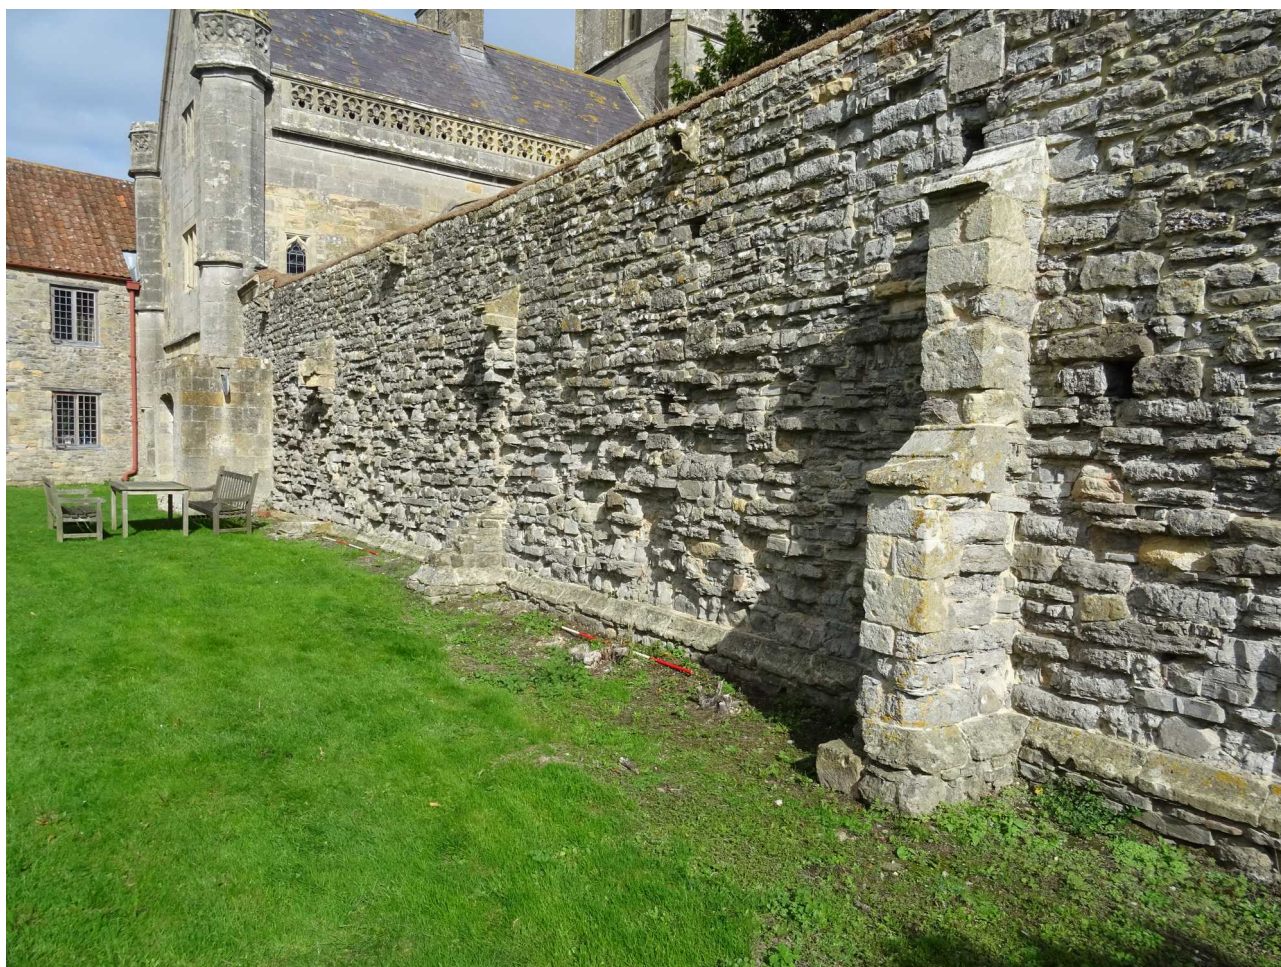
Fig 60: Northern (external) view of wall 10, after repairs, 2022 - note buttresses, gargoyles and basal string course

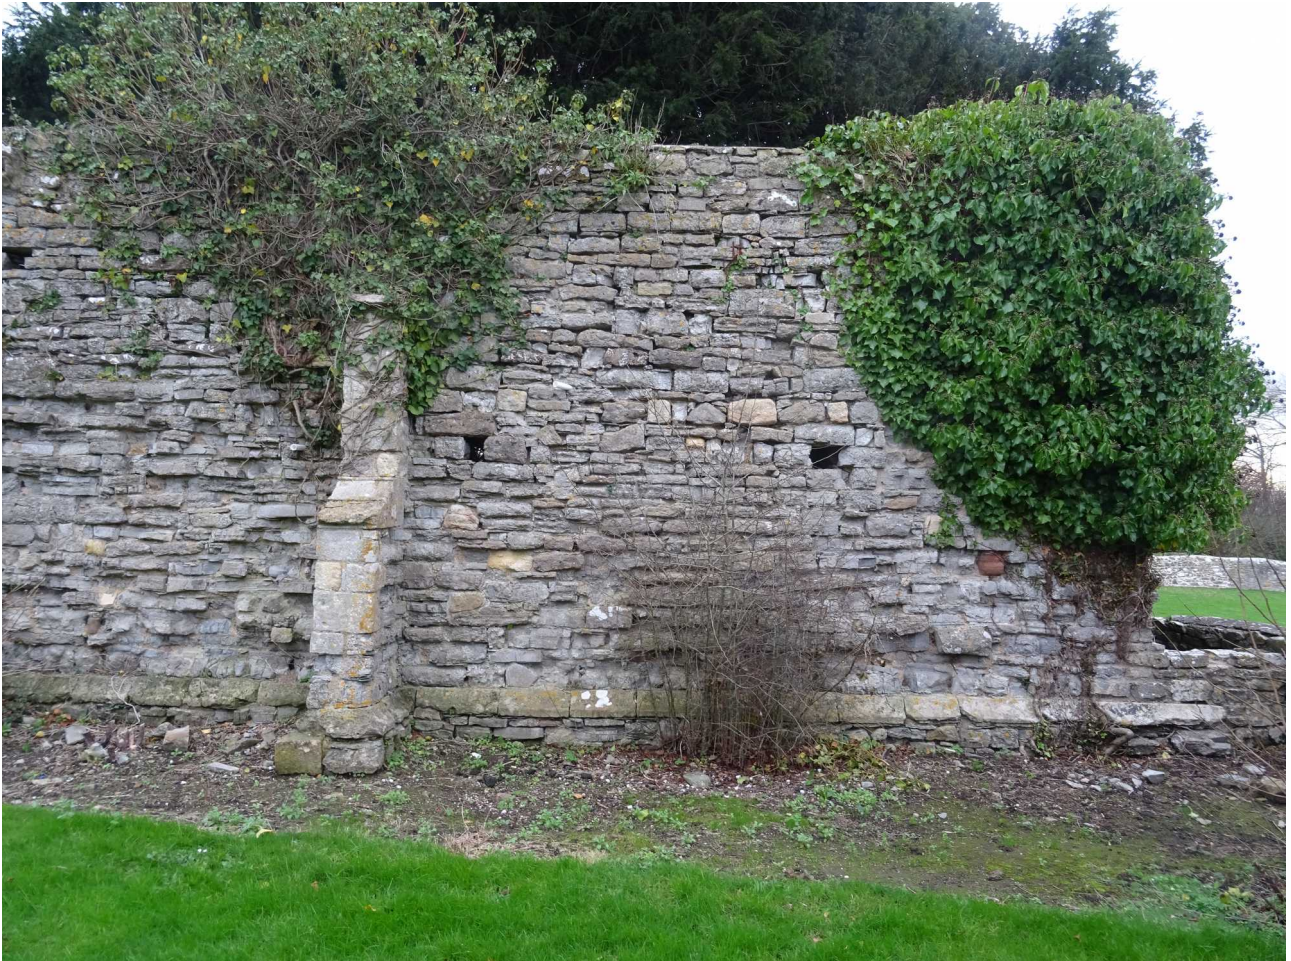
Fig 61: By contrast, southern (external) view of wall 10 before clearance and repair, 2022

The difference between these two views shows the necessity for the works of 2022.

One potentially limiting factor in the works was the presence of roosting bats in the top of wall 10 during winter 2021-22. These introduce a necessity to obtain a licence and procedures for 'demolition, construction and maintenance' of buildings where such bats are shown to be in residence (on-site notice). While this may cause problems with timing and scheduling of repairs, such issues can usually be (and were here) solved with goodwill. The fact that bats were able to roost in the structure of the wall is another indication of how necessary the 2022 repairs had become.

Most of the works to this wall consisted of the stabilisation of the top of the wall (where the bats were) and the repointing of the rest of the faces. This was accomplished from scaffolding during March and April 2022.

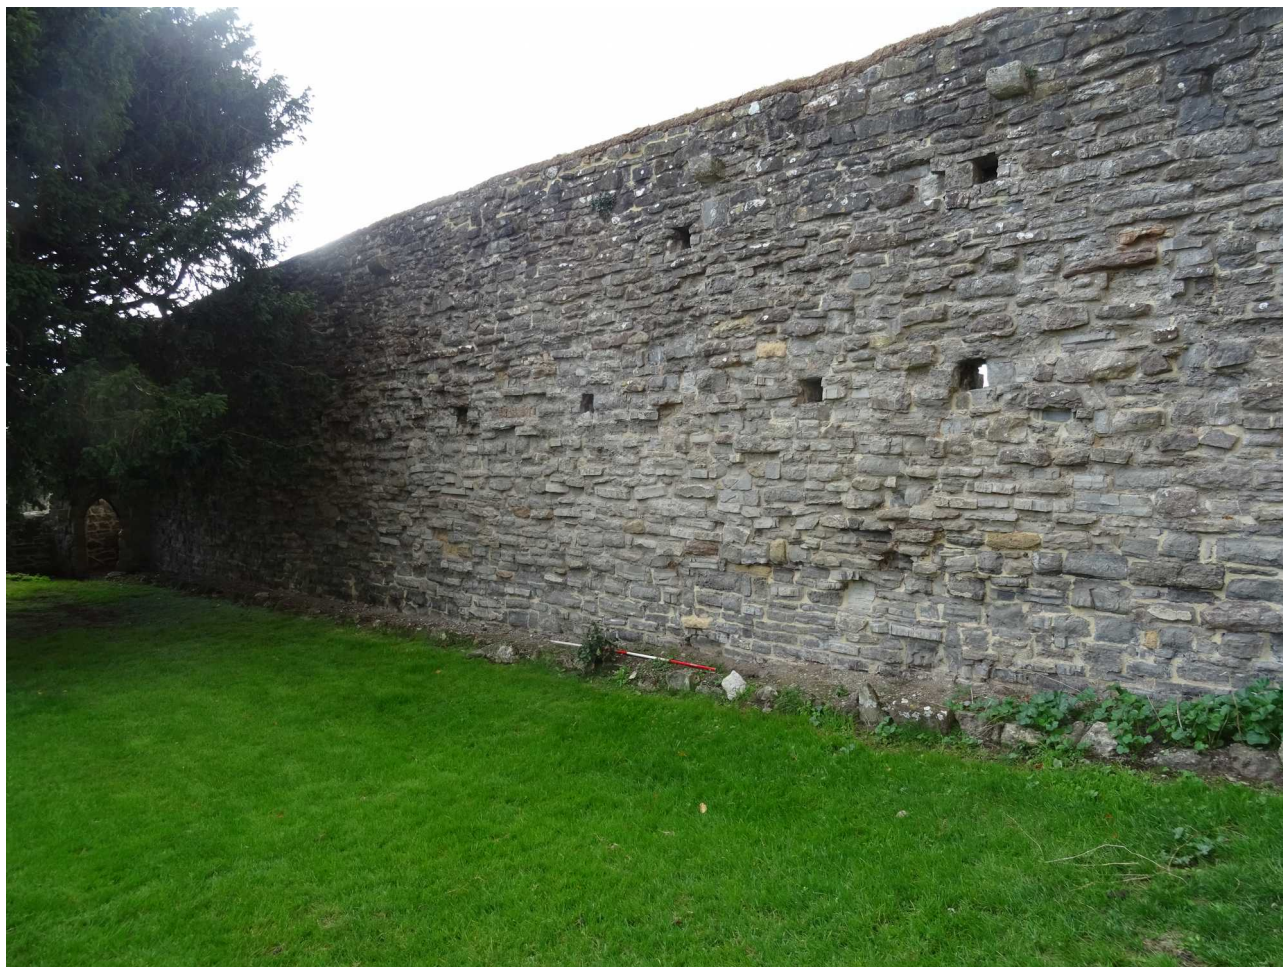
Fig 62: Eastern (interior) view of wall 10, looking south-west, after repairs, 2022

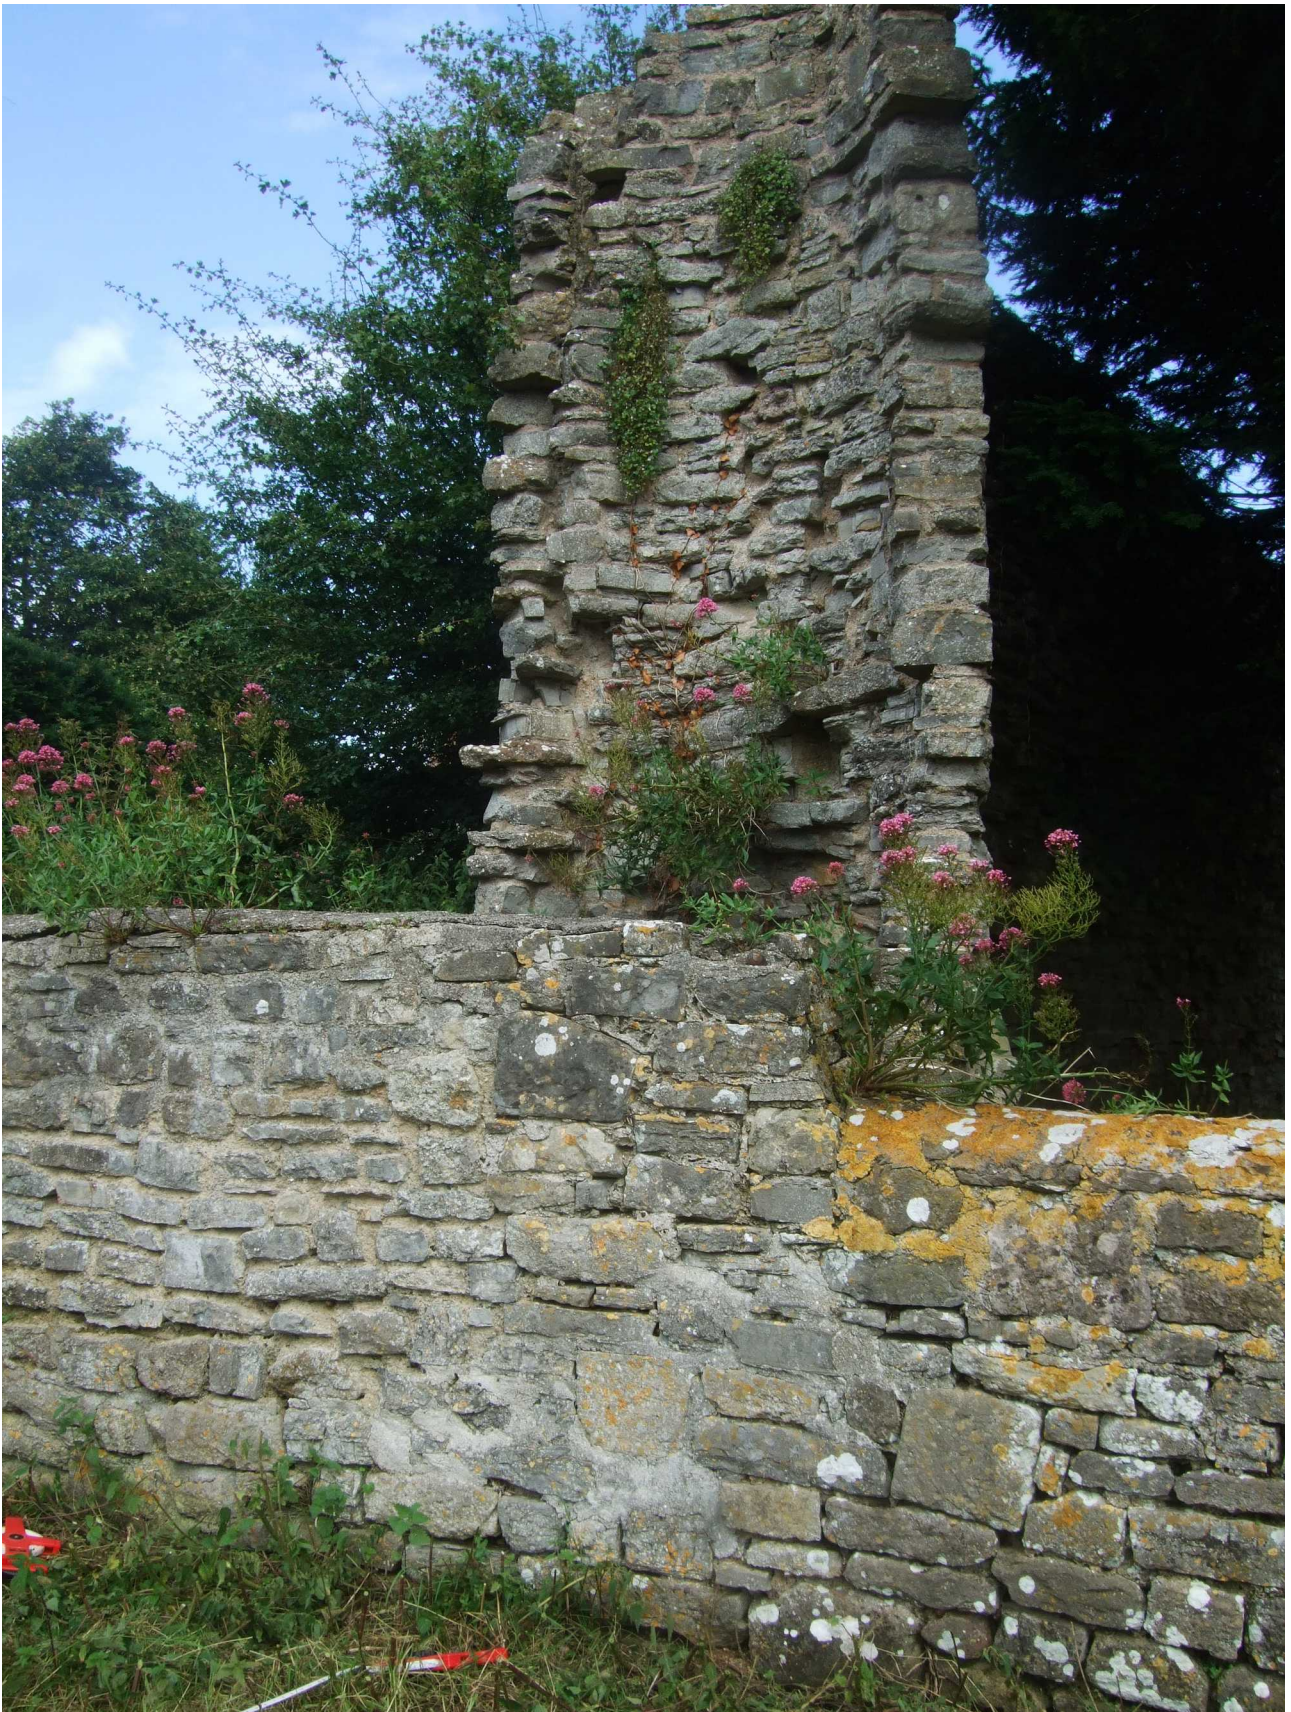
Fig 68: Interior of staircase and junction of walls 9, 10 and 11 before works (2012)

The mismatch of the three walls can be clearly seen in Fig 68 (above) and Fig 69 (below).

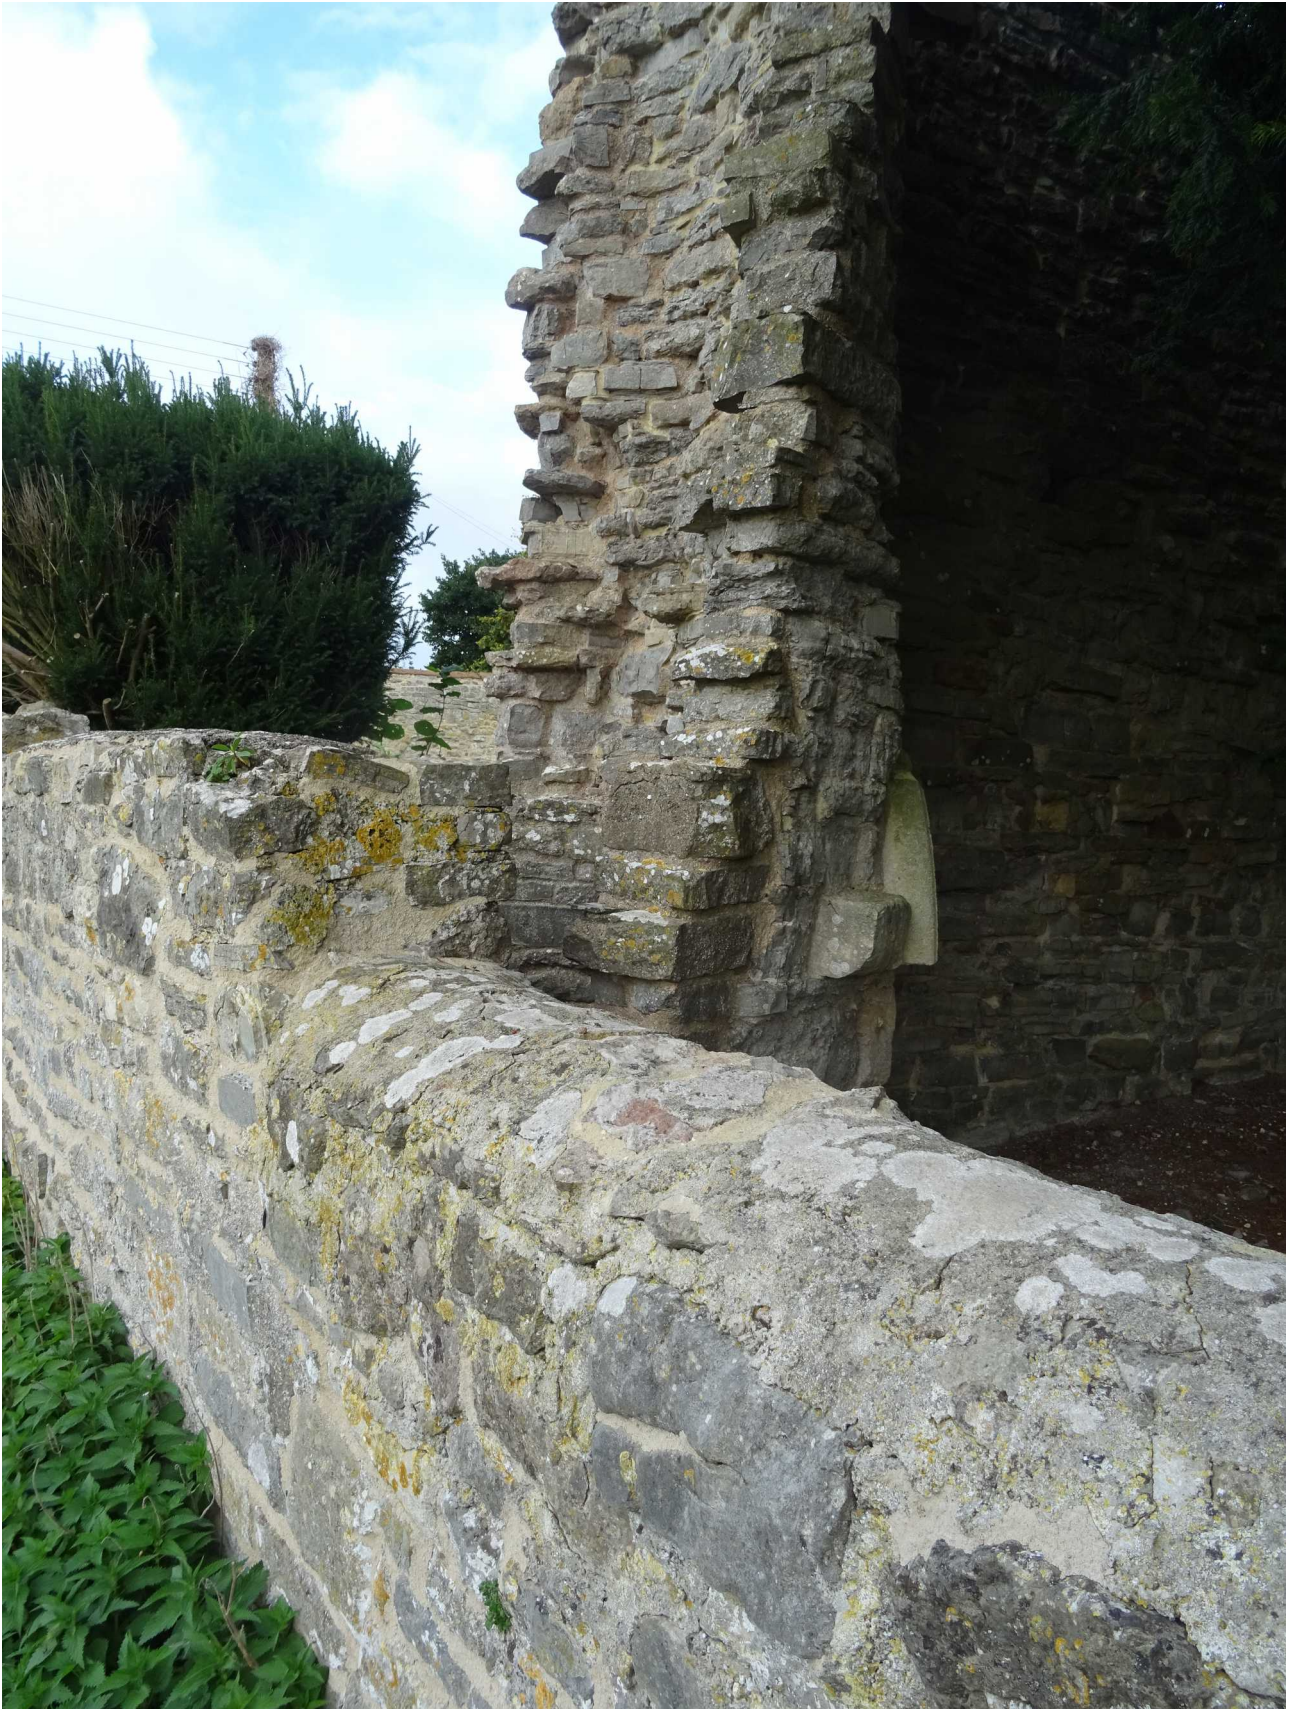
Fig 69: Junction of walls 9, 10 and 11 after repointing works, 2022

It is clear from these photographs that walls 9 and 11 have encroached on the area

formerly occupied by the stair turret in wall 10, implying it was probably already in more or less its current state by the time of their 19th century construction, despite Paul's (Paul 1885) attempting to depict the whole staircase on his plan of the priory.

The north part of the interior of the stairway survives, and was comprehensively repointed, with the rest of wall 10 in March and April 2022.

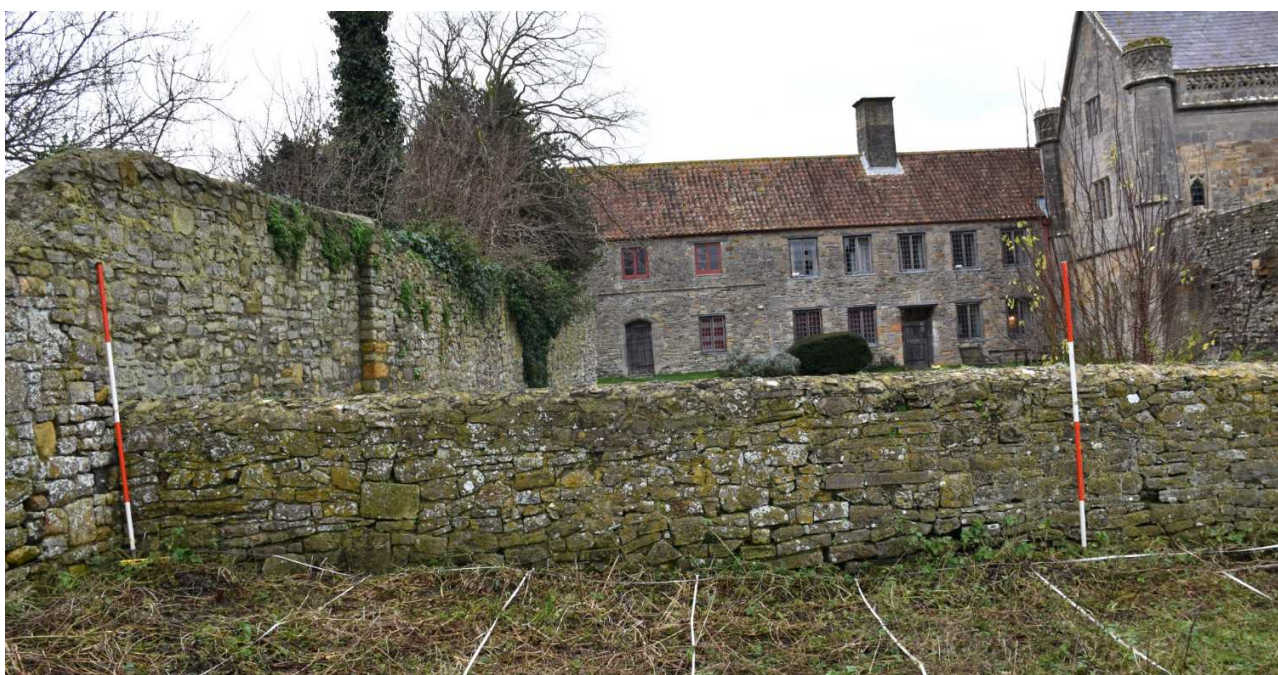
Fig 73: Wall 11 before repairs (tapes laid out for geophysical survey 2020)

Most of the necessary works to wall 11 were repointing: presumably its proximity to the farmhouse and its garden meant that the wall was usually well-maintained.

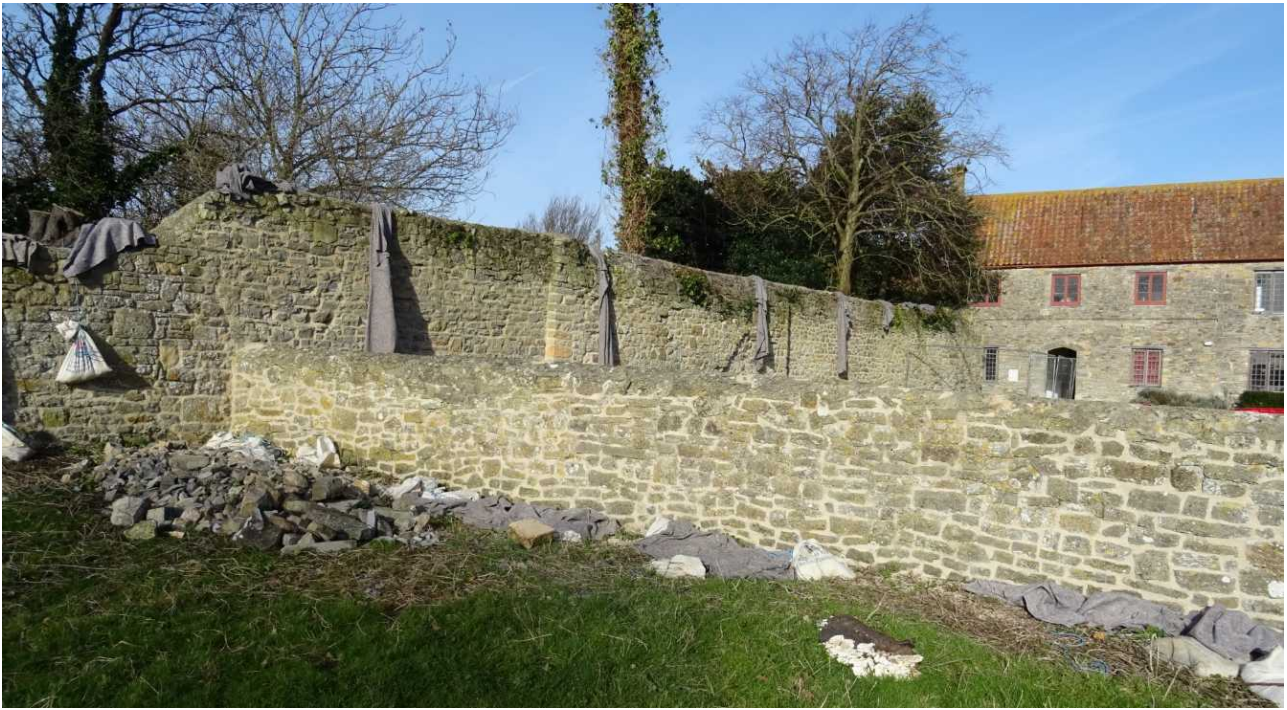
Although repointed during frosty weather (on one occasion, the south face of the wall (in the sun) at 7° C was workable, while the north, at 2° C, was not), the repointing has taken and has not been subject to frost damage.

Fig 76: Wall 11 successfully repointed, 2022

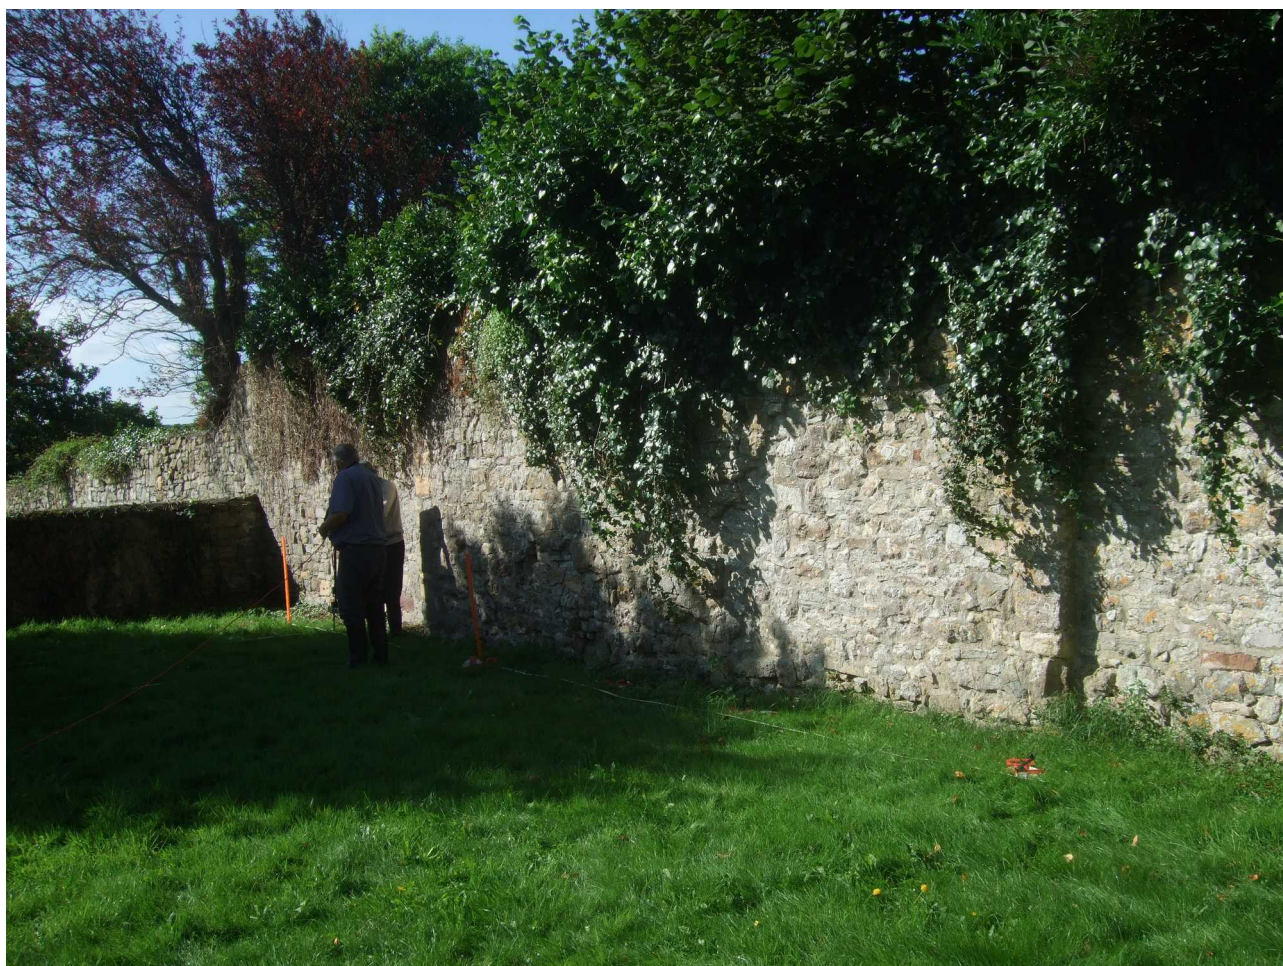
Fig 78: Wall 12/15 in 2012 (during resistivity survey), showing heavy growth (especially of ivy) on the wall

This undergrowth had rooted into the top of the wall, reducing the mortar there to little more than dark brown dust, from which the stones could be lifted by hand. Apart from this necessary 'gardening', the wall was in reasonably good shape, having clearly been repointed more recently than some other walls in the complex, and repairs in 2022 were

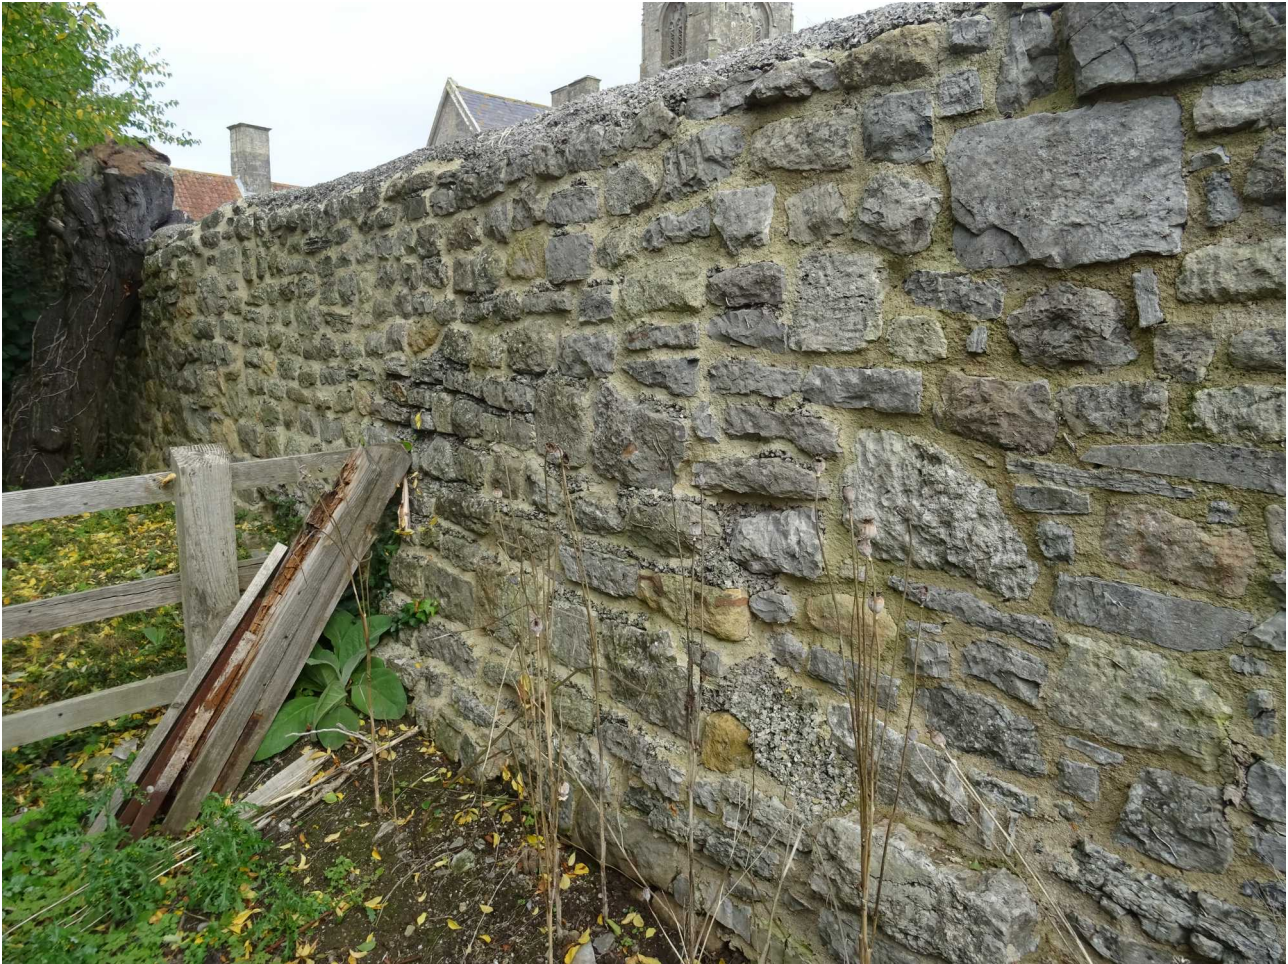
Fig 81: Repointing at southern end of wall 15 (2022)

Less recording was carried out (or necessary) on the overgrown western side 15 of the wall, which was subject to the same intense and extensive repointing as side 12.

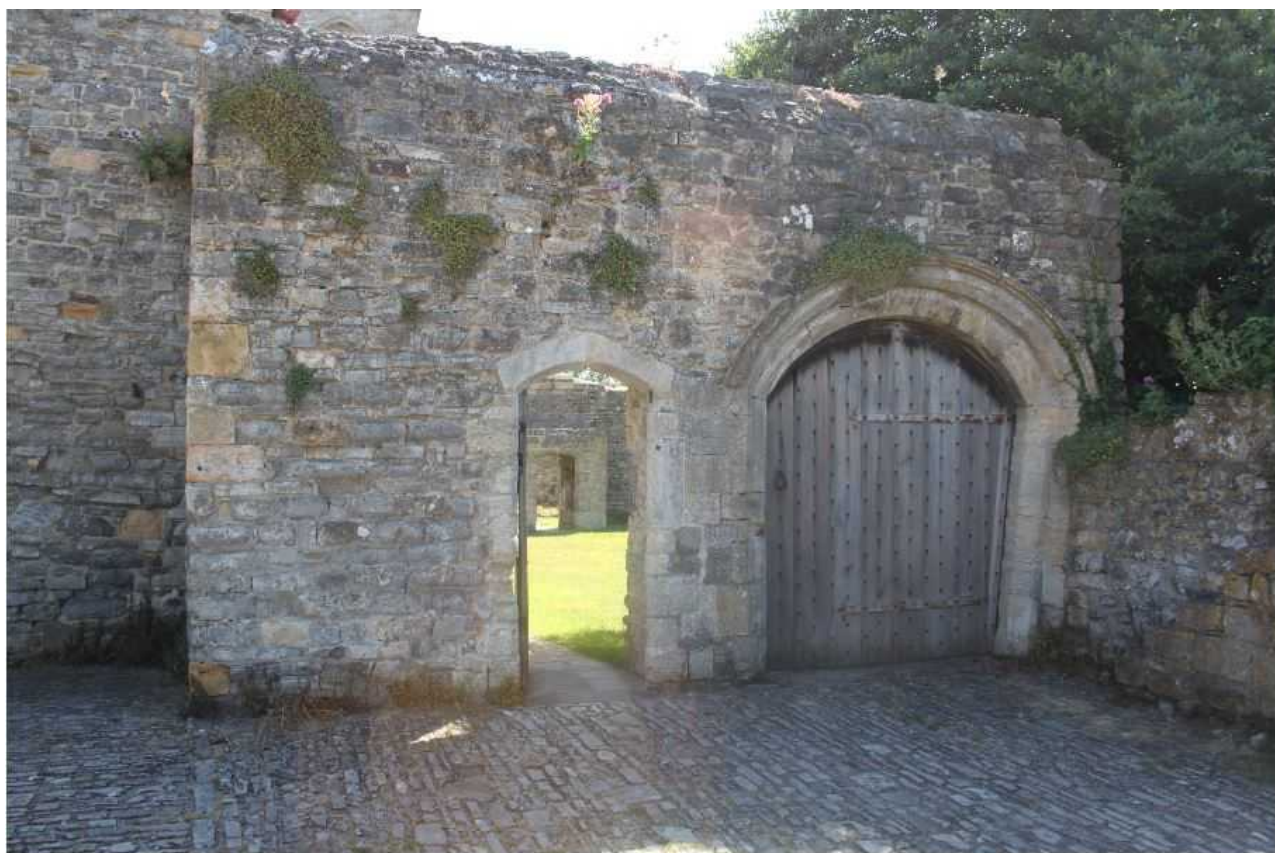
Fig 83: Wall/structure 13 before repairs (2018)

It is immediately obvious that the wall and the entrances are fairly crudely constructed, compared to the rest of the core of the site: the round-headed vehicular access arch to the south in particular is anomalous, the round arch apparently not fitting with the largely Perpendicular nature of the rest of the site, although similar can be seen elsewhere (e.g Maxstoke in Warwickshire). In addition, it is also clear that the south pillar of this opening is now nearly 10 degrees out of vertical: this may be due to initial sloppy building, but cracks in the adjacent wall (see below) imply this is at least partly due to settlement, and some drastic moves are described to prevent further movement.

Repairs to this structure were largely limited to clearance of vegetation and repointing: its position in the complex probably implies that it has been maintained reasonably well.

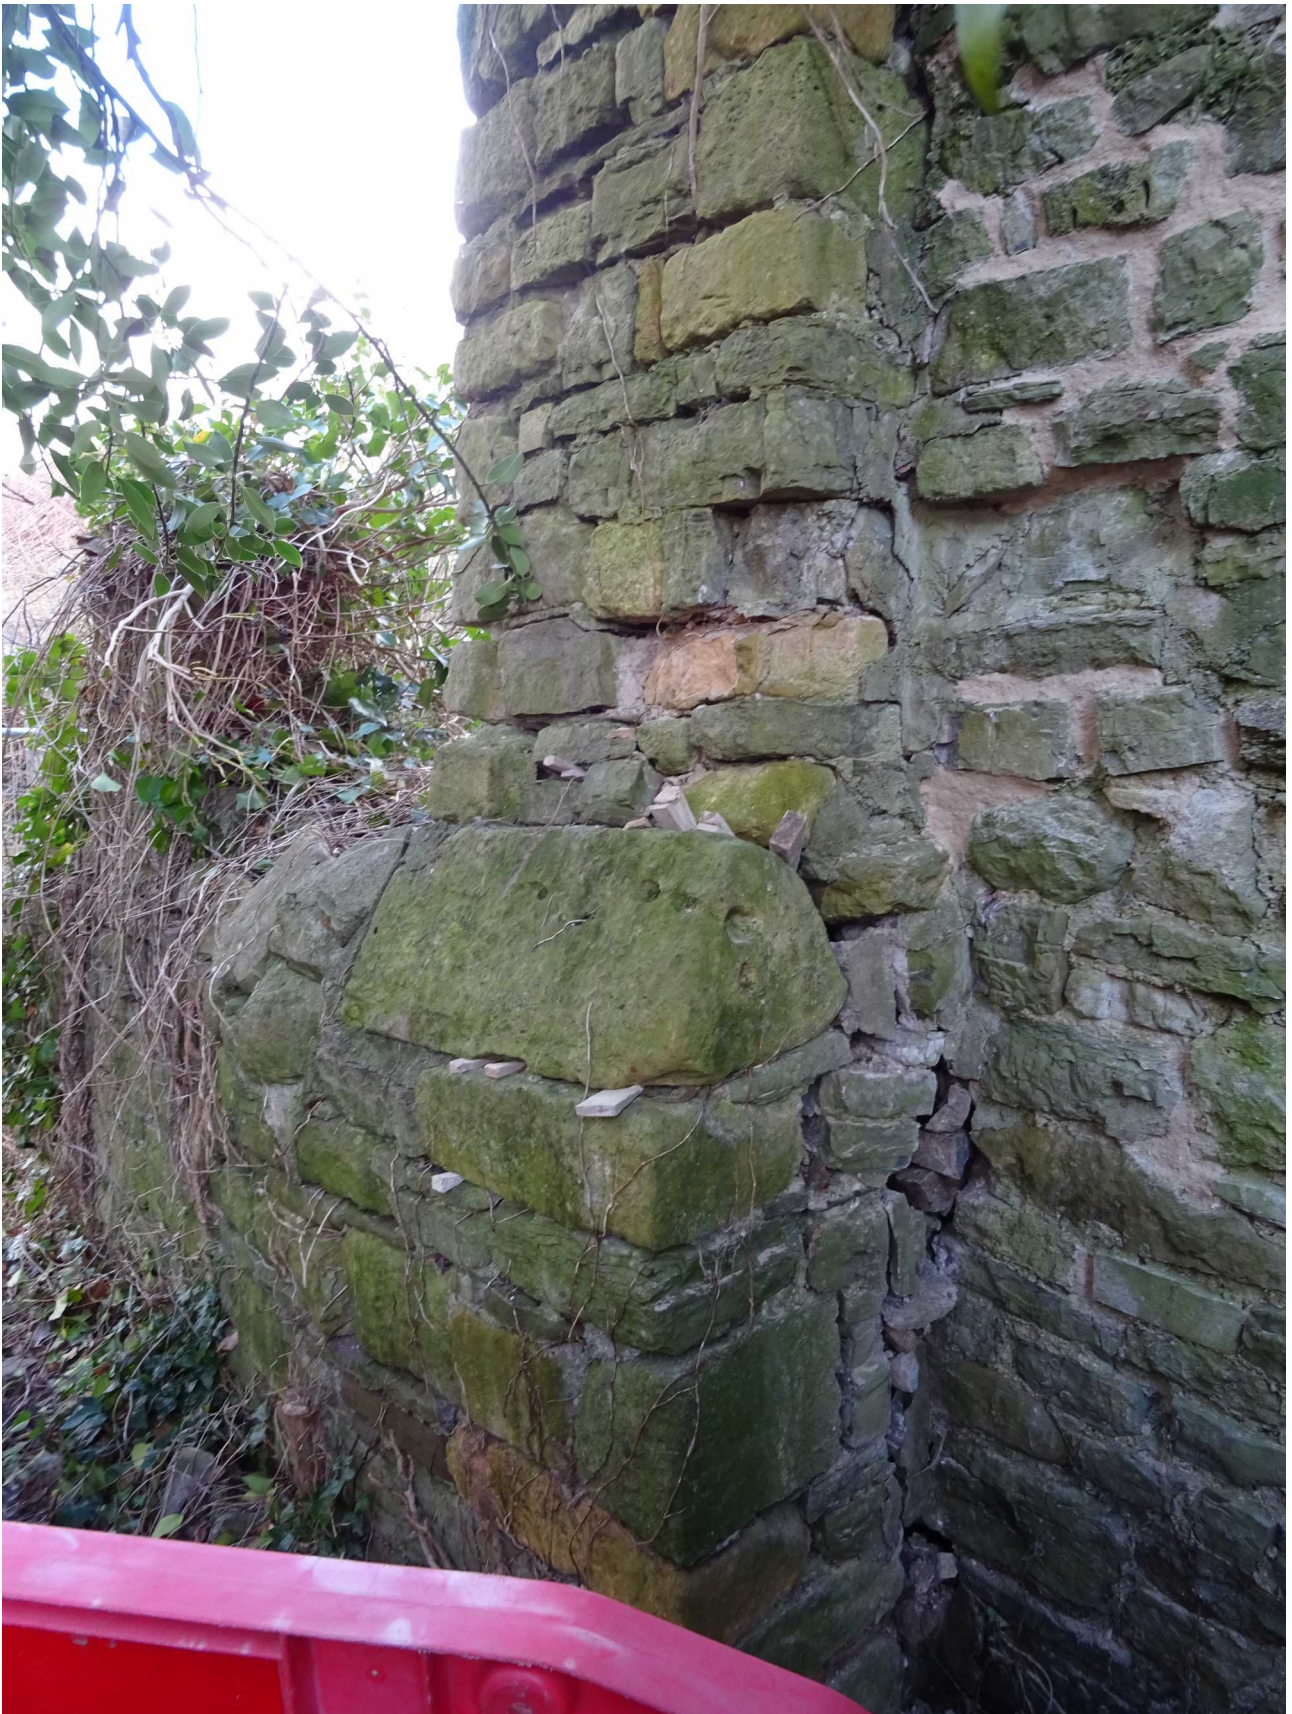
Fig 86: Butt joint of walls 13 and 14 (Feb 2022), showing failure and movement of the south part of 13.

The potential settlement of the gateway to its south was remediated during the works in 2022. The obvious movement of the whole of structure 13 (Fig 86 below) was righted by the construction of a new buttress (after a small trial excavation to make sure this did not interfere with any buried archaeology, which revealed nothing untoward).

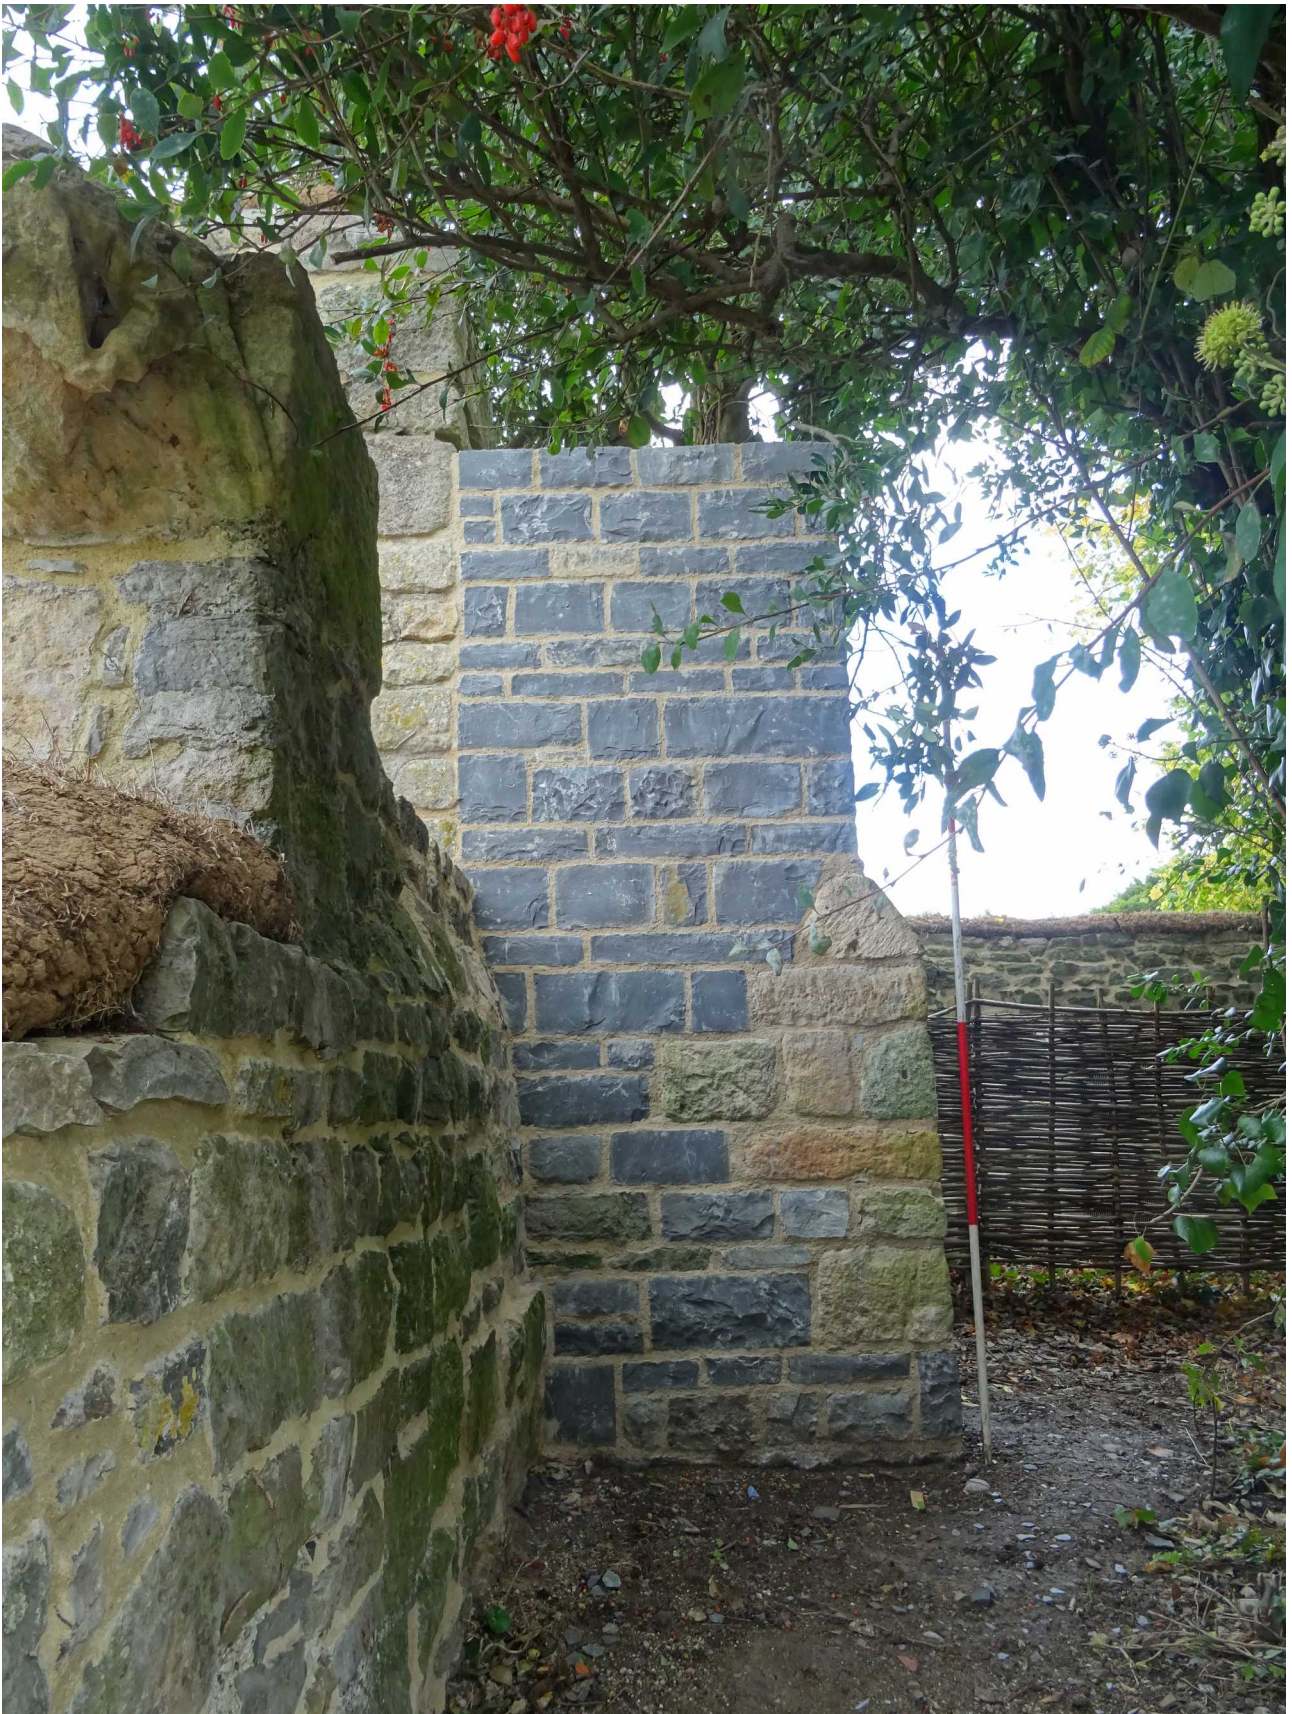
Fig 87: New buttress (2022) and repointed south side of wall/structure 13

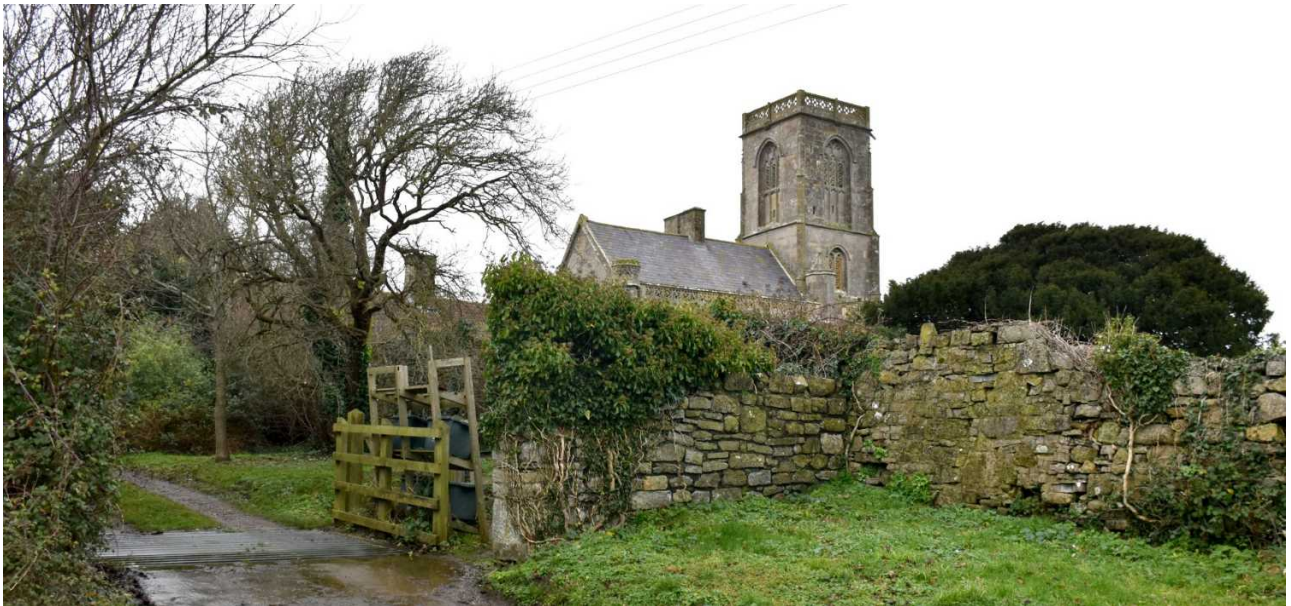
Fig 89: Wall 16 before repairs (2020)

Repair here was limited to clearance of vegetation and repointing.

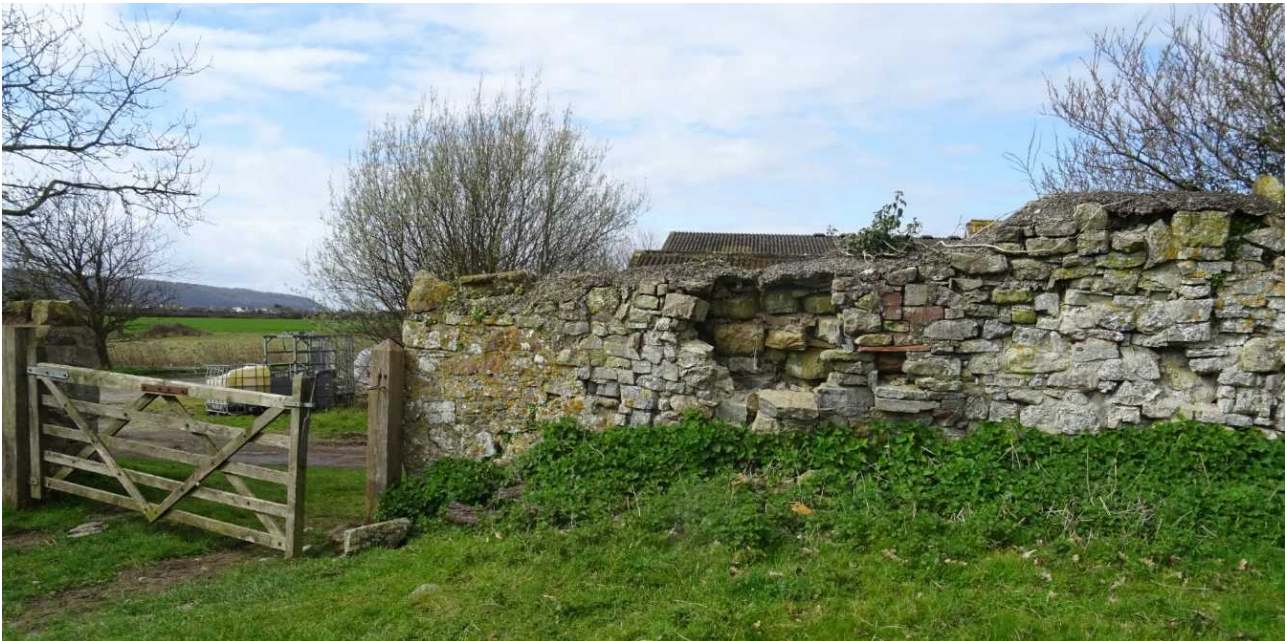
The primary damage to wall 17 was a collapse immediately north of the field gate (Fig 94 below), which collapse had happened since YCCCART carried out geophysical survey in the plot in 2012. This collapse again illustrates the futility of poured concrete capping of field walls, beneath which the wall content collapses leaving the concrete bridging a gap.

Fig 94: Wall gate and collapse in wall 17 (2021)
