PART 2: Walls 9 - 19 and endrefs

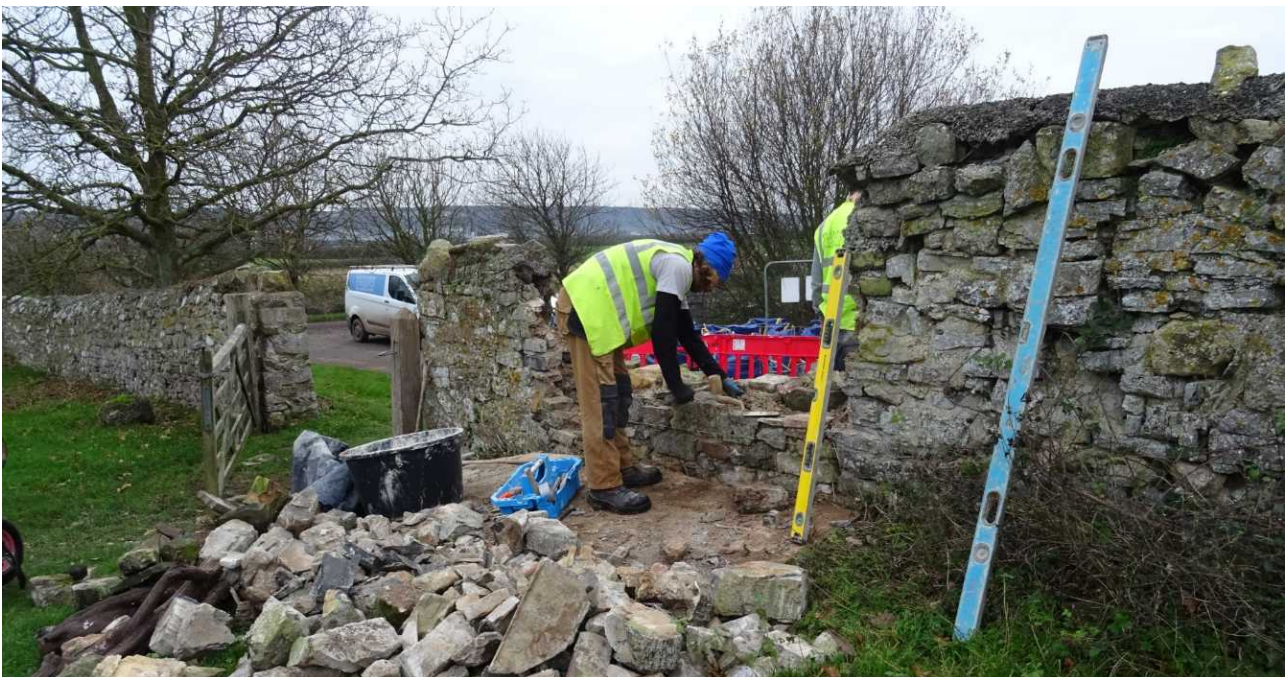
Fig 95: Wall collapse under repair, late 2021

Apart from this collapse, and a few areas missing large amounts of surface mortar, repair was largely limited to heavy repointing of both sides of the wall, and foundation levels were not reached in repairs.

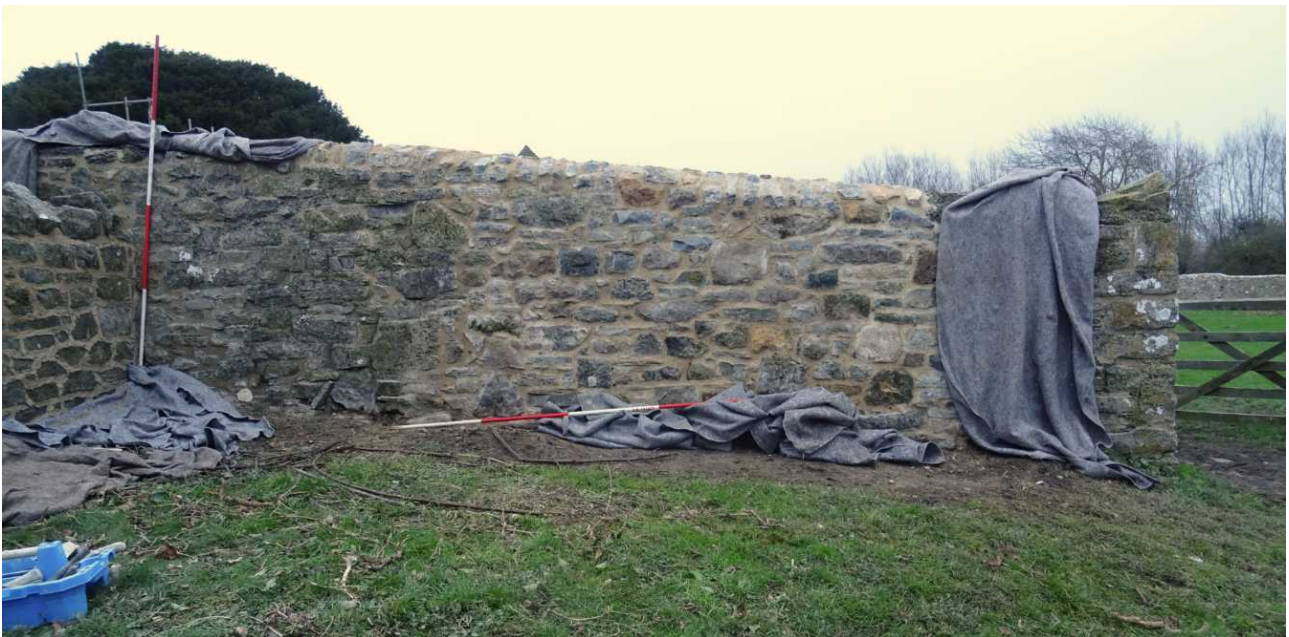
Fig 97: Repaired wall collapse and repointing, wall 17 north of field gate, 2022

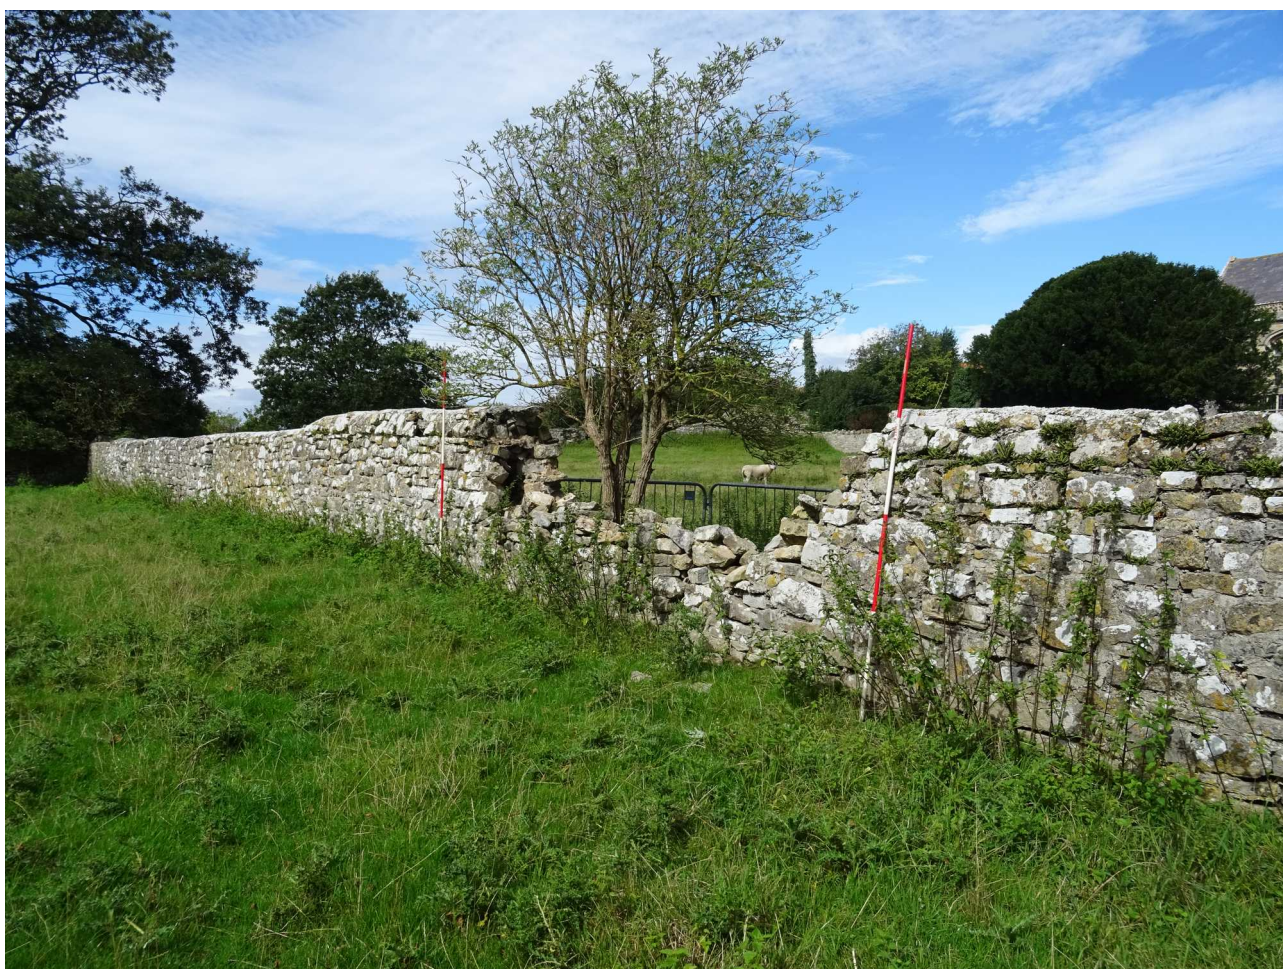
Fig 101: Wall 18 (2020) showing patched nature of wall and major collapse

Wall 18 seems to have been particularly prone to collapses (possibly due to its structure), and most of the repair works in 2020-22 were rebuilds of such. This was followed by large-scale repointing of most of the north face of wall 18, and much of the south face.

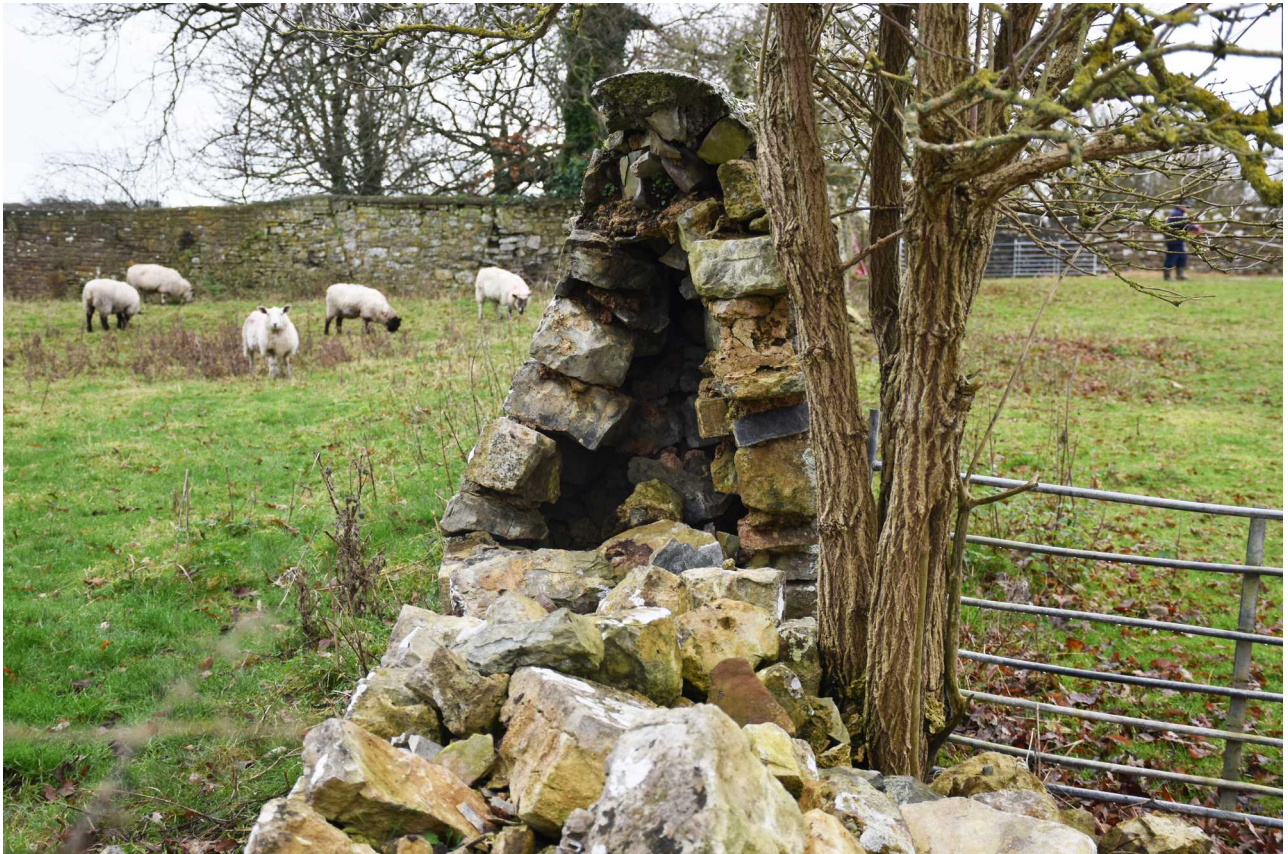
The wall seems to be double-skinned with a (now) hollow core, presumably once filled with mass rubble and mortar, but now weathered out (Fig 102 below).

Fig 102: 'Double-skinned' structure of wall 18, seen in collapse at its eastern end, 2020

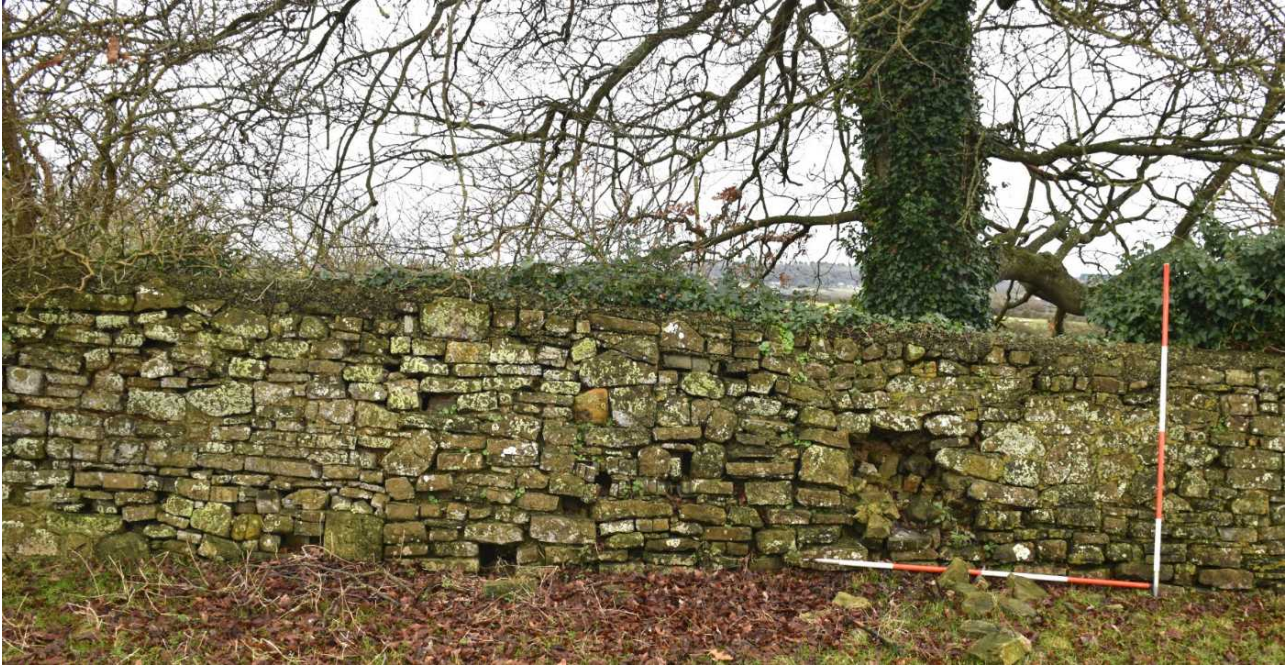
Fig 105: Small collapse towards the western end of wall 18, opposite the Turkey Oak outside (2020)

While the first collapse (Fig 105 above) required little more than patching, the two larger required demolition to foundation level and reconstruction. Various carved freestone elements were found incorporated in the walls during these works.

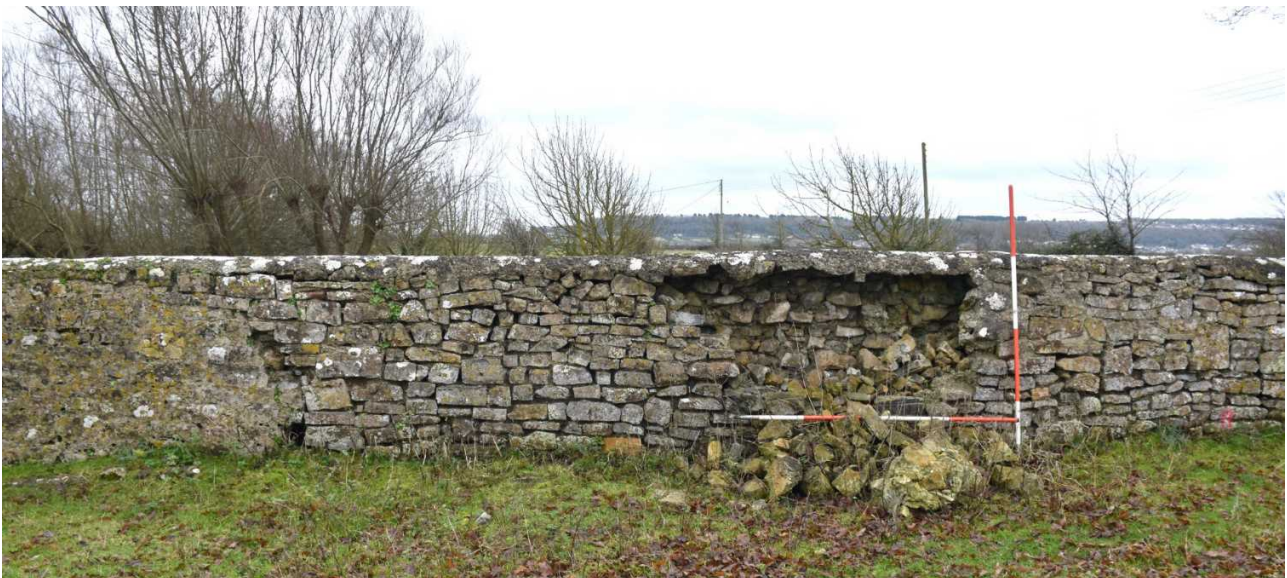
Fig 106: Larger collapse (ii) under concrete wall topping, towards the centre of the wall (2020)

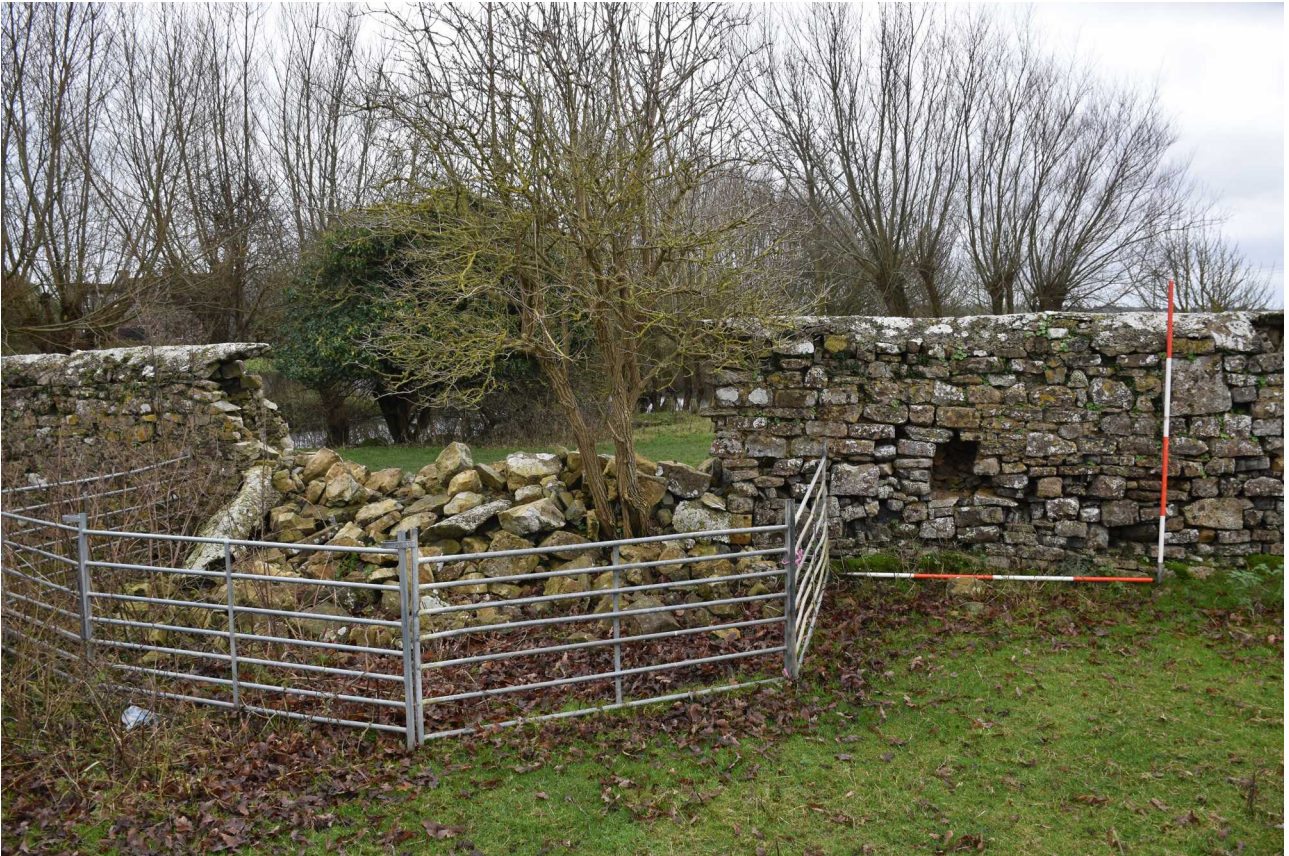
Fig 107: Large collapse (iii) close to junction of wall 18 with wall 19 (2020)

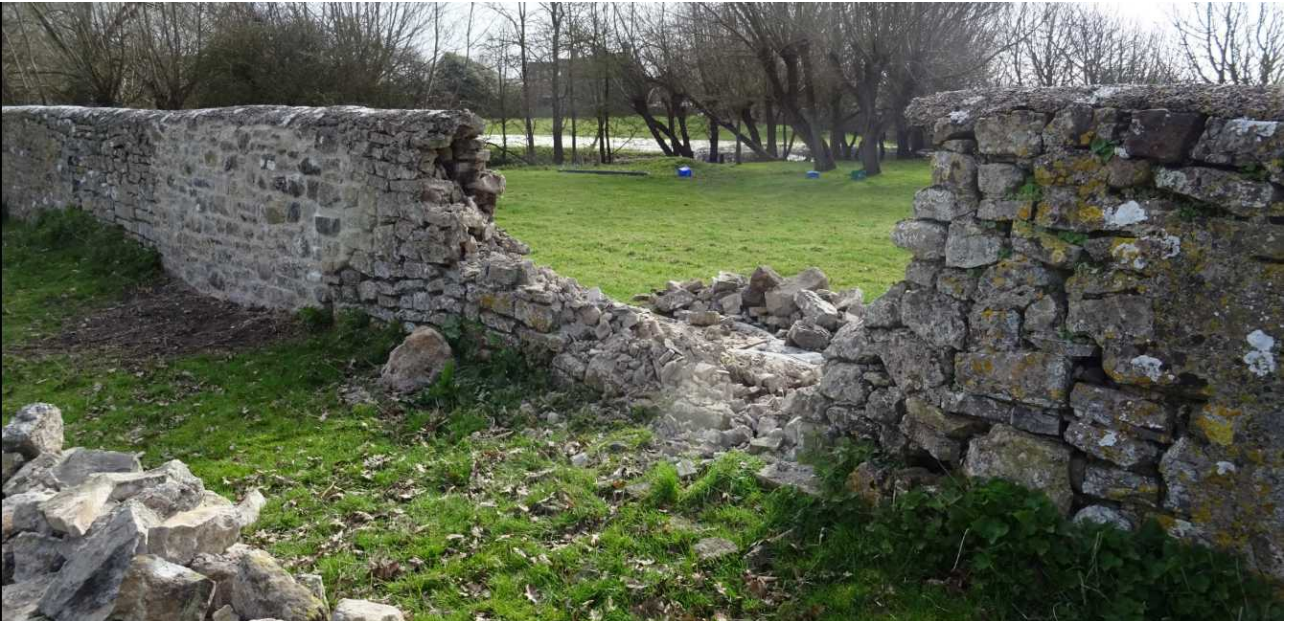
Fig 108: Collapse ii, cleared for rebuilding (2020) other area of major repair alongside to left)

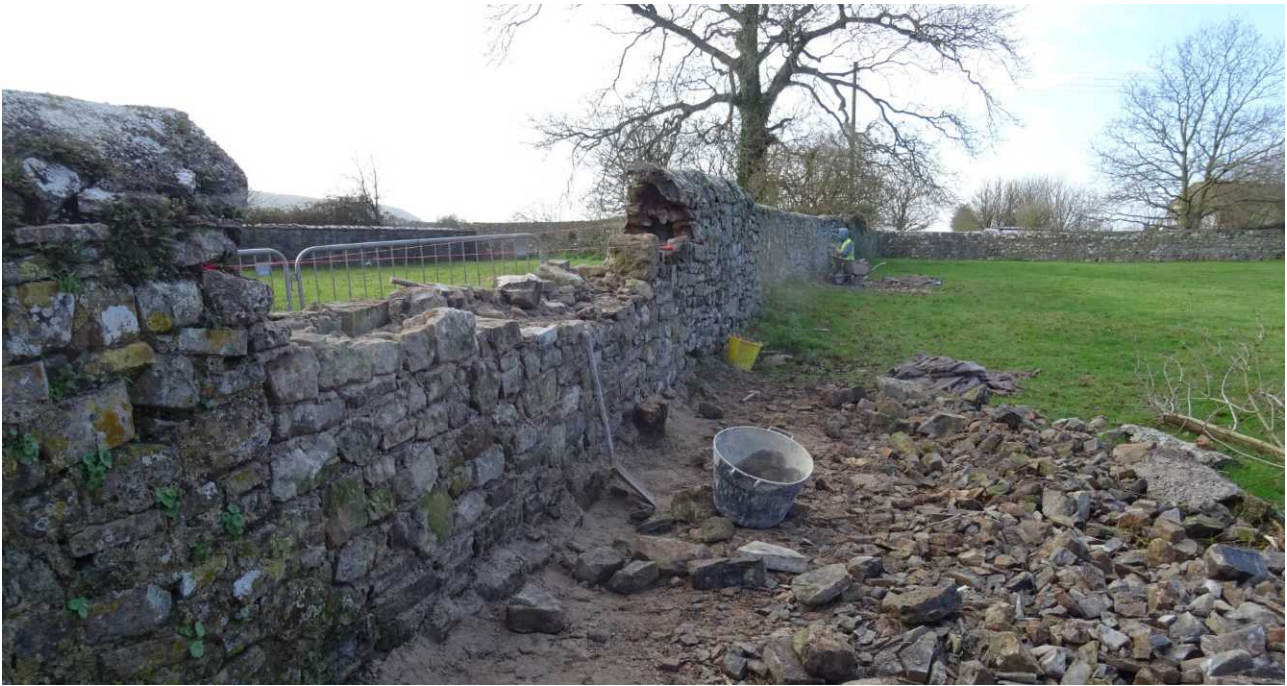
Fig 109: Collapse ii under repair (late 2020)

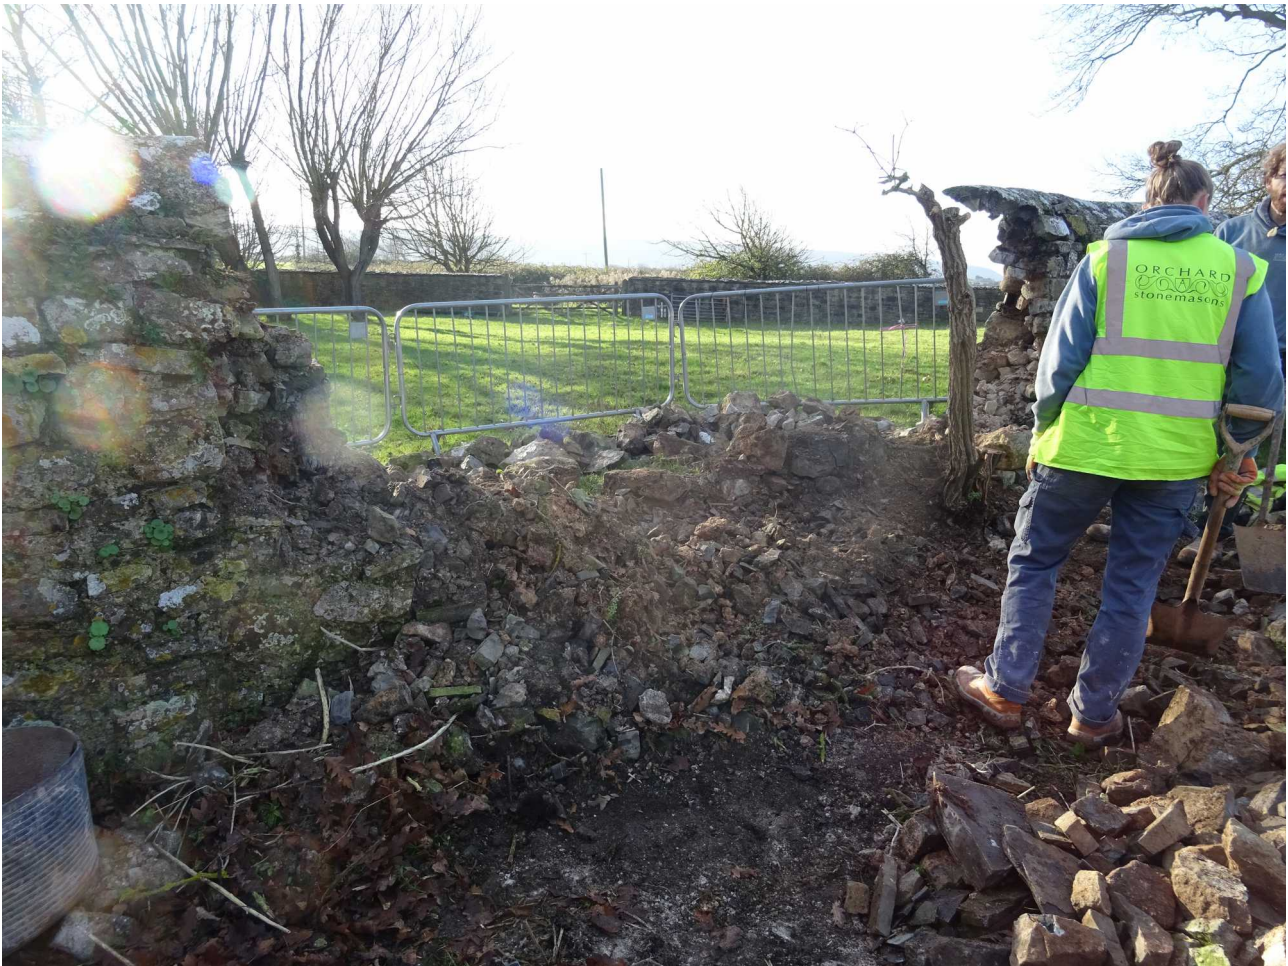
Fig 111: Collapse iii cleared for rebuilding, late 2020

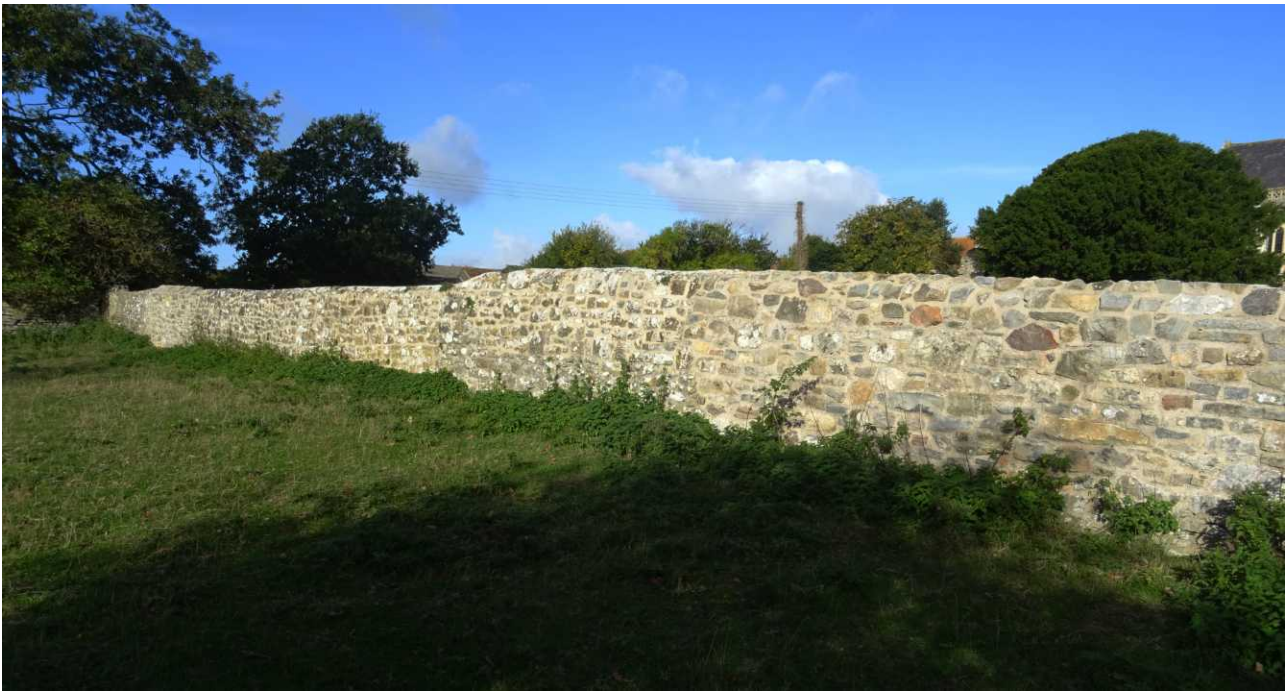
Fig 113: Wall 18, south side, completely repaired and repointed (2022)

Once all three collapses had been repaired, the repointing of both sides occurred during the winter and spring of 2022.

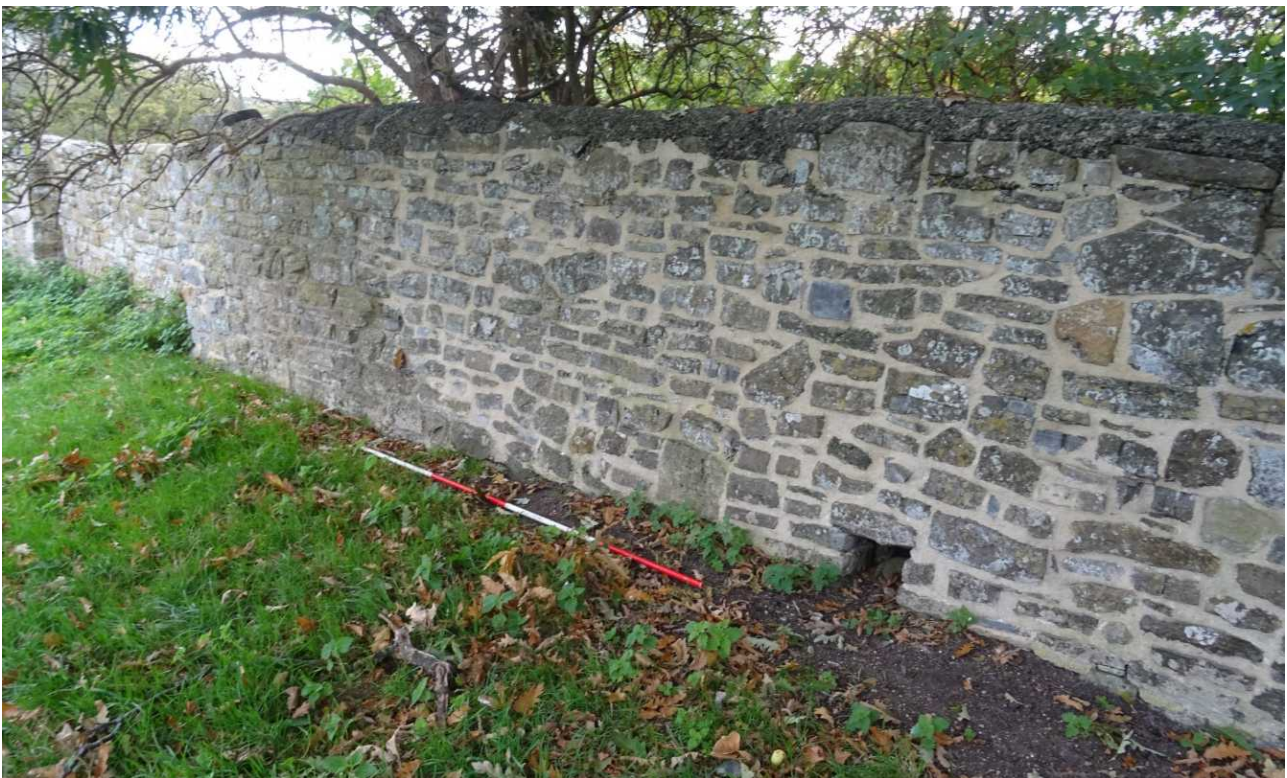
Fig 114: Wall 18, north side, east end, completely repaired and repointed

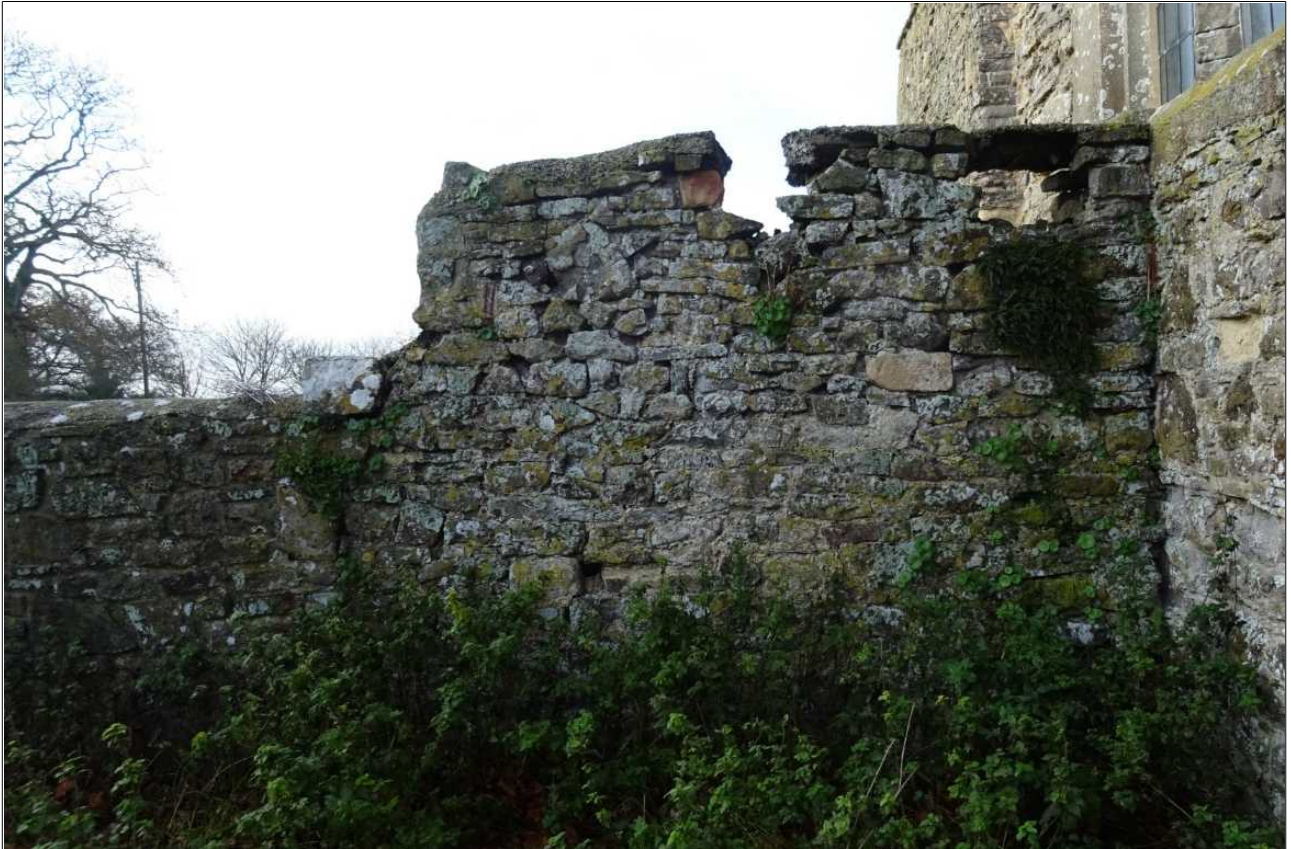
Wall 19 was, on the whole, in good condition, with the exception of a partial collapse in its centre, and the rather parlous condition of the last 3m against the infirmary.

Fig 121: Section of wall 19 against infirmary (2021)

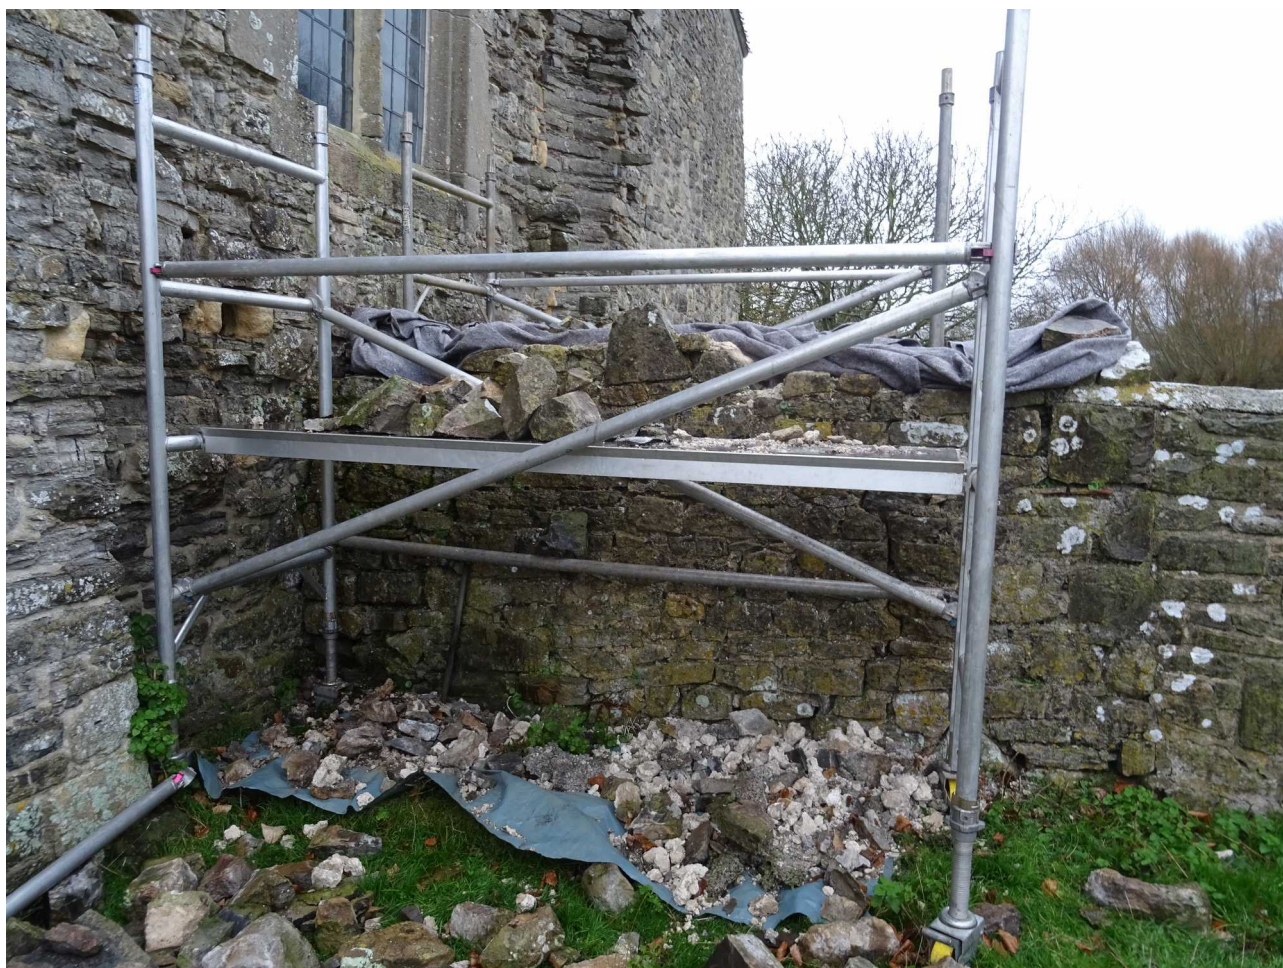
Fig 123: Works underway to rebuild part of wall 19 against the infirmary (late 2021)

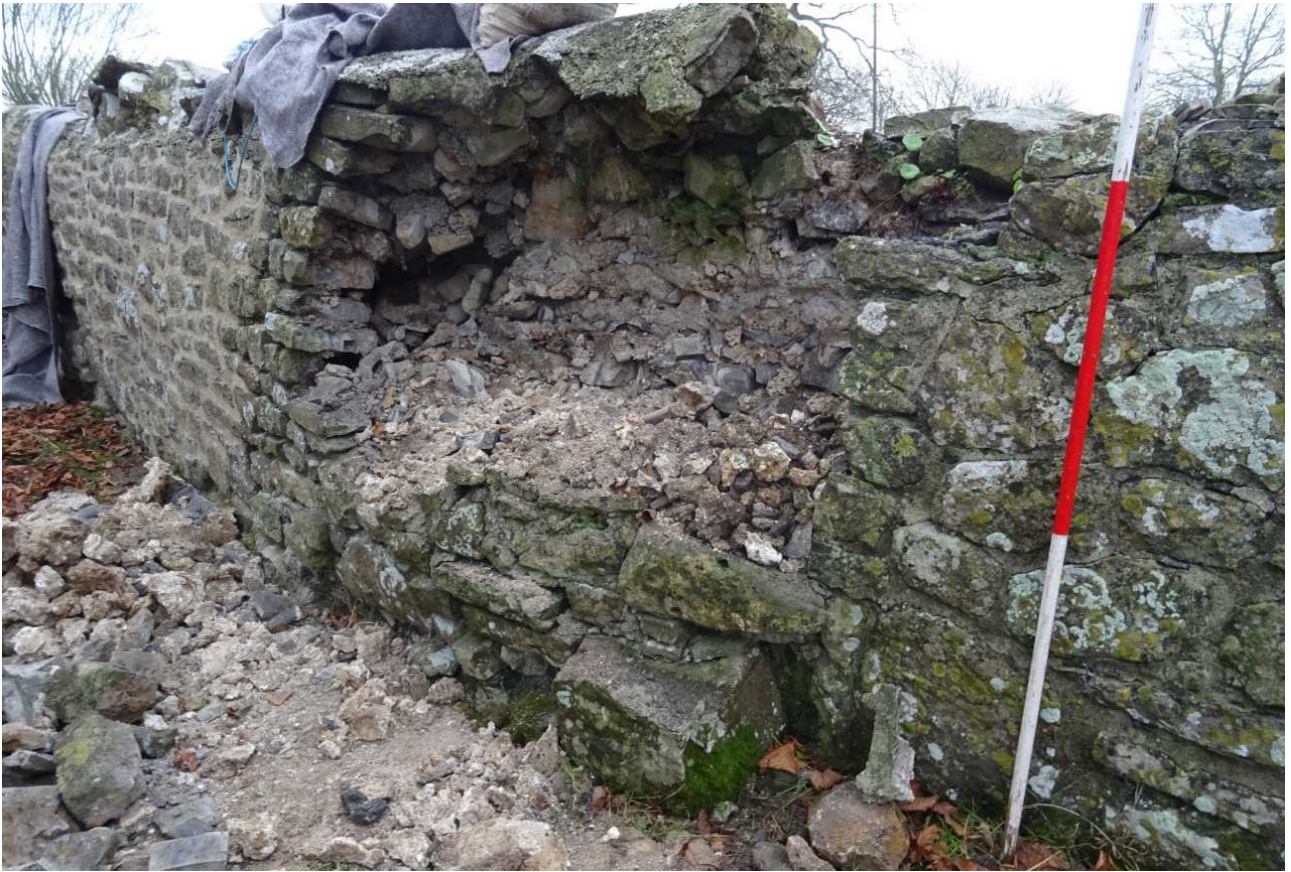
Fig 124: Central portion of wall 19 (from east): this was unstable, and had to be rebuilt

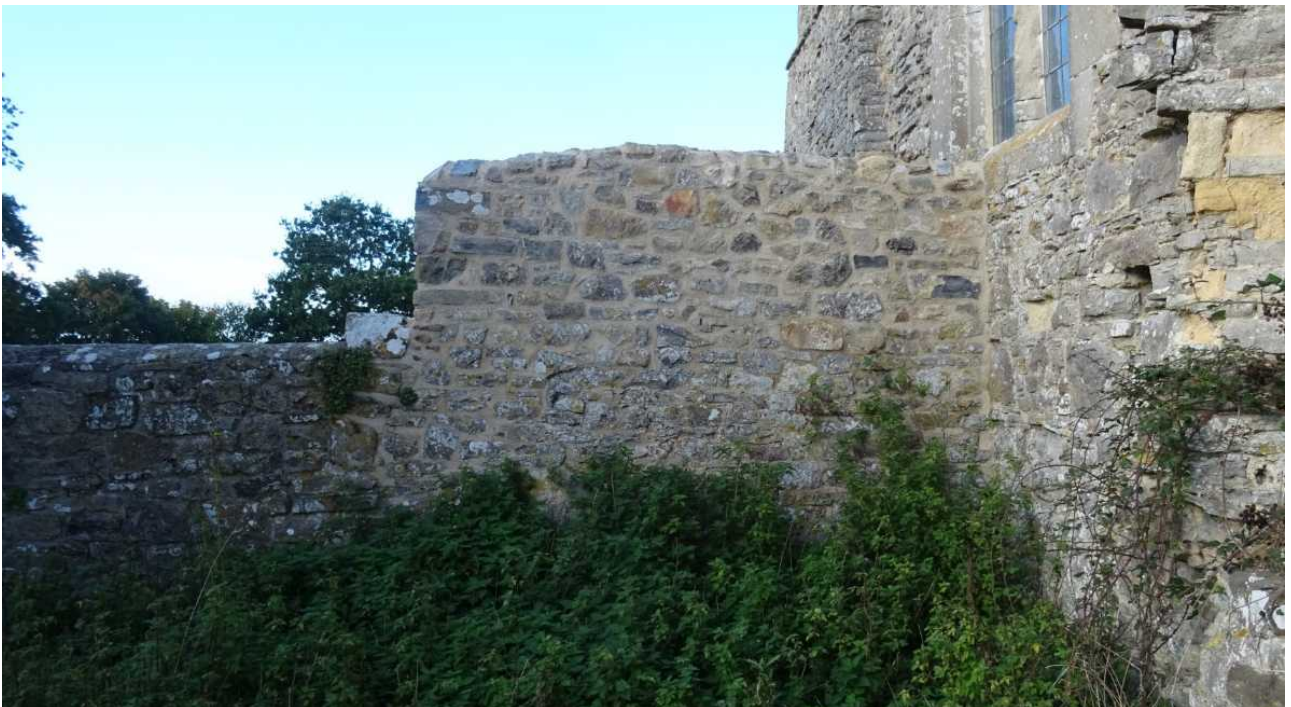
Fig 125: Rebuilt and repointed north end of wall 19

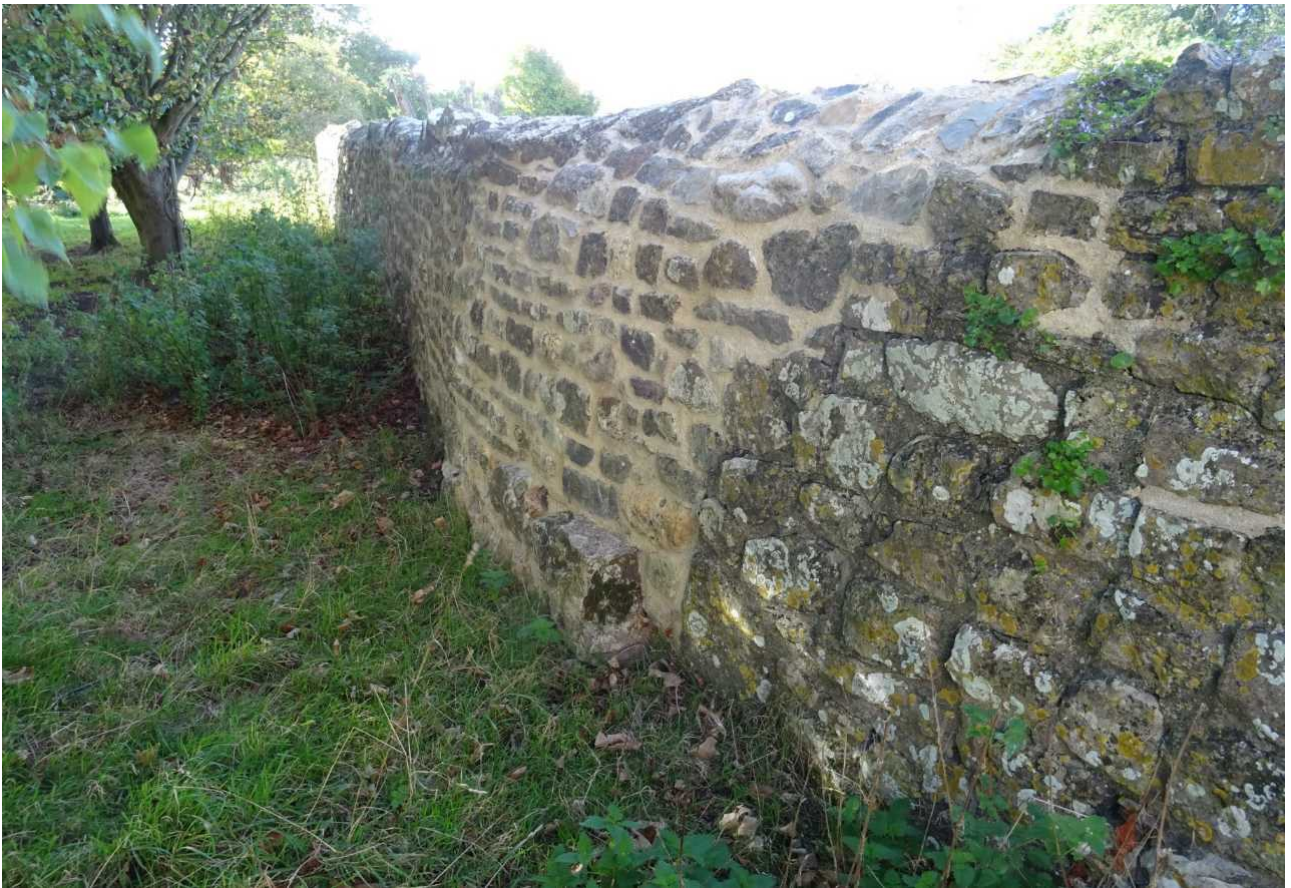
Fig 126: Exterior (east) of wall 19 after rebuild and repointing (2022)
