**YCCART 2010 / Y31
North Somerset HER 2011/140**

St Andrews Church, Congresbury

Geophysical survey of area to west and south of vicarage

**YATTON, CONGRESBURY, CLAVERHAM AND CLEEVE ARCHAEOLOGICAL
RESEARCH TEAM (YCCART)**

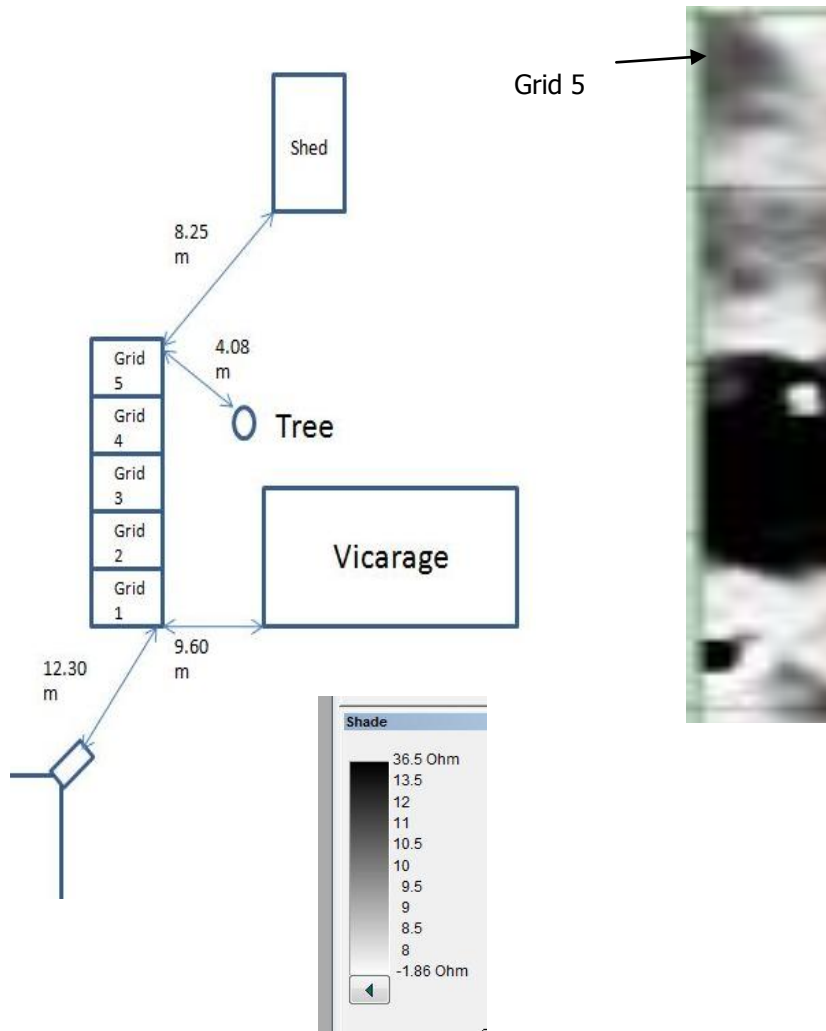
Fig 2 Survey plan plus Archeosurveyor results – west of vicarage

These results are complicated by the presence of several large mature trees, making the interpretation of the results more difficult due to moisture deficit around their roots. In Grid 5, there is a low resistance feature trending NW – SE, not dissimilar to those seen in earlier studies, but otherwise, this survey adds little to the earlier studies reported in Y23.

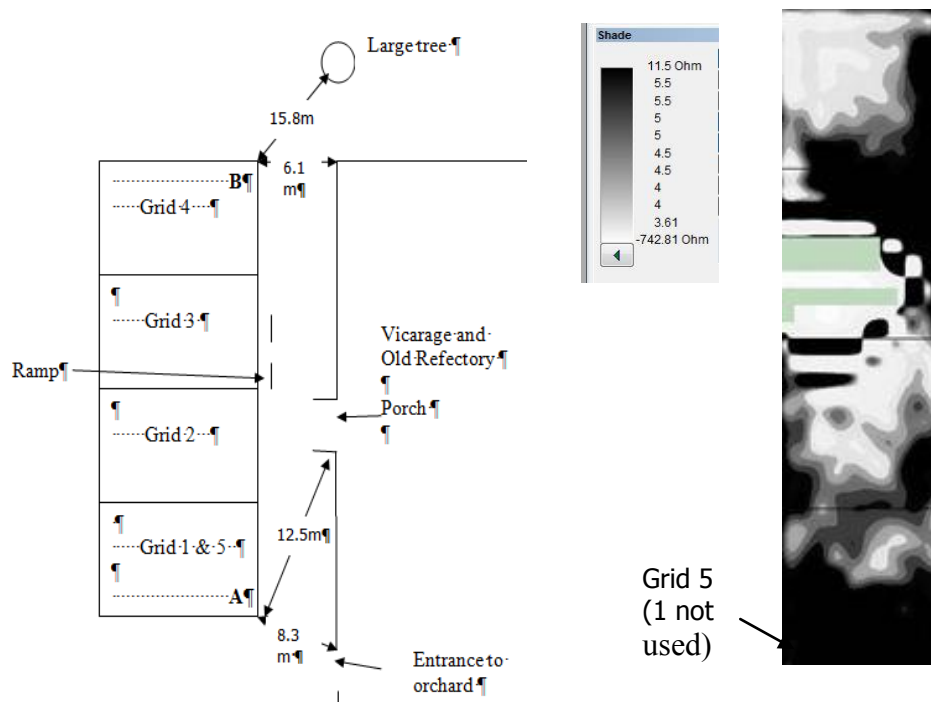
Fig 3 Survey plan plus Archeosurveyor results – south of vicarage

These results are not capable of clear interpretation. From earlier studies, and a watching brief on works to the ramp in 2007, it is clear that a stone bank runs from the top of the ramp at right angles, and in line with the eastern edge of the current churchyard, which is represented by a substantial lynchet today. It may be indicated by the patch of high resistance in Grid 3, although the artefacts in the area immediately to its east make this interpretation less than secure.

The survey does not extend far enough to reach the potential moat seen in the Glebe field to the east (see report Congressbury church Y14 this web site).

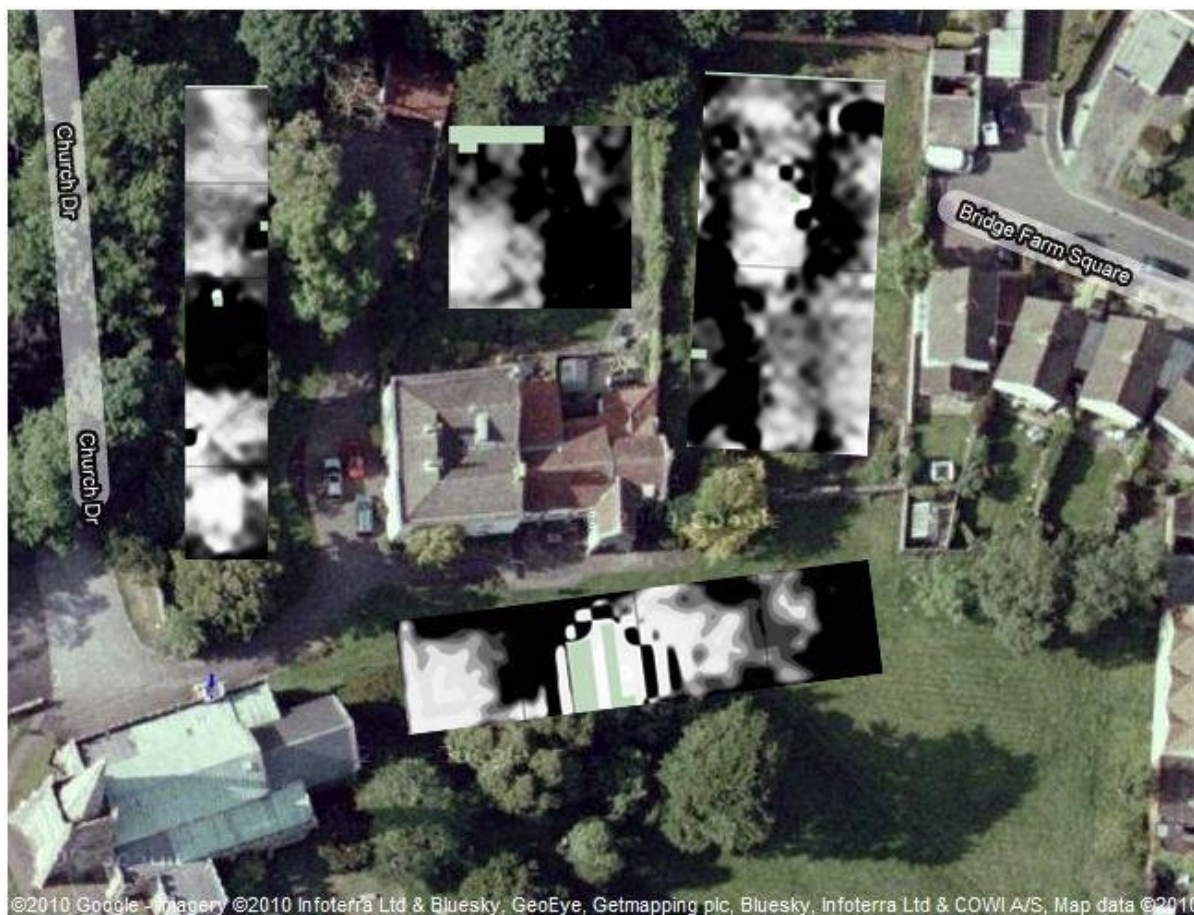
Fig 4 Results from this report and Y24 superimposed approximately on map.

This report adds a little to the overall conclusions reached in earlier reports. The general NW – SE trend of the results is striking, and as reported in the earlier work, this respects the alignment of the parish church, and not the late medieval building of the Refectory.

Presumably, this reflects the alignments of the earlier (minster) buildings at the church, although the square enclosure indicated by ditches historically recorded around three sides of the church does not, maintaining a more ritually 'correct' E – W alignment. The origins of this discrepancy are unclear. Is it a coincidence in the layout of the village that the long axis of the church, if projected from its south wall, runs exactly through the site of the village cross?
