**YCCCART 2010 /29  
North Somerset HER46779**

***A one-up, one-down cottage at Kenn Moor Gate, Yatton: Salvage  
photographic recording***

**YATTON, CONGRESBURY, CLAVERHAM AND CLEEVE ARCHAEOLOGICAL  
RESEARCH TEAM (YCCCART)**

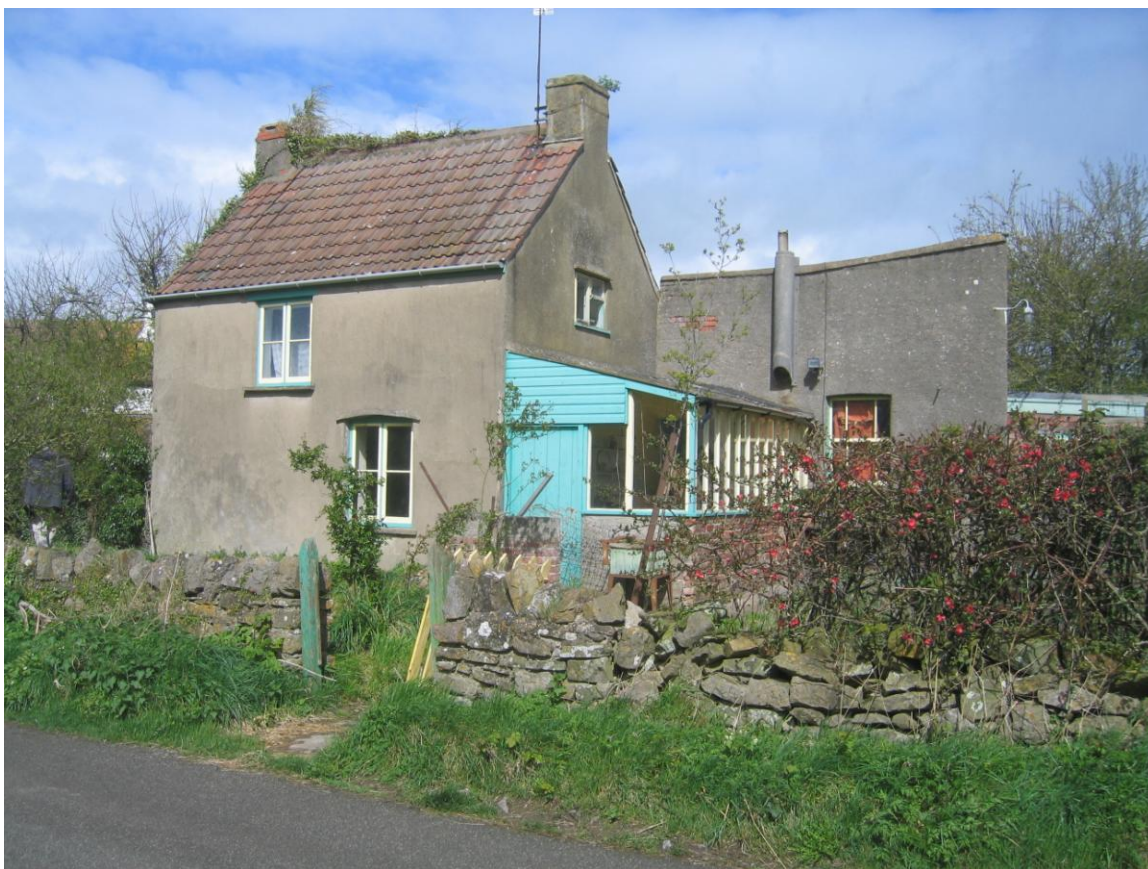
*Stonehurst Cottage immediately before demolition in 2005*

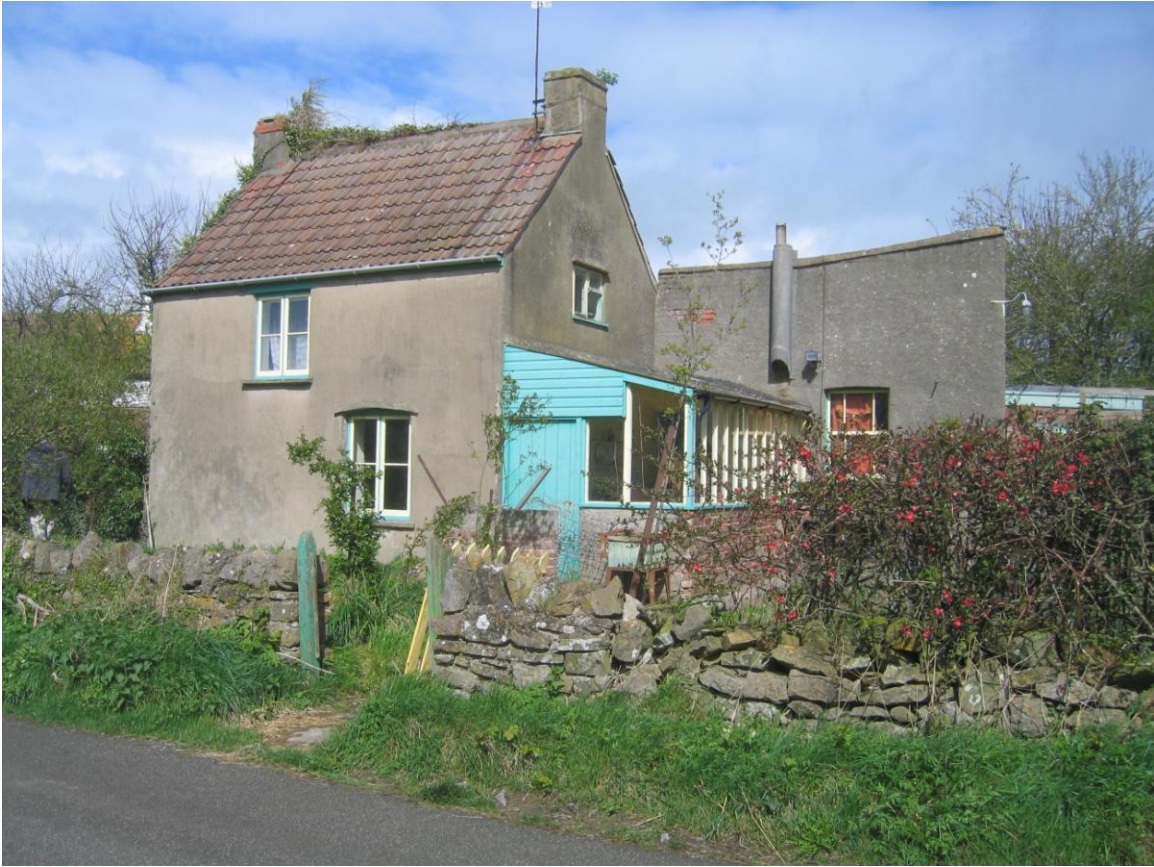
*Main building.* Rectangular rendered farmhouse, gabled with end stack to west and false stack to west gable. Roof in double Roman tiles. No evidence internally or externally of central door: current entrance to rear of east end of structure (now in extension) possibly original. One offset four-light casement to east side of ground floor front elevation: one central four-light casement to centre of first floor. Central small three-light casement in east gable under false stack to first floor.

*Fig 3: Cottage from the road, extensions to right of picture. Note false stack to right gable.*

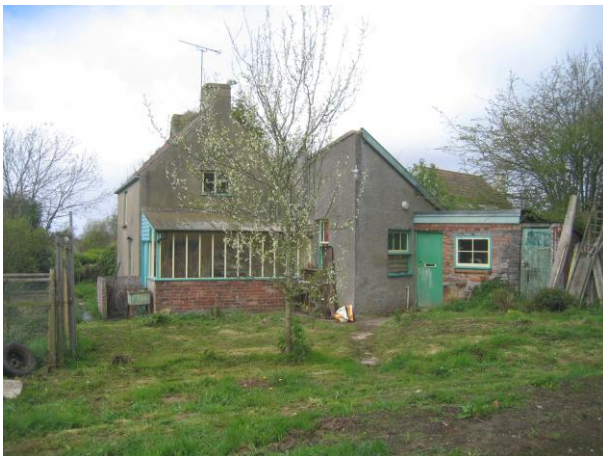
*Fig 4: Cottage from garden*

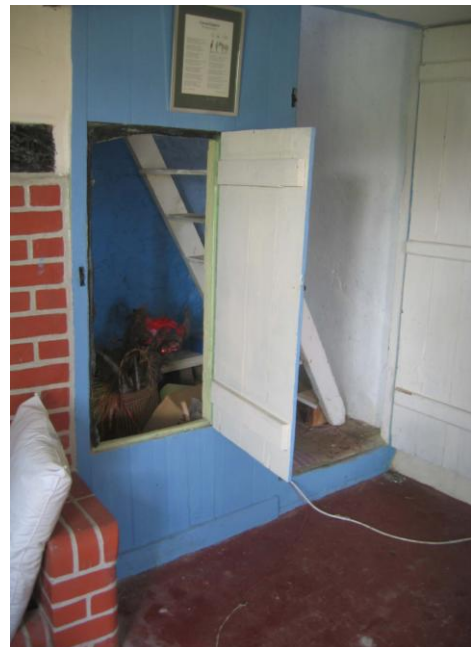
*Interior:* Ground and first floors open, with stair consisting of open ladder in cupboard to right of stack. First floor consists entirely of wooden planks. Stack stepped back at first floor; brick fireplace of uncertain age to ground floor with rustic bressumer. Cupboard to left of fireplace in front elevation wall.

*Fig 5: Open stair in cupboard*

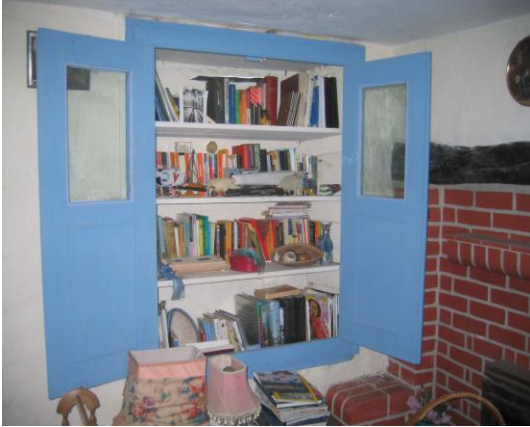
*Fig 6: Cupboard in front wall and fireplace*

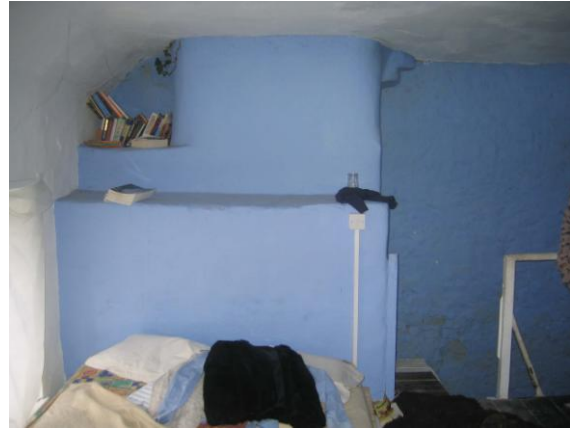
*Fig 7: Stack on first floor - top of stair to right*

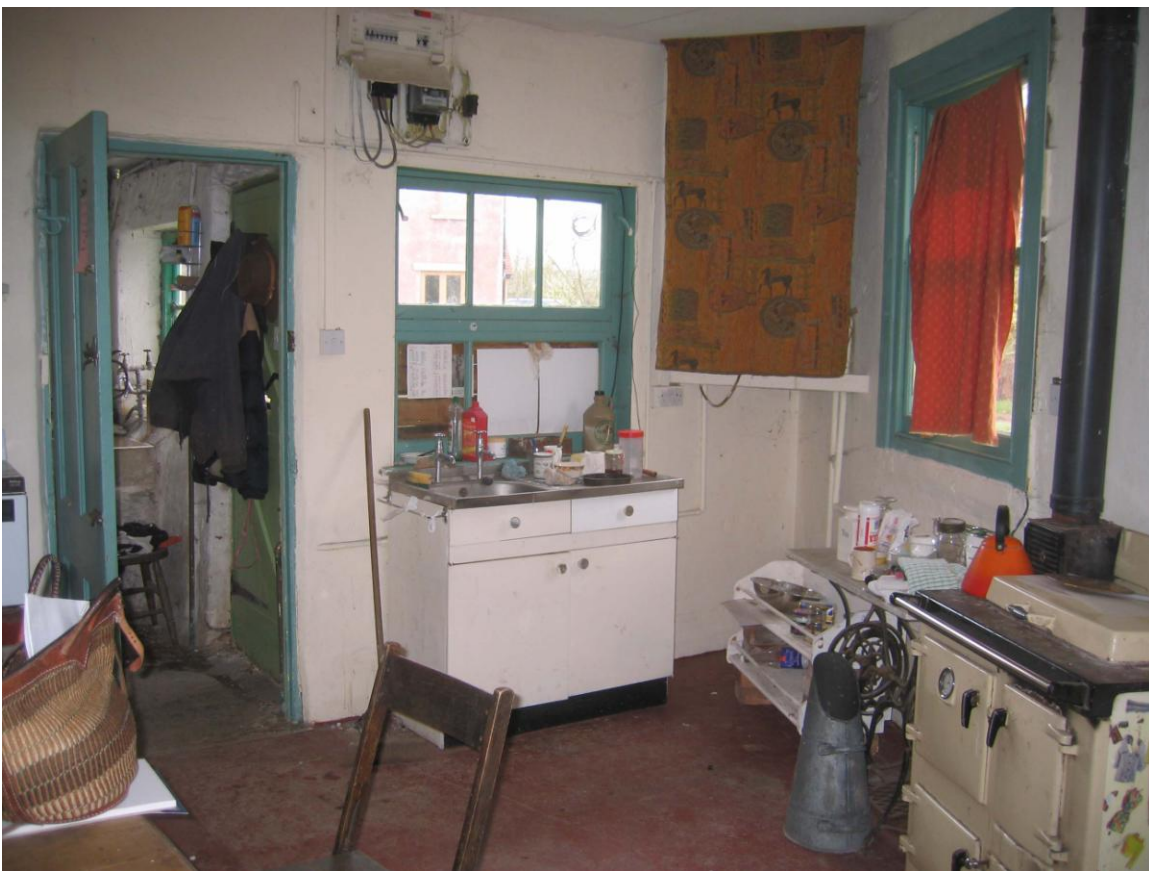
*Extensions to north-east of building.* Rendered single-storey one-room, with monopitch roof, materials unknown. Door under adjacent 'conservatory': sash window to front elevation, casement to side, all 20<sup>th</sup> century. Front elevation parallel to house, side right angles to ditch, giving odd 'pointed' corner.

*Fig 8: Interior of first extension showing non right-angle corner and windows*
