**YCCCART 2019/Y14**

**Geophysical and terrain modelling survey at Towerhead, Banwell, 2019**

**YATTON, CONGRESBURY, CLAVERHAM AND CLEEVE ARCHAEOLOGICAL  
RESEARCH TEAM (YCCCART)**

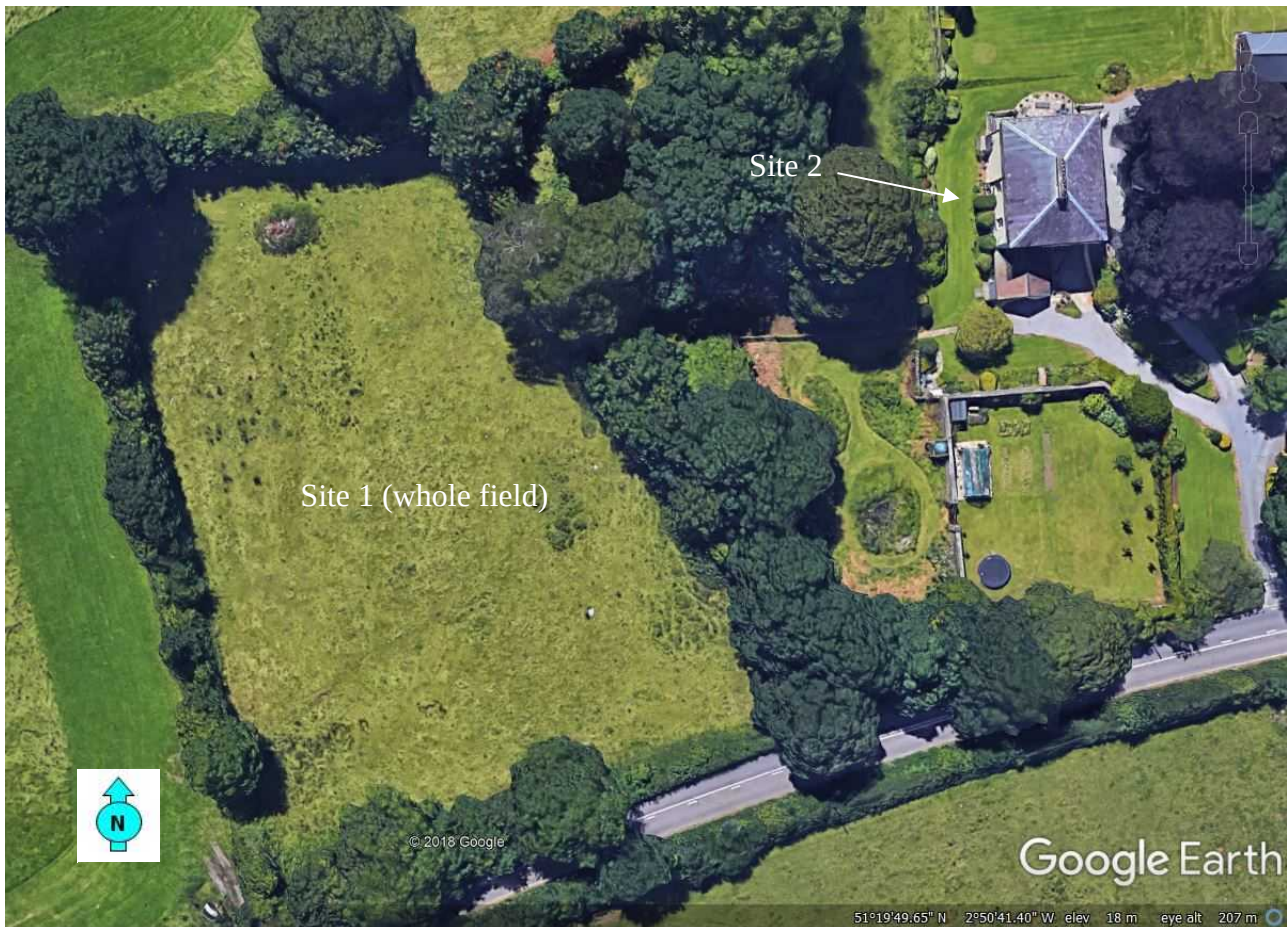
*Fig 1: Site locations looking south. The current house is to the right of site 2.*

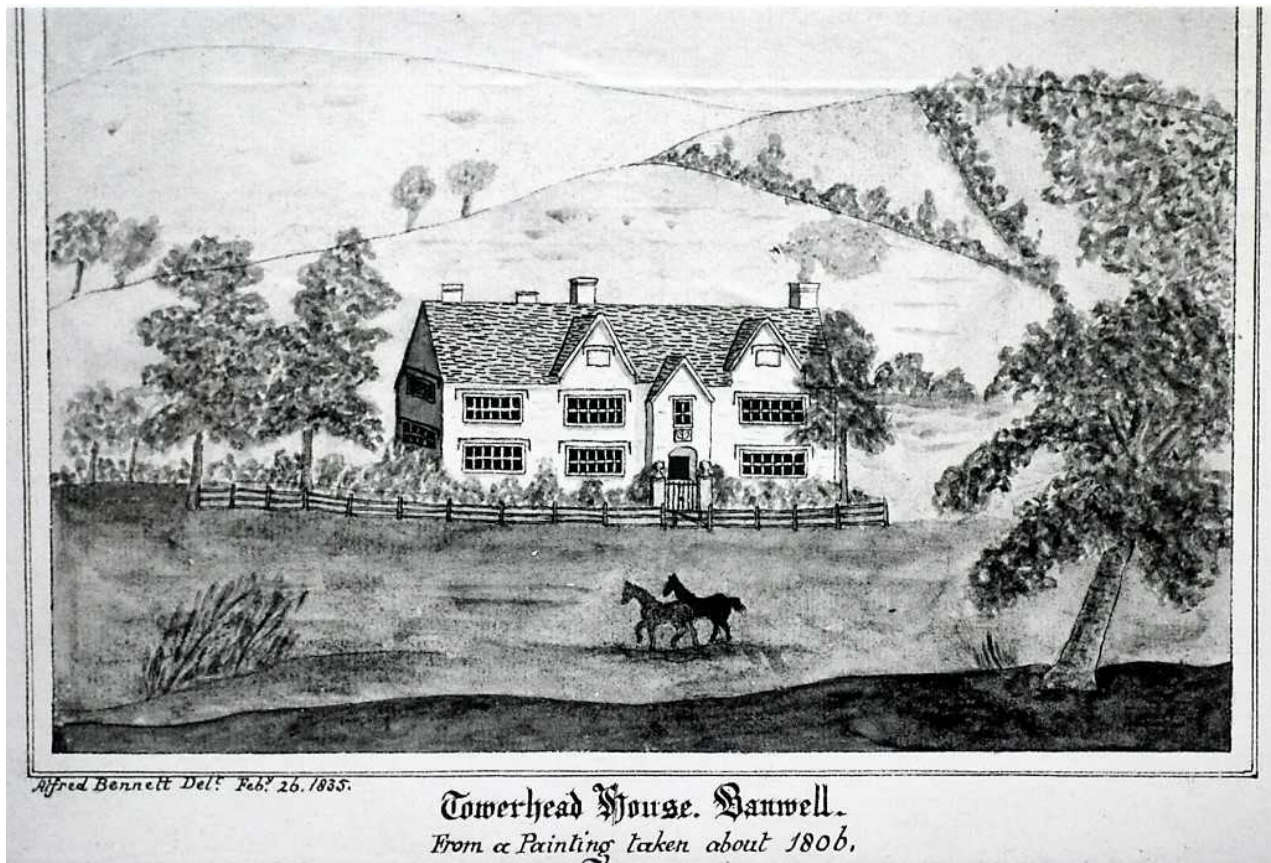
Fig 2: Towerhead House c 1806 (courtesy of Banwell Archaeological Society)

The salient points of the documents are that Knight states that the old house was entirely pulled down about sixty years ago so c1842. and a new building erected to the south-west of it. He also states that across the foot of the orchard, now buried under the turf, is an ancient road. This causeway is also mentioned by Rutter, who dates the old house to about 1584 and describes it as a large substantial structure, in the Elizabethan style. The emphasis on the structure being 'large' is not borne out by the painting (Fig 2 above), which shows a single-pile building.

These include the 'WYN.GOD.WYN.ALL' shield, currently in the northern wall, a plank door with iron studs and hand-made long hines, and the stone gate posts at the modern entrance, which appear to be those depicted in the 1806 painting (Fig 2 above). Certainly, the Historic England List description dates them as 'Late C17/early C18', although unlike certain features in the house, it does not discuss their possible re-use at the modern site, and so presumably HE are unaware of the existence of the painting. Otherwise, details in the painting agree with the assumed date (the three front gables, the hood moulding over the multiple pane windows and the square door frame set in its own slightly projecting gable). The two chimneys on or behind the east end of the house perhaps imply domestic activity at the rear. The section of wall remaining at the west of the building in the field boundary shows the building was of Carboniferous Limestone and other rubble, some dressed into squared-off blocks. The thin nature of the roof cover implies tiles rather than thatch, as would be expected of a high-status building at this time.

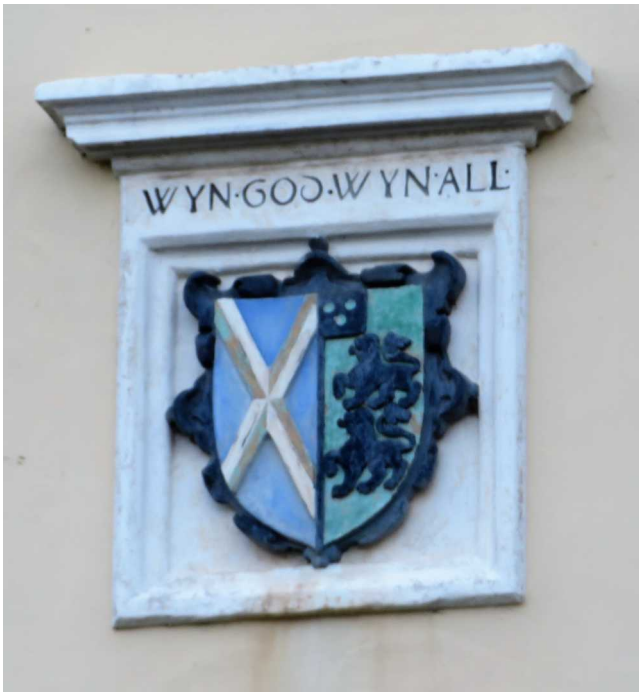
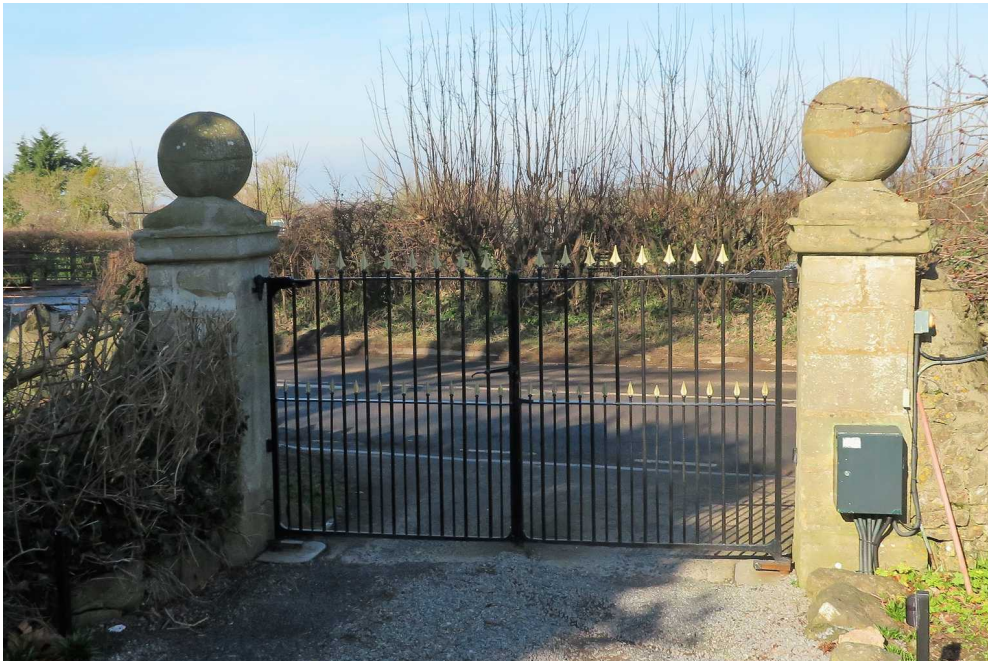
*Fig 3: Remnants of the old house.*

*Top left a shield with the Bishop's arms, impaling those of Bath and Wells, with the motto, WYN GOD. WYN.*

*Top right the oaken iron-studded door*

*Left the stone gate posts are said to be from the old house and are shown in the 1806 picture*

Some elements of the old building (and probably much rubble stone, although this cannot be shown since modern Towerhead House is completely rendered over- see Appendix 1 below for the List Description of the modern house) were incorporated into the modern house (see Fig 3 below).

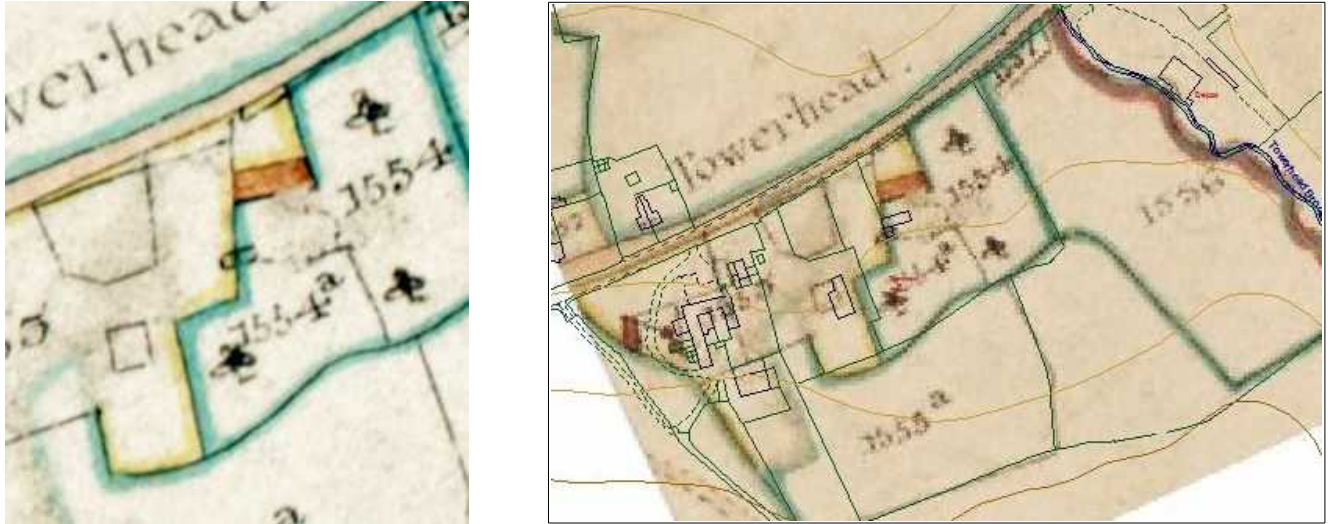
*Fig 4: Towerhead House from the Tithe Map (1834, left) and (right) georeferenced to OS data. The match is not perfect, but the work of James Poole, the map's surveyor, seems tolerably accurate*

The Banwell Tithe map (see Fig 4 below) is a re-purposed map of 1834 (the Tithe Commutation Act was not passed until 1836), and clearly shows a structure to the north-east of the current site of Towerhead House. Notably, it is the north-east structure that is coloured as a dwelling (red): a square at the site of the current house is left open, so Towerhead House was either under construction in 1834, or had not yet become inhabited. This does perhaps raise some issues about whether the oak door in Fig 3 above may not relate to a separate earlier structure (perhaps non-domestic) on the current site of Towerhead House.

A few more clues come from a commission to study the apparent sacking of, and theft from, the old Towerhead House when Bishop Godwin died (Hembry 1951: 98). It described the house as having a hall, a great chamber, a parlour with a little chamber above, two more little chambers, a study, a kitchen, a larder, a backhouse and a dairy, and a well which served it outside. All sources imply that the old Towerhead house was demolished about 1840. It was thus depicted on the Tithe Map (see Fig 4 below) in the last few years before its removal.

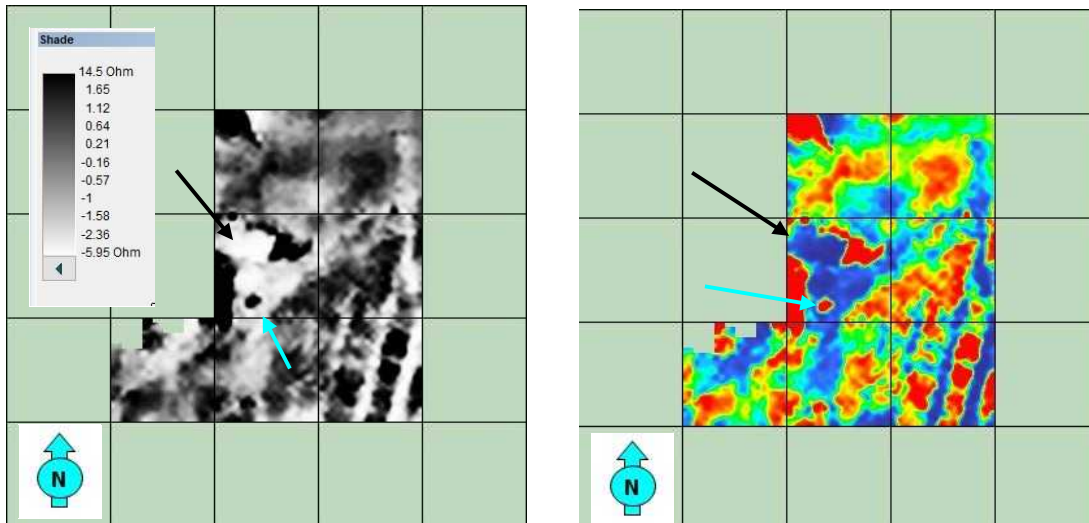
*Fig 6: Resistivity results.*

The lines in the lower right - hand side grid are the remains of an orchard. The white (left) and dark blue (right) rectangular areas are clearly the footing of the old house (black arrows). It is possible that the small circular anomaly (cyan arrows) is the external well referred to in the documents.

A coloured image alongside reflects the same anomalies.

Site 1: Orchard east of current house. The resistivity results in Fig 6 clearly show part of the old house as indicated by the black arrow.

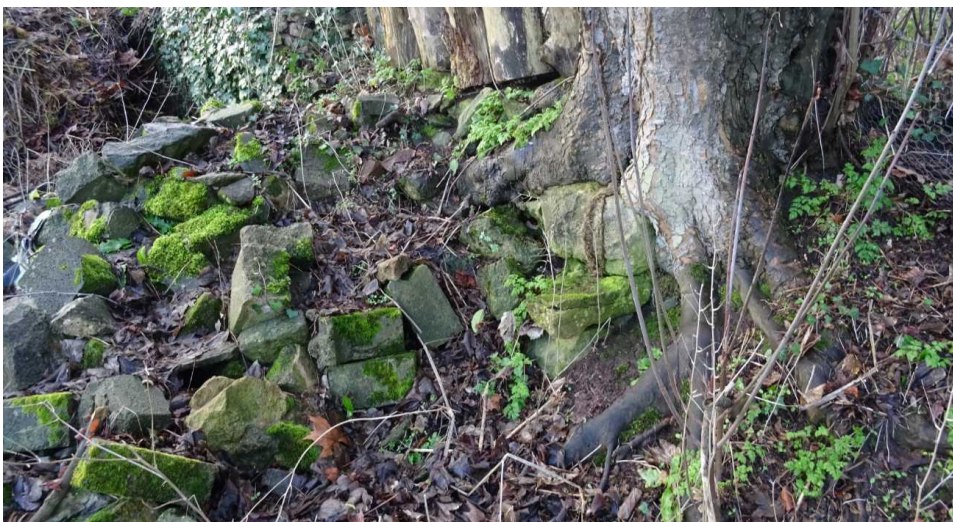
Part of the west end of the house could not be surveyed because it lay under a dump of stone and rubble, and piles of roof tiles from an adjacent demolished building. Checking this, however, it became clear that remnants of the stone wall of the old house were visible by the field boundary as shown in Fig 7.

*Fig 7: Part of the wall of the old house survives among the roots of a sycamore.*

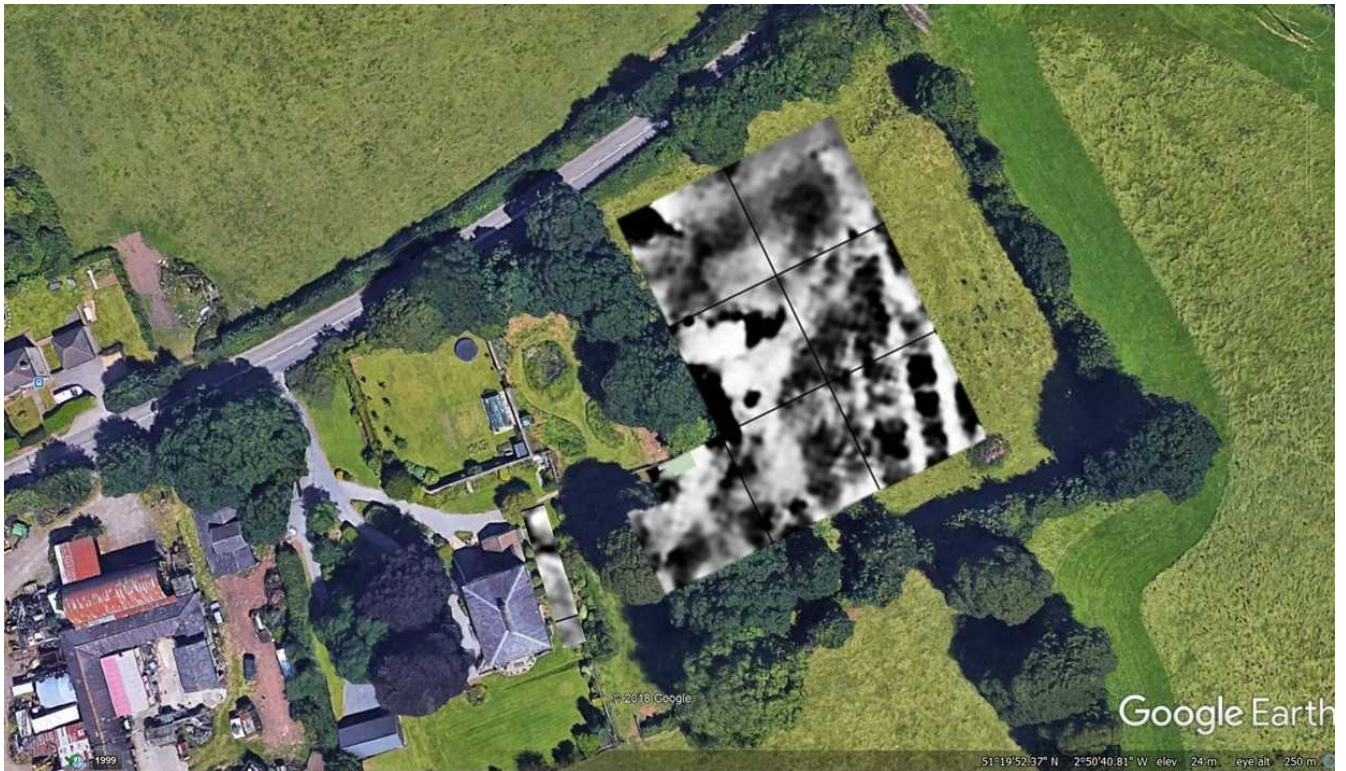
*Fig 10: The resistivity results from site 1 & 2 (See arrow) superimposed on a Google Earth image*

The resistivity survey has established that the remains of the Elizabethan house lie in the orchard to the east of the house, as recorded by Knight. This is further substantiated by a fragment of the old house wall remaining where the resistivity results indicate the structure, and to a degree by the terrain modelling results.
