YCCCART 2021/Y6

The Old Stone Crosses of Bleadon, Loxton and Compton Bishop

**YATTON, CONGRESBURY, CLAVERHAM AND CLEEVE ARCHAEOLOGICAL
RESEARCH TEAM (YCCCART)**

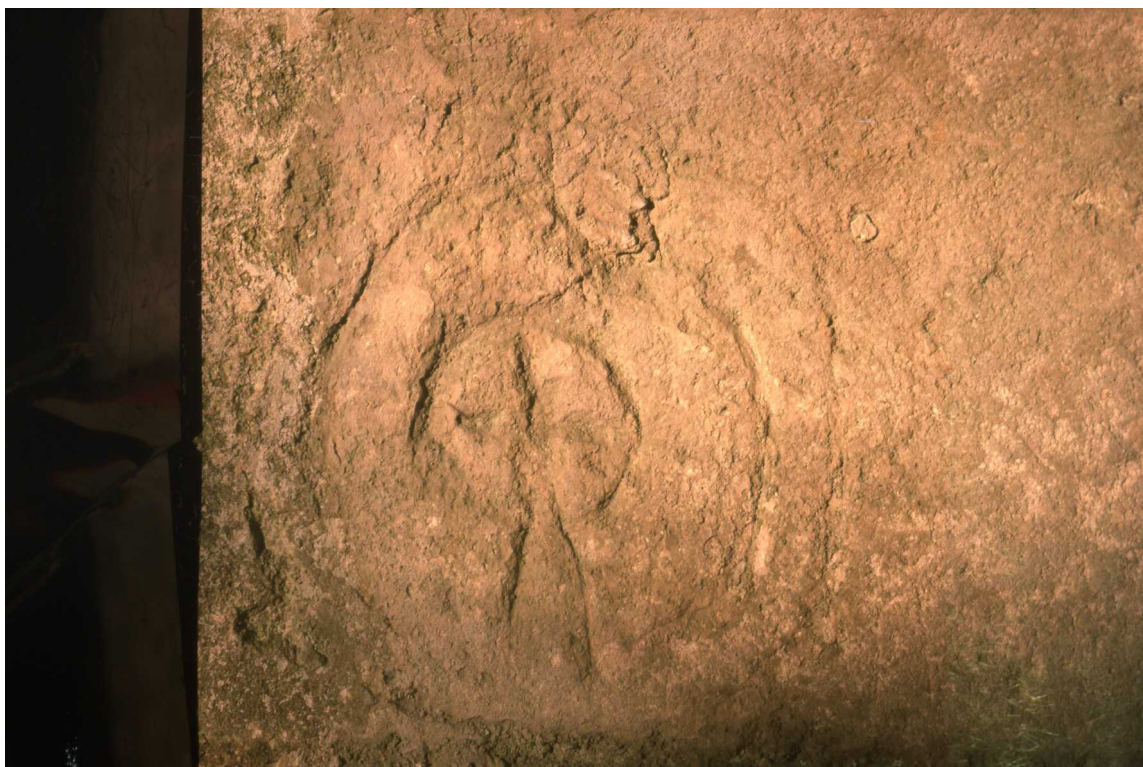
Graffito on jamb of Loxton church porch door

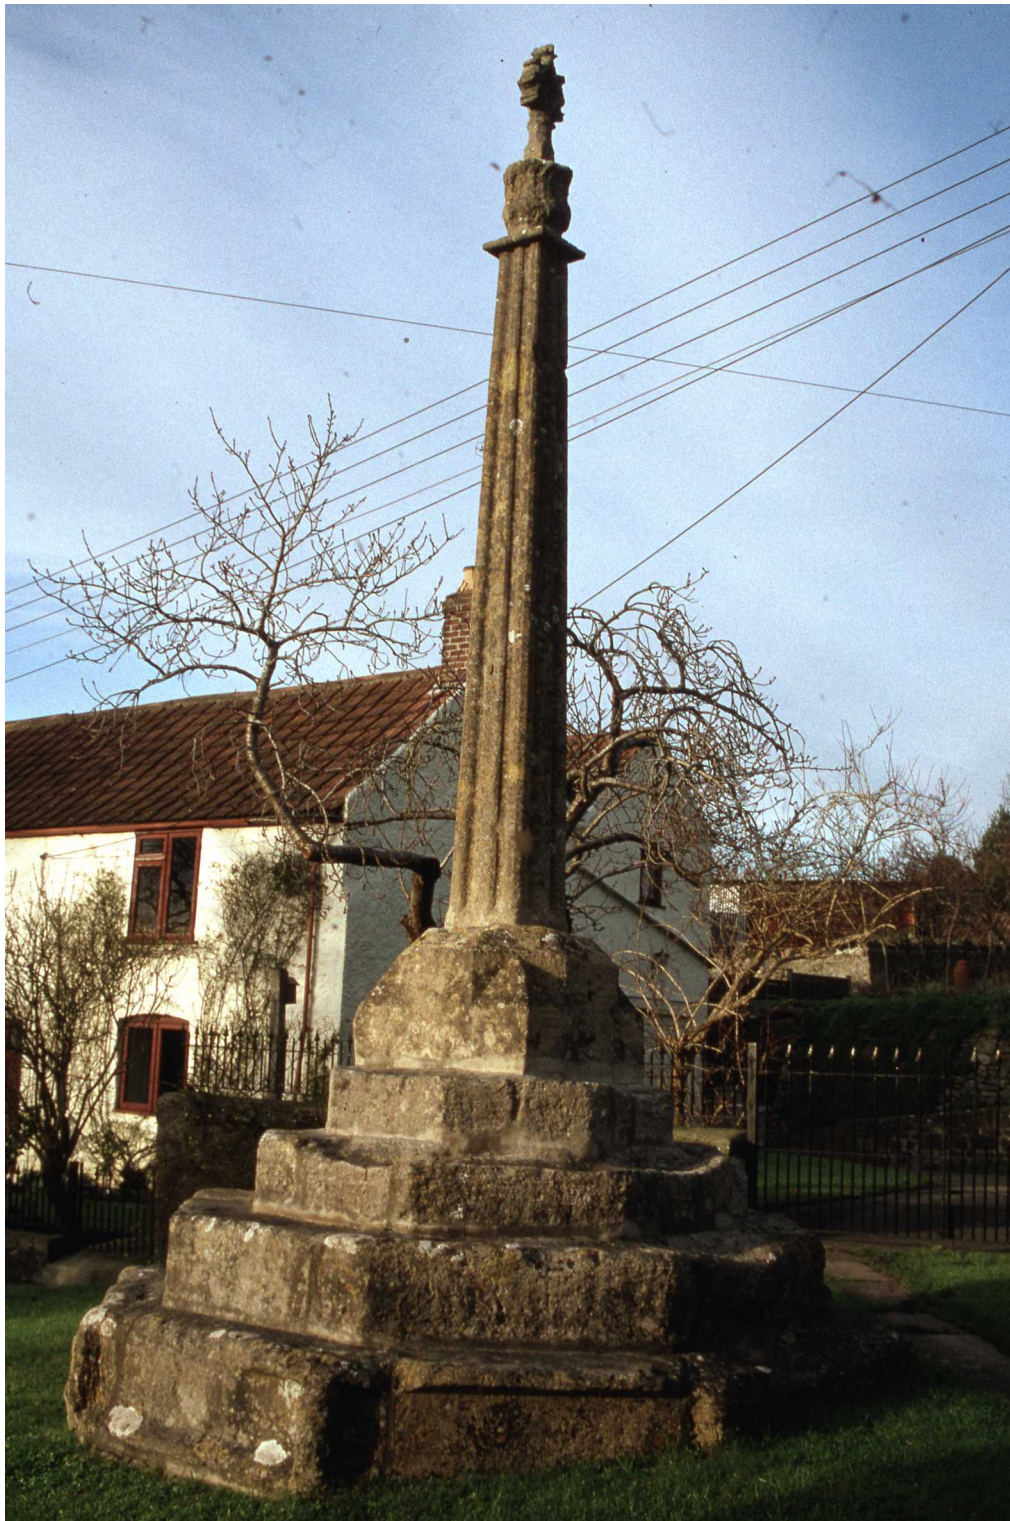
Fig 5: Bleadon 1: 'Village' cross

The word village is included here in inverted commas because there is a persistent rumour that the cross was once in the churchyard, but '..in an open space, formerly included in the precincts of the churchyard, but which of late years has been walled off and become part of the thoroughfare of the village..' (Pooley 1877: 66).

If this was so, it certainly happened before 1828 (Fig 6) (hardly 'of late years' in 1877).

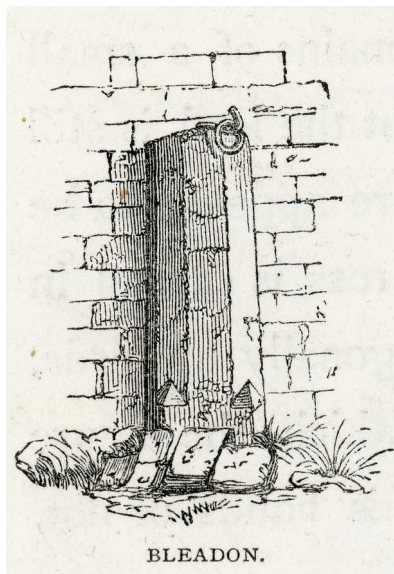
Fig 7: The 'hitch-stone' from Pooley (1877)

A clue to the previous appearance of the cross is given in Pooley, where he illustrates (Fig 7) an object referred to as 'the hitching-stone' since an iron hook set into it sufficed for the hitching of horses. This appears to be the base of the demolished cross shaft.

This stone had a curious later story: a later vicar found it had disappeared, but he found it, and put it in the church, where it was in 1929: by 1966, when the OS archaeologists looked for it, it had disappeared again.

It might be worth checking the churchyard at Bleadon in winter conditions to check if the 'hitching-post' still remains there.

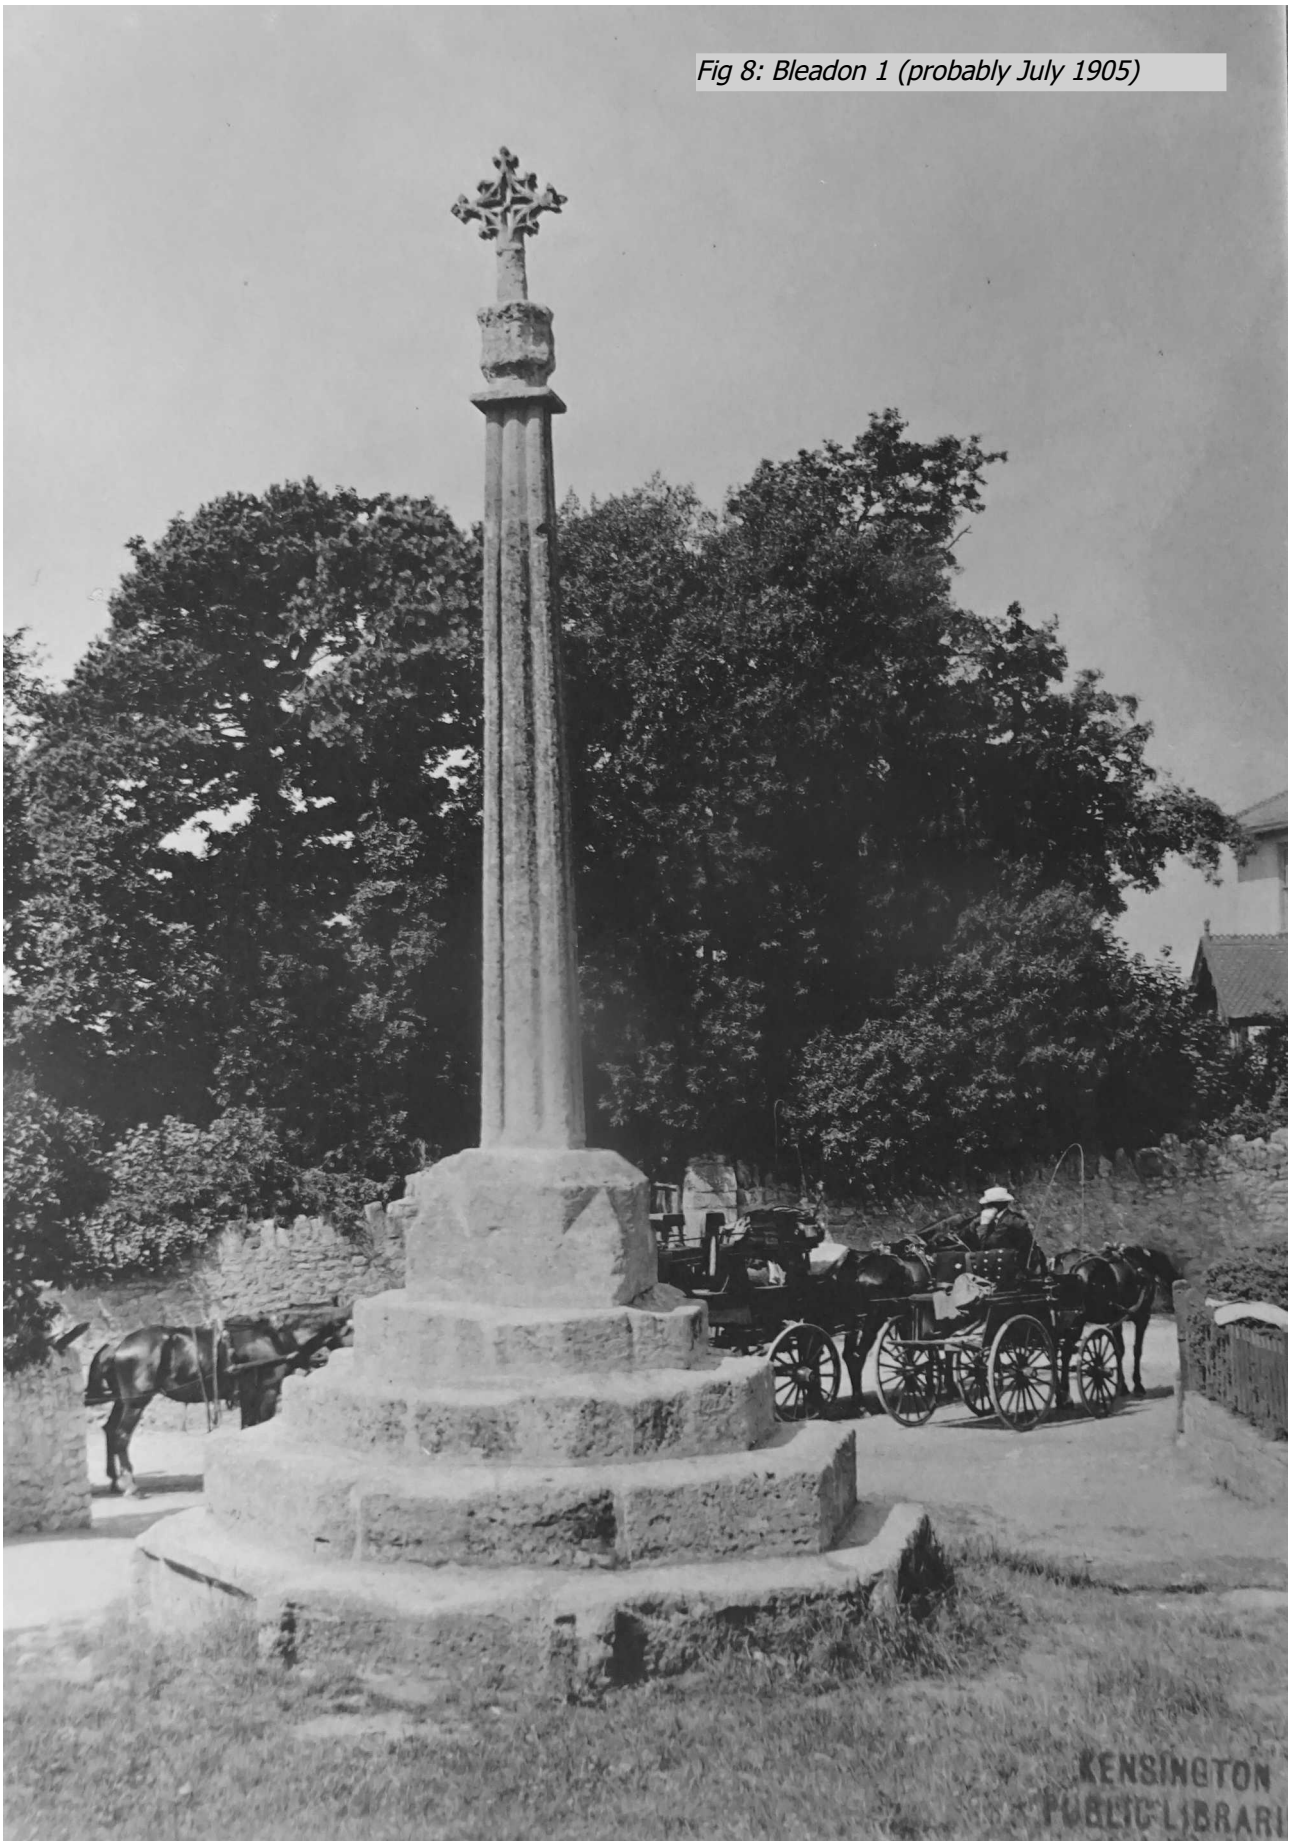
Fig 8: Bleadon 1 (probably July 1905)

The position of the structure has led to some picturesque photographs, such as that in Fig 8.

I wonder if this photograph was taken during a visit to Bleadon church by the Somerset Archaeological and Natural History Society, who visited Bleadon on July 19th 1905, and we are specifically told that they *'inspected the Cross'* (PSANHS 1906 Annual Meeting 1905: 33). Perhaps surprisingly, Bleadon does not have a Conservation Area: the cross is protected by its Listed status.

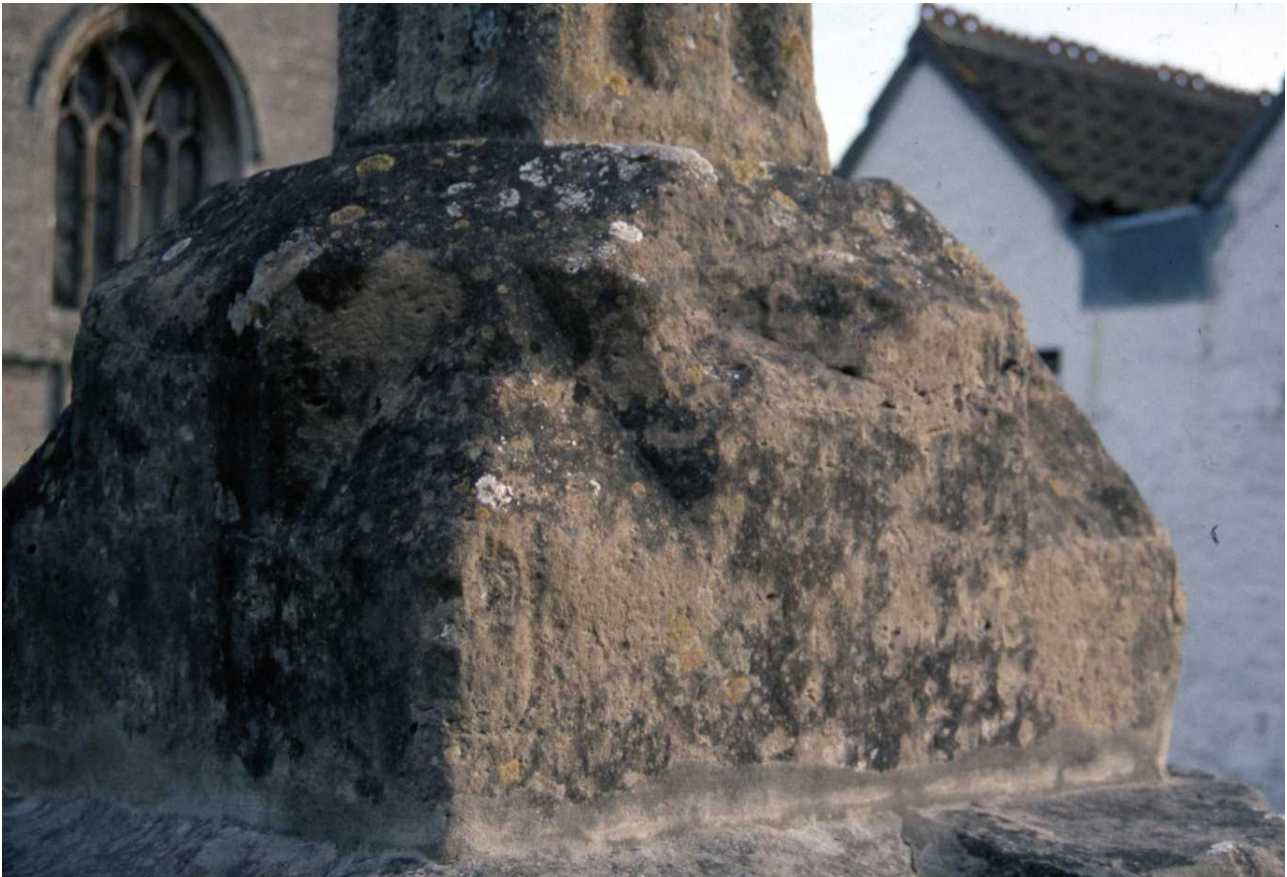
Fig 9: Socket of Bleadon 1 (1992)

The cross is only in average condition: Fig 9 below shows what appear to be concrete repairs, and in the upper centre of the side facing the road, a possible concrete-plugged hole for an affix.

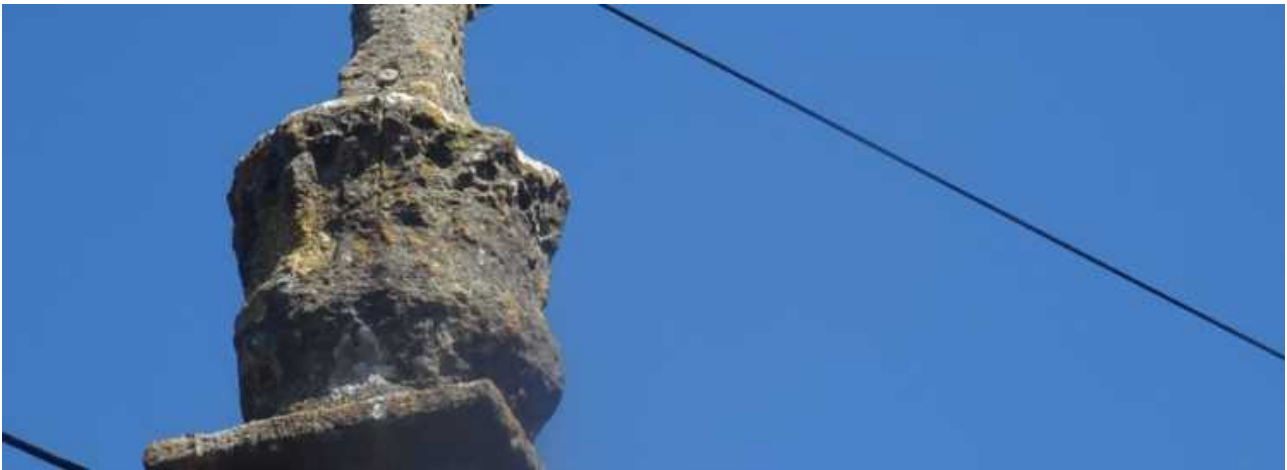
Fig 10: The late medieval abacus

The survival of the medieval abacus (especially in an early 19th century 'restoration') is little short of miraculous. A few others are known (at say, Cheddar or West Pennard), but precious few survive from medieval Somerset.

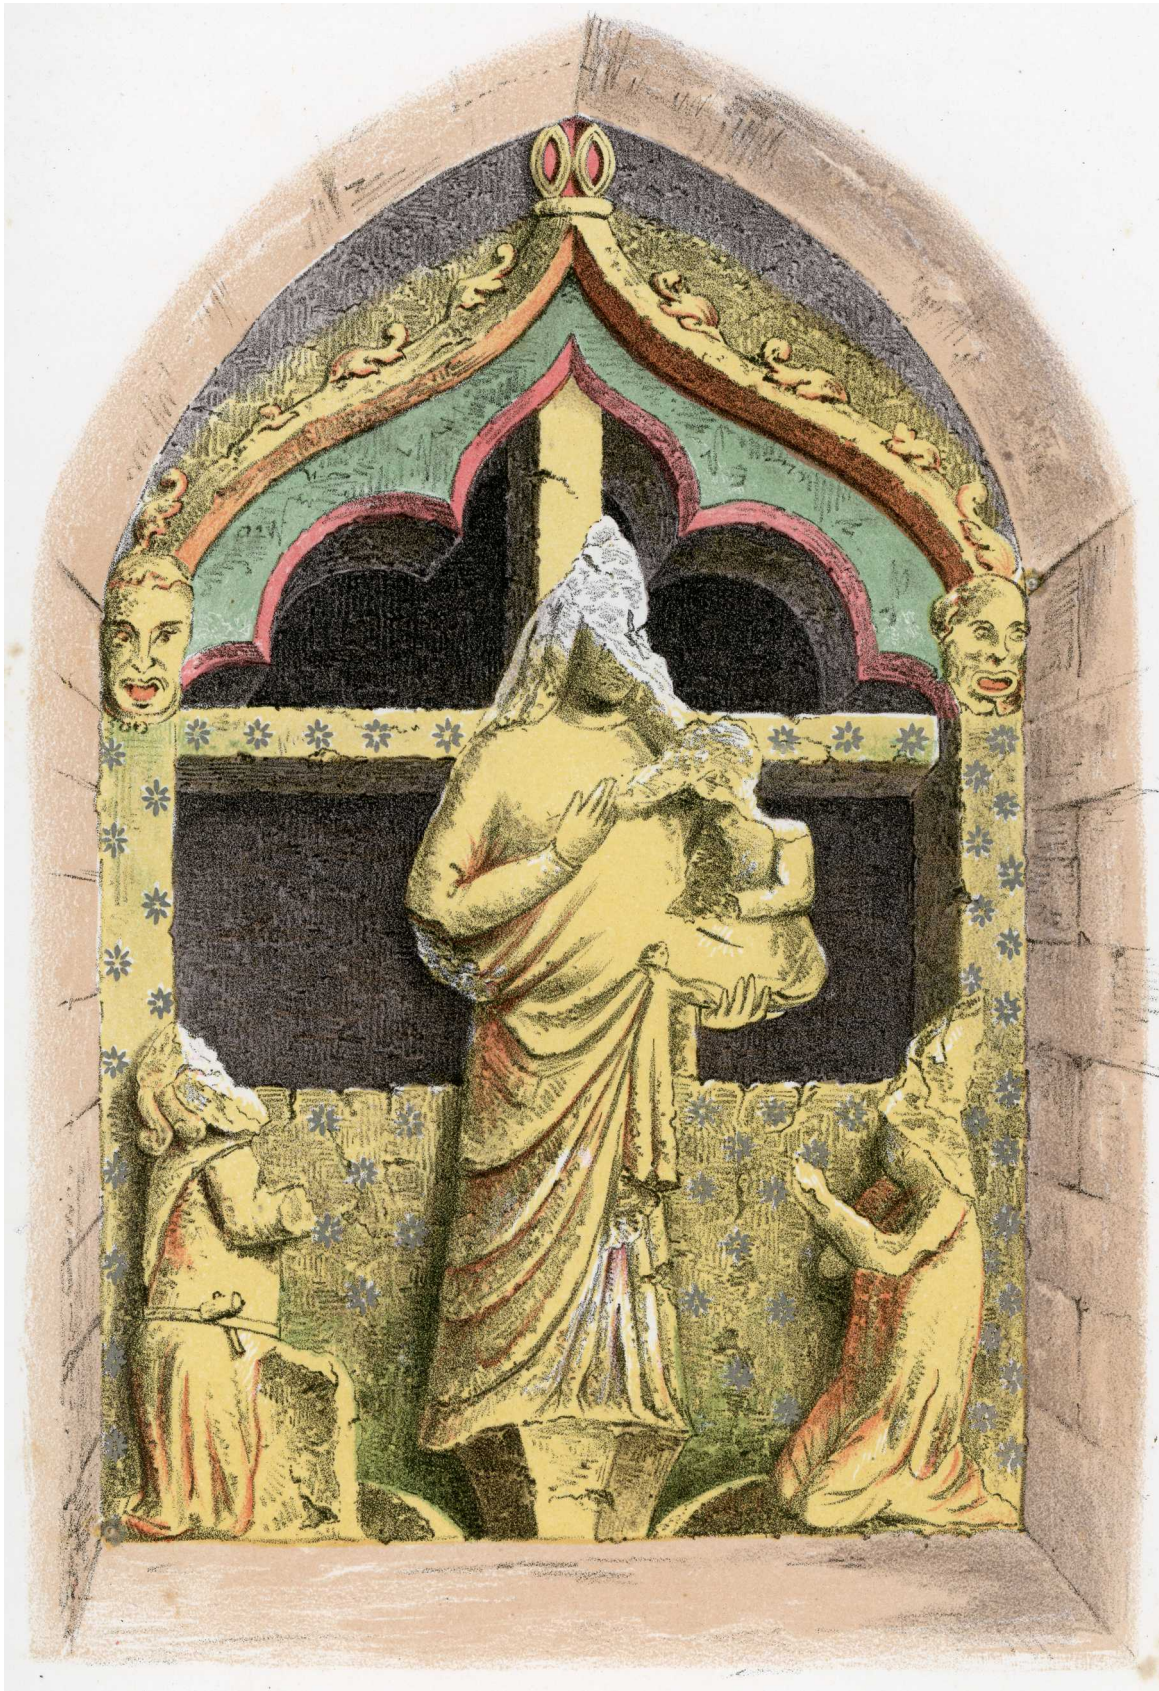
Fig 11: Bleadon 2: Cross in church porch by WM Pooley (1877)

Porch Cross. -A discovery of no ordinary interest was made a few years ago, during the restoration of the church. On removing the plaster from the east wall of the porch, the workmen exposed to view a canopied niche containing sculpture. The niche is formed of a five-centred arch, beneath an ogee moulding that springs from corbel heads. Occupying the centre position, and standing on a pedestal in front of a Cross, is the figure of the Virgin, carrying the Holy Child on her left arm; she wears a close-fitting vest, as well as an ample robe, which, falling under her right arm, is gathered up in graceful folds to the left side. Although the head is much broken, she appears to have been crowned.

The niche measures 30 in. in height, by 20 in. in width, and the upper part of the block in which the group is cut, is pierced. Early Fifteenth century

Pooley was so impressed with the colours he saw, that he included a colour lithograph (Fig 11) - it was the only one in his book.

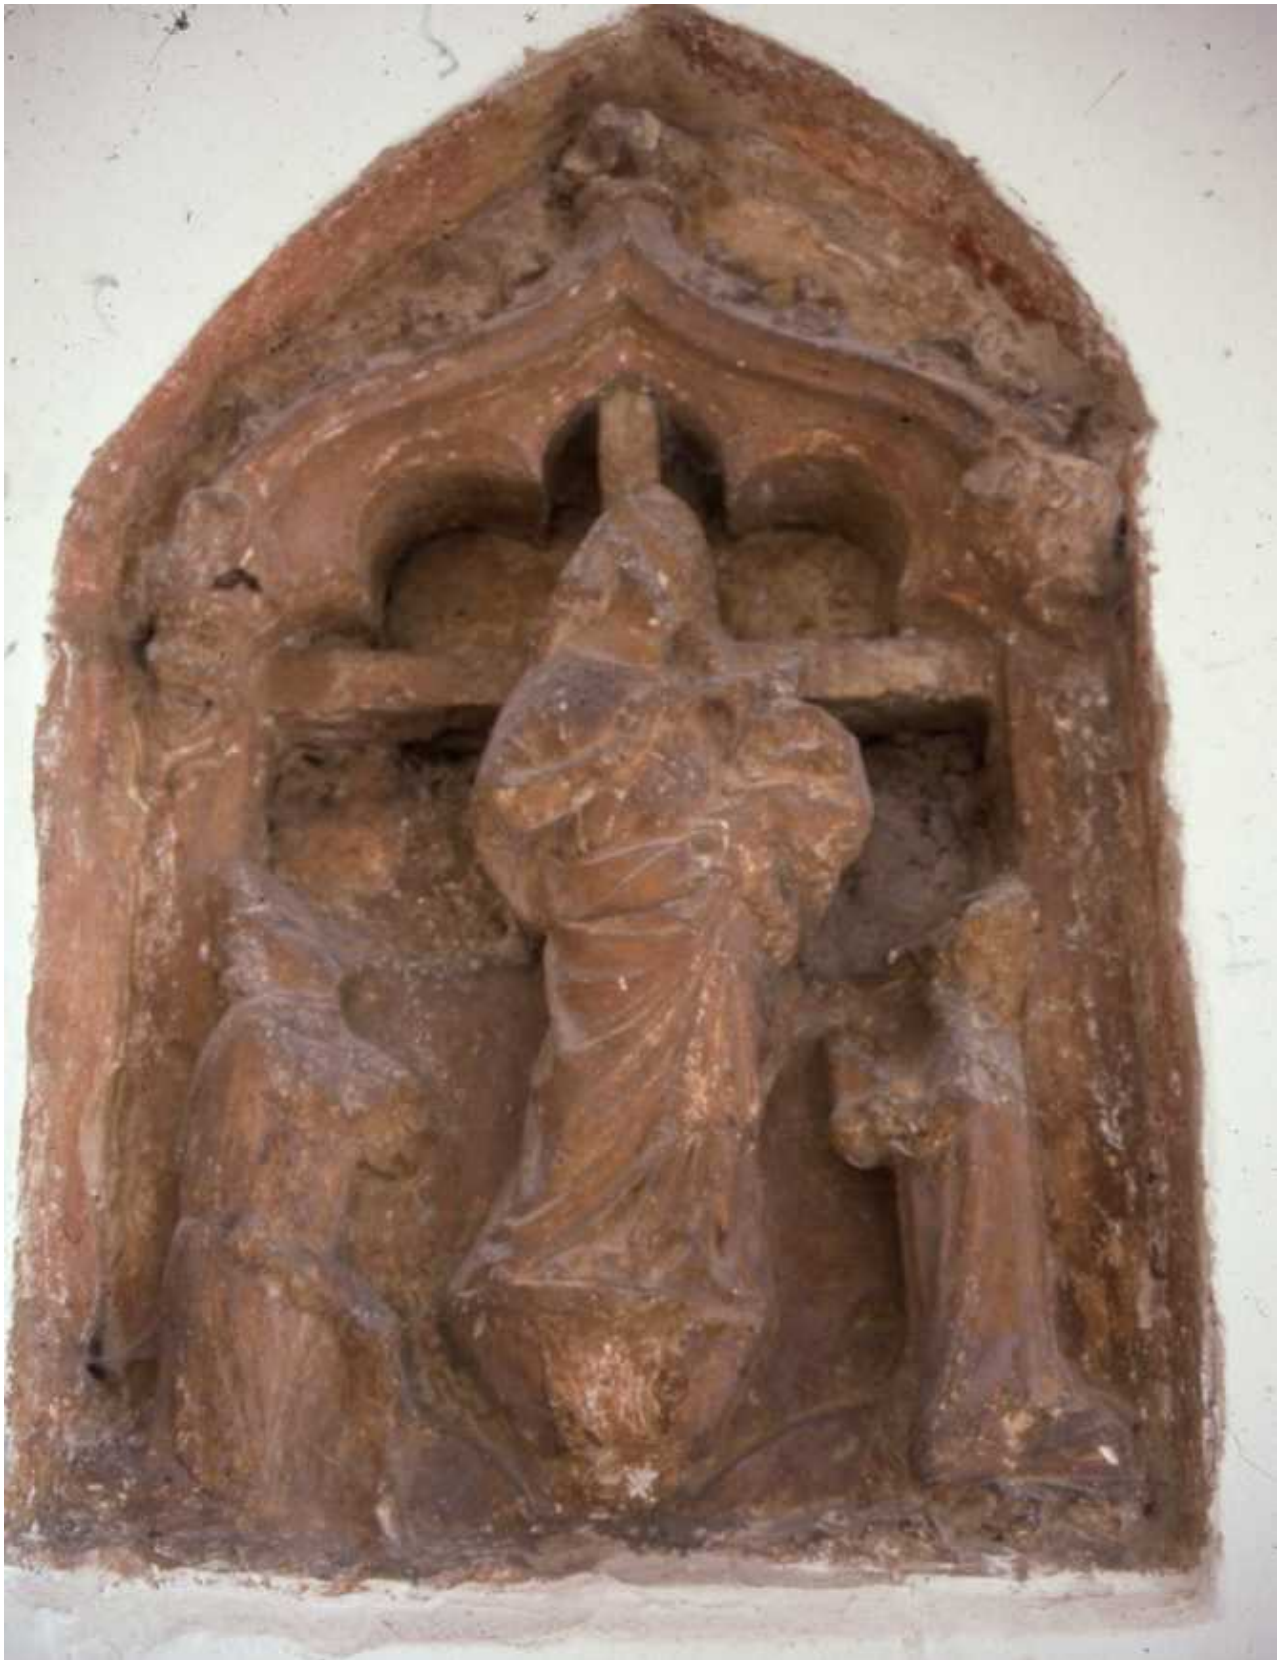
Fig 12: Bleadon porch cross (1974)

The colours have faded since exposure - certainly, when I first photographed this structure in 1974, they were not detectable to the naked eye (Fig 12 below).

Extreme processing with Photoshop did reveal some traces of Pooley's colours, but most had faded beyond recall.

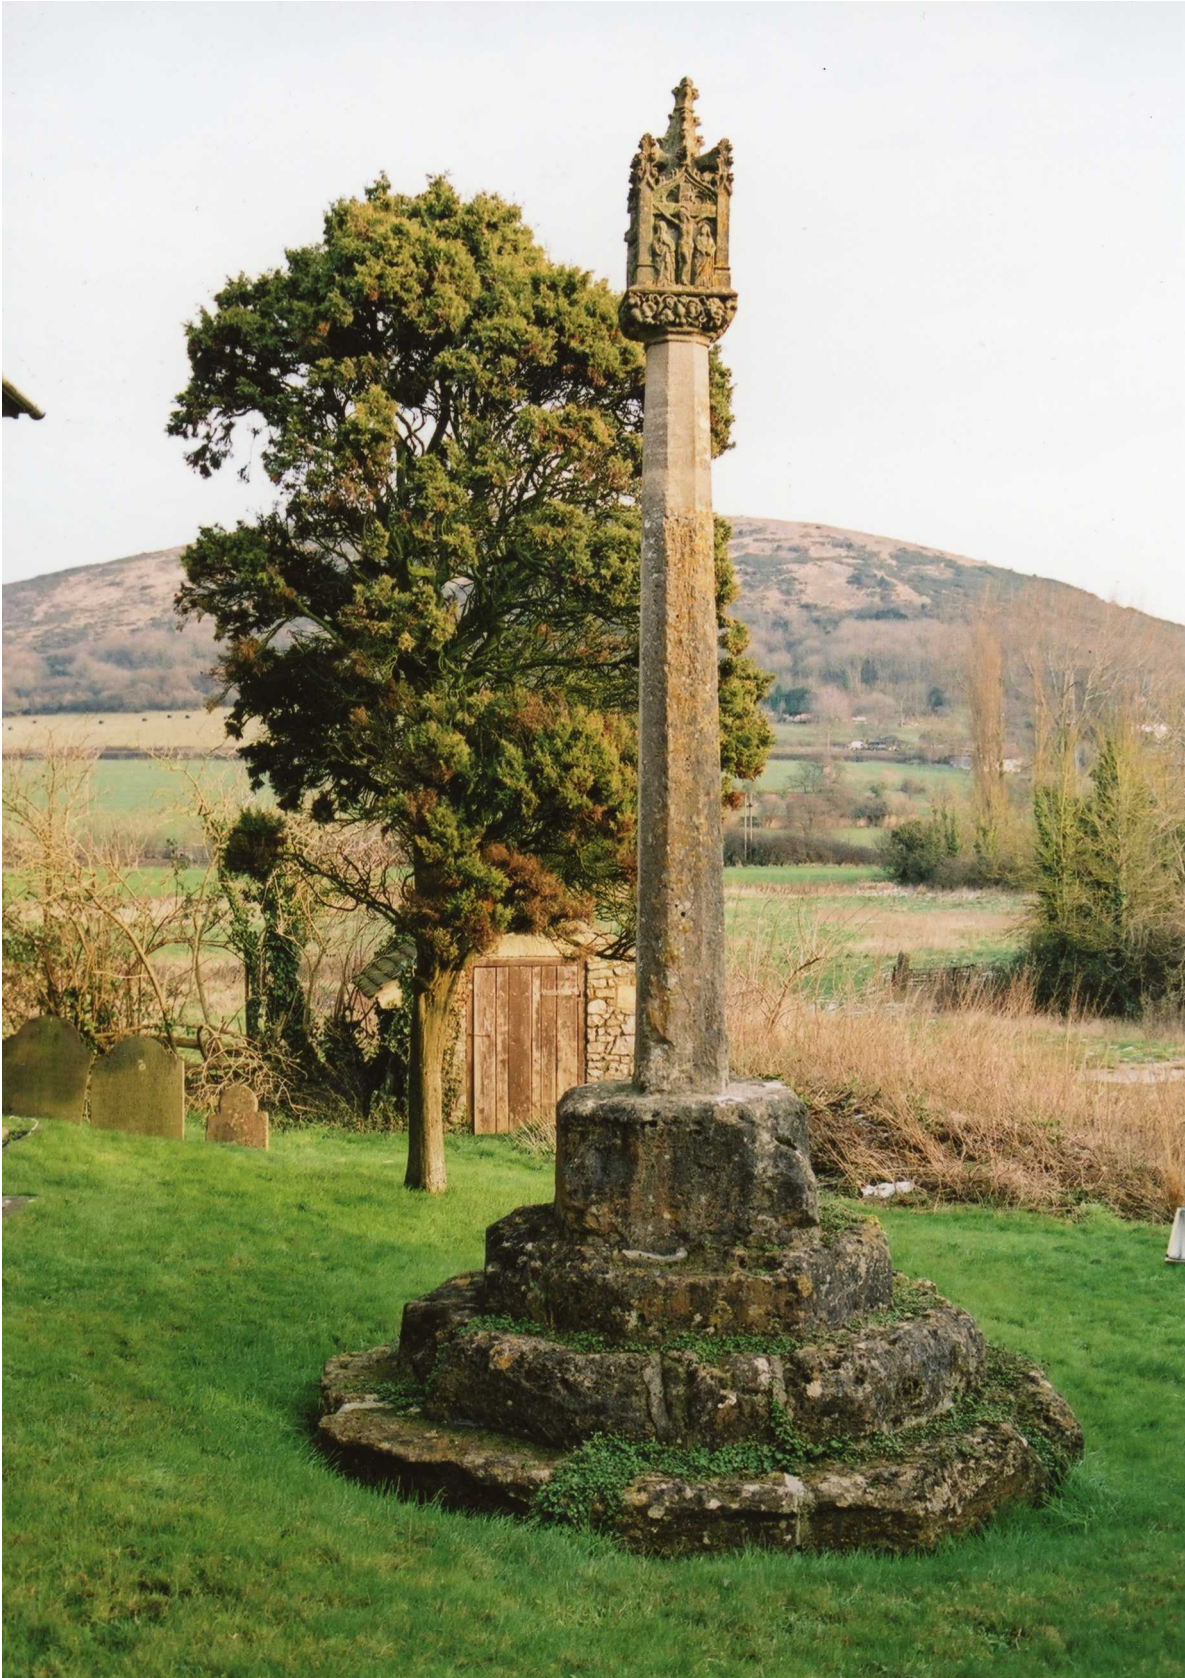
Fig 13: Loxton 1: Churchyard Cross

The cross today is in reasonably good condition: the Tiarks works still stand out, although carried out more than 110 years ago.

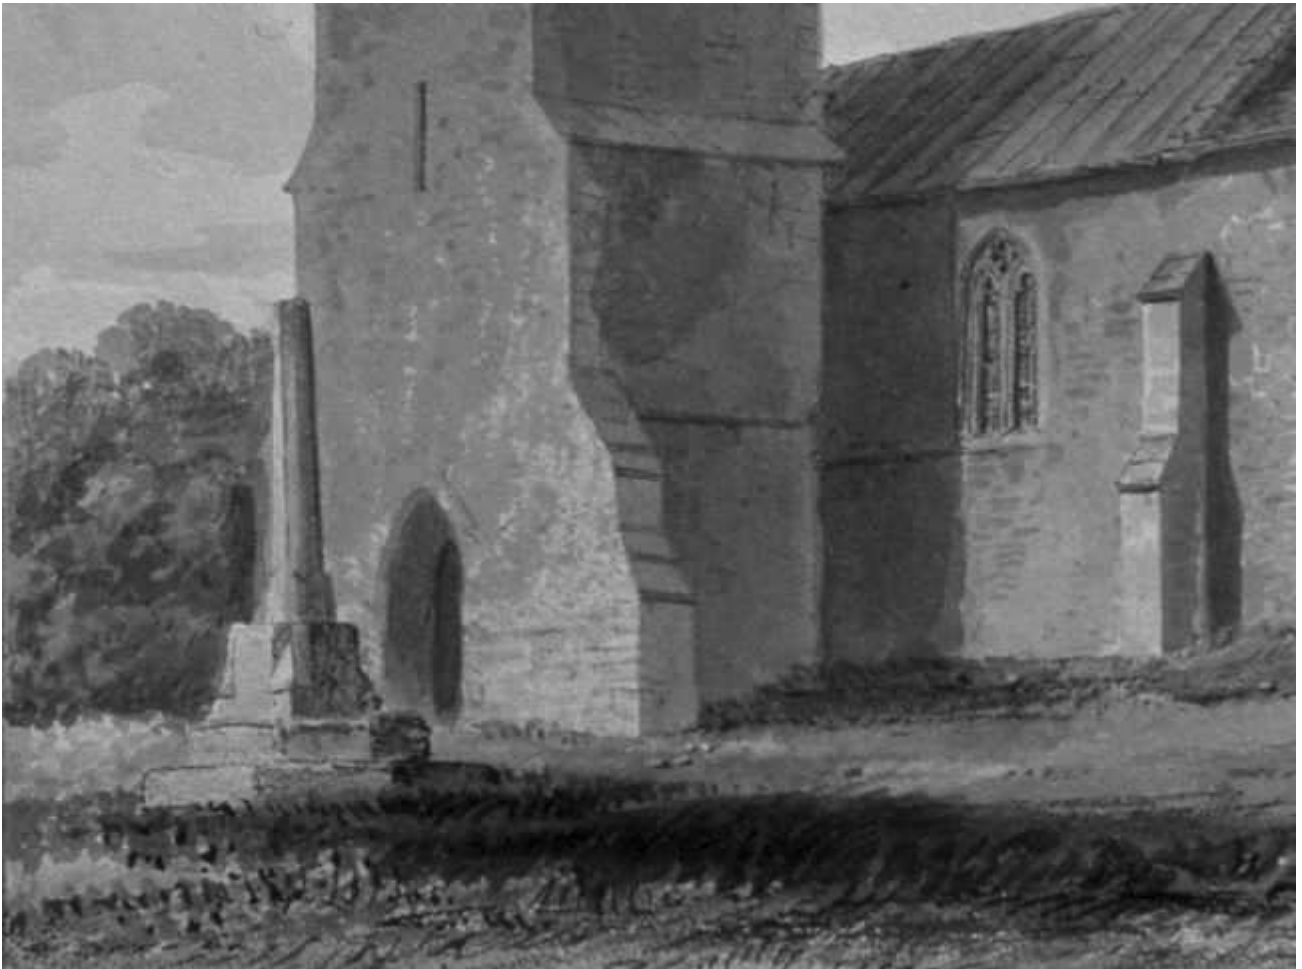
Fig 14: Loxton 1 (churchyard cross) by Buckler (1828)

Bucklers drawing of 1828 shows some detail of the churchyard cross, although Fig 14 is extracted from a drawing of the church, so this lack should not be surprising. It is not until Pooley's drawing of 1877 then anything like an accurate image of the site is made. He discusses the statement by Collinson (1793 (3): 605) that the cross has five steps; Pooley saw three, and it is clear on the ground today, that since the basement of the cross can clearly be seen as a narrow crop mark in dry seasons, below the bottom step, that there were probably always three steps.

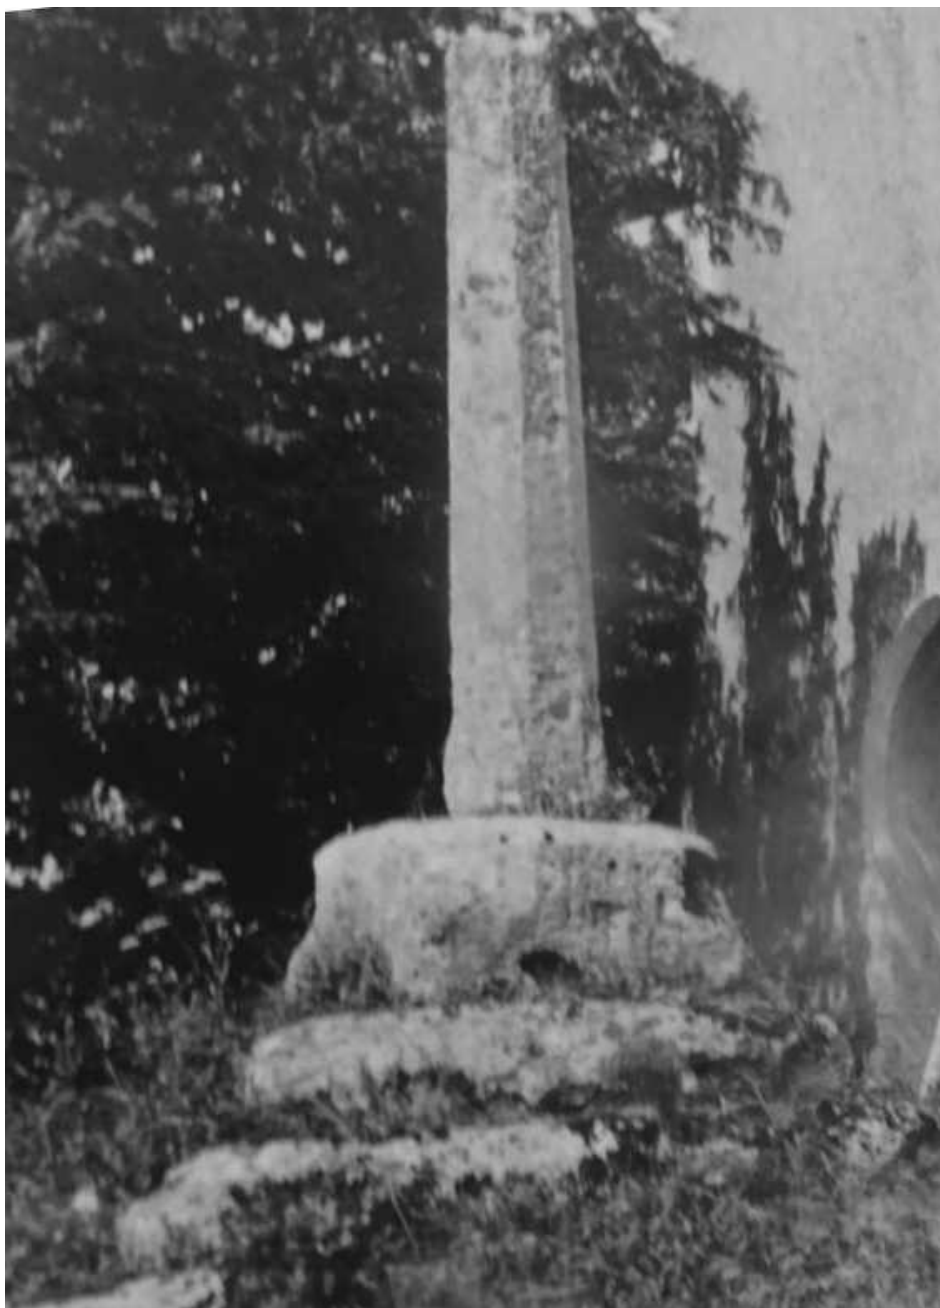
*Fig 15: Loxton 1 in c1900
(from the Frederick Wood
collection)*

The first (of c1900) (below) shows the cross in the same headless state as when seen by Pooley in the 1860s.

Just to confirm, there had been no restoration at this date, the shaft of the cross still broken.

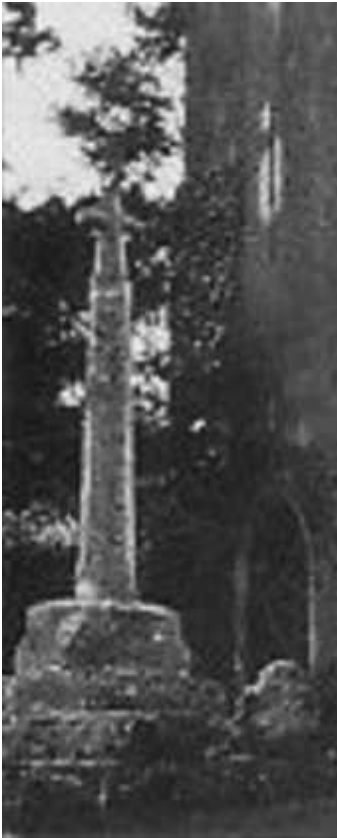
Fig 16: The 'interim' head of Loxton 1 (from post card posted in 1910)

However, an intriguing note is struck by Fig 16 (below), which shows there had been the addition of an cross to the stump of the shaft by 1910 (please forgive the poor quality of the image: this is taken from the edge of a picture postcard of Loxton church posted in 1910 in VR collection).

This appears to show an equal-armed cross set on the squared-off top of the old shaft, which work must have been done between 1900 and 1910, by a person or persons unknown (there is no faculty for the work, for example).

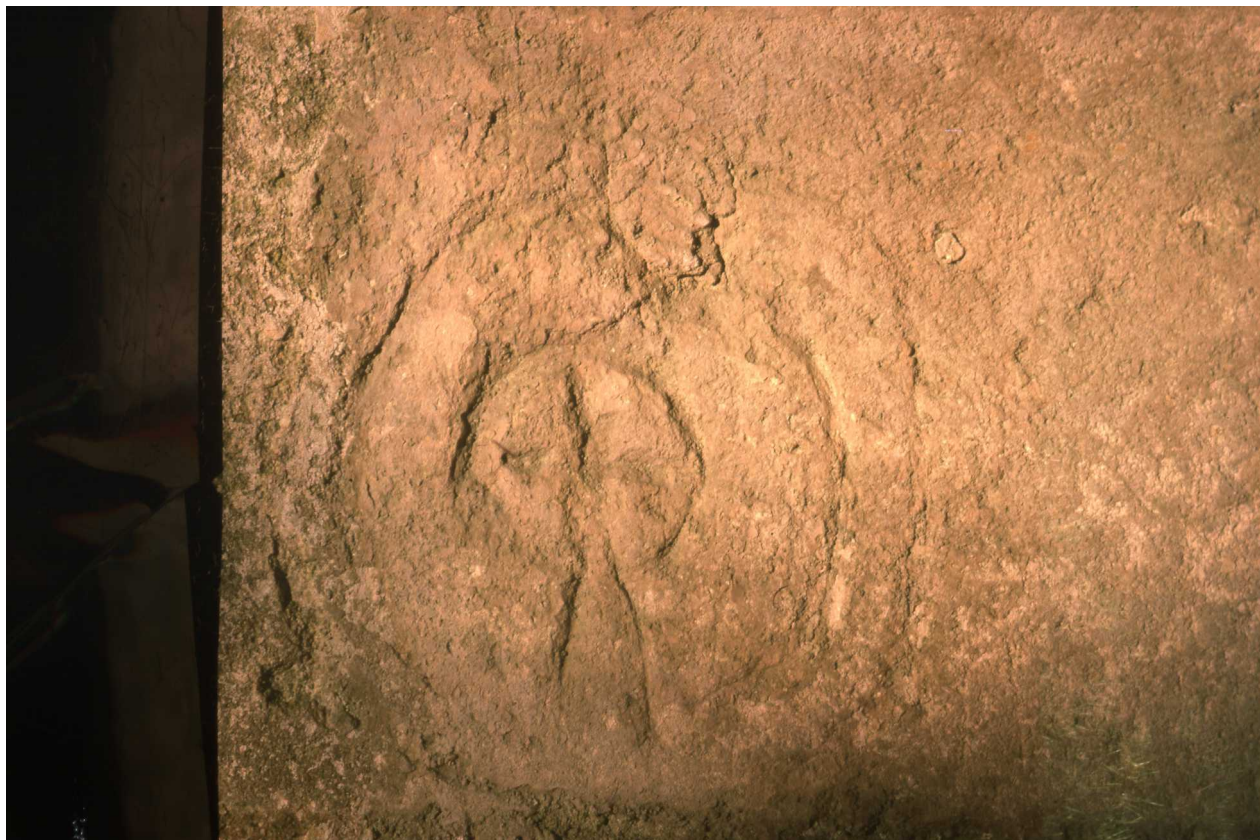
Fig 18: Carving (?graffito) in Loxton church porch

The above carving (about 15cm high) is on the door jamb of Loxton church porch. It seems to show a wheel-headed cross with tapering shaft, surrounded by two concentric circles. The cross is not centred within them.

Its origins and meaning are obscure: it is clearly no idle scribble, though, and would have taken some time.

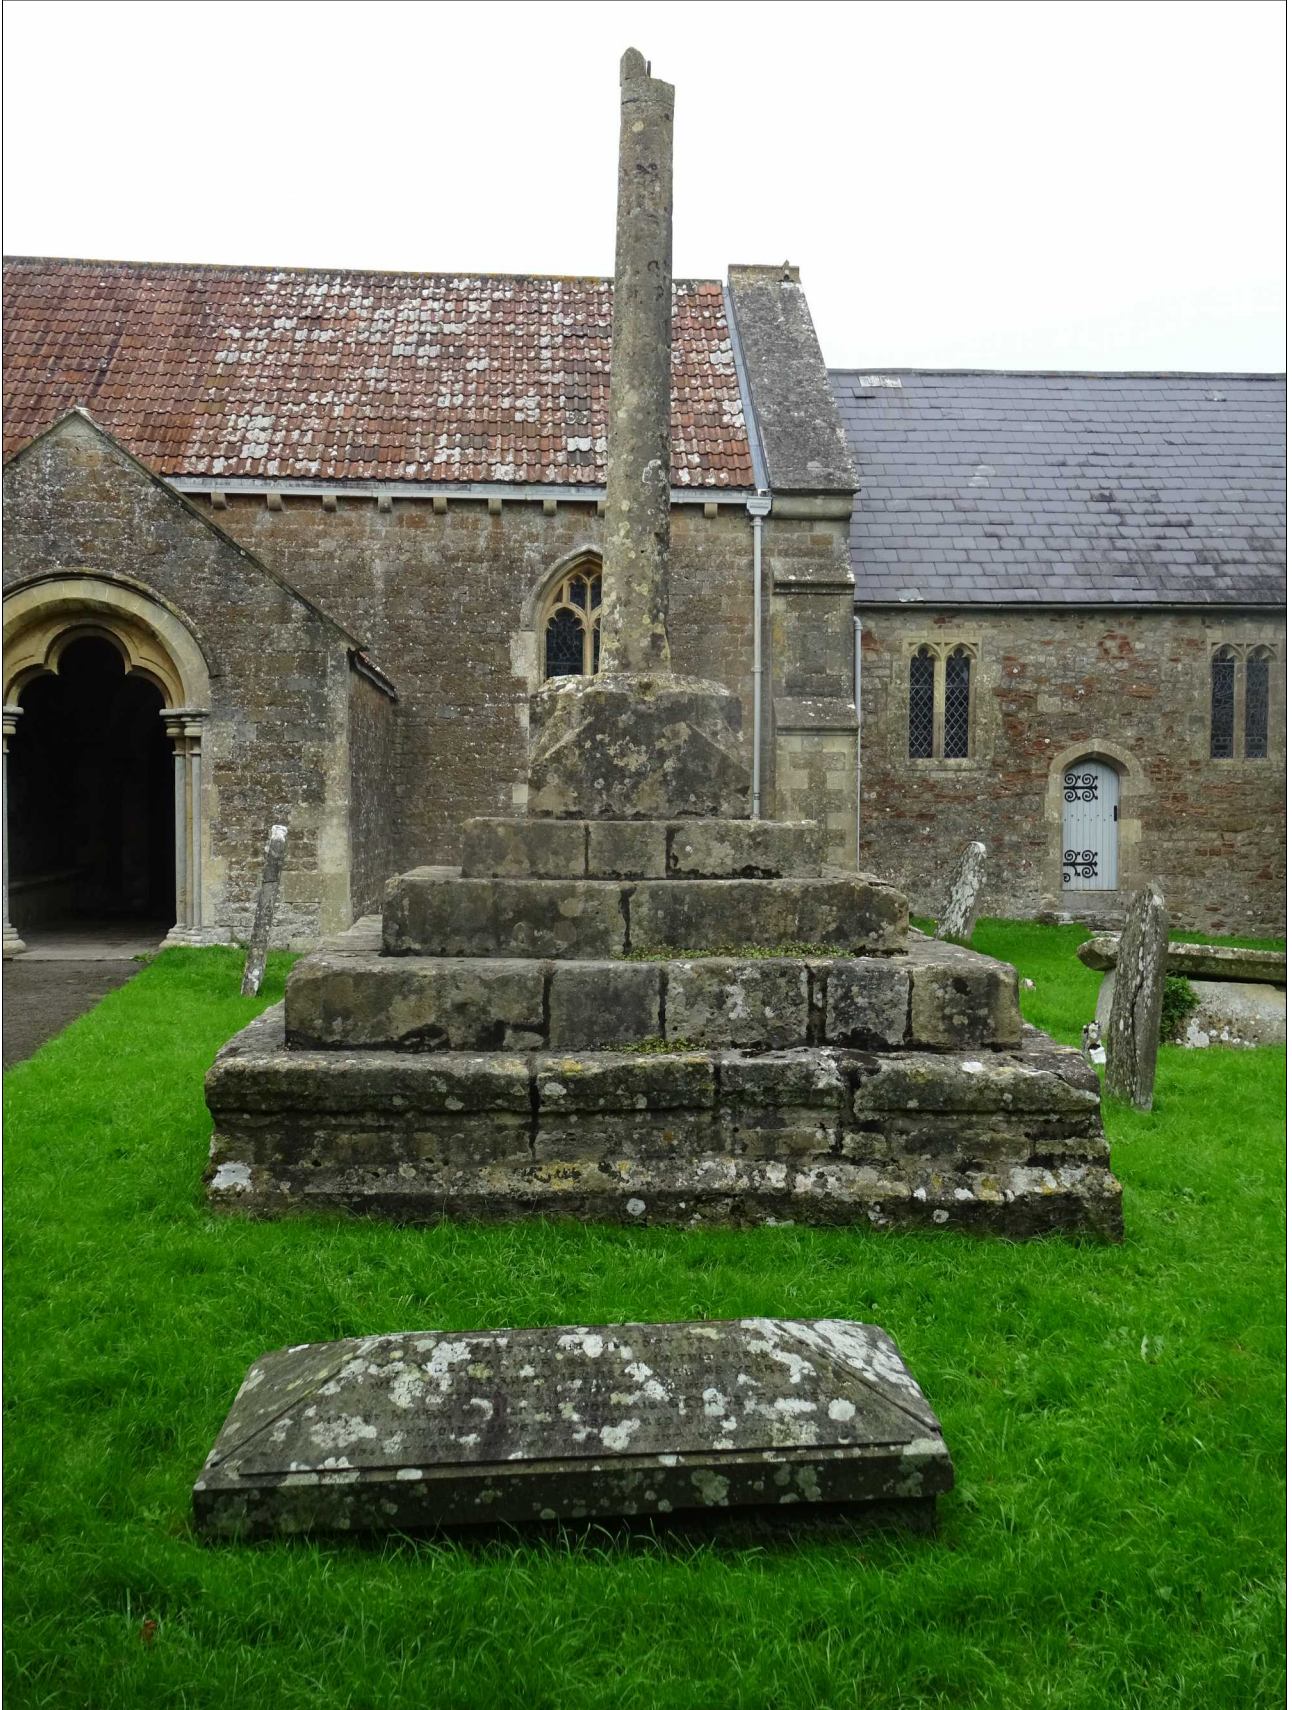
Fig 19: Compton Bishop 1 (2016)

However, by the time Pooley came to record the cross, the earlier head recorded by Buckler had been replaced with a floriated finial remarkably similar to that of Bleadon 1. The resemblance is so marked that they may well have been commissioned from one firm or individual.

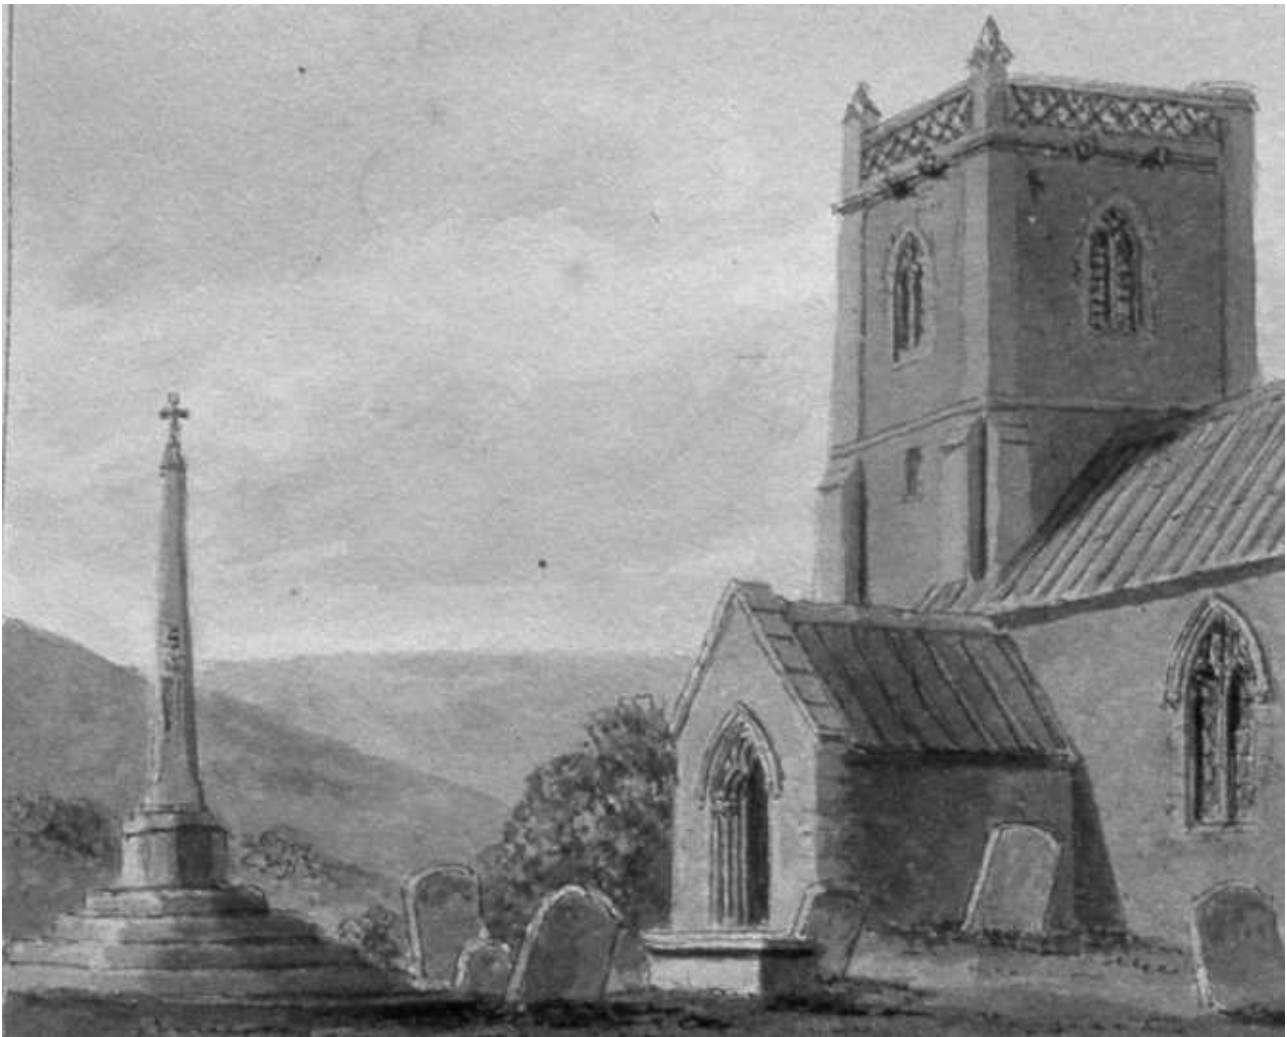
Fig 20: Compton Bishop 1 by J C Buckler (1844)

While Buckler's drawing of the cross is not particularly accurate (showing, for example the square present and original socket as an octagon more like that at Cheddar), he does illustrate the presence of carving on the shaft, and shows a small equal-armed cross on top of it.
