YCCCART 2021/Y6

The Old Stone Crosses of Bleadon, Loxton and Compton Bishop

**YATTON, CONGRESBURY, CLAVERHAM AND CLEEVE ARCHAEOLOGICAL
RESEARCH TEAM (YCCCART)**

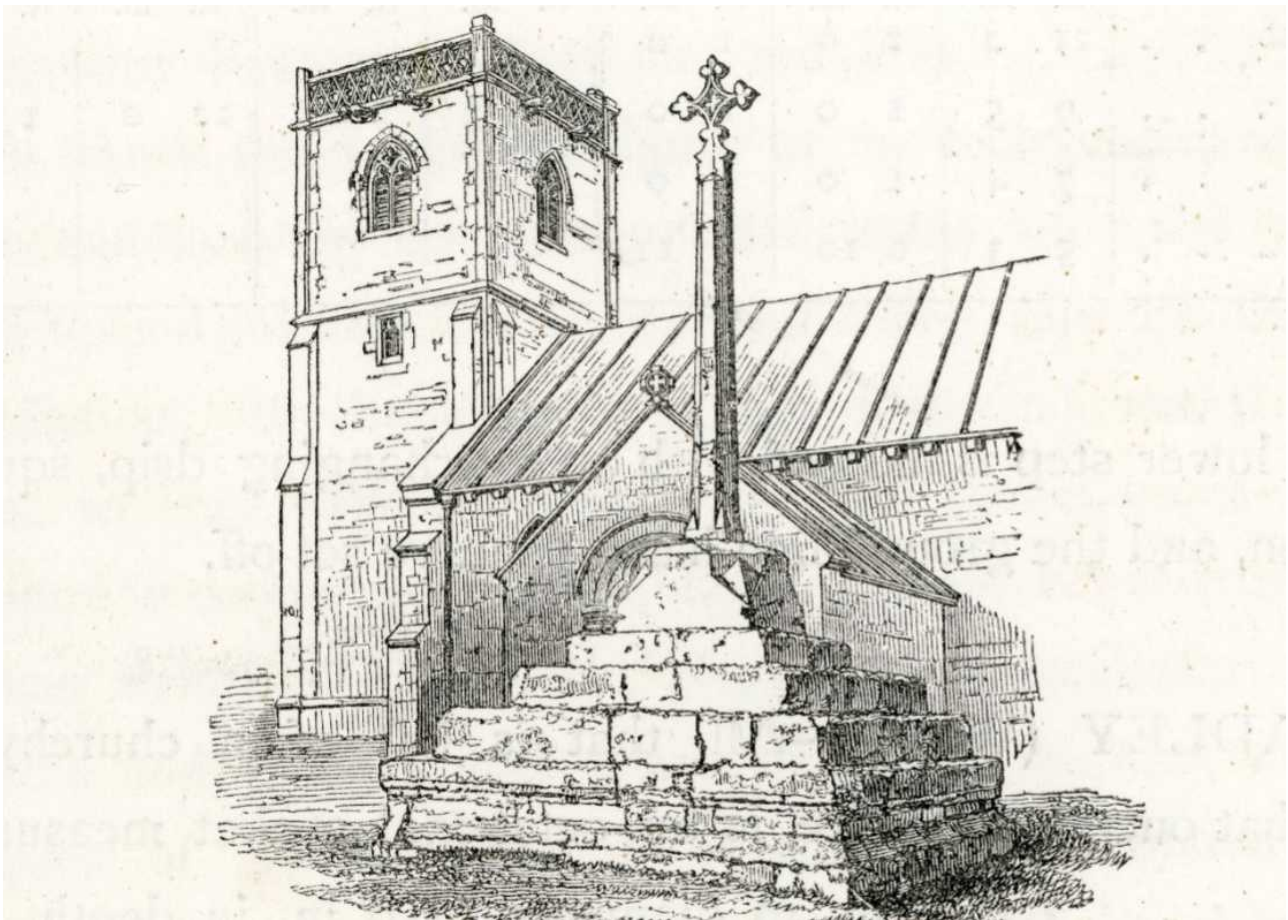
Fig 21: Compton Bishop 1 by Pooley (1877)

However, by the time Pooley came to record the cross, the earlier head recorded by Buckler had been replaced with a floriated finial remarkably similar to that of Bleadon 1. The resemblance is so marked that they may well have been commissioned from one firm or individual.

The floriated cross was still in place in 1955-65 (SHC DD/X/CND), but by the time I first photographed it in 1973, the head had gone, and the familiar sight of an iron peg projecting from the top of the cross shaft was all that remained to show it had been there.

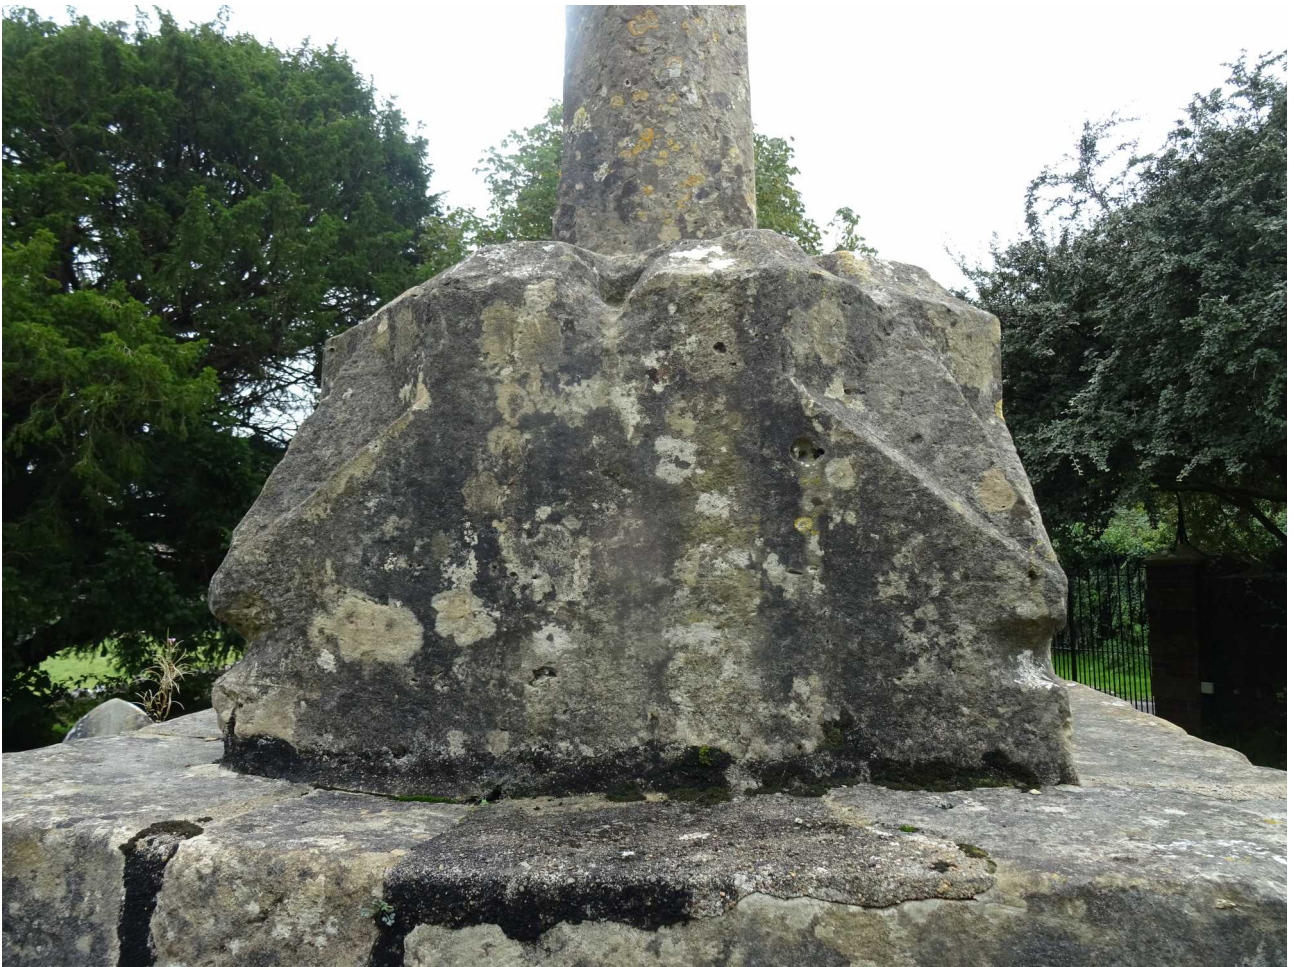
Fig 22: West side of the cross socket (2016)

Fig 22 shows both the 'bold sweep of the broaches' (a type I have never seen elsewhere in the counties of Somerset, Gloucestershire or Wiltshire). Beneath each broach (on each corner of the socket) is a second unique feature, the semi-circular notch near the base.

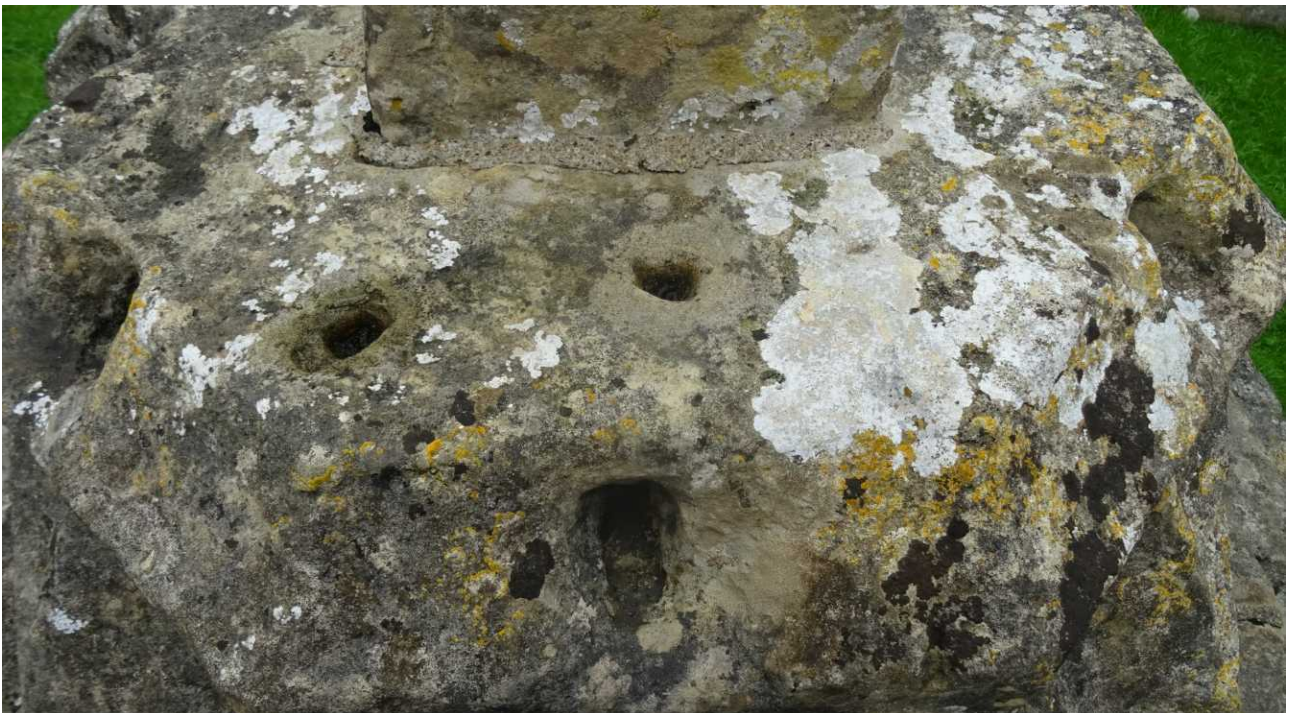
Fig 23: View across the top of the socket (2016)

Fig 23, a top view of the socket shows the variety of drill holes, notches and gaps where plugs for affixes have been removed.

The gaps half-way along each top face might well be regarded as resulting from the removal of affixes (Kingston Seymour village cross socket has something similar). These are presumably original and of late medieval date, their loss presumably during the 17th century. The other drill holes could be of any date.

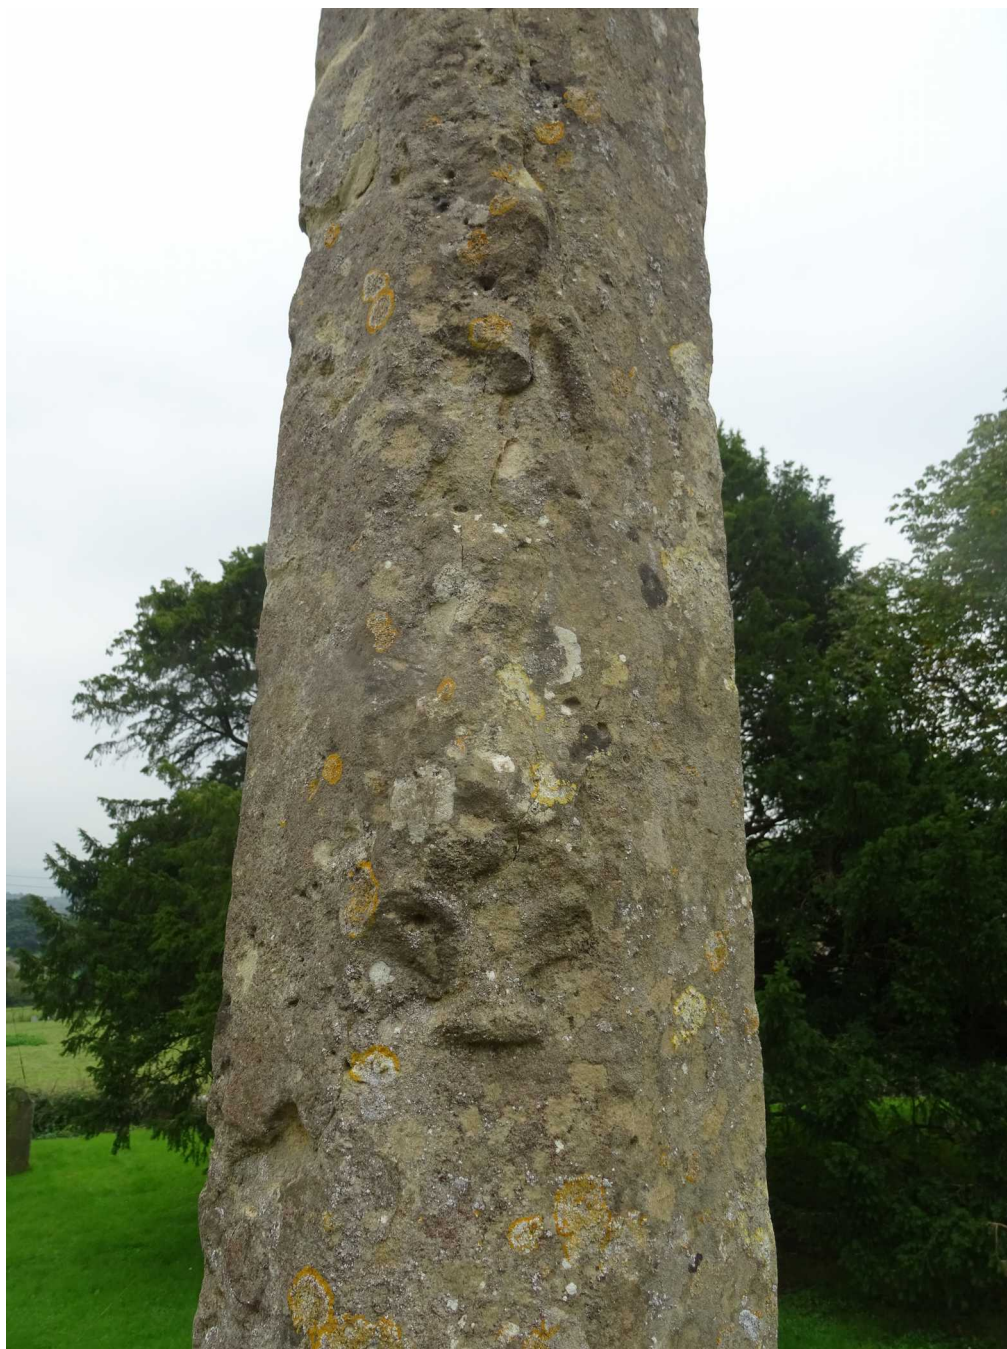
Fig 24: the shaft carvings (2016)

Also unusual are the carvings on two opposite sides of the octagonal shaft (Fig 24).

These are now extremely worn, and I can't really add to Pooley's '..carved weathercrockets and finials..'

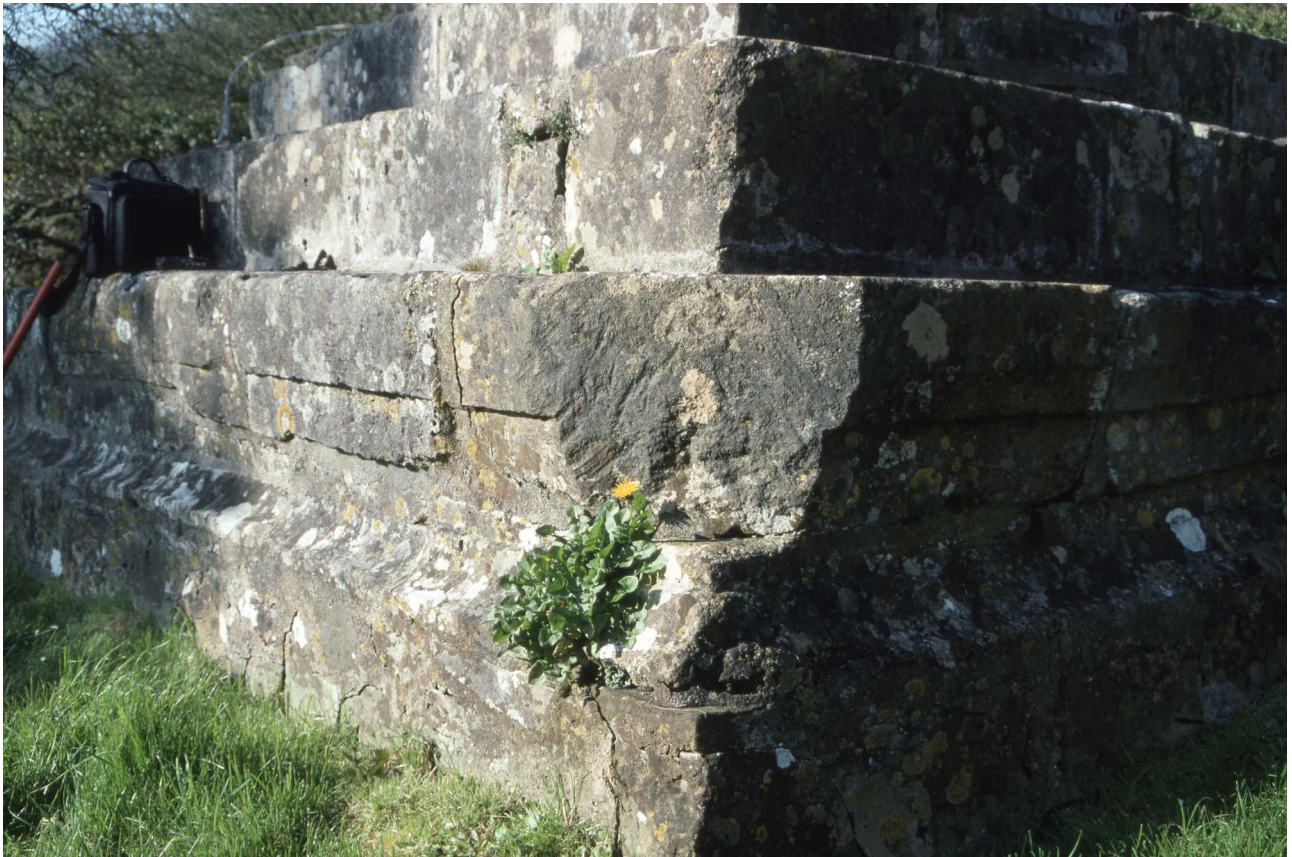
Fig 25: Sharpening marks on the corner of the lowest step

The final indignity to which this cross has been subjected is damage caused by implement sharpening (probably during grass-cutting in the churchyard).

These are not unusual (there is a notorious example at Dundry churchyard).
