**YCCCART 2010/Y23  
North Somerset HER 2011/018**

**Congresbury Church - Orchard & Vicarage**

**YATTON, CONGRESBURY, CLAVERHAM AND CLEEVE ARCHAEOLOGICAL  
RESEARCH TEAM (YCCCART)**

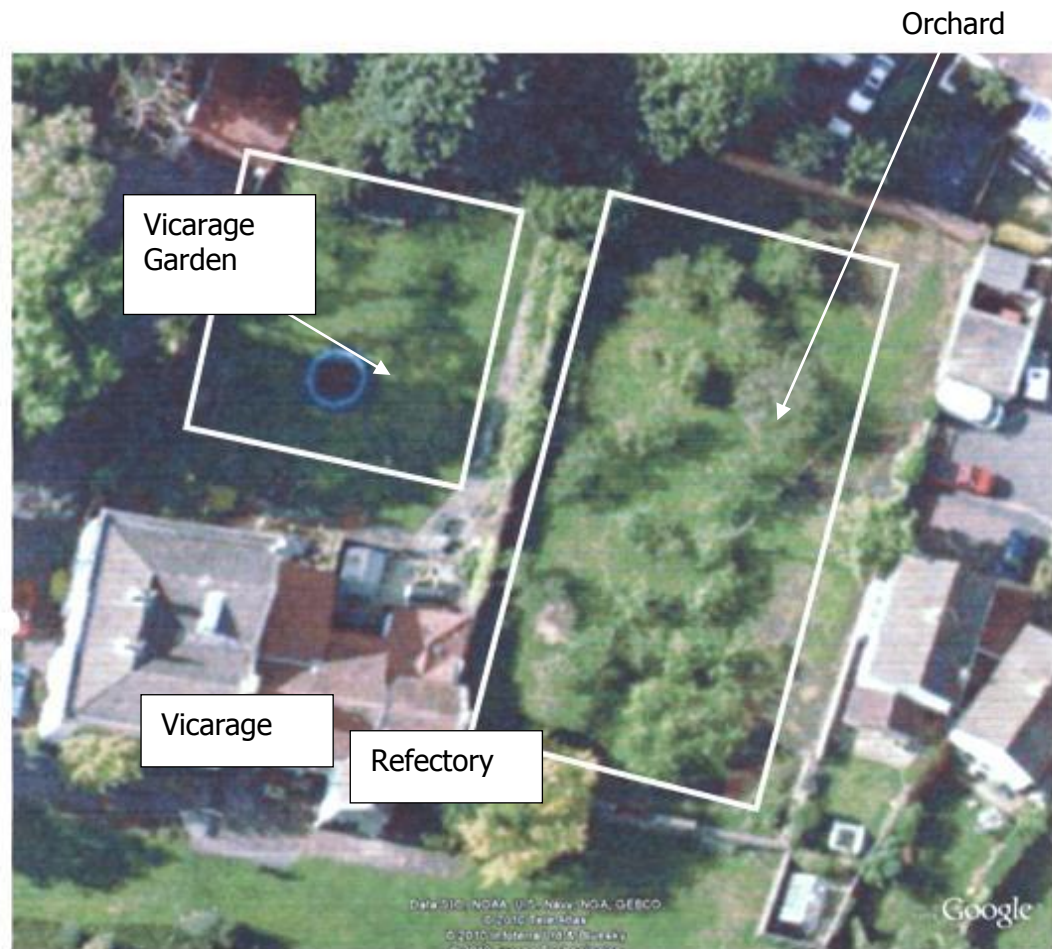
The prayer garden / orchard is adjacent to the Grade1 listed 'Refectory', which itself is attached to the 19<sup>th</sup> century vicarage (built 1824). The survey in the rear garden of the vicarage, is separated from the orchard survey by about 7 meters and a high stone wall.

*Fig 2: Showing the sites in relation to the extant buildings. (Google image)*

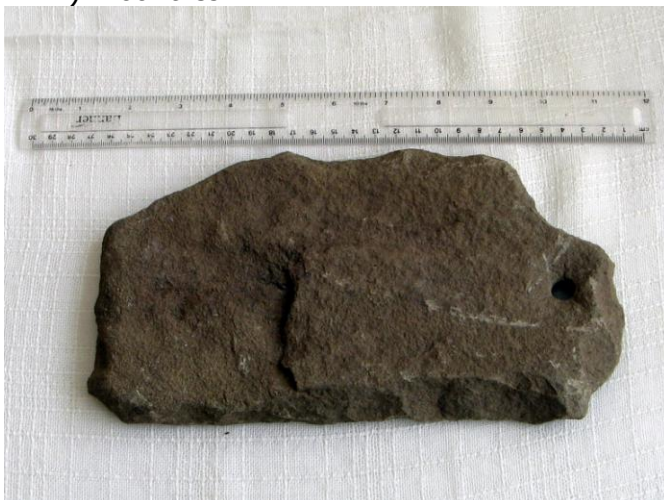
*Figure 6 : Pennant stone roof tile from the church orchard*

Nine fragments of roof tile were found, identified by Prof. Mick Aston as Pennant Sandstone of the medieval period.

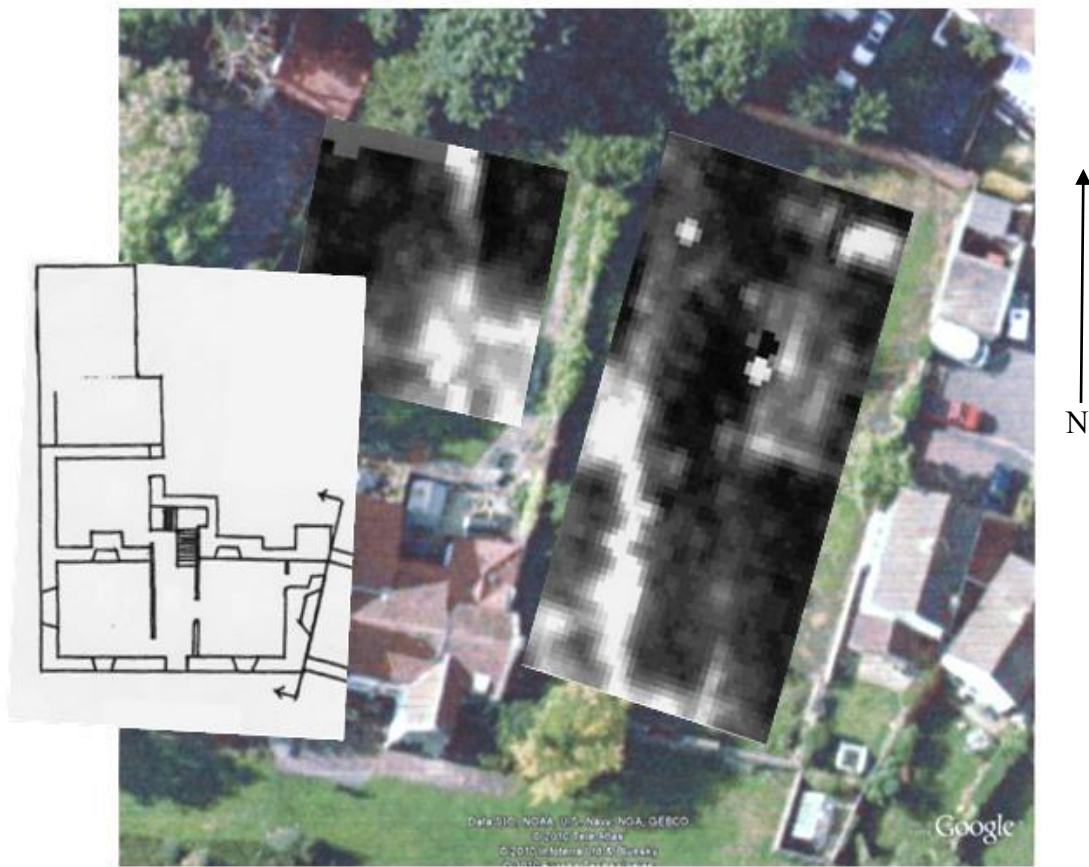
*Fig 10: Combination of Google Earth, 1823 map and superimposed resistivity results from Snuffler*

The resistivity results by both Snuffler (Fig 9) and ArcheoSurveyor (Fig 10 below ) imaging showed clear evidence of major linear anomalies (white areas in fig 9 & 10 and black areas in fig 11 & 12) consistent with wall structures aligned approximately NW-by-N to SE-by-S, and several minor ones at right angles to these. It is noticeable that the alignment of this possible building is very close to that of the (now demolished) vicarage rooms shown in the 1823 floor plan. (Fig 10 below)

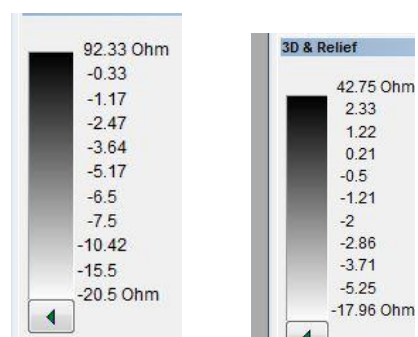
*Fig 11: Resistivity results from Vicarage back garden (left) & orchard (right). ArcheoSurveyor imaging.  
NB. Resistivity range readings for 2 grids to the right are below right. For grid on left it is below left.*

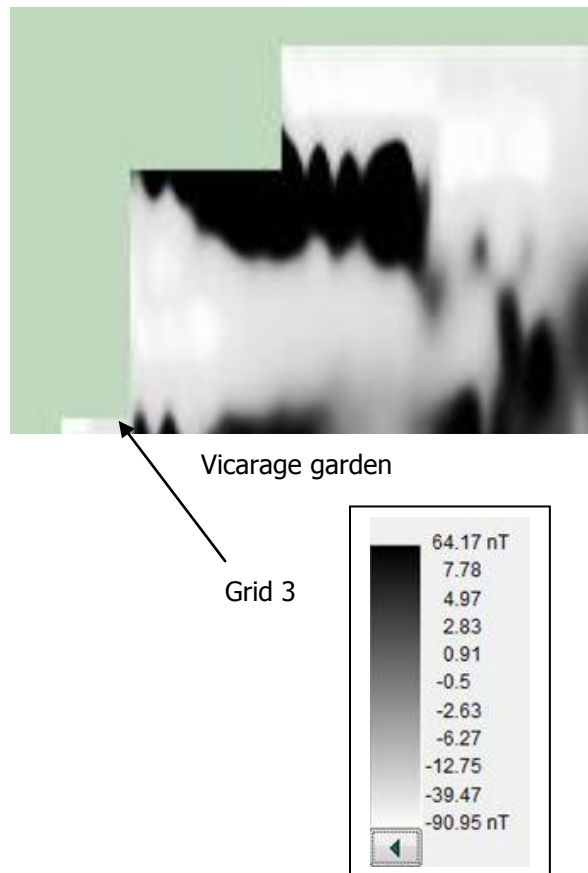
Fig 15: Grad 601 survey plan

NB. Plan is not to scale
