Part 4. The Refectory, Vicarage, Orchard and Paddock

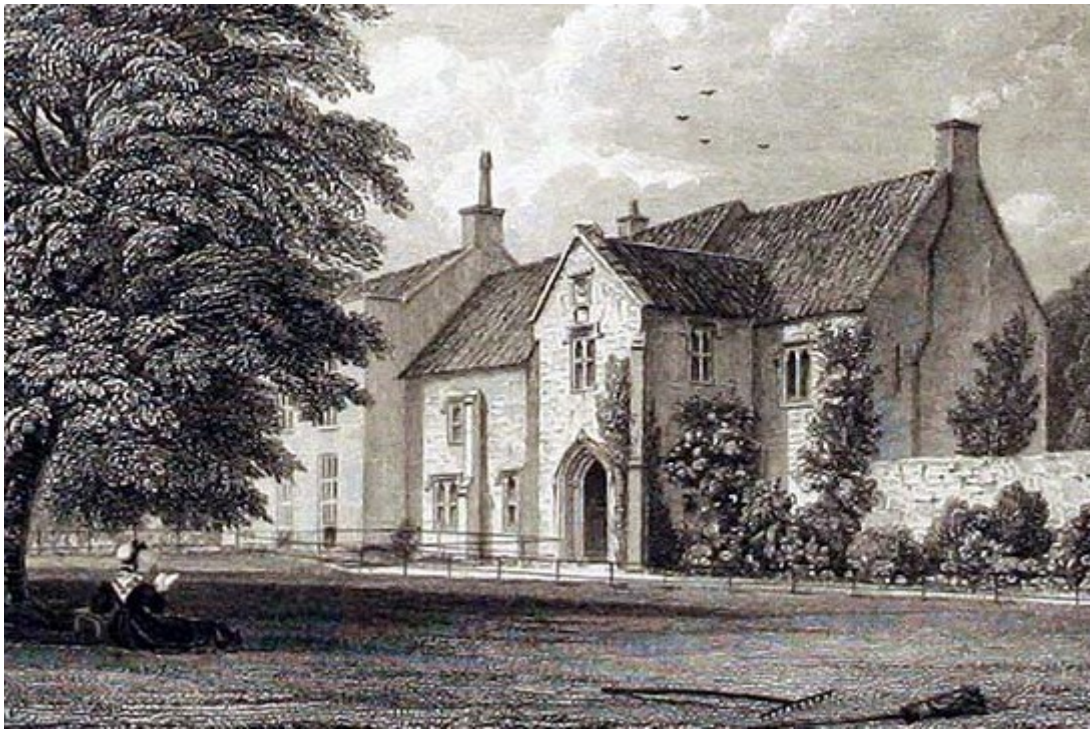
An 1829 engraving of the Refectory from John Rutter's "Delineations of the North Western Division of the County of Somerset."

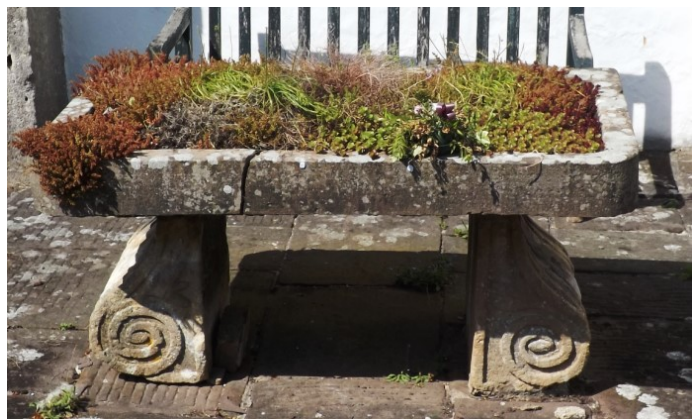
*Right:
The stone slab in front of the
Refectory is a pig salting slab removed
from the (now demolished) pig larder
at the rear of the building.*

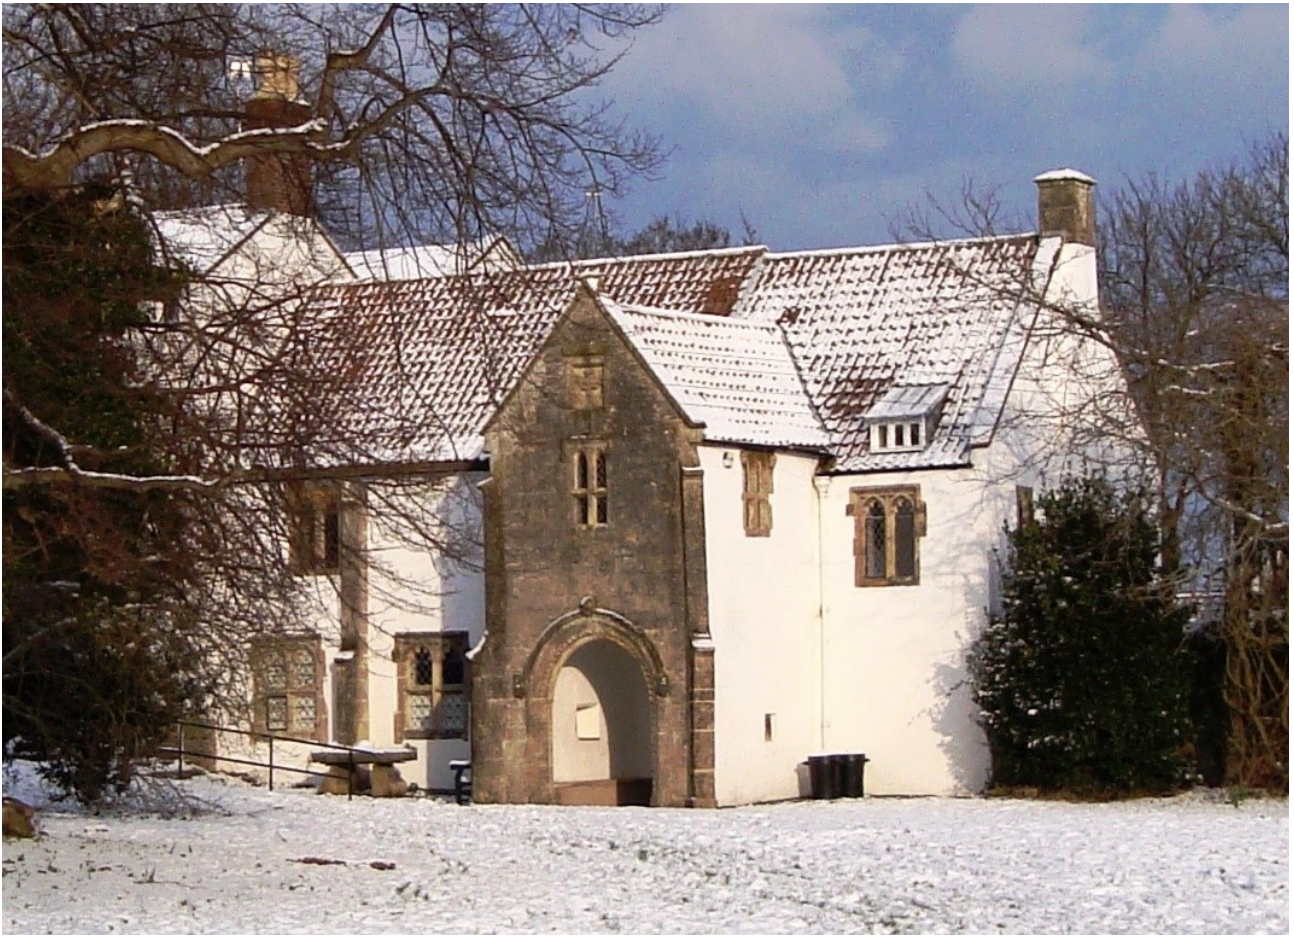
The Refectory in February 2009.

It is worth spending time studying the south face of the Refectory. Margaret Wood in her book about the English medieval house says that the Refectory is,

"remarkably unspoilt and has many original windows."

Notice the carved faces on the window surrounds. Some of them are rather unusual.

Looking to the left on the ground floor, the window nearest the porch seems to be squeezed in, which suggests that the porch was added after the main building was completed.

The roofline suggests that the building was constructed in two stages. (Or are the two roof levels possibly the result of unrecorded damage at some time?)

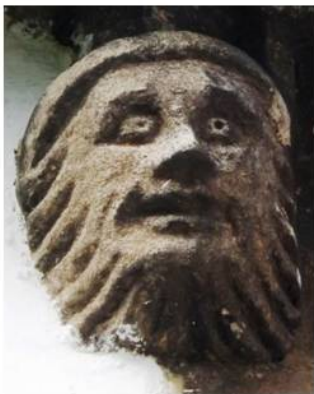
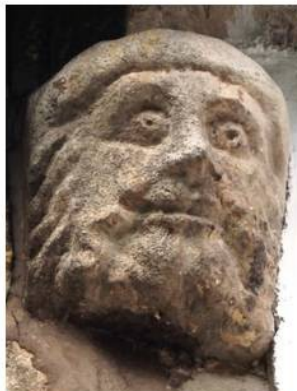
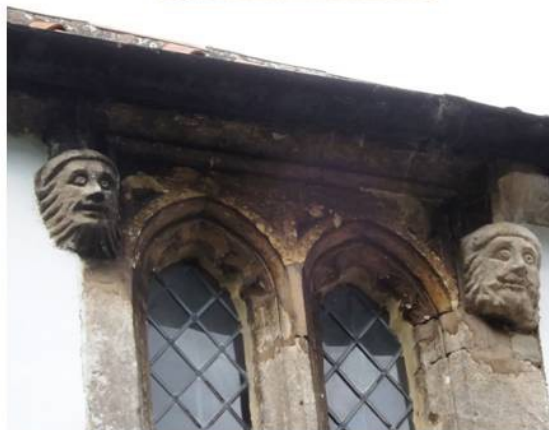
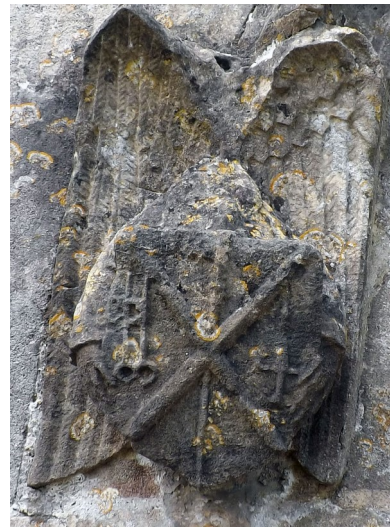
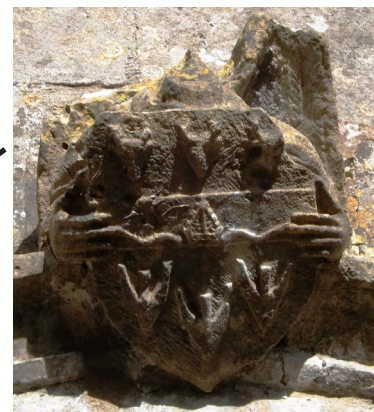
*Above : Details of the Refectory 1860.
From Somerset Archaeology Society, Vol X,
p9. Courtesy of Somerset Archeological &
Natural History Society.
Right :The shields as they are today.*

The two storey porch has dogtooth carving around the doorway (usually a 13th century device) and the remains of three angels holding shields. The drawings above show the details, some of which have been lost.

The shield with the three bucks' heads and a bishop's mitre is that of Bishop Beyknton or Beckington and is over the entrance. The arms of the See (An early composite coat of arms of the diocese), are on the left and the Pulteney family arms are on the right. The Pulteney or Poultney or Pountey) family, oddly has no known connection with Congresbury.

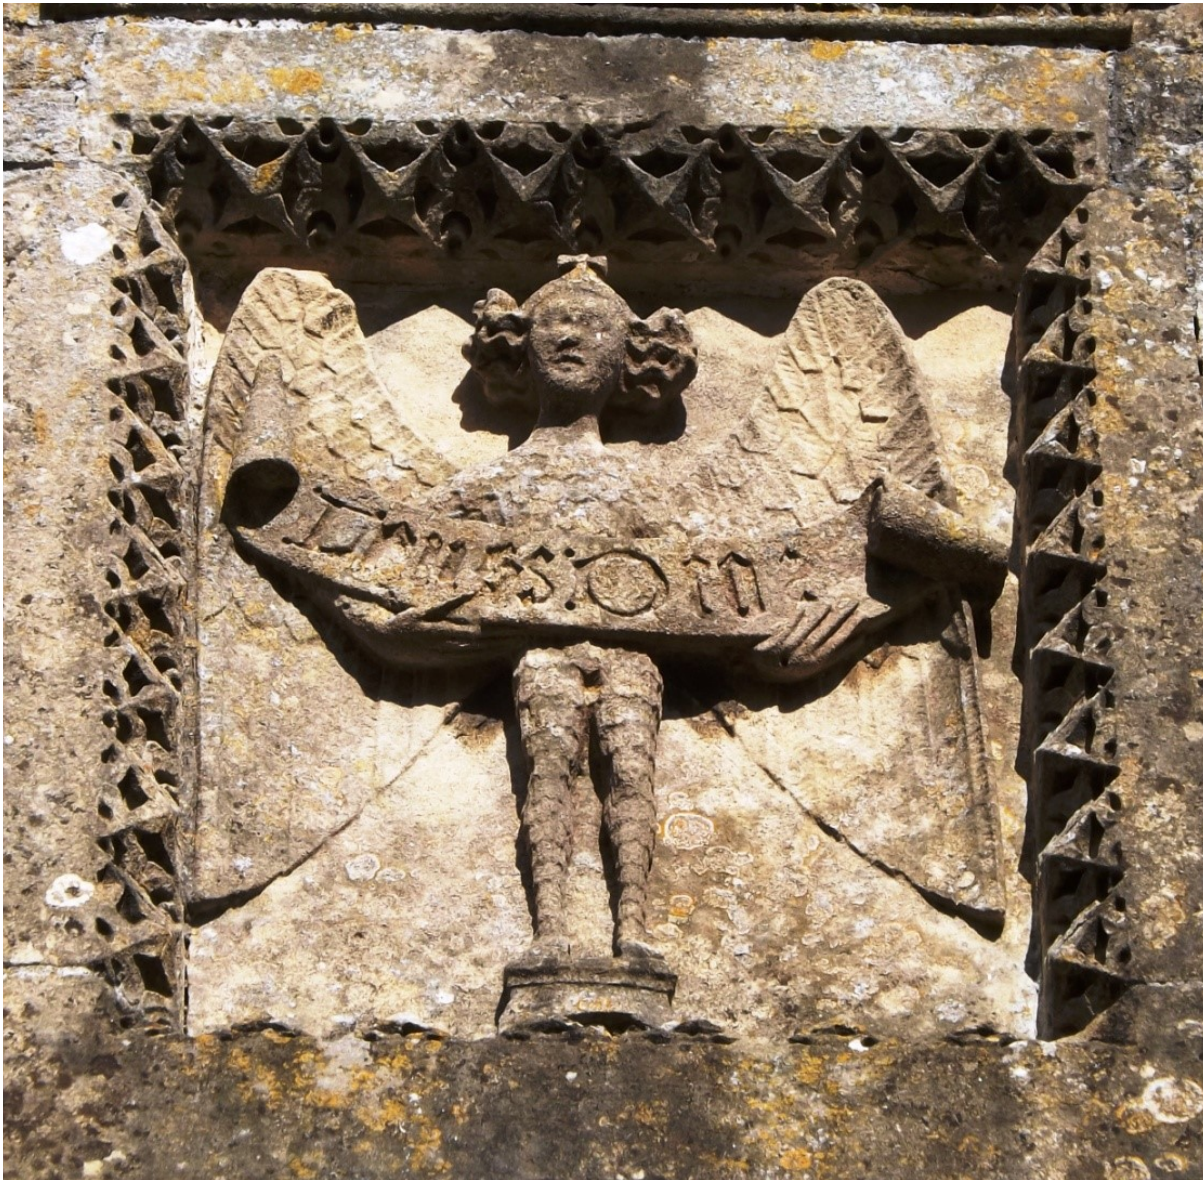
Above the doorway is another, but most unusual, angel whose legs are covered in feathers. The inscription "Laus Deo" is latin for "Praise God."

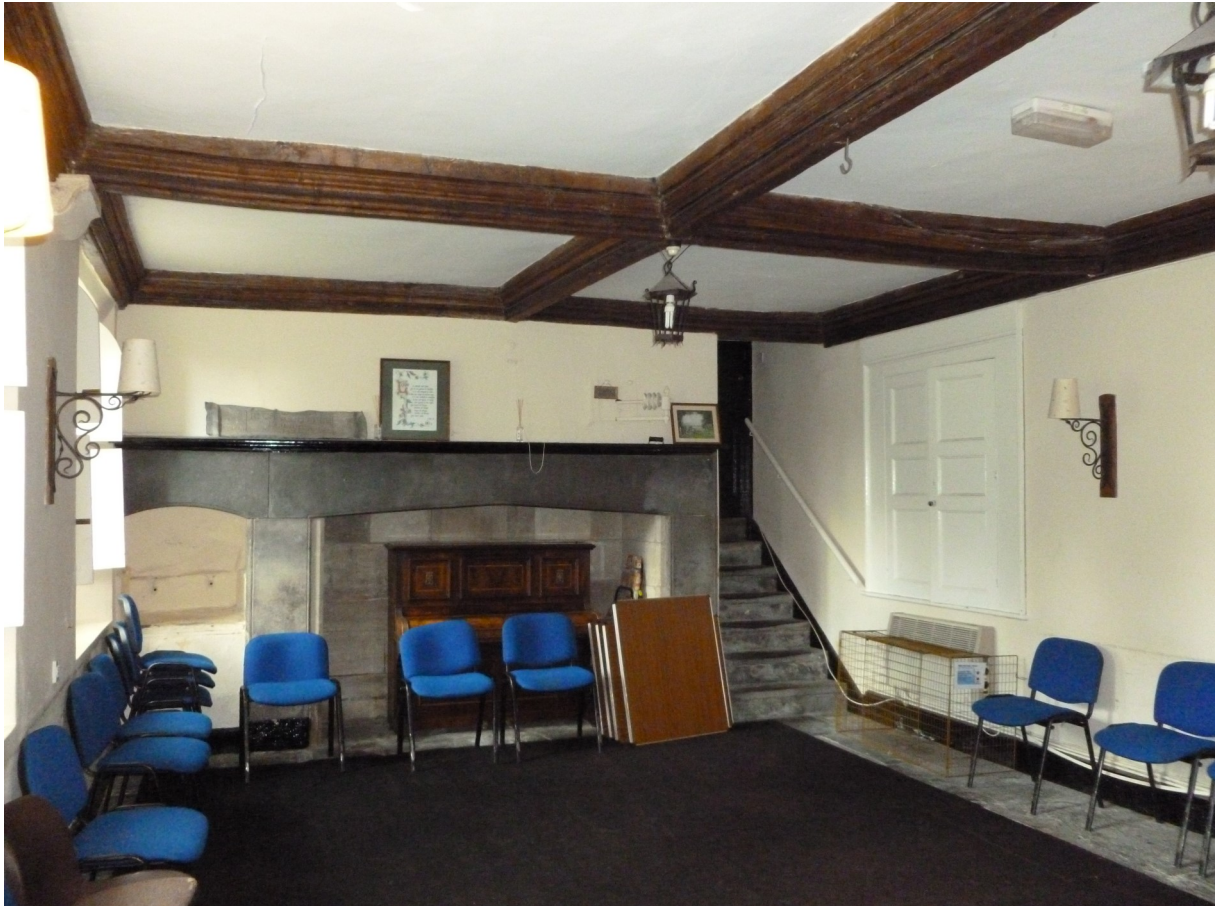
Enter on your left and you are in the hall, which originally the priest used as a reception room and for church affairs. This was never open to the roof but was built as two storeys and retains its original ceiling. The stairs to the right of the fireplace (said to be completely rebuilt and impossible to date) give access to the 19th century vicarage.

The lower hall. Note the original ceiling.

In the cupboard to the right of the staircase is a blocked window. The other windows in the hall have at some time each been reduced in height.

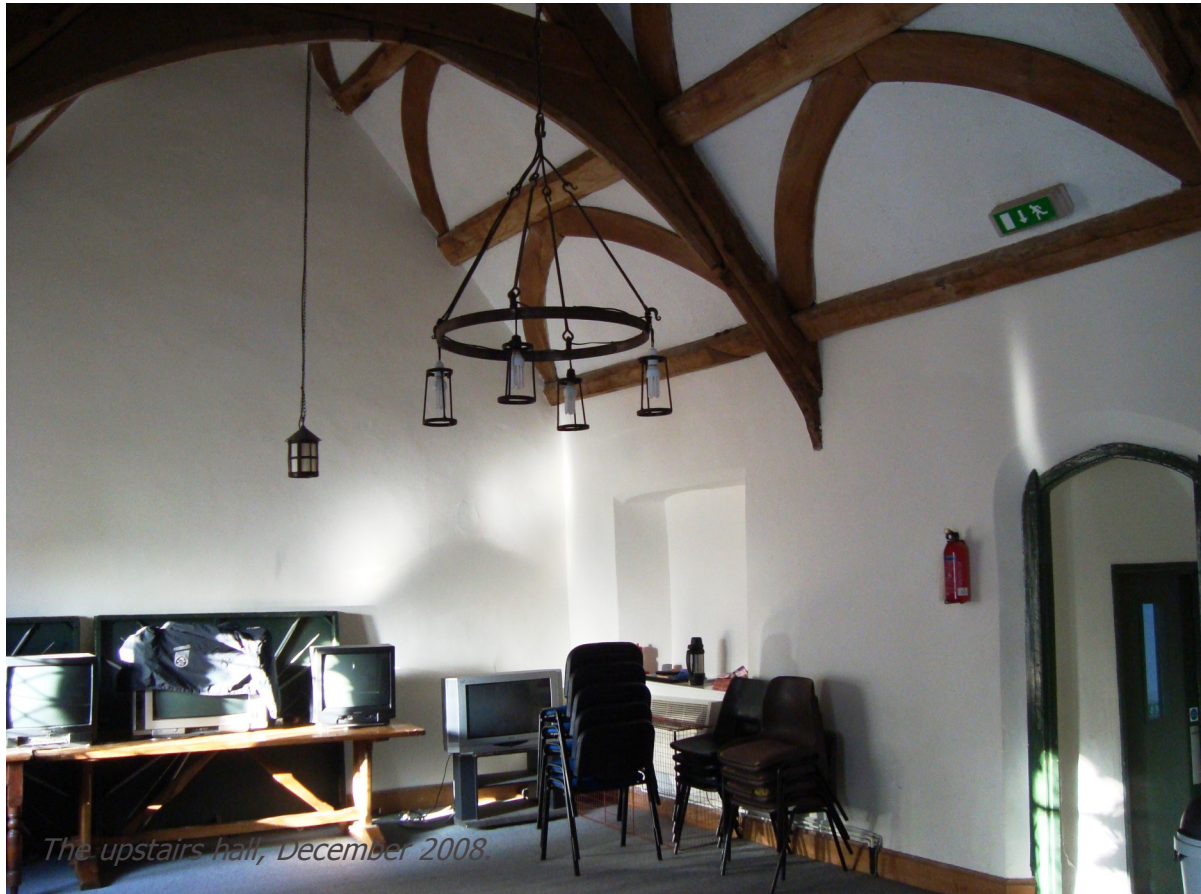
Go up the modern staircase and through the original doorway into the upper room with its collar-beam roof and three tiers of wind braces - a lovely room. Sadly none of the timbers are original. In 1955 it was suggested that a hole be made in the then ceiling of this room to determine the state of the roof. It was then, presumably, that the death watch beetle was found.

The upstairs hall, December 2008.

This room is the same size as the hall below and with the new staircase can now be easily used for meetings and displays. A blocked window in the north wall can be clearly seen.

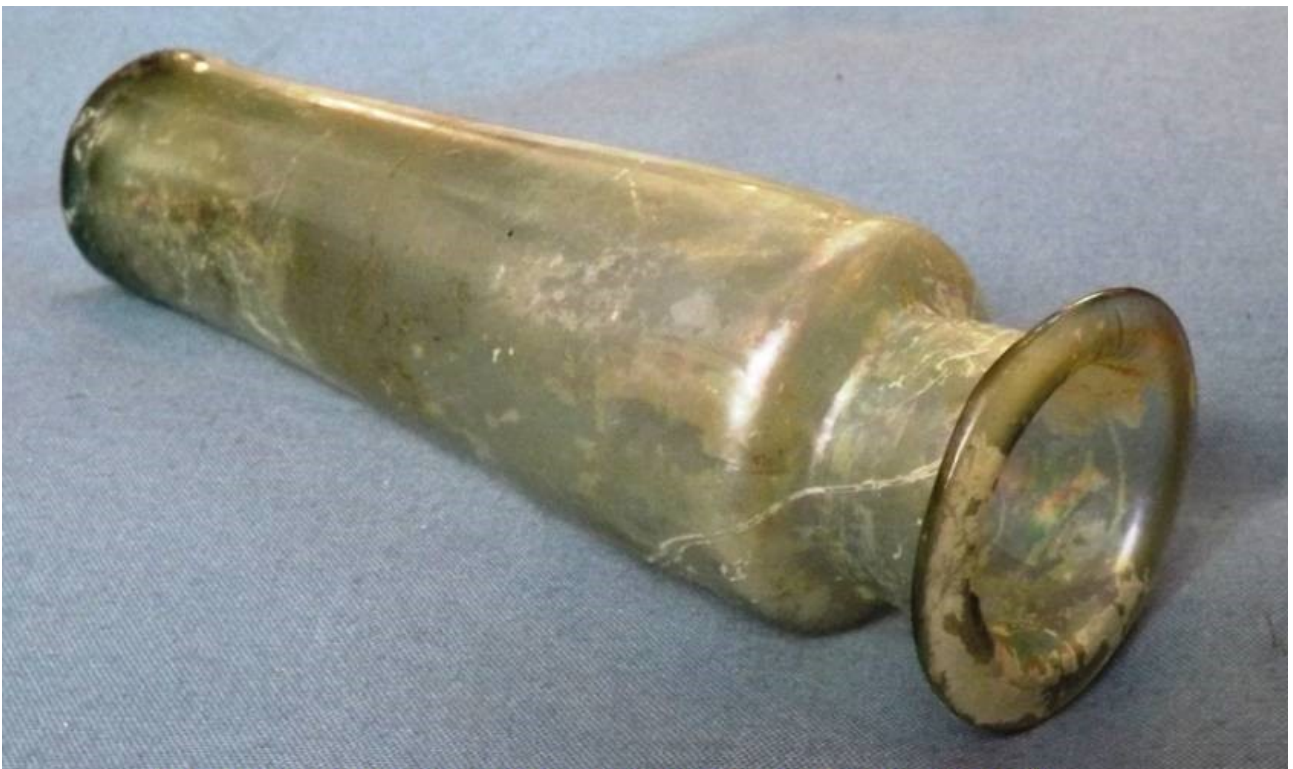
Bridget Colquhoun recalled how, in the 1920s, the current orchard was a kitchen garden with peaches, figs and plums and that the next vicar (Thomas Goodchild) turned it into an orchard. When Alex Cran was vicar a Roman glass vessel was found in a sewage trench in the orchard.

The Roman vessel is 16 cm (6 ½ inches long). Courtesy of Miss Elizabeth Cran.

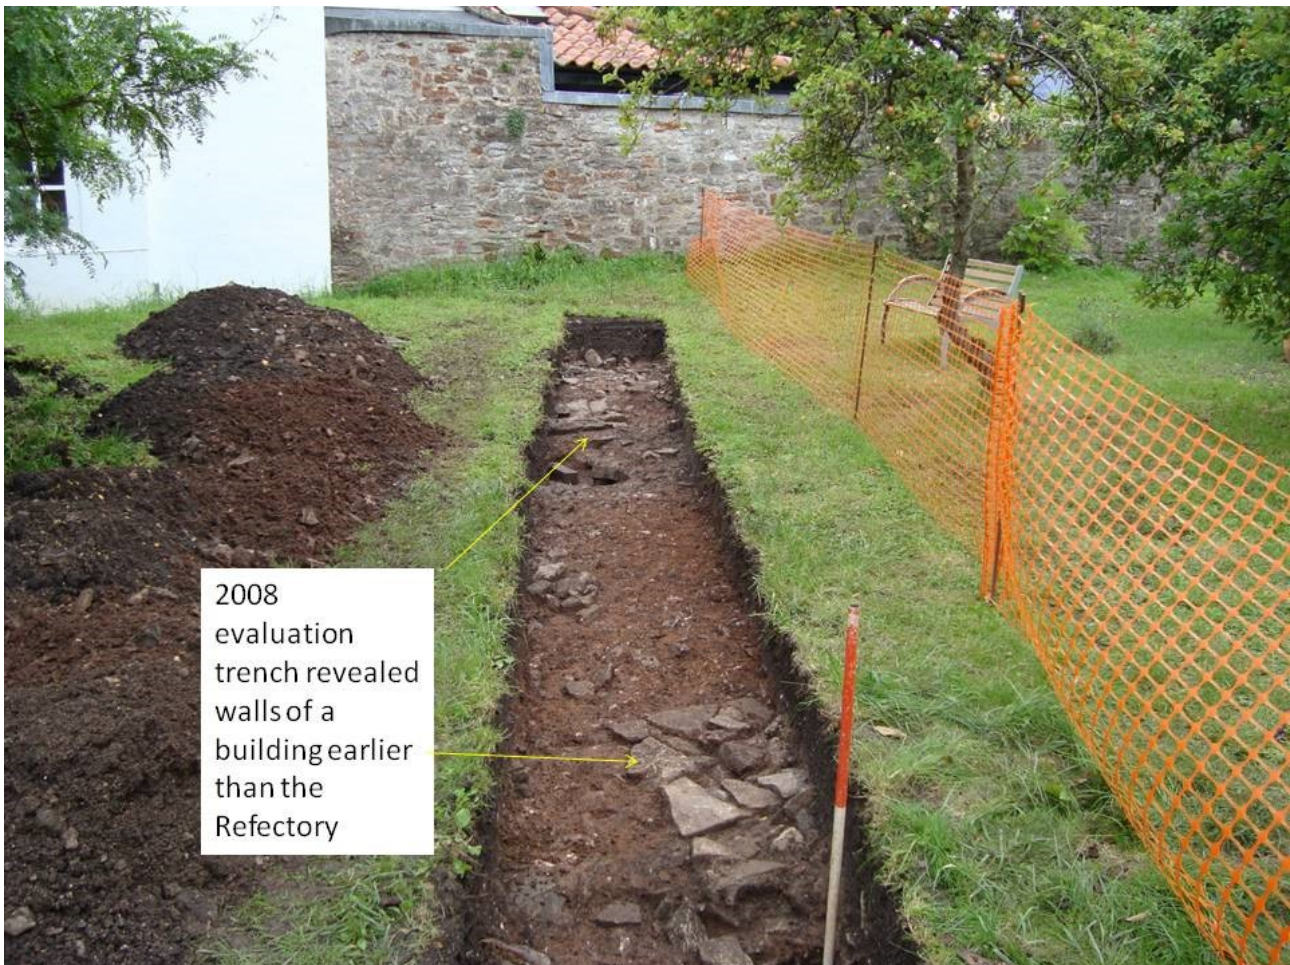
In 2008 a small scale archeological excavation was undertaken in the orchard by R.A Broomhead B. A., Field Archaeologist. This revealed the walls of a building, 14th century pottery sherds and wall plaster indicating a building of some significance.

A geophysical survey by YCCCART in 2010 revealed more evidence of the building/s which appear extensive.

These descriptions fit well with the location of the building/s revealed by the 2008 excavation and 2010 geophysical surveys.

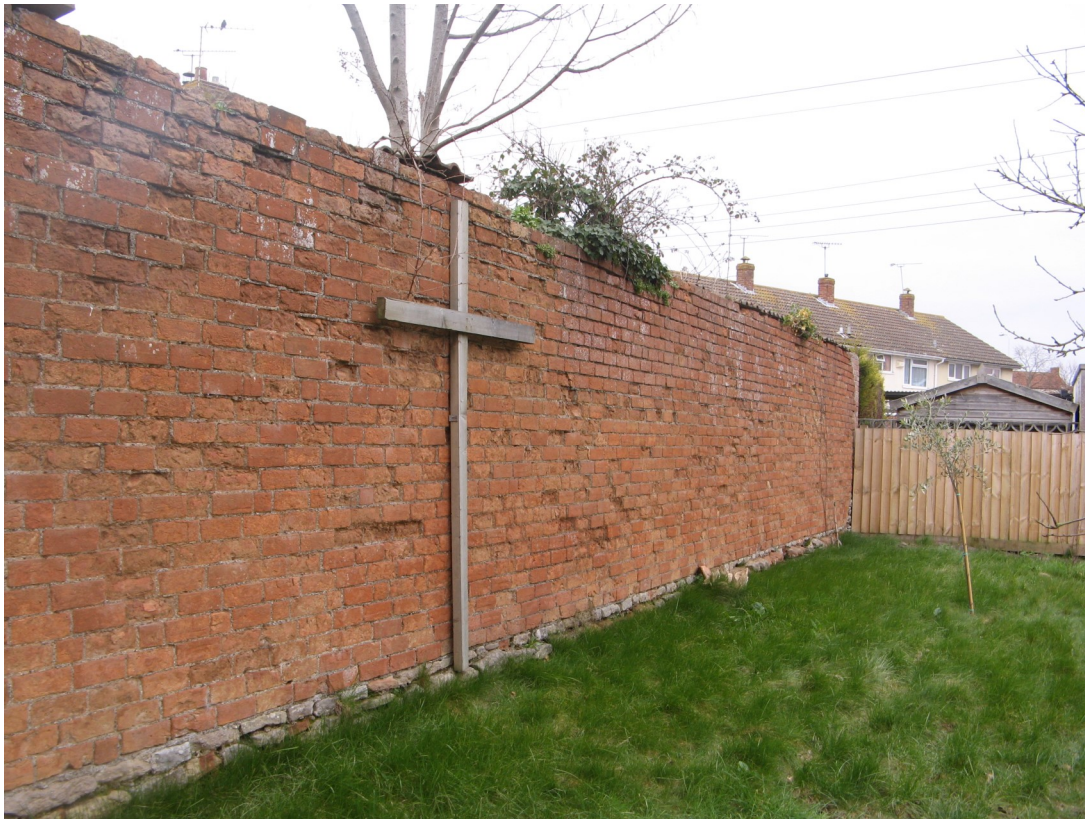
The north wall.

A visit to the orchard will take you to the most tranquil place in the village. Whilst there note the wall to the north which seems to have earlier foundations.

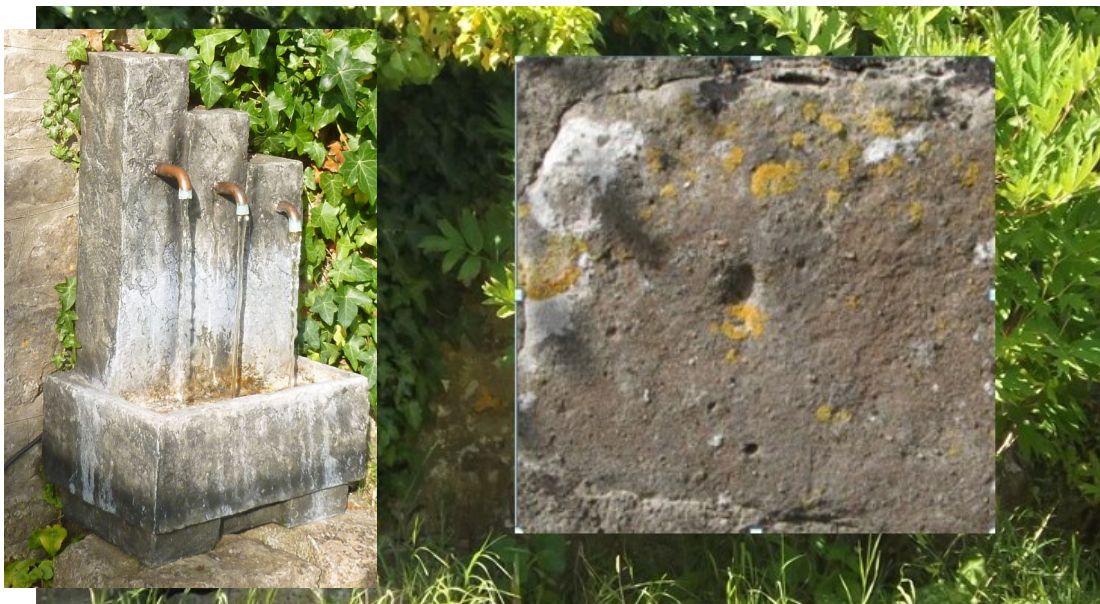
The west wall. Inset are the modern fountain and possible scratch dial.

The west wall dividing the orchard from the vicarage garden is also of interest. It contains what appears to be another scratch dial.

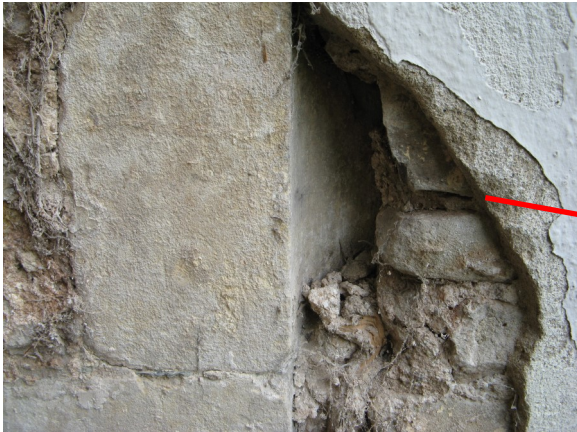
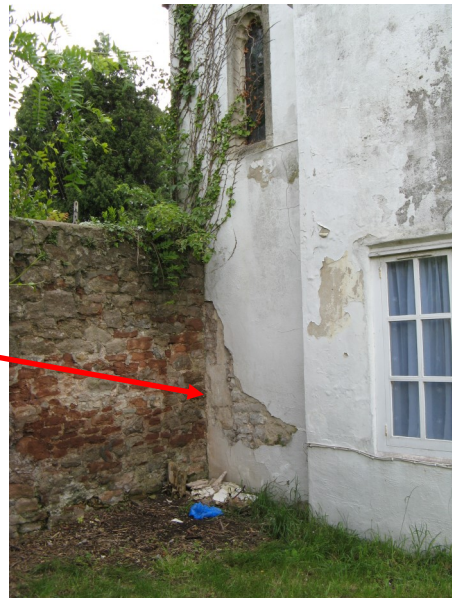
In 2007 repairs to the Refectory revealed what appears to be a blocked window on the east wall facing the orchard as indicated above.

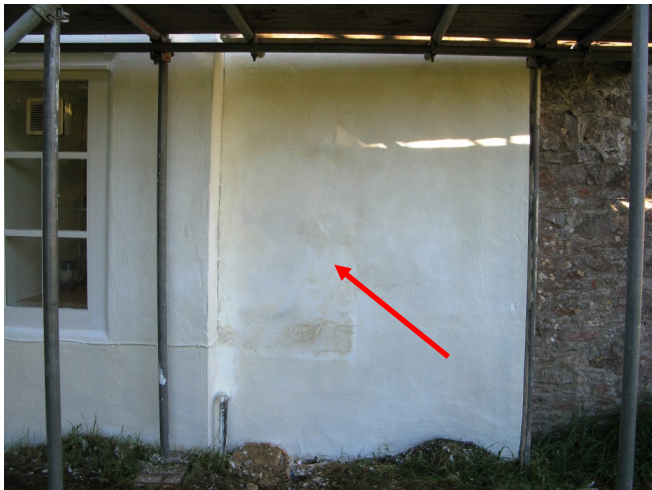
Also, is this another now blocked window, the other side of the existing window (indicated by the red arrow)?

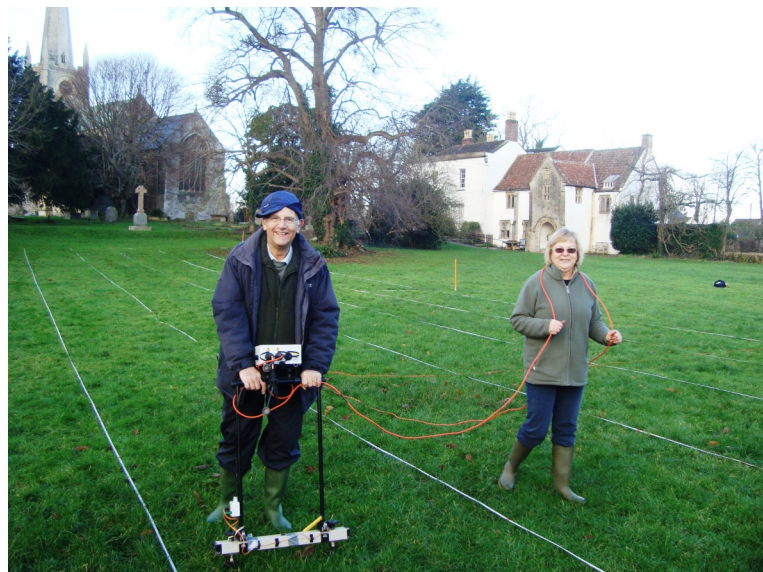
In 2014 a YCCCART geophysical resistivity survey revealed possible buildings on the paddock in front of the Refectory.

Right: John Wilcox and Anne Dimmock of YCCCART undertaking the resistivity survey.
