**YCCCART 2016/Y11
North Somerset HER 43654**

**Ox-house and associated features at Whitegates Common, Claverham Court Farm:
Earthwork and building survey and excavation 2005**

**YATTON, CONGRESBURY, CLAVERHAM AND CLEEVE ARCHAEOLOGICAL RESEARCH
TEAM (YCCCART)**

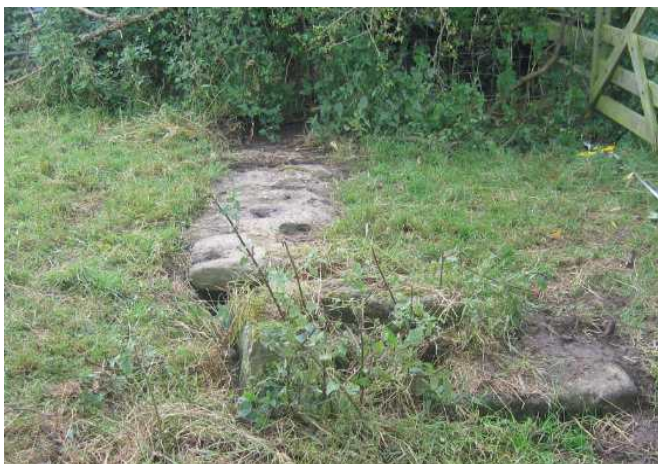
Fig 4: The stone gout

Close to the site of the oxhouse today, a stone built gout which would convey water from the leat still exists, but with the removal of the weir in Claverham, the leat is now dry.

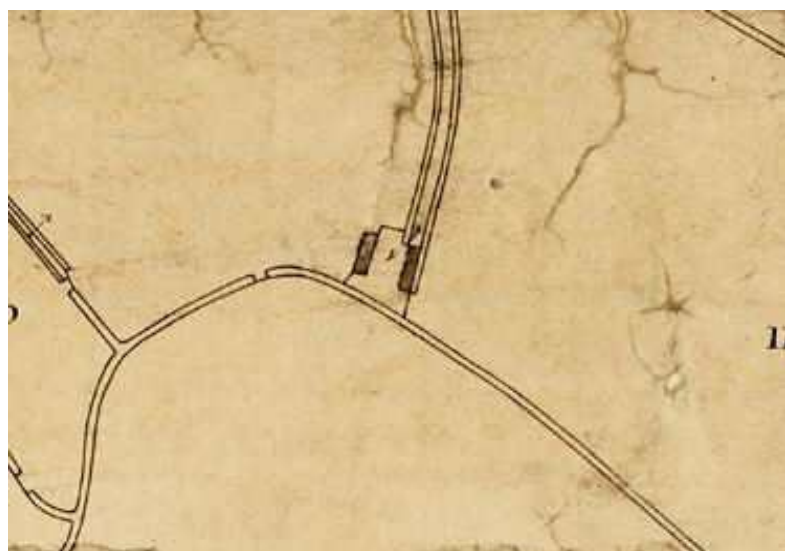
Fig 7: The site from the 1840 Yatton Tithe Map

By the time of the 1840 Tithe Map (Fig 7), the Poor House was no longer there, but a second building and an enclosure between the two buildings was present.

The ditch running away to the north is shown as a double feature, like a trackway, running down to the Little River, meeting a second running parallel to the river. Several ditches in the Claverham Moor seem to have been doubled, something not seen elsewhere.

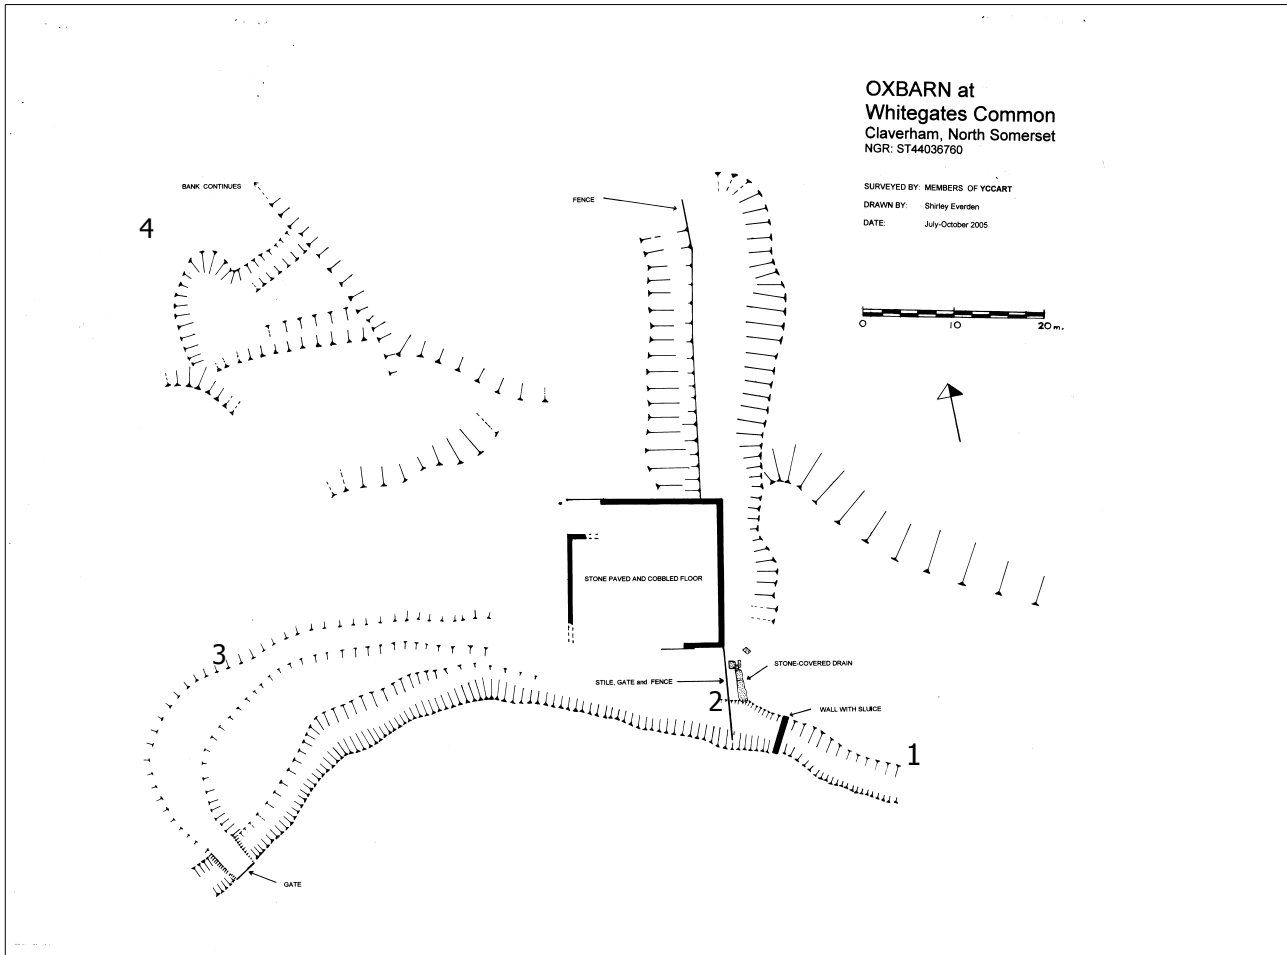
Fig 9: Earthwork survey at the oxhouse

This showed the leat (1), with a later wall set into it, running to and past the oxhouse, with a gout (2) connecting it to the double ditch to the north-east. A built-up modern track (3) runs from the gate to the entrance of the oxhouse. A small area of ditches (4), not respecting the regular lines of the grypes in the field, are also visible on lidar, not available at the time (Fig 10). It is still not clear what the purpose of these ditches was, although the lidar also shows some other extremely faint features, which may be pre-Inclosure palaeochannels.

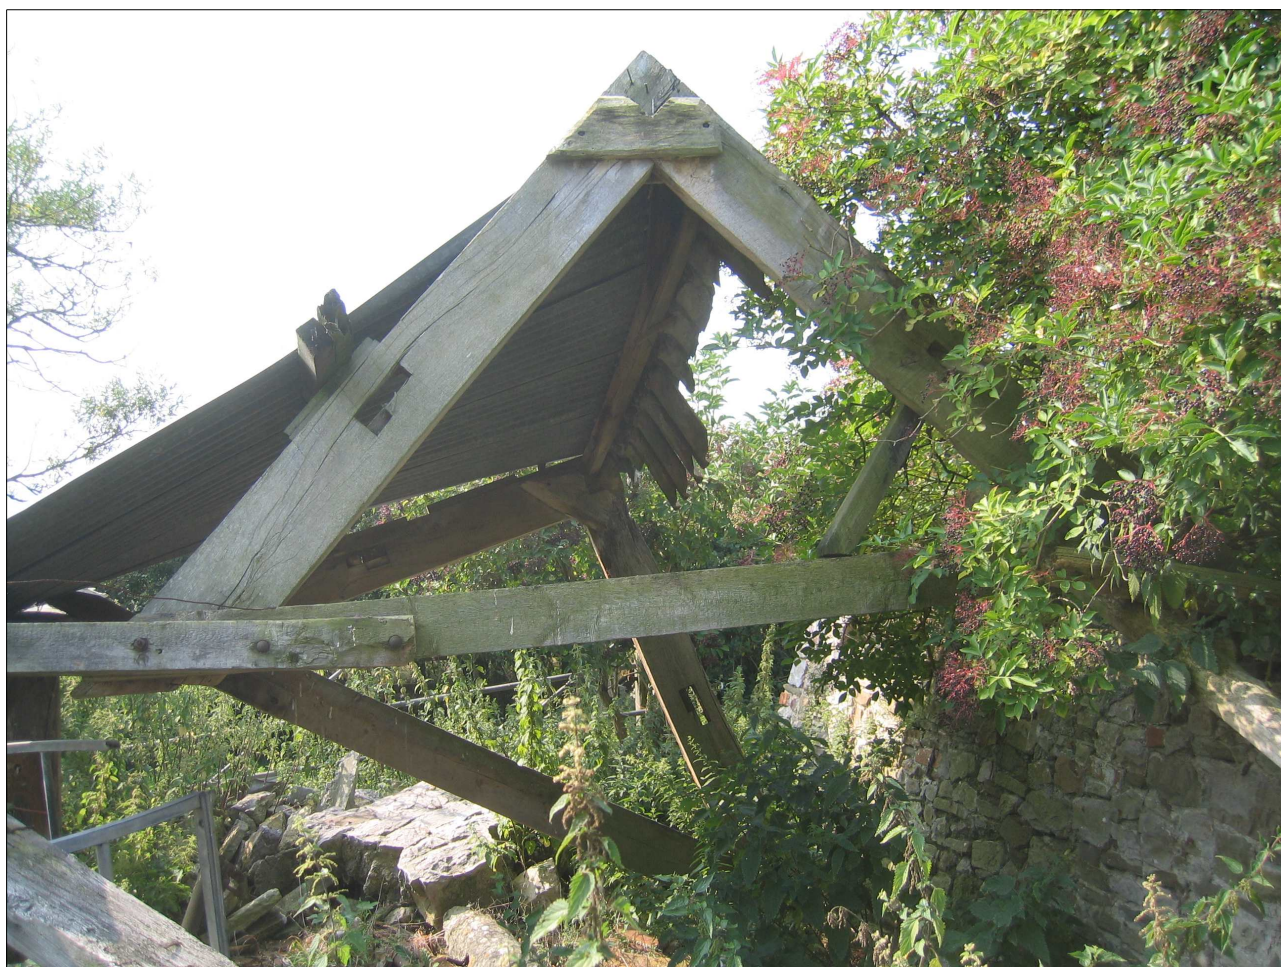
The roof structure was of cut-down and re-used wooden trusses from another building. These were originally sawn, and had half-lap joints for purlins in them, one of which survived with a tusk-tenon still in place (Fig 13). At the apex these were nailed together with re-used older bevelled ridge-pole supports. The cross member of each truss had been extended by the addition of bolted members, which themselves rested on the cross-lintel at the front of the building.

Fig 11: Collapsing roof structure of western building, August 2005. Note the re-used elements

Speculation on the origins of the re-used roof are pointless, but the basic techniques of the original roof could date it from any time between (say) 1650 and 1820: tusk tenons were uncommon in buildings after that date. It came, however, from a building of higher status than an ox-house, probably a domestic dwelling.

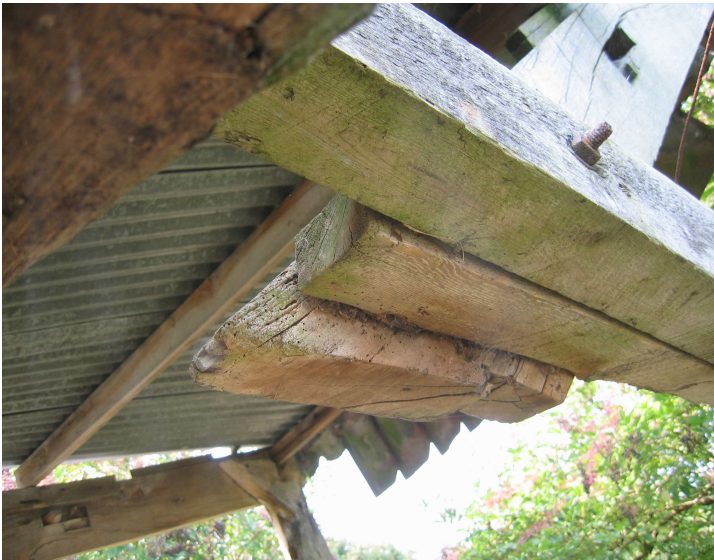
Fig 12: Sawn-off foot of re-used truss

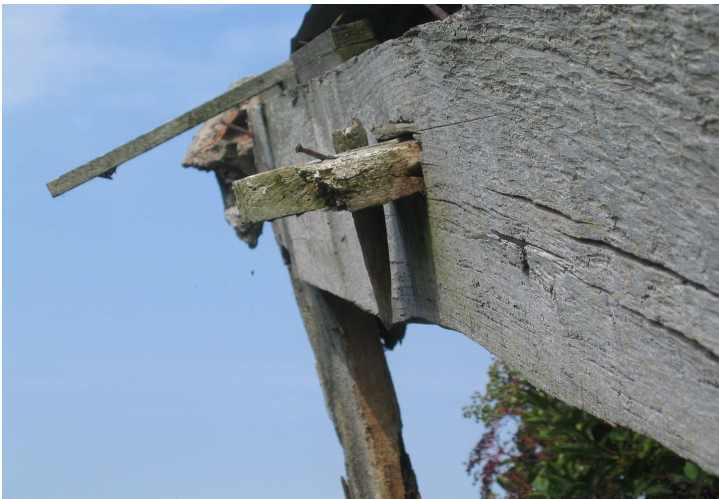
Fig 13: Surviving tusk-tenon in purlin end

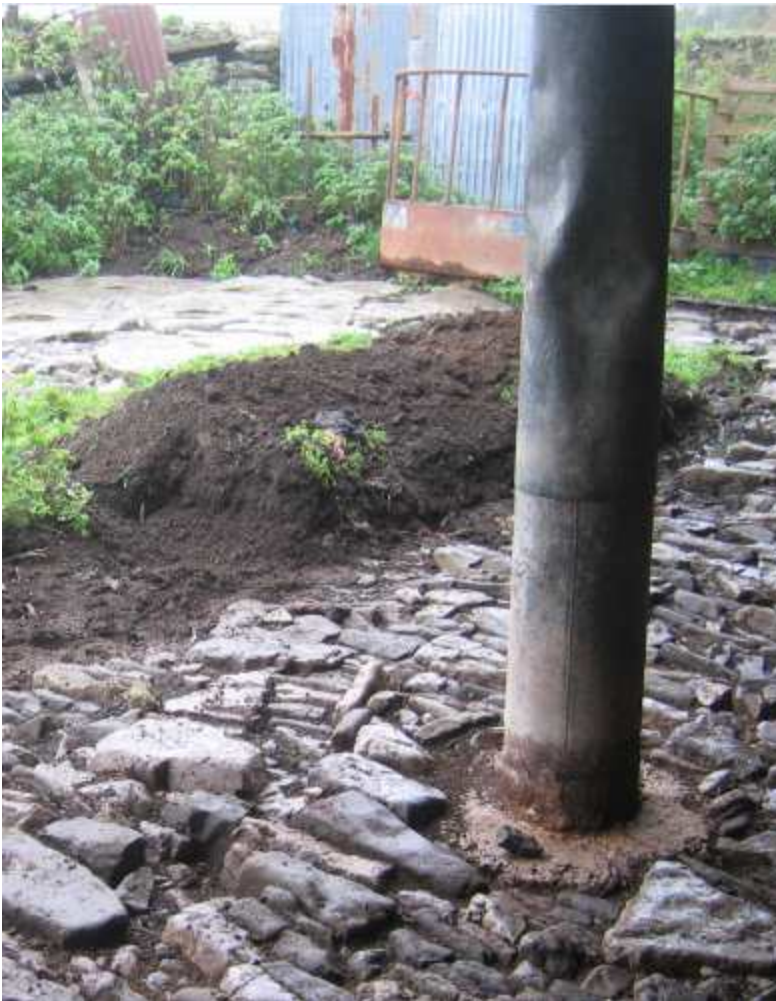
Fig 14: Cylinder holding up the roof structure of the eastern building

The front is held up by four cylindrical hollow galvanised iron cylinders, of unknown origin, concreted into the traditional floor.

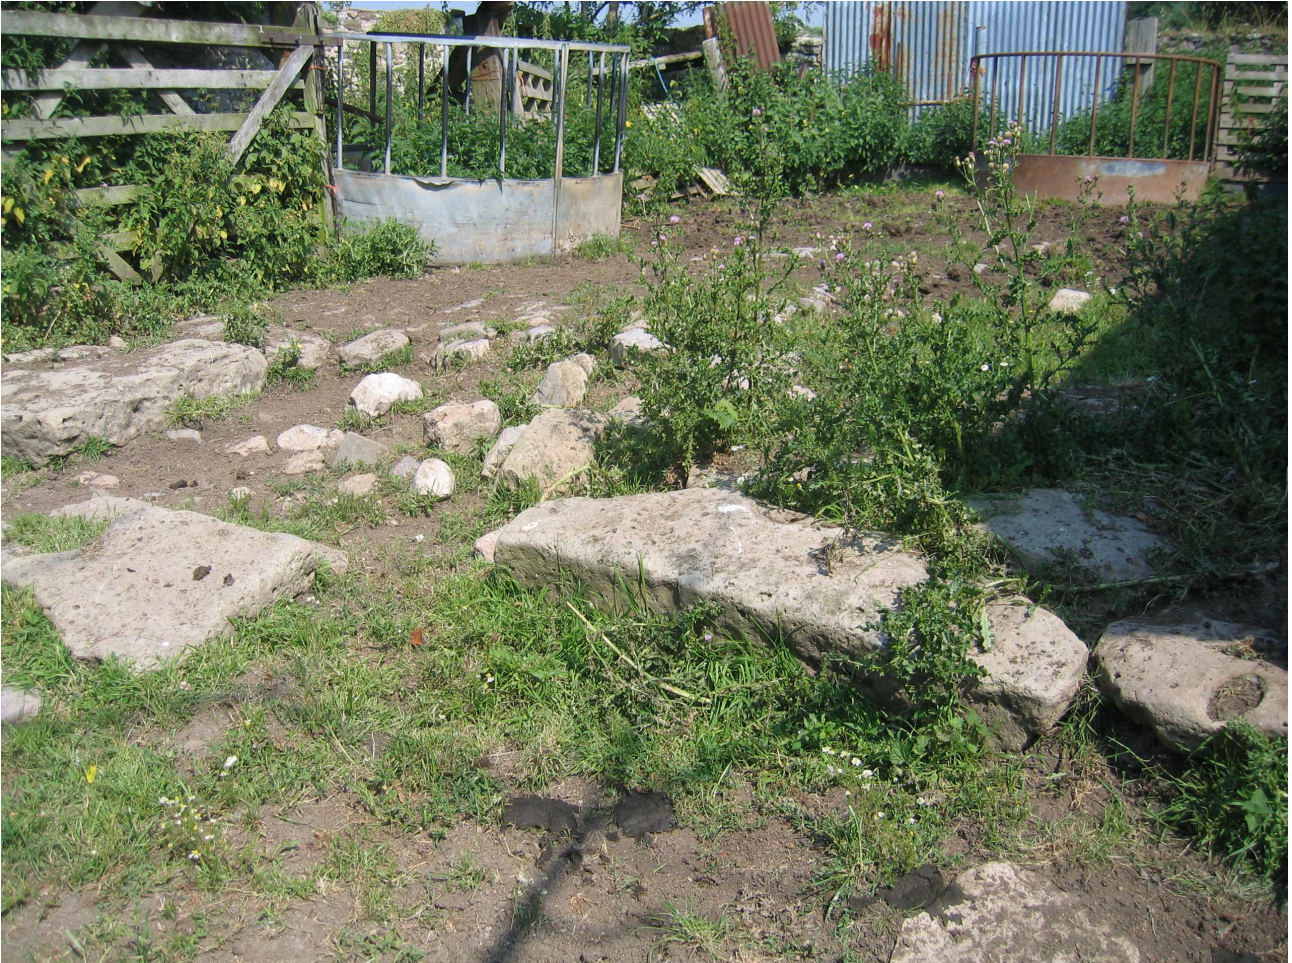
Fig 15: Entrance step and floor of ox-house before excavation

The stone all appears to be of local origin, mostly of the Claverham stones, with Carboniferous limestone (including a few recognisable yellow stones with limonite, probably from Broadfield Down) and of Pennant Sandstone. There were no reused worked stones in the floor: the right-angled edges on the Claverham stones are a natural phenomenon.

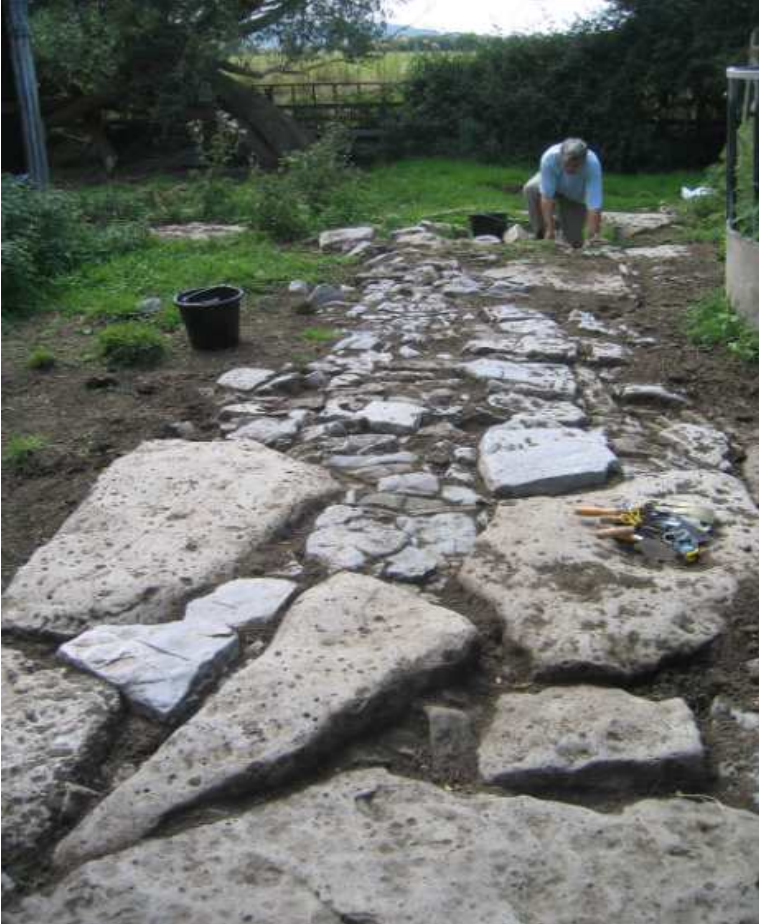
Fig 16: Clearing the floor surface in front of the western building (looking S)

There was no obvious reason for the spacing or selection of the stones: the whole was buried under several centimetres of very well-rotted manure when first encountered, and was probably so from very soon after it was first laid down.

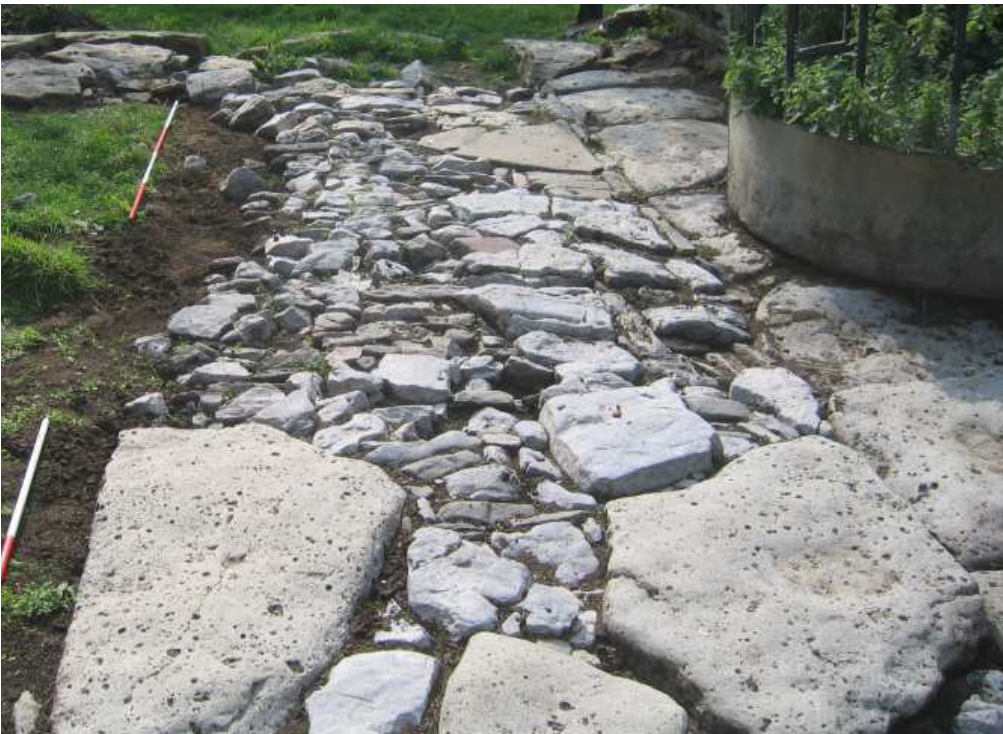
Some straight lines of thin Pennant stones at a slightly lower elevation would have acted as drains for the surface.

Fig 15: Recording the same area: note the 'edge' of the Claverham stones at the drain to the upper right. Scale in half-metres

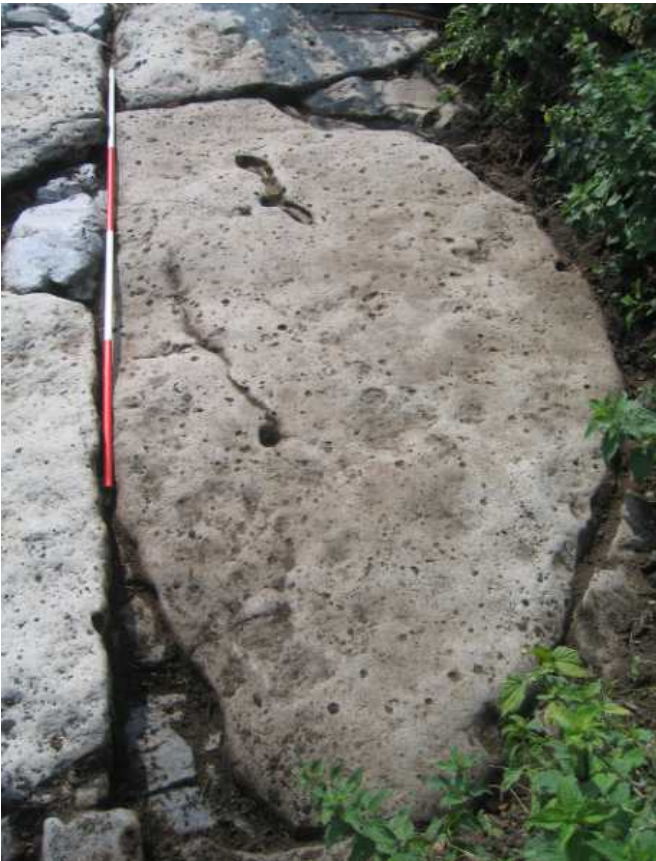
Some of the larger stones must have required extraordinary handling: Fig 17 shows one of the largest at the site.

Fig 17: A Claverham stone in the western building frontage (scale in half-metres)

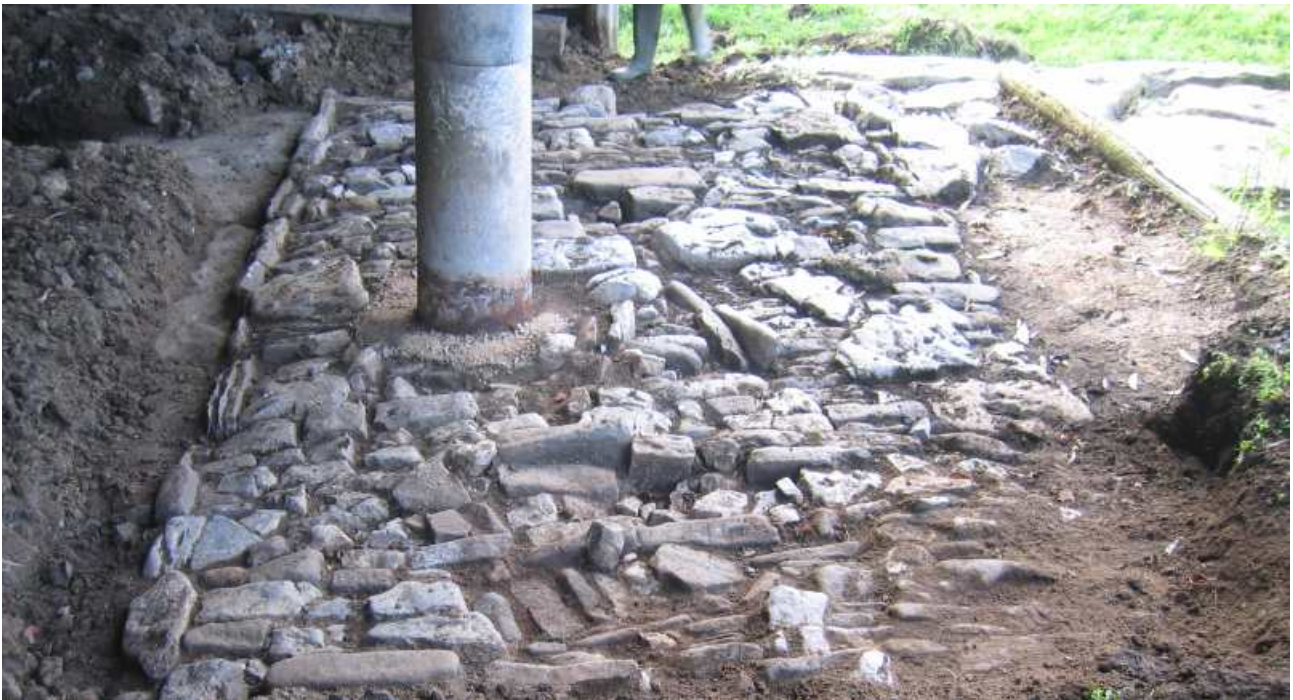
The eastern building had a sill on its open side of upright Pennant slabs, with a Claverham stone floor, seen in Fig 18.

This presumably indicates the former extent of the eastern building.

The skilful cambering of the surfaces and provisioning with drains and kerbs seems rare, but few ox-houses have been recorded in such detail.

Fig 18: The cambered threshold and sill of the eastern building
