YCCCART 2019/ Y16

Earthwork survey of building remains at Garrett's path, Kings Wood, Cleeve

The foundations in the woods: a possible 19th century beer house

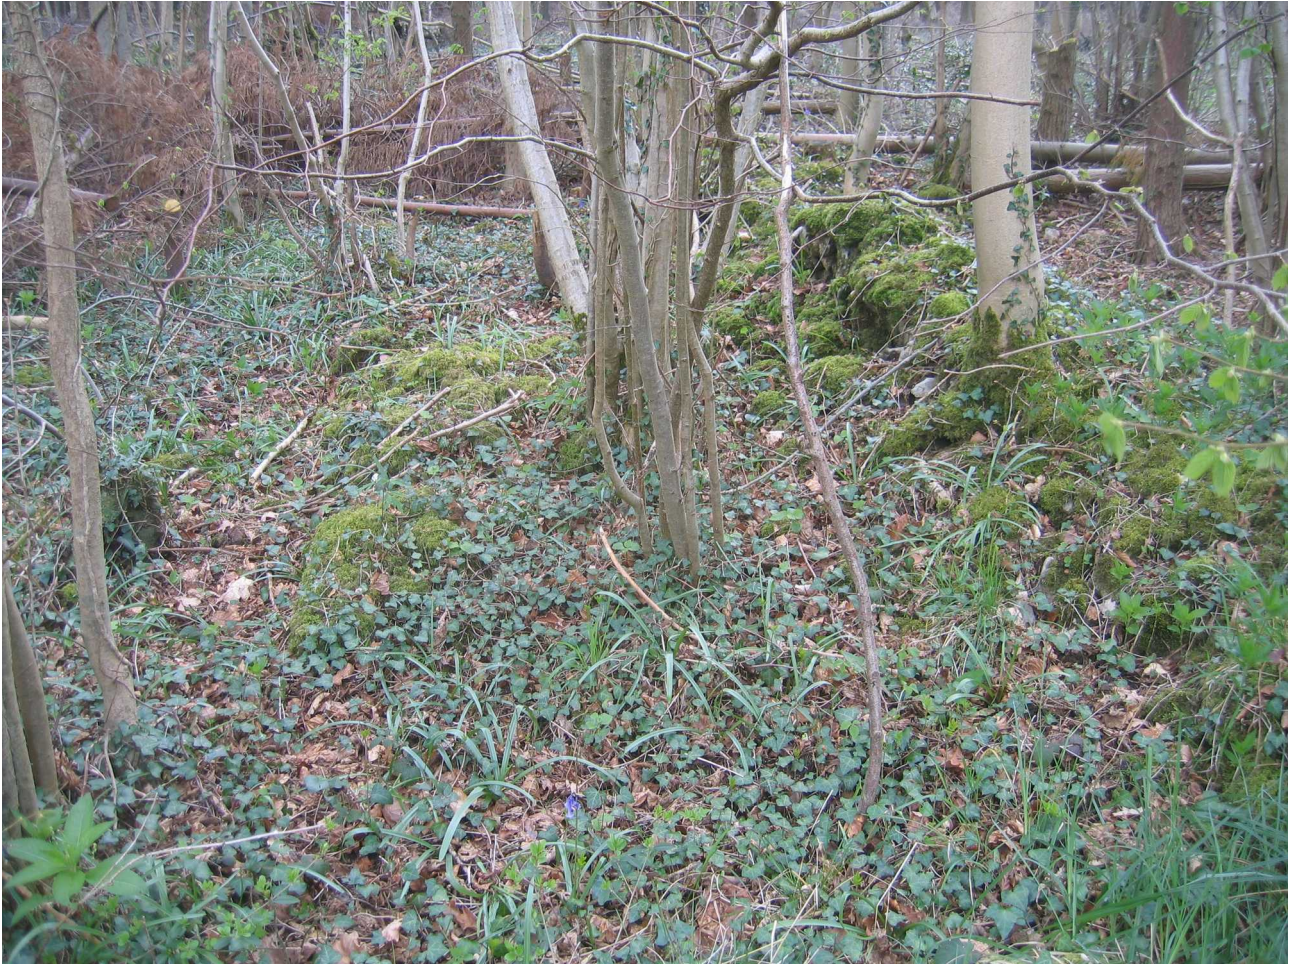
Fig 4: North wall and 'outshot' of structure, from the path
