YCCCART 2021/Y5

The old stone crosses of Clevedon

**YATTON, CONGRESBURY, CLAVERHAM AND CLEEVE ARCHAEOLOGICAL
RESEARCH TEAM (YCCCART)**

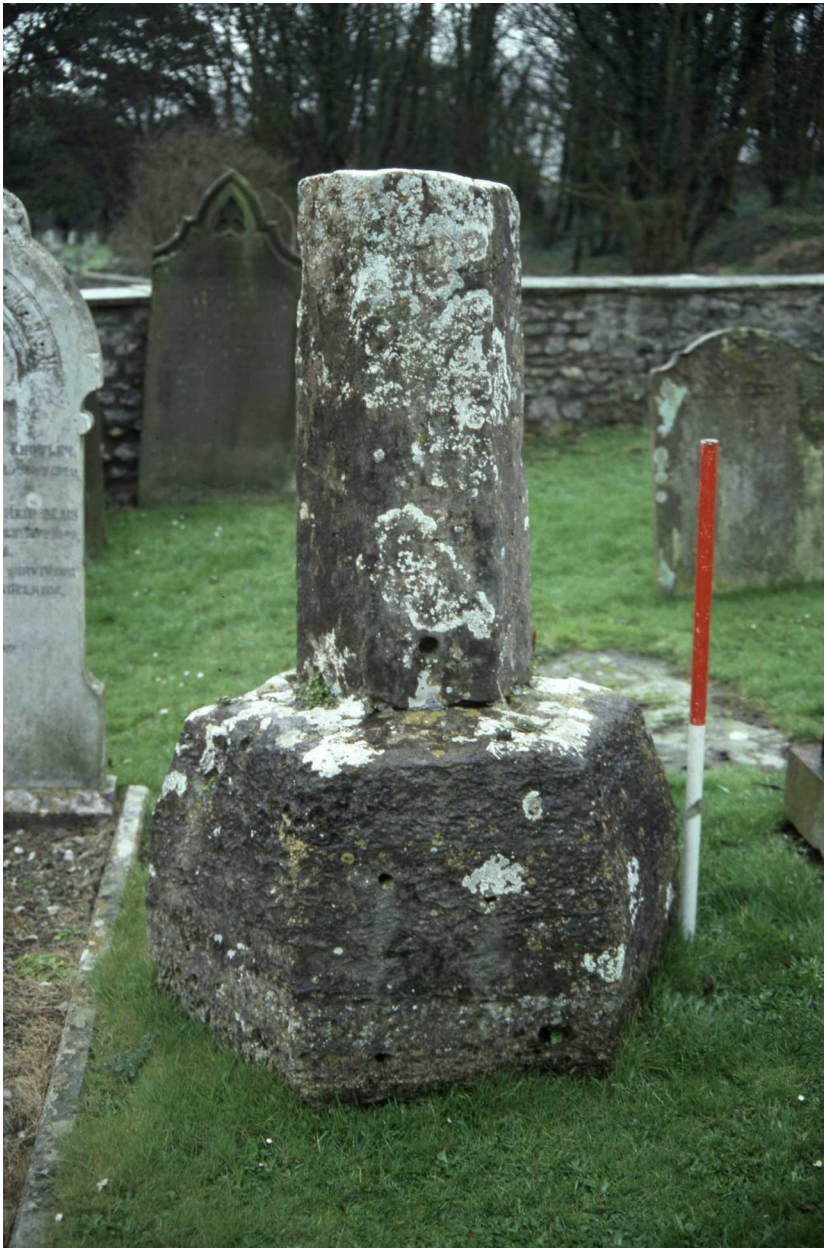
Fig 4: Clevedon 1 (1994). Scale is 2x50cm

The remains of this cross are only a simple socket and around 1m of shaft.

This fragment of a churchyard cross is clearly not in its original position: liturgically, it should be on the other side of the path, and there cannot be buried steps below, since the graves each side are so close any such steps would have been destroyed.

The socket is most unusual, with its hexagonal sloping side, steepening towards the base.

As Pooley (1877) noted (an unusual detail from him), the cross has a number of boreholes in it, not least two on opposite sides of the shaft just above the top of the socket: the socket has double drill-holes containing iron plugs leaded in on the top surface of three of its six faces, each about 2cm across. The earliest record of this cross (Fig 5 below) shows it already at this site.

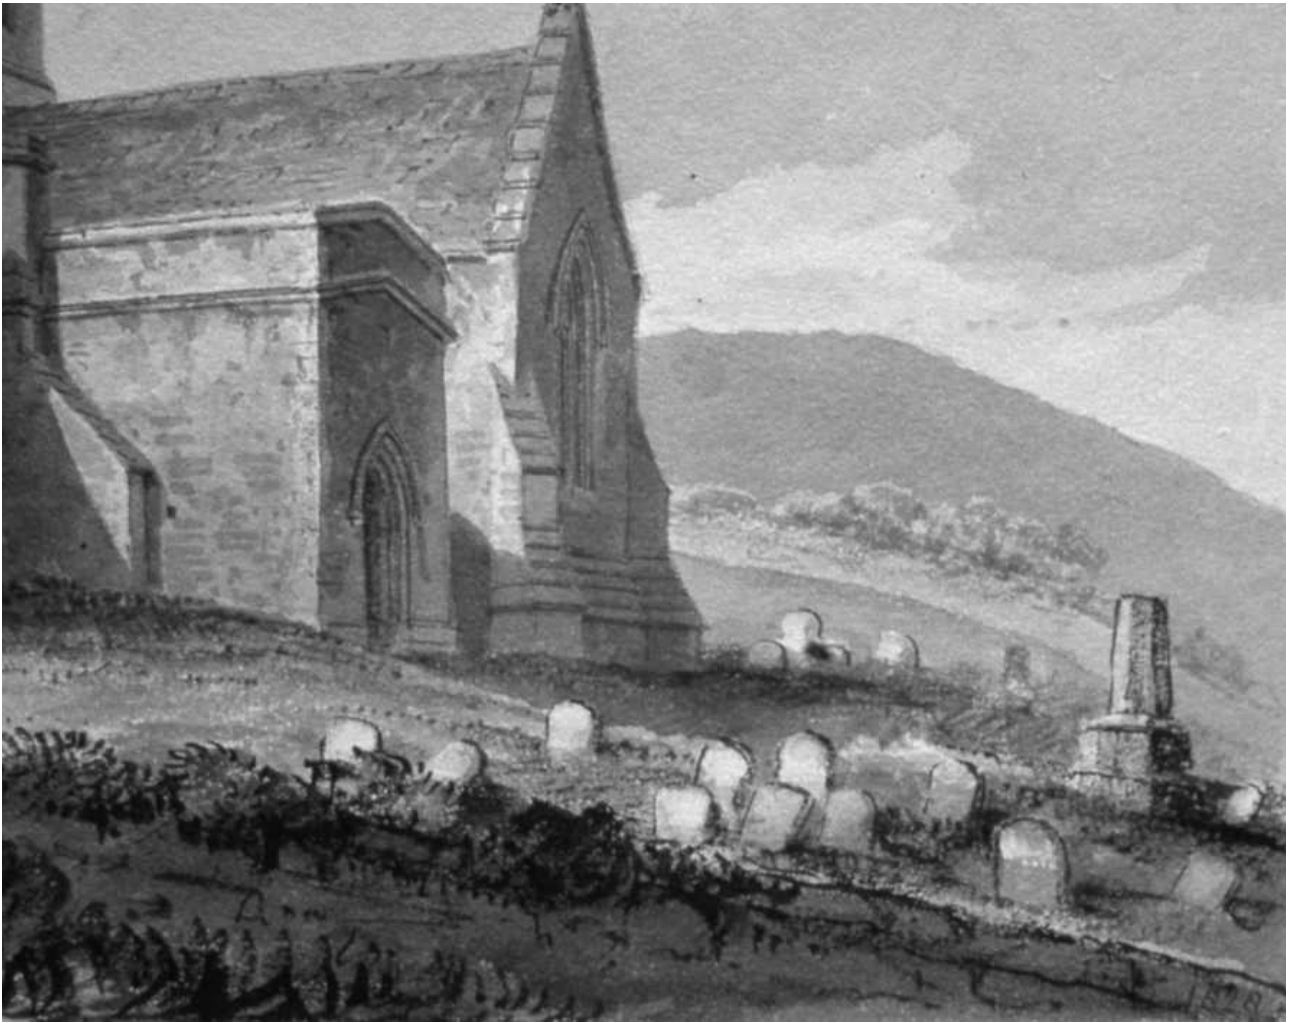
Fig 5: Enlargement of drawing by Buckler (1828)

The unusual nature of the cross socket has caused Buckler to depict it as a two-stage socket, which it clearly has not been. This feature is repeated in a copy of the drawing from 1840.

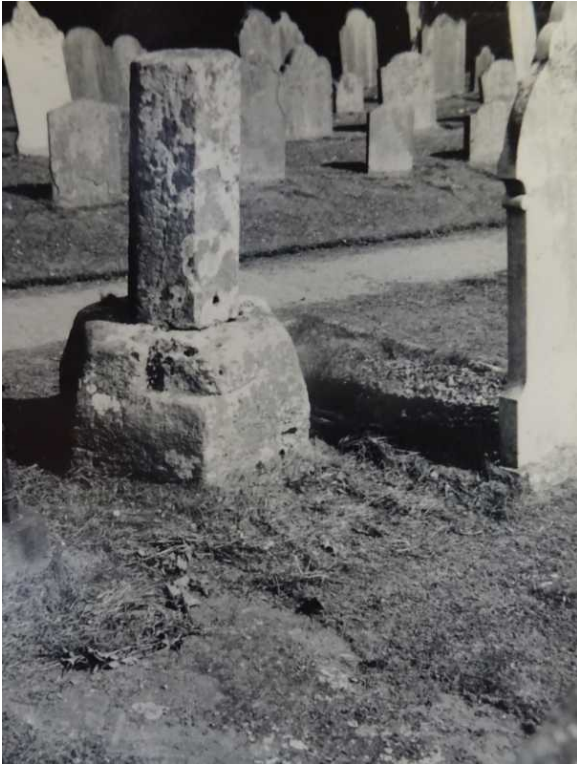
Fig 7: Photograph by 'CND' (1955-65)

The iron plugs lead into the upper side of the socket are very unusual: if there are affixes relating to (say) Rogation Day, these are usually horizontal on the face of the socket.

The drill holes on the shaft are possibly for affixes, but the upright plugs are something I have never seen anywhere else, except perhaps at Henstridge churchyard cross in South Somerset, where there are multiple iron plogs in the broken off-shaft. (Incidentally, Pooley compares the socket of Clevedon 1 to Henstridge, but they are nothing like each other).

CND's photograph also confirms Pooley's depiction of damage to the upper part of the socket.

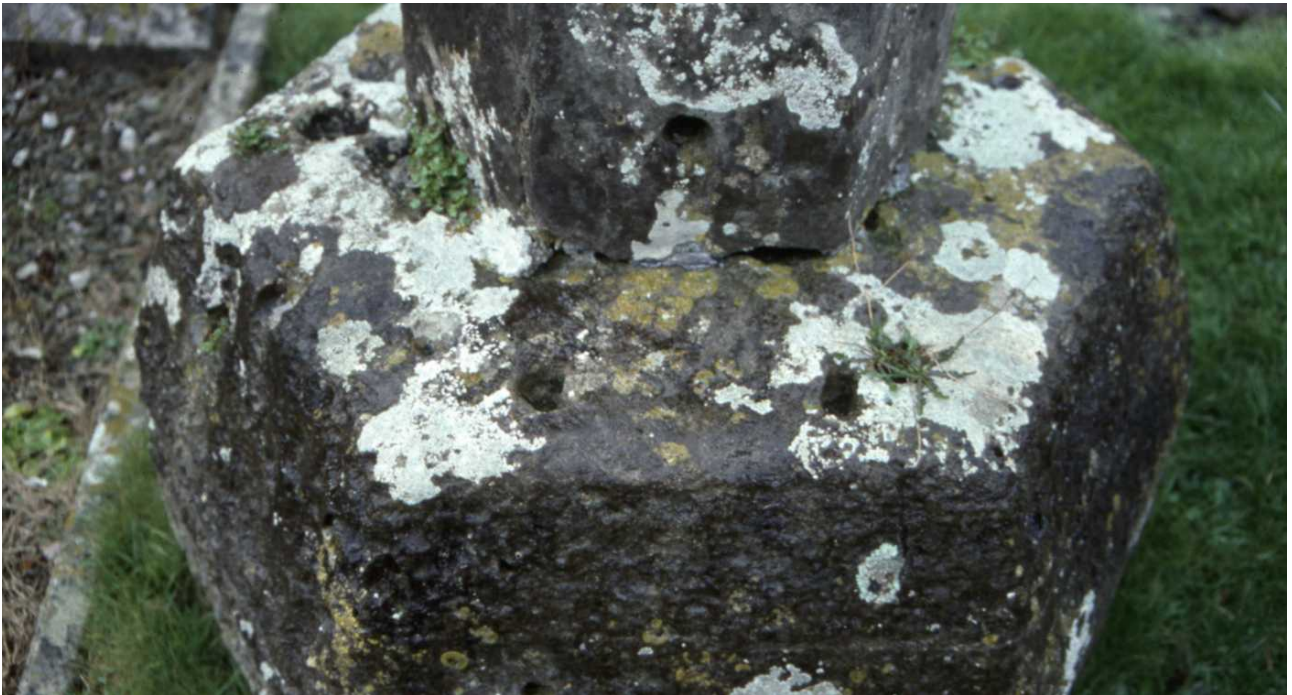
Fig 8: The iron plugs on three opposing upper surfaces of the socket and one of the shaft drill-holes (1994)

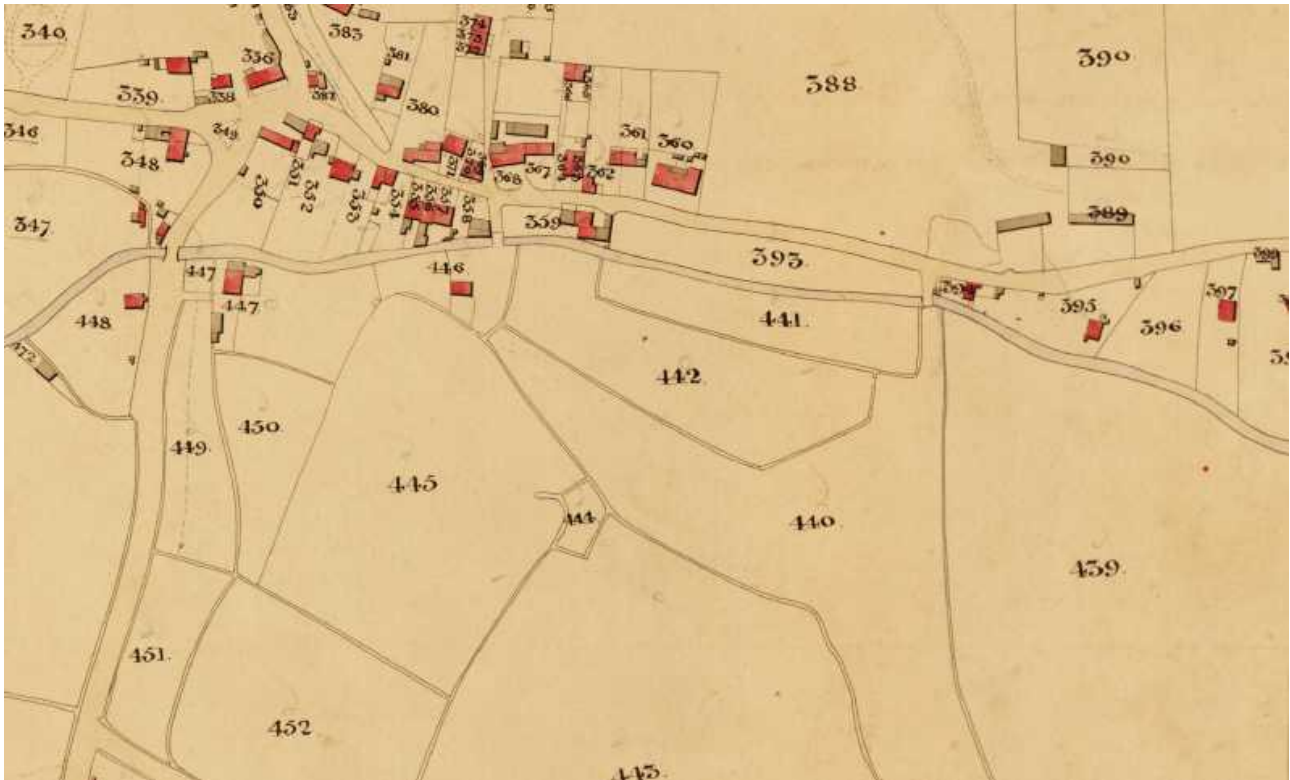
Fig 9: Site of Chipping Cross in Old Street (to the top right of land parcel 393)

The riverside land parcel 393 may once have acted as a market place.

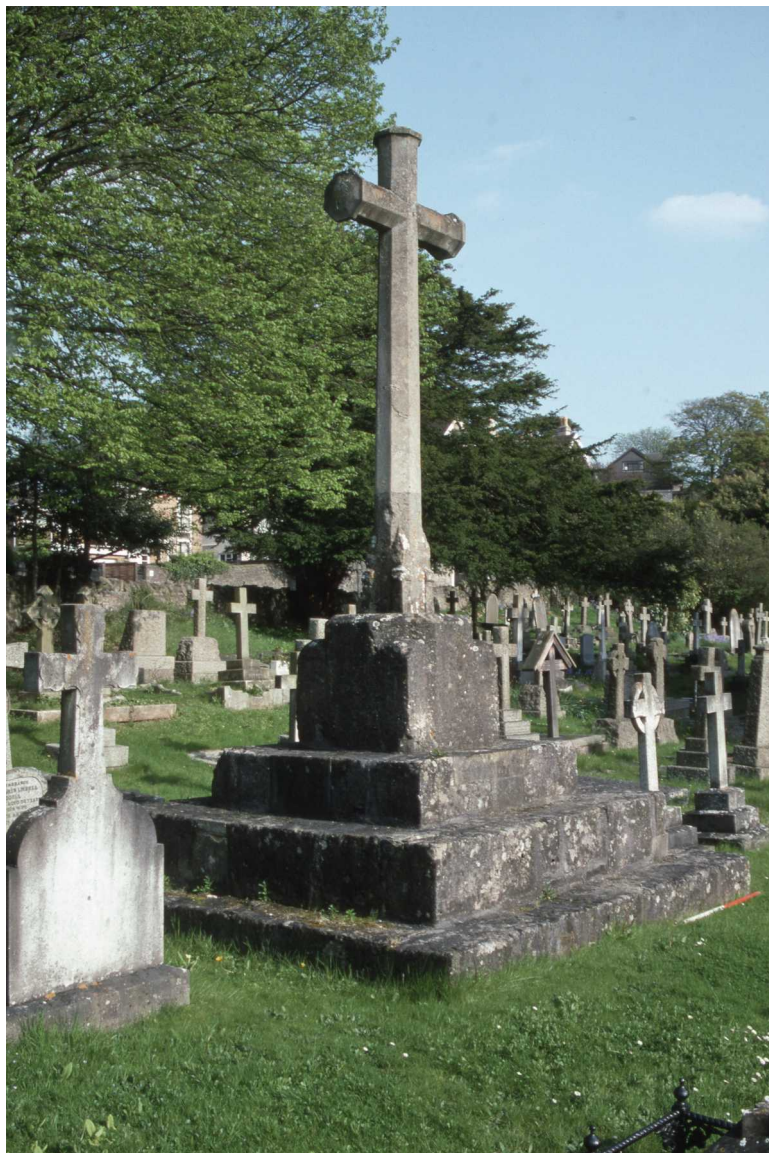
Fig 10: Clevedon 3 (1994)

Walton St Mary church and churchyard has had a curious history. Originally constructed as St Paul's in the 13th century, it went out of use at some unspecified time in the post-medieval period, and subsequently became a ruin, as did the cross.

St Paul's was rebuilt (finished 1870), and the cross rebuilt and restored.

In my experience, these tend to be very prone to erosion (especially if the stone has been chosen badly), and today, the chunky cross seen in Fig 10 (above) has replaced it. The occasion for this may have been in 1957, when a faculty was granted for 'works to the churchyard cross' (SHC D/P/walt.g.m/6/3/1).

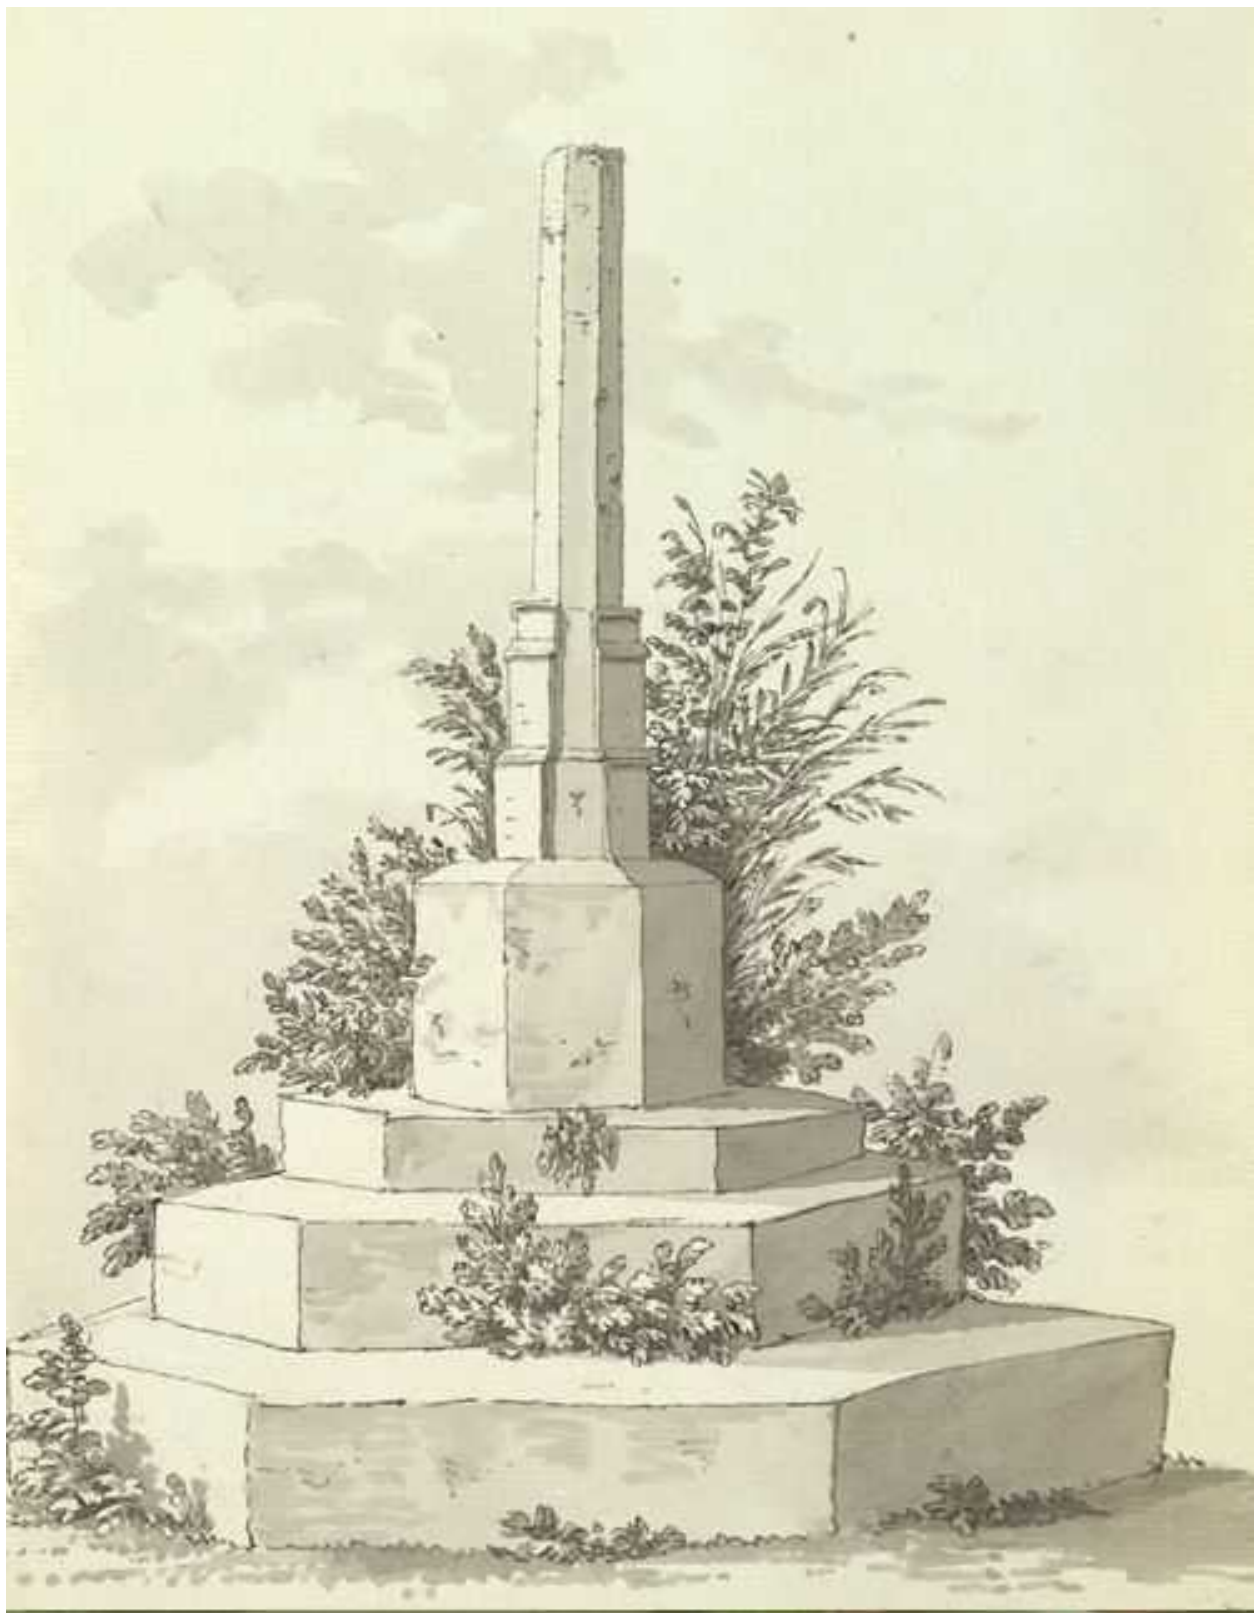
Fig 11: Clevedon 3 by S H Grimm (1788)

This means that Grimm's drawing of 1788 is the earliest known drawing of Clevedon 3 (Fig 11 below).

This is a curious drawing, but the brooches at the base of the shaft seem to be unique (in Somerset, at least). And yet, in both his detailed drawing, and the more distant view in his depiction of the church and cross, he shows it with hexagonal plan steps, whereas all other drawings (both before and after the rebuilding) show a cross with square steps and a square-to-octagon stopped socket of 'normal' type.

Being charitable, the cross does seem very overgrown in Fig 11: perhaps it was difficult to discern the plan form.

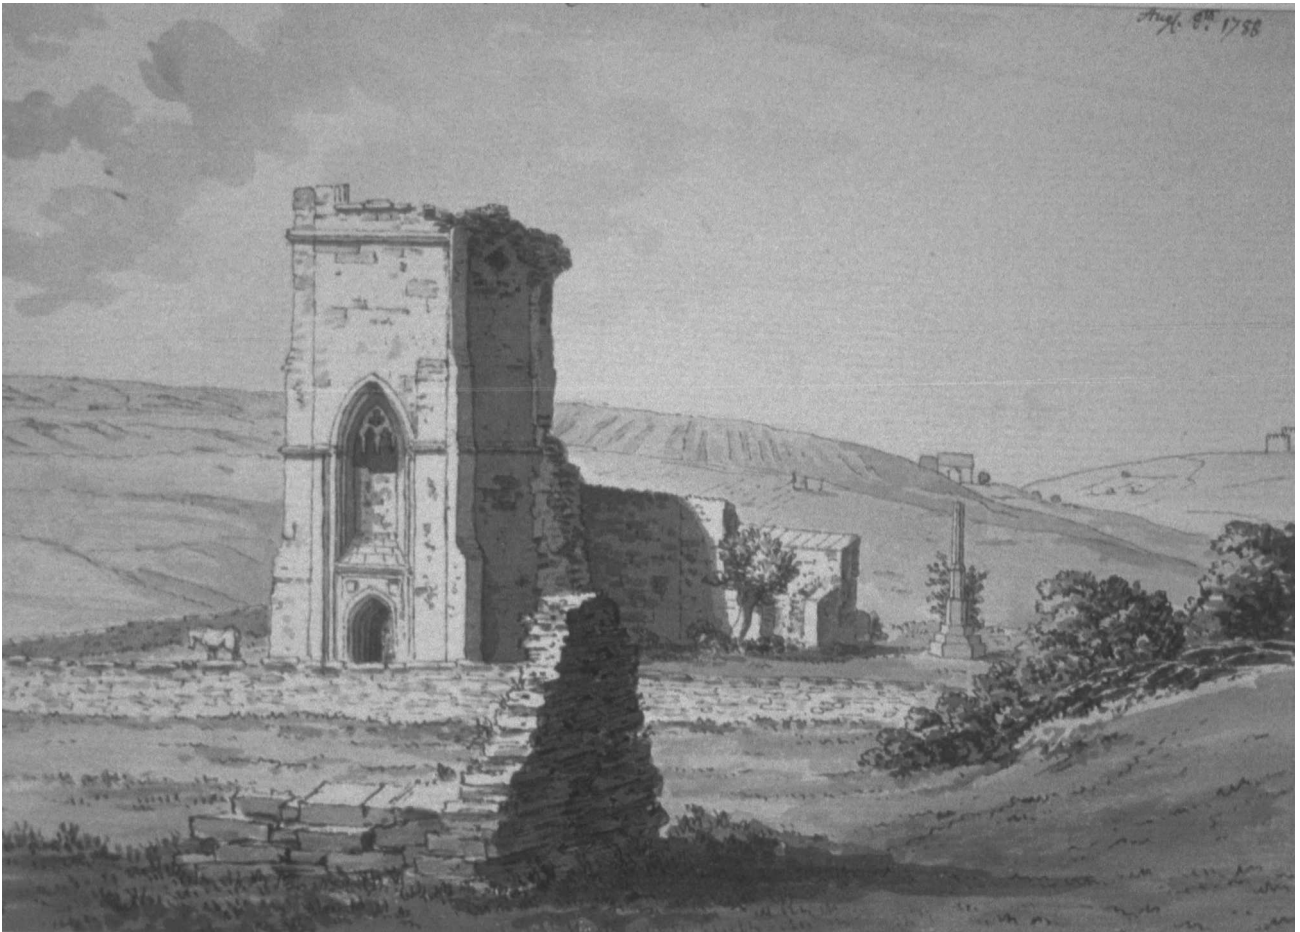
Fig 12: Walton St Paul and cross by SH Grimm (8 August 1788)

He also shows the cross on its original site, before the rebuilding elsewhere in the churchyard in the 1860s (Fig 12 below).

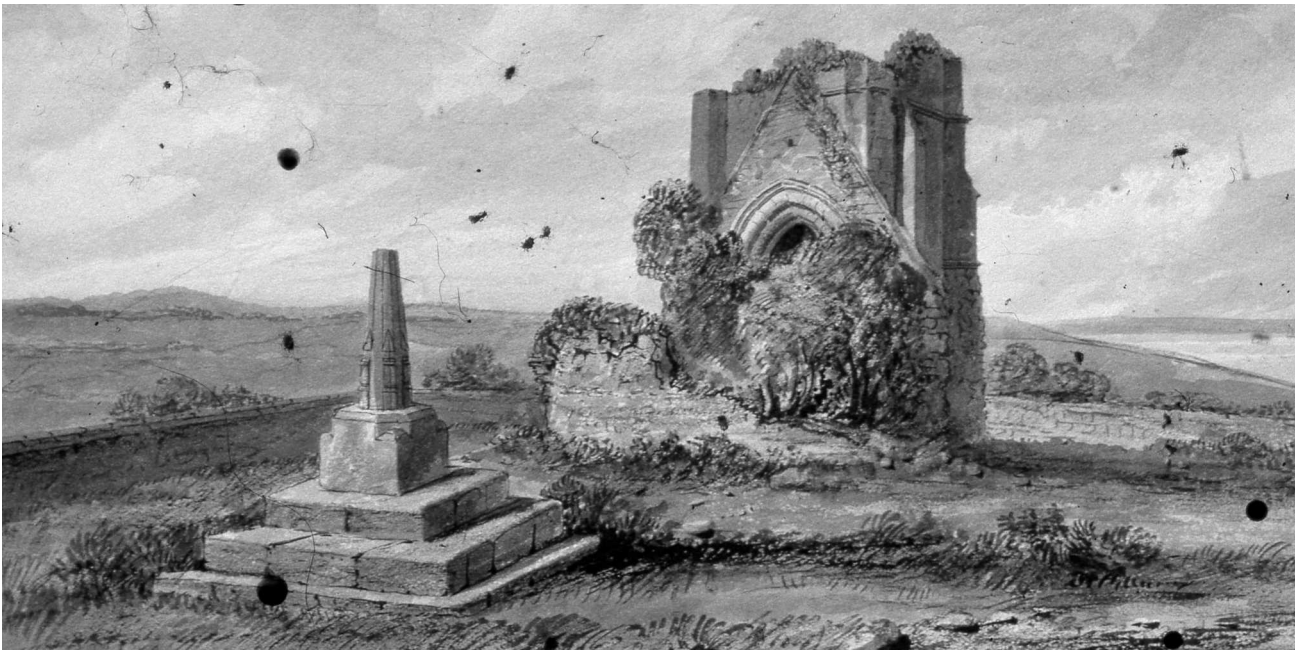
Fig 13: Clevedon 3 and church by Buckler (1829) (the blobs are defects in the original)

He and Pooley (in 1877) both saw and drew the cross before 'restoration',: although Pooley didn't publish until after the restoration, he must have originally drawn it before.

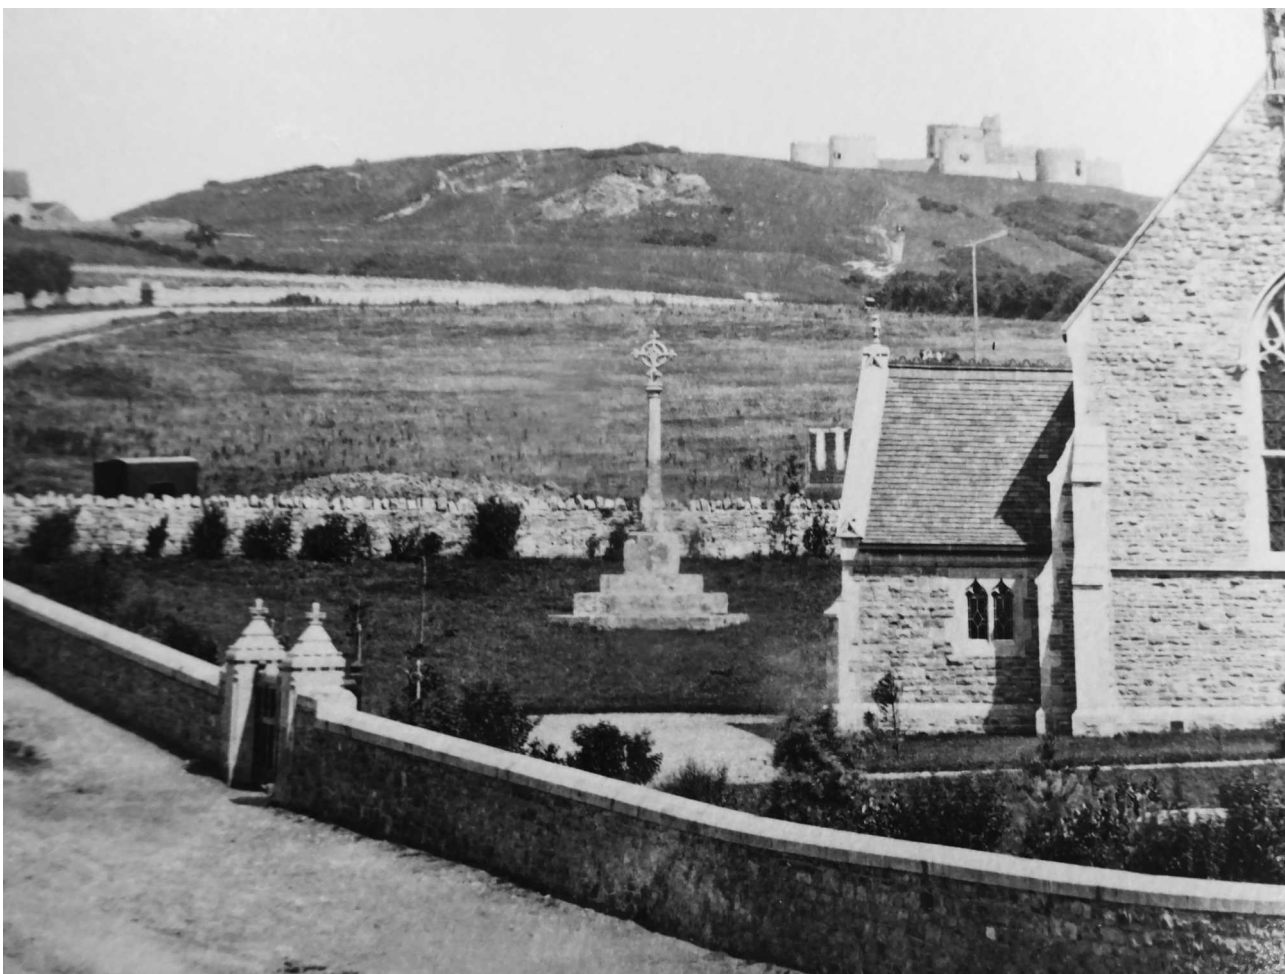
Fig 14: Photograph of cross in new position and restored church c1900 (Photograph kindly loaned for copying by Dave Long)

Note that the new head of the cross was not the one present today: it was a pierced equal-armed ring cross.

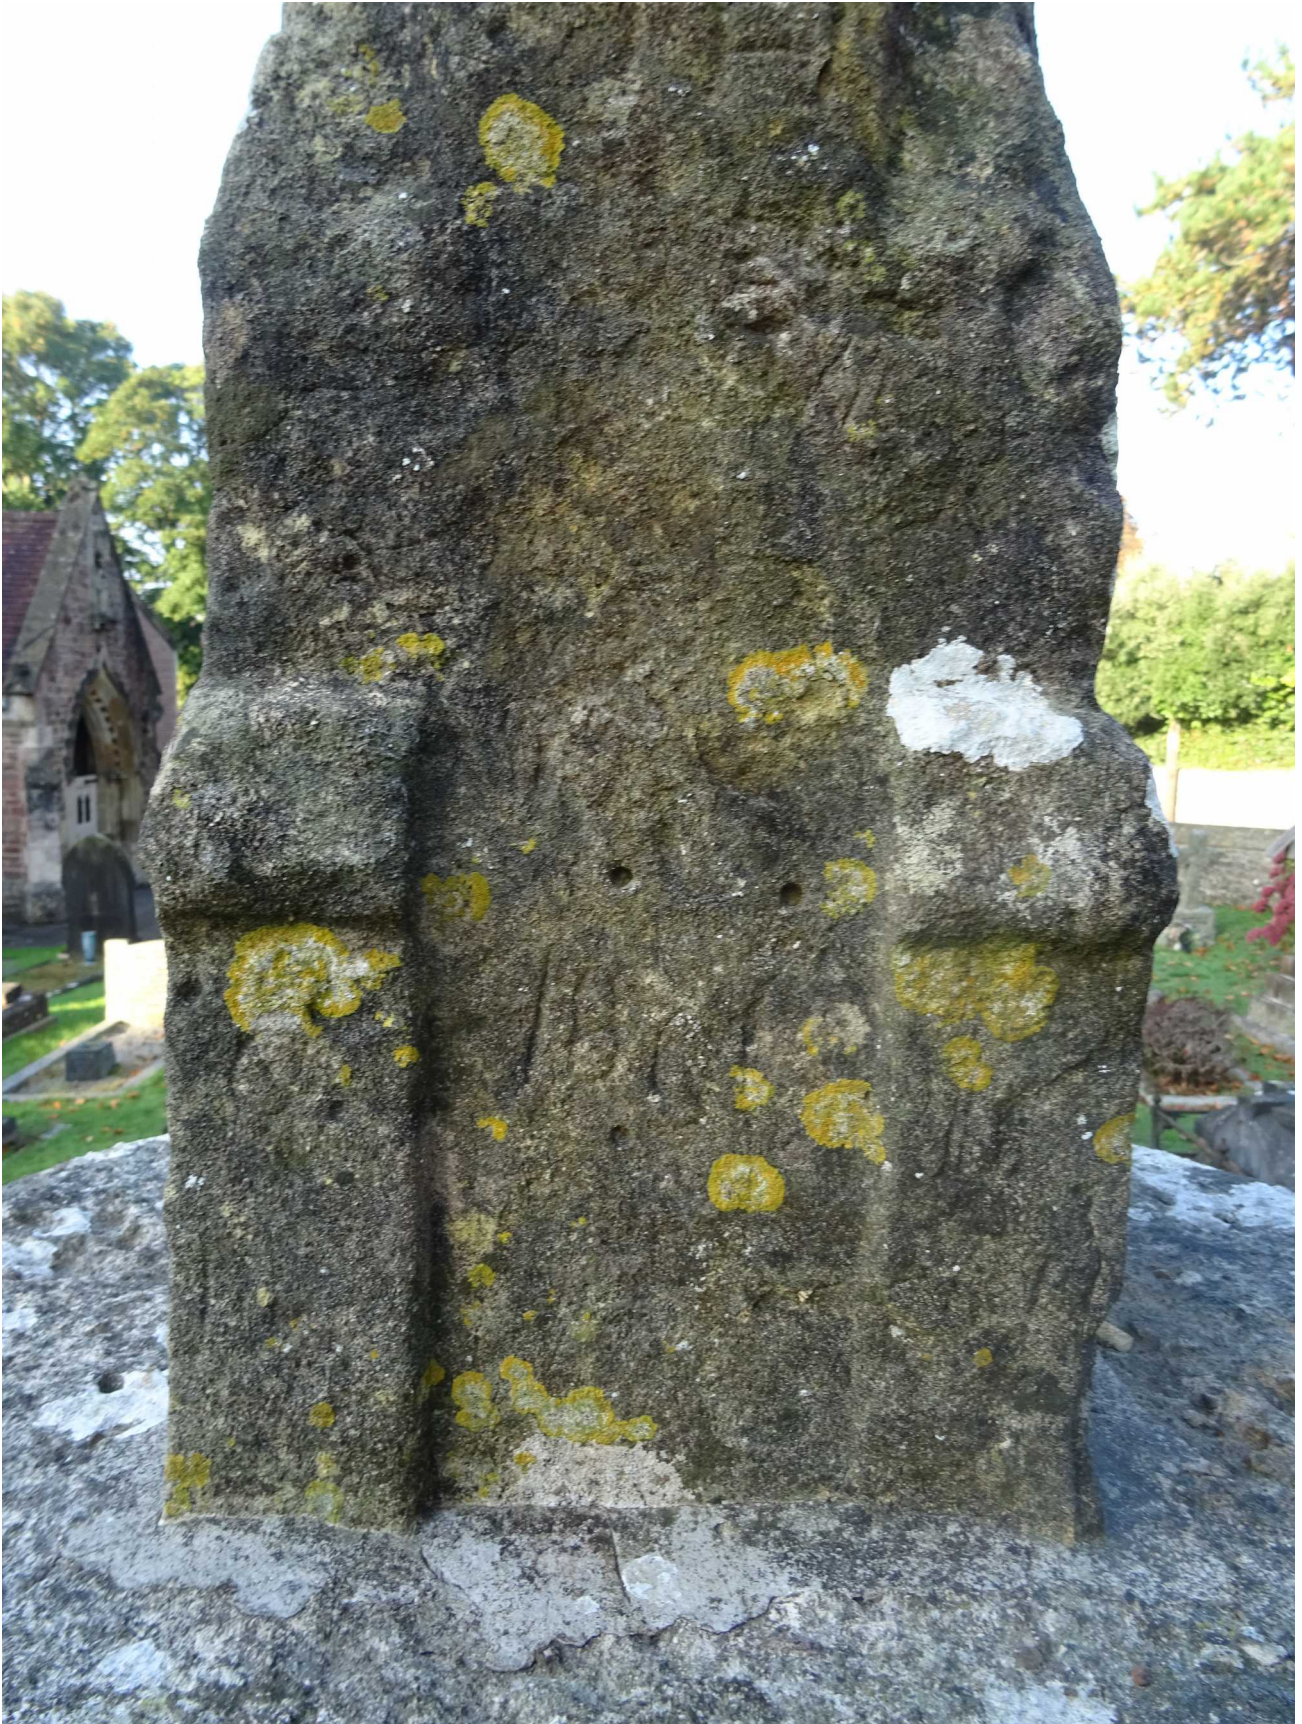
Clevedon 3 did not emerge unscathed from its centuries in an abandoned churchyard: graffiti of the date 180(?1) can be seen on the shaft (Fig 15 below).

I imagine this was an eerie place at dusk, and whoever made this graffiti may have been looking over their shoulder, since the cross was still in its original place.

Fig 15: Graffiti on shaft from a date when the churchyard was still abandoned (taken 2018)
