Fight or flight? An introduction to recent coastal change at Woodspring Bay

**YATTON, CONGRESBURY, CLAVERHAM AND CLEEVE ARCHAEOLOGICAL
RESEARCH TEAM (YCCART)**

Clevedon, Kingston Seymour and Wick St Lawrence, Documentary and photographic study, Woodspring Bay, 2023, Y13, v1.

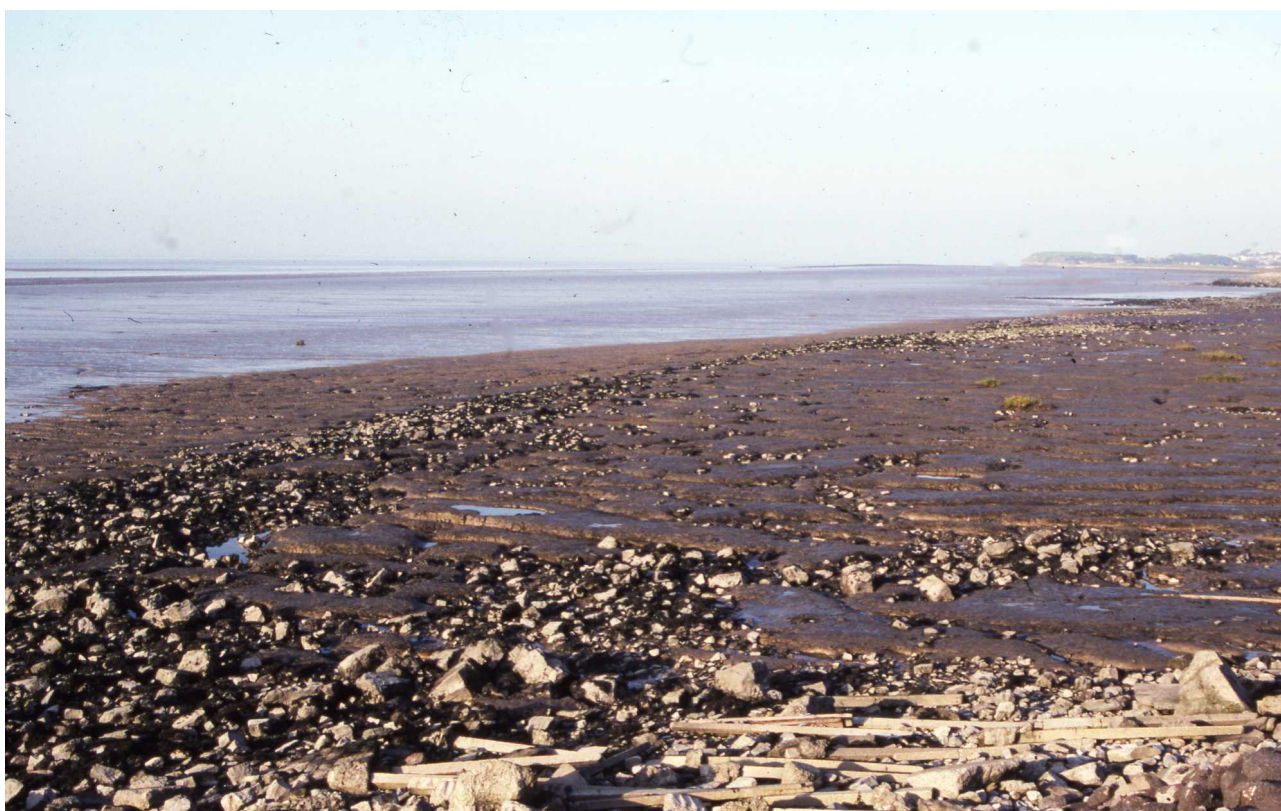
The rubble remains of a former sea defence runs along the shore of Kingston Seymour

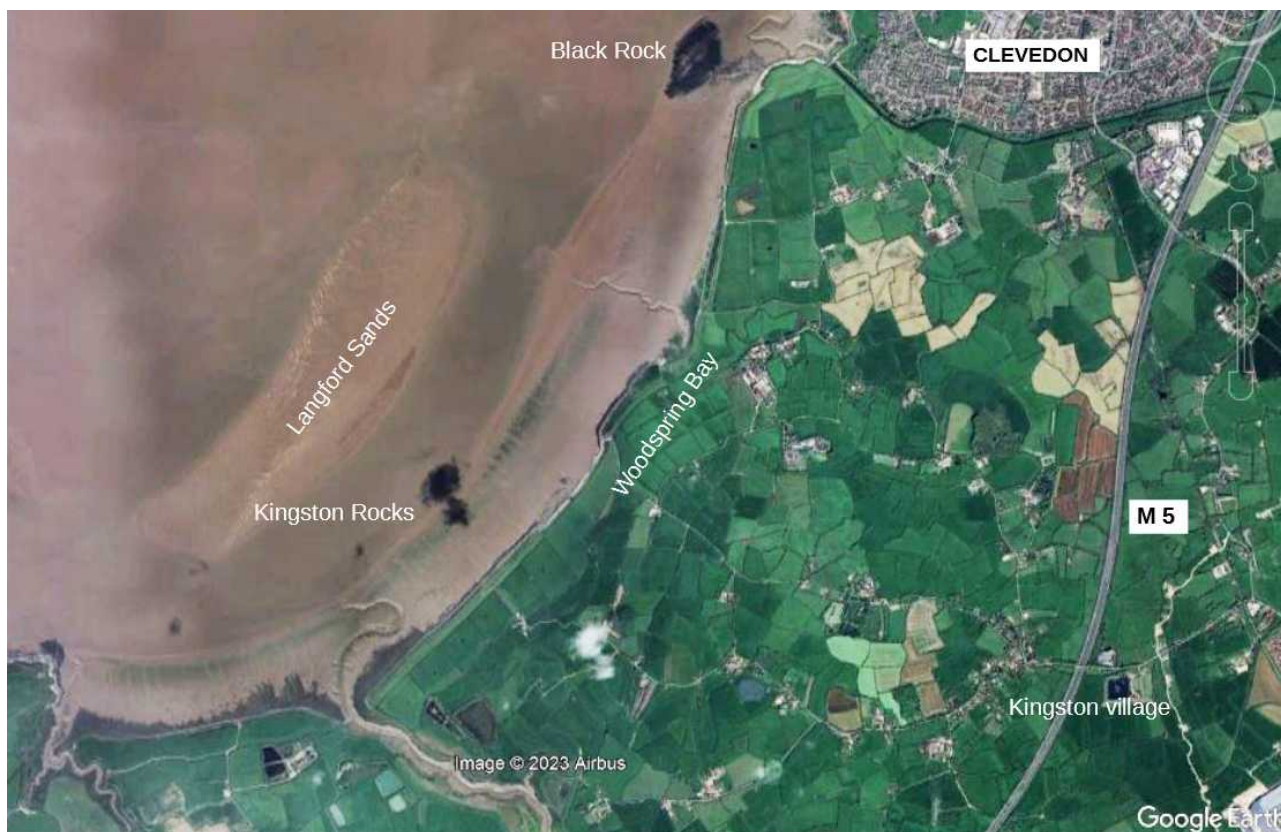
Fig 1: Woodspring Bay

Woodspring Bay is a natural embayment of the Severn / Bristol Channel, running some 5.5km as the crow flies, from the limestones of Sand Point (Kewstoke) to Wains Hill (Clevedon). It lies midway along the North Somerset coastline between Weston-super-Mare and Portishead, its central point at the northern end of Hurdiches in Kingston being at ST38006821.

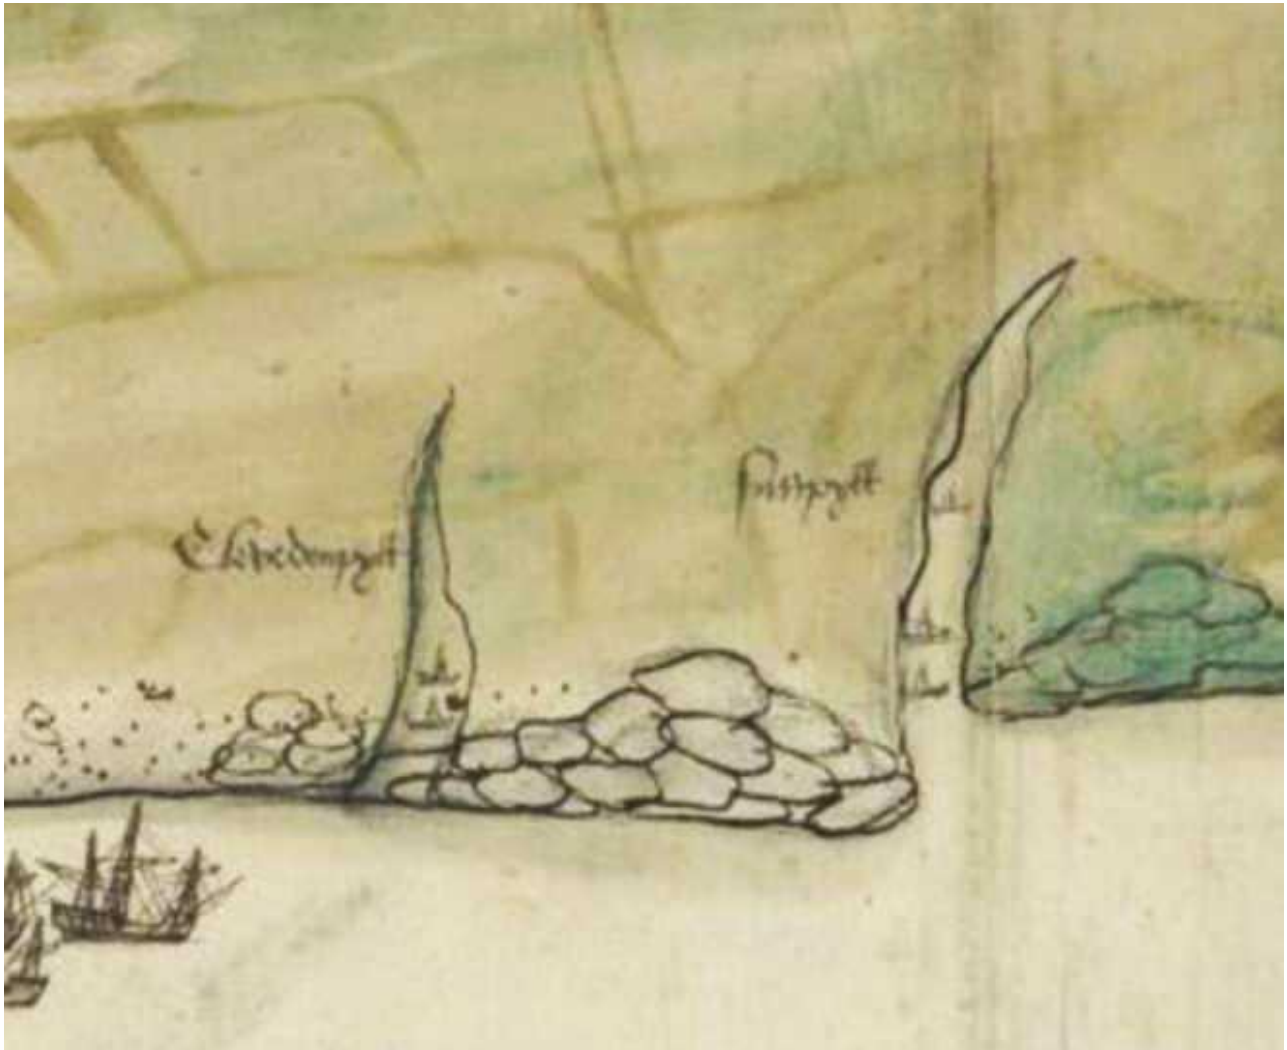
Fig 2: Part of 'The Coste of England uppon Severne' map

This shows *Clevedonpyll* (left) and *Suttpyll* (mouth of Kenn River) to right, with the land between being part of Woodspring Bay. Intriguingly, the map shows piles of rocks on the coast between the two (the same system is used to depict rocky shores at Portishead and Watchet). The map is clearly derived from a sea-borne position, so this represents the visual impression of the Clevedon and Kinsgston shores (that for Wick is far more difficult to interpret).

Is this an impression of mid-16th century sea defences? Without further work, we cannot be sure where this line lies with respect to the modern shoreline.

The earliest images we possess of this coast are from the 'Coste of England uppon Severne' map of c 1539, apparently planning coastal defences that were never built (YCCCART 2019) (Fig 2 below).

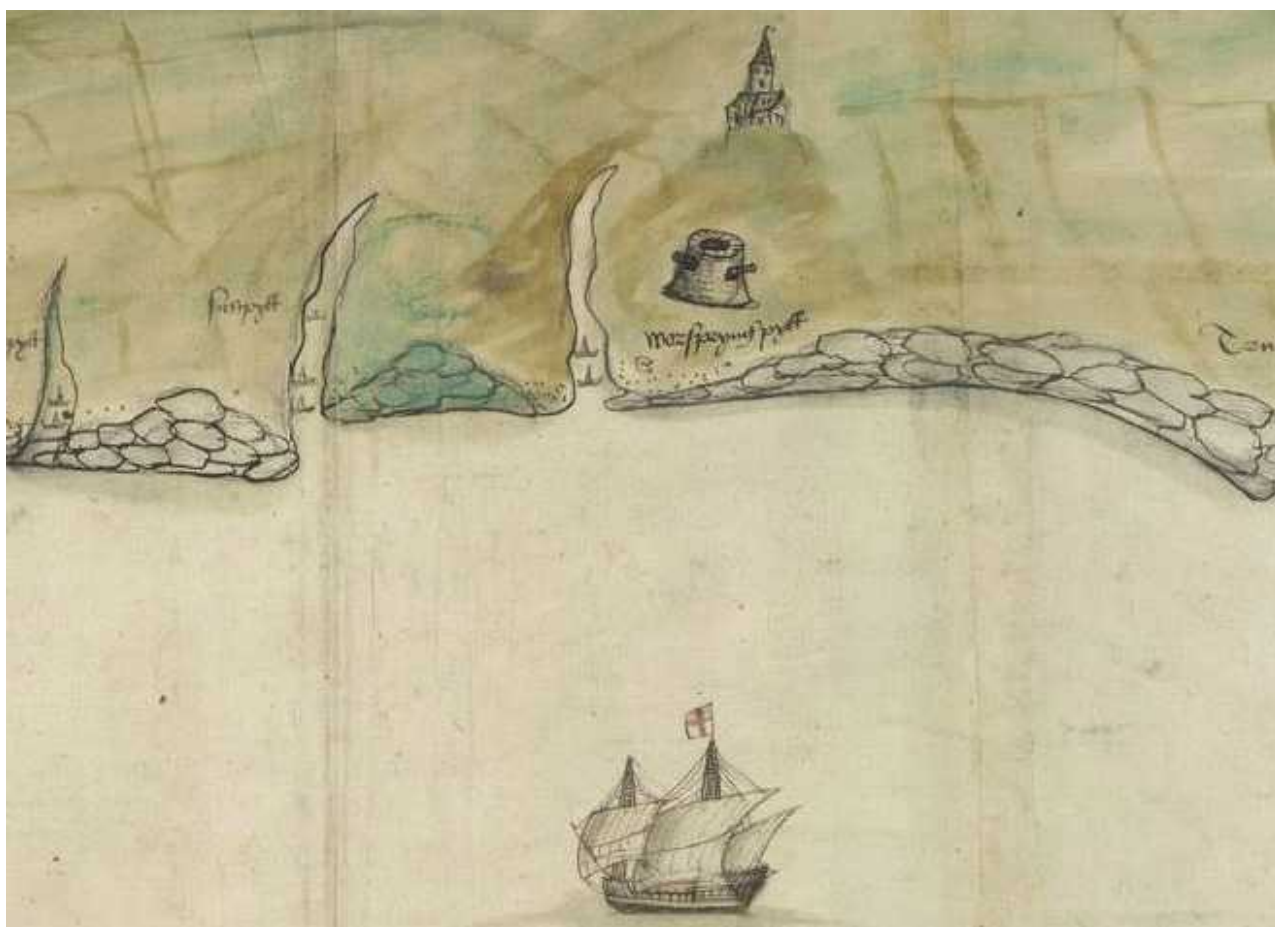
Fig 3: Suttpyll to Sand Point, 1539

Further down the coast (Fig 3), the area between *Suttpyll* and *Worspryngs pyll* is also shown to have some kind of sea defence (the tower with guns above Woodspring Pill seems never to have been built). In view of some later evidence (see below), it is possible that this represents earthen (painted green on the map) banks, just possibly those at the rear of Hurdiches in Kingston (or possibly, Wick Warth).

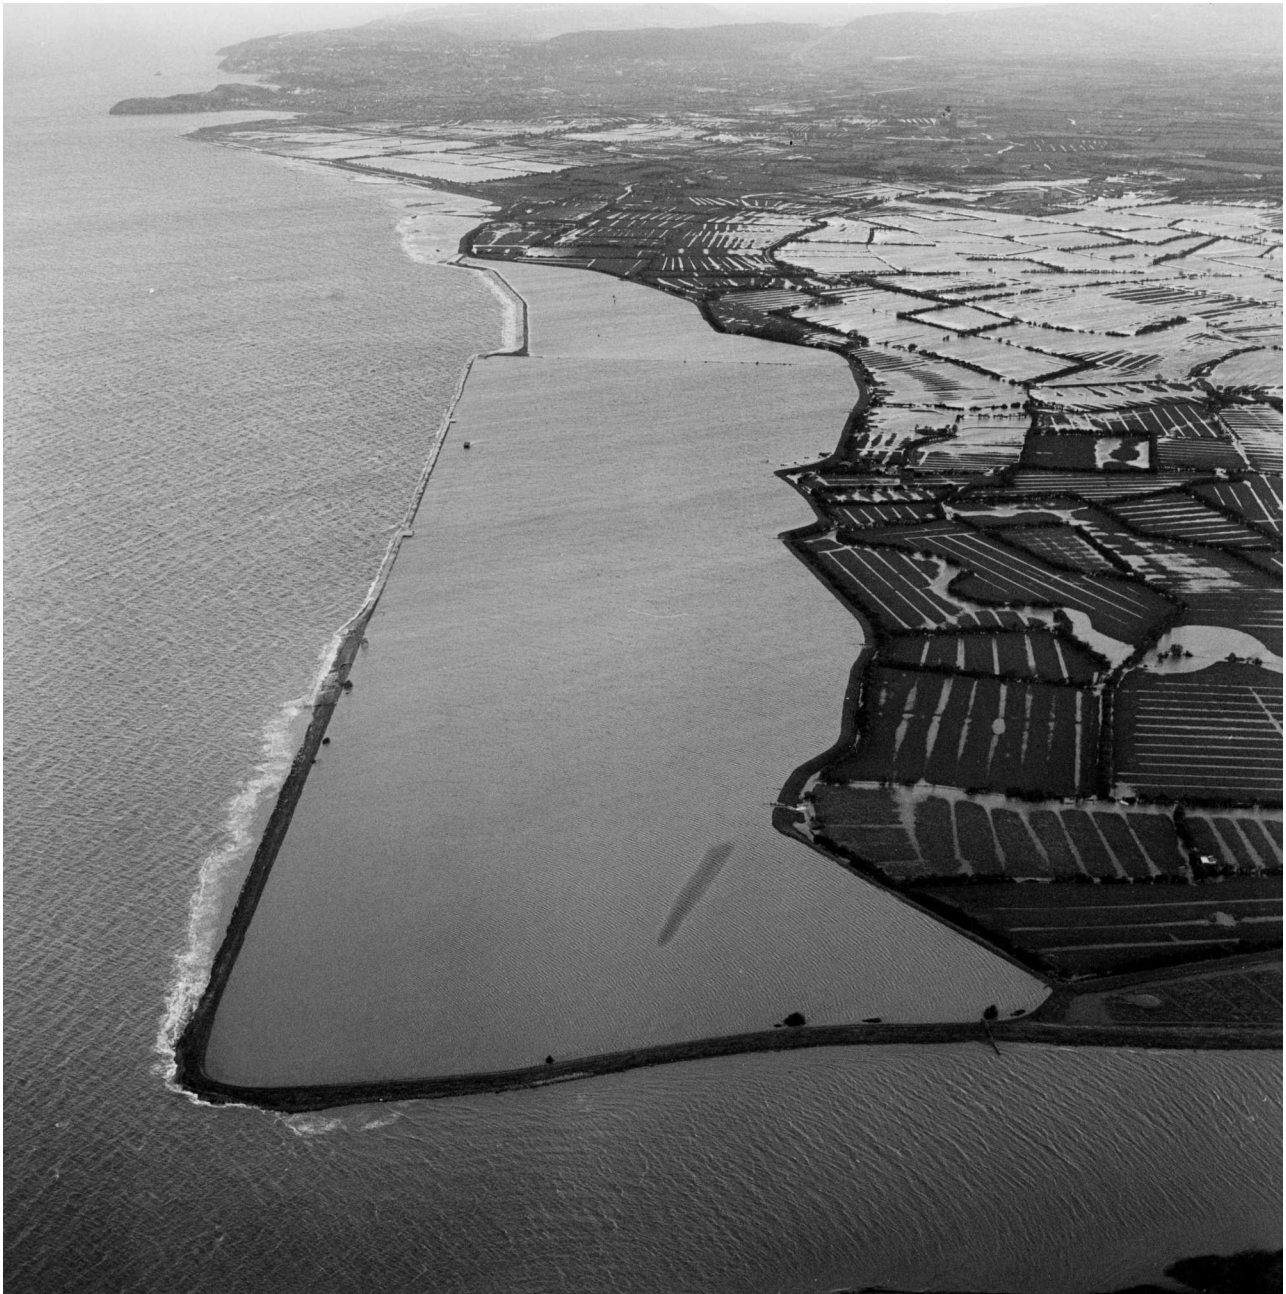
Fig 6: Hurdiches acting as flood reservoir during winter 1981 (Environment Agency)

Although the reservoir was clearly not capacious enough to store all the excess water, it is obvious that much that might have spilled into agricultural land and dwellings in Kingston was held back.

Incidentally, the area continues to perform a useful anti-flood option:

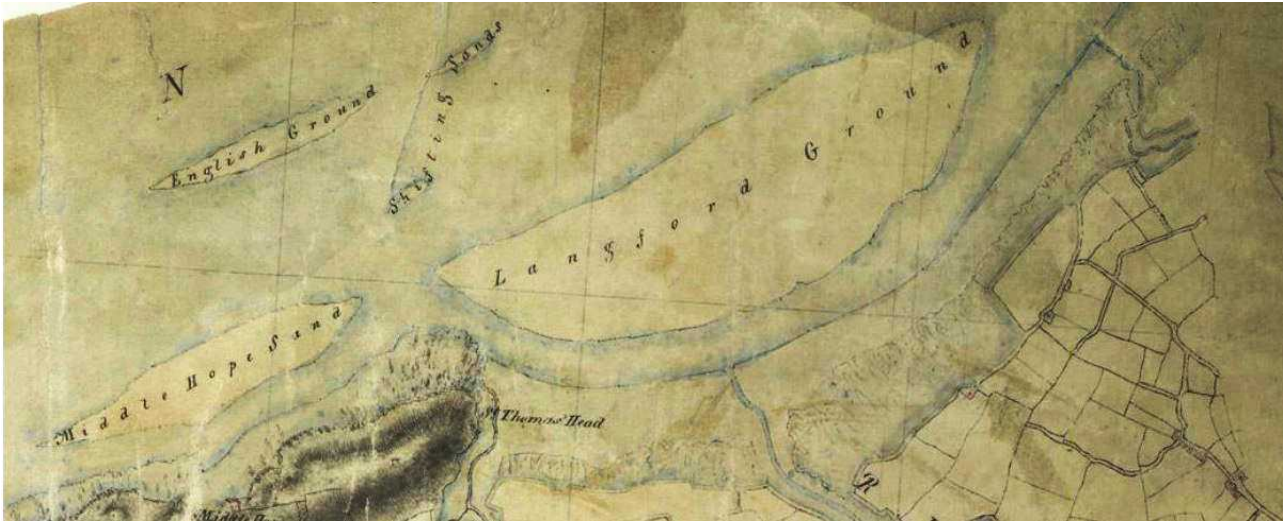
Fig 7: Southern end of Woodspring Bay from OS 1st draft, showing sea banks and shore defences

Next in time are the OS 1st draft maps of 1809 and 1810 (British Library). By their nature, these are slightly impressionistic views of the land, and show a similar situation to that implied by the Kingston 1784 map.

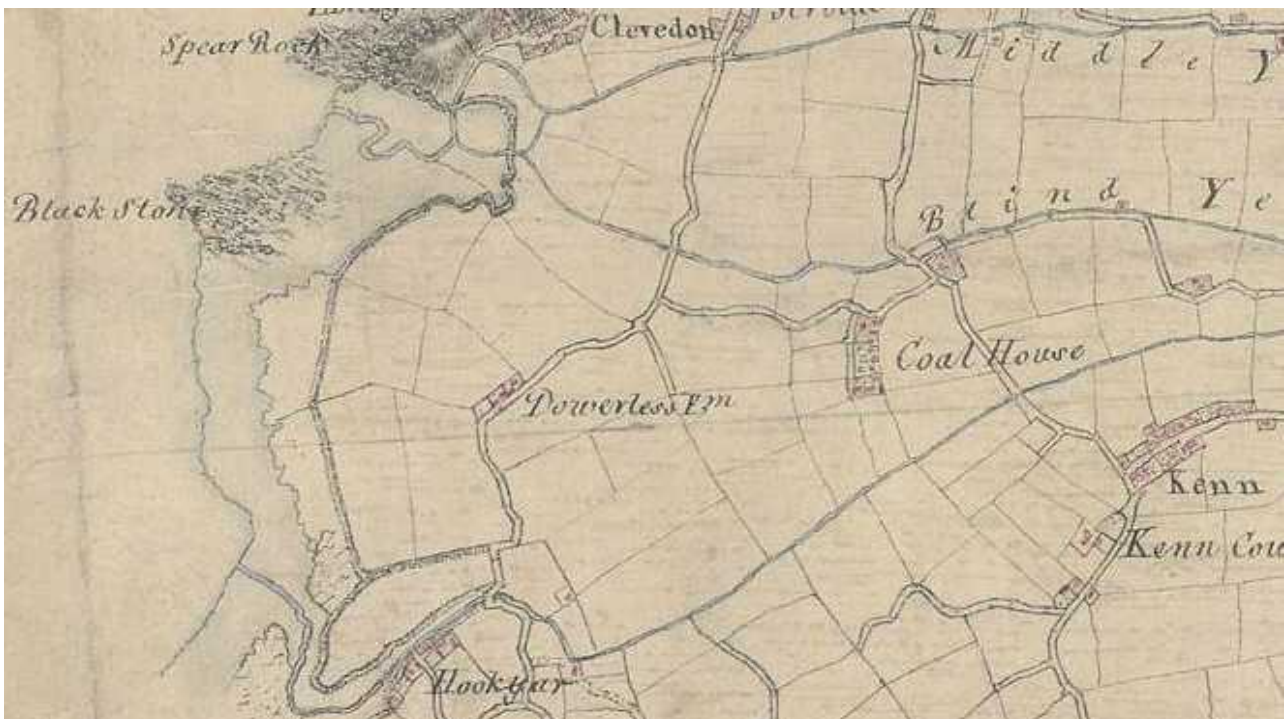
Fig 8: Northern end of Woodspring Bay from 1st draft, with 'Black Stone' and shore defences

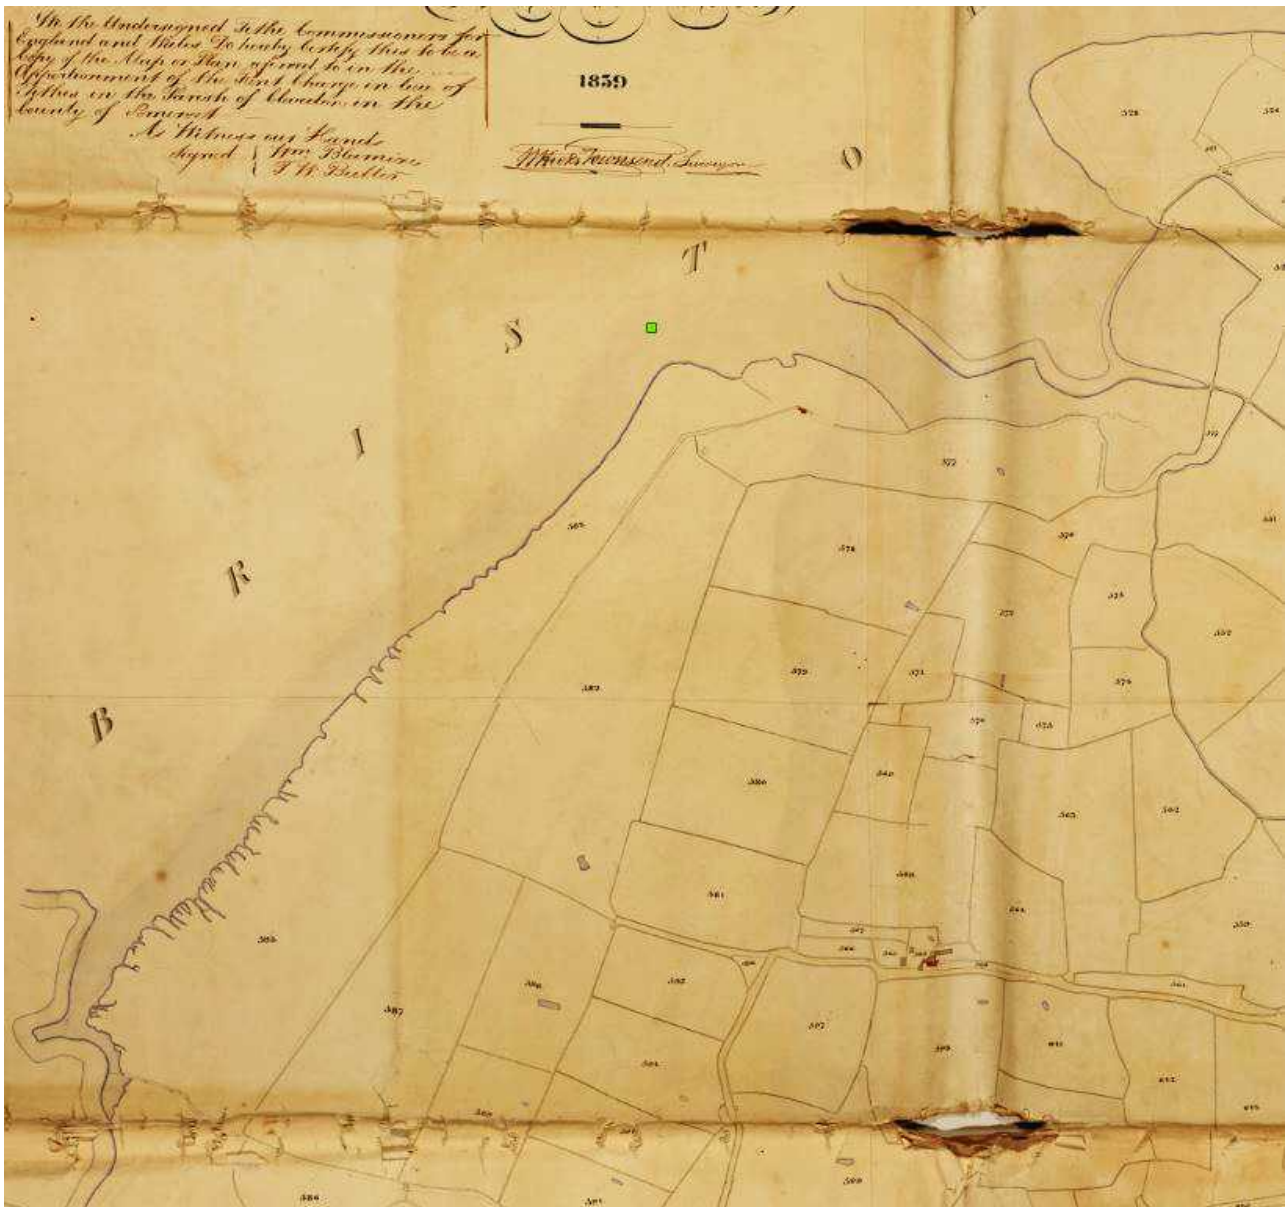
Fig 12: Clevedon coastal strip from Tithe Map 1839

The Clevedon Tithe Map of 1838 (Fig 12 above) shows the contemporary sea defences as a normal field boundary, with the current ones set back slightly. There is, however, a substantial warth outside of this, seemingly somewhat reduced by today, although this process can be seen in action as early as the Epoch 1 OS plan of c1885.

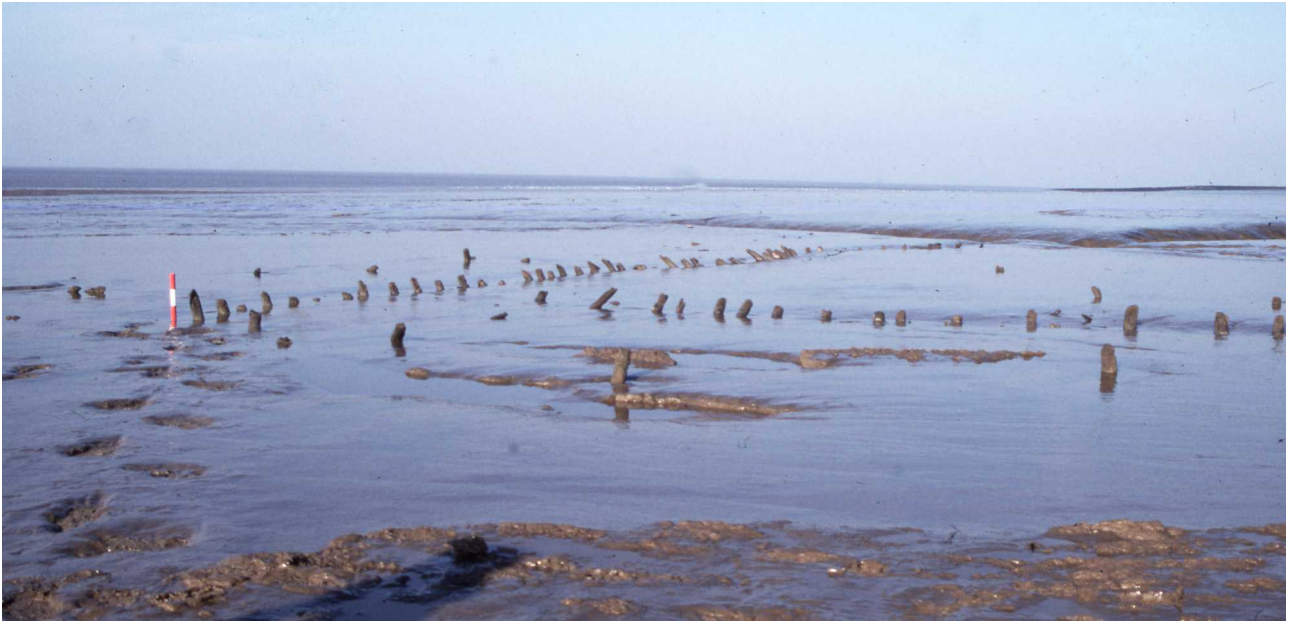
Fig 15: Offshore V-shaped fishtrap at Kingston Seymour: Kenn river channel in background

This coast shows signs of V-shaped basket and other fishtraps (Figs 15; 16). It is always suggested that such traps are set at the edge of the modern warths / saltmarsh, both in Europe and the New World (Lutins 1992). Since Hildich recorded what are in effect, two lines of traps at different heights on the beach, this might well be interpreted as former saltmarsh edges, something which might be clarified if sufficient C14 dates could be obtained from the timbers in the traps. Other forms of fish traps, such as putcher rows, and basket rows are also evident in the intertidal zone: lines of stones that might be the net weights that are all that remains of others, can also be seen.

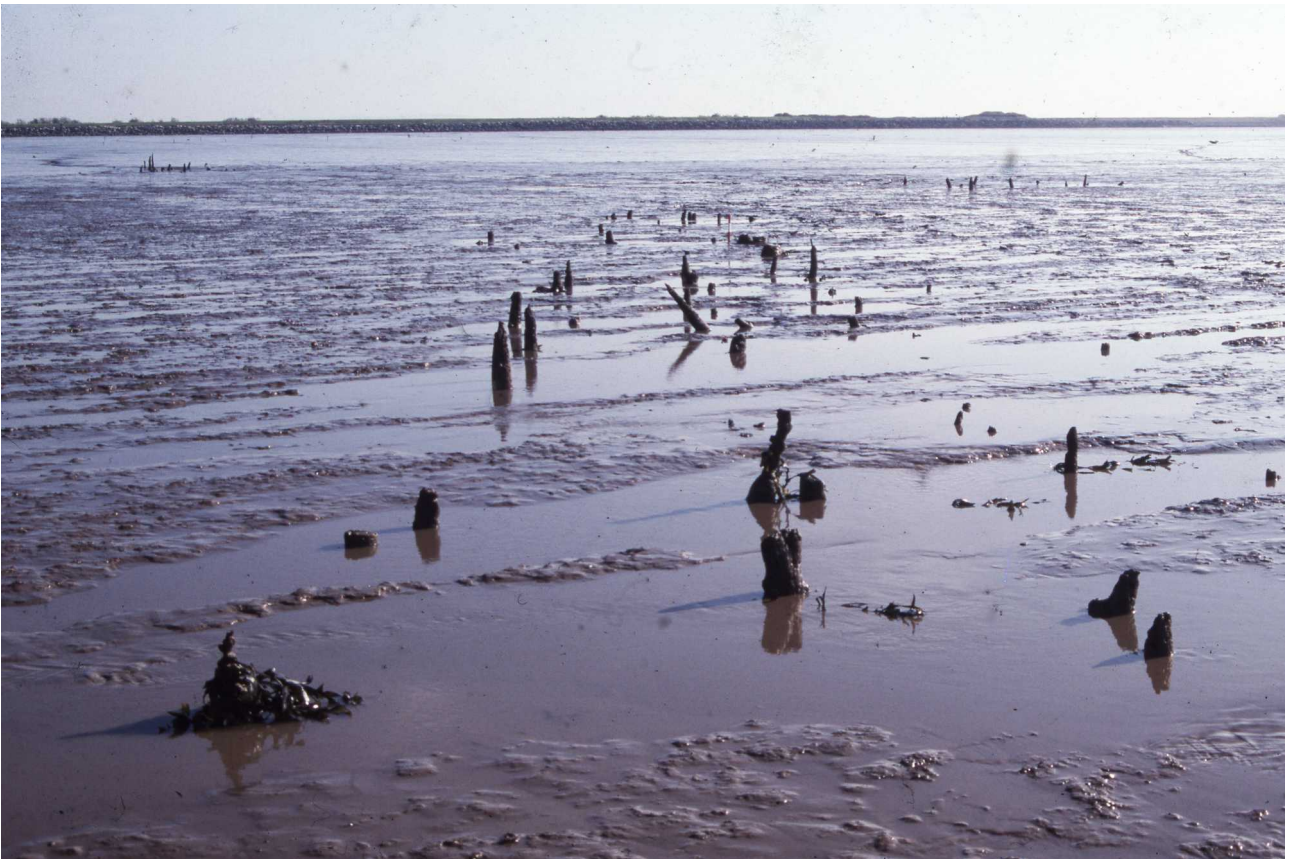
Fig 16: Remains of offshore putcher (longbasket) row, Kingston Seymour

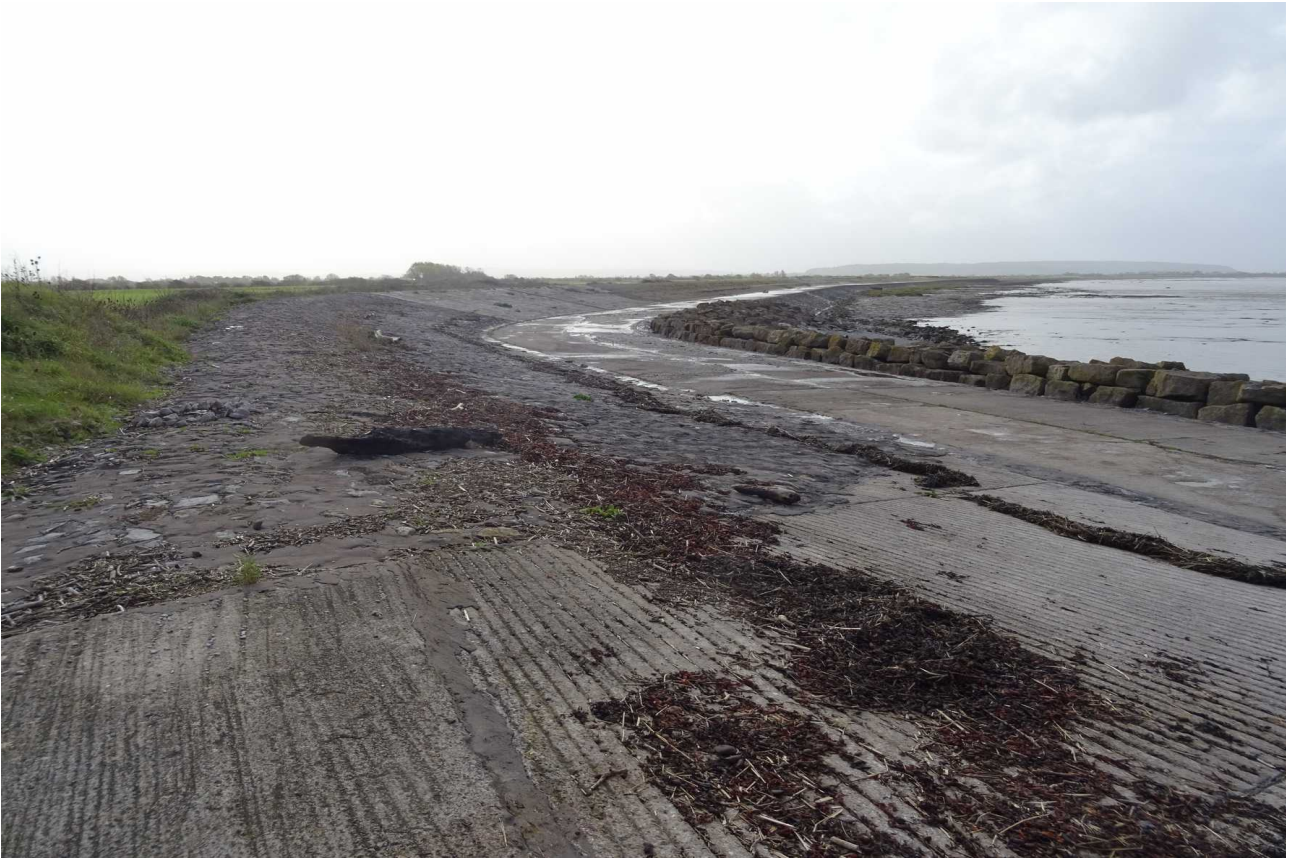
Fig 17: Hurdiches, Kingston, with modern concrete sea defences. Note the immense width.

Current coastal defences are generally huge, concrete and not particularly photogenic, but their protective function is critical to life in the three parishes.

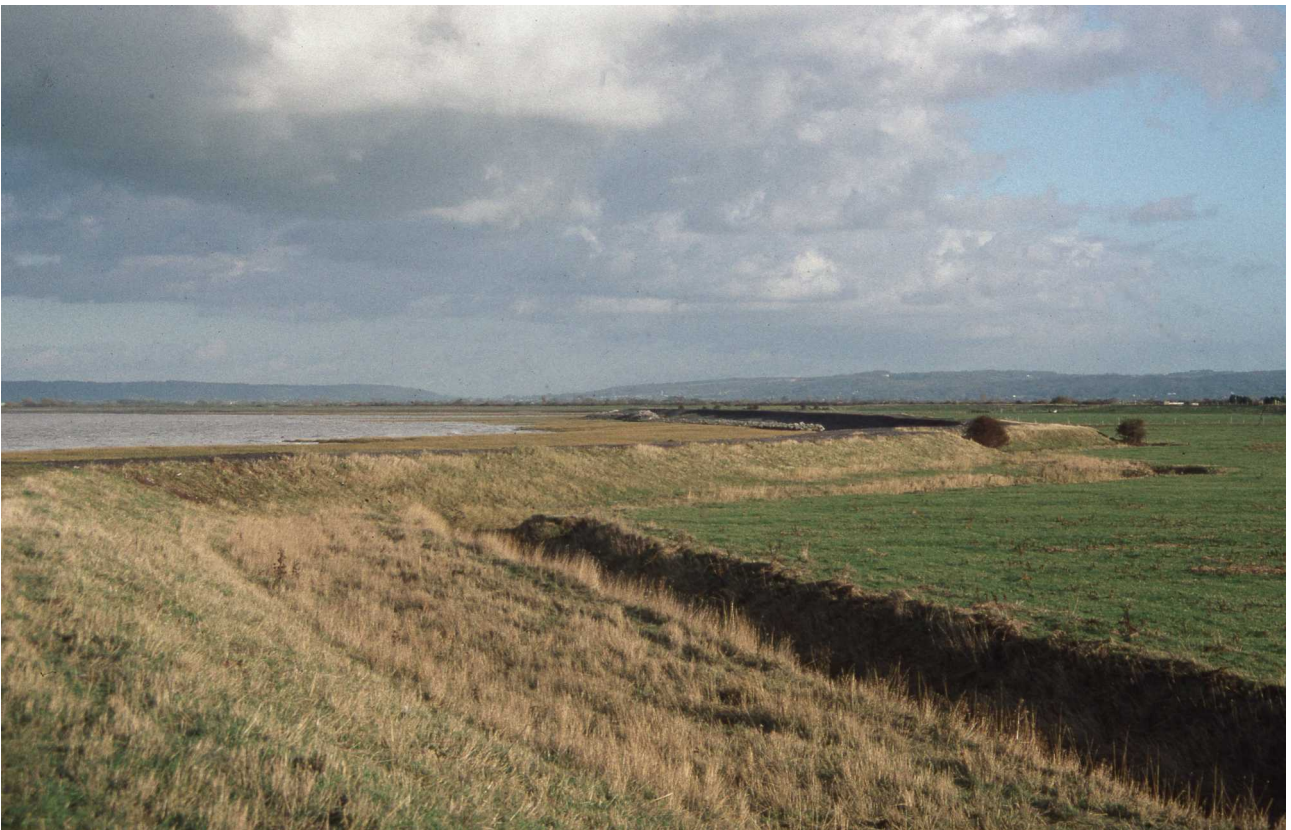
Fig 18: Wick Warth earthen sea defences

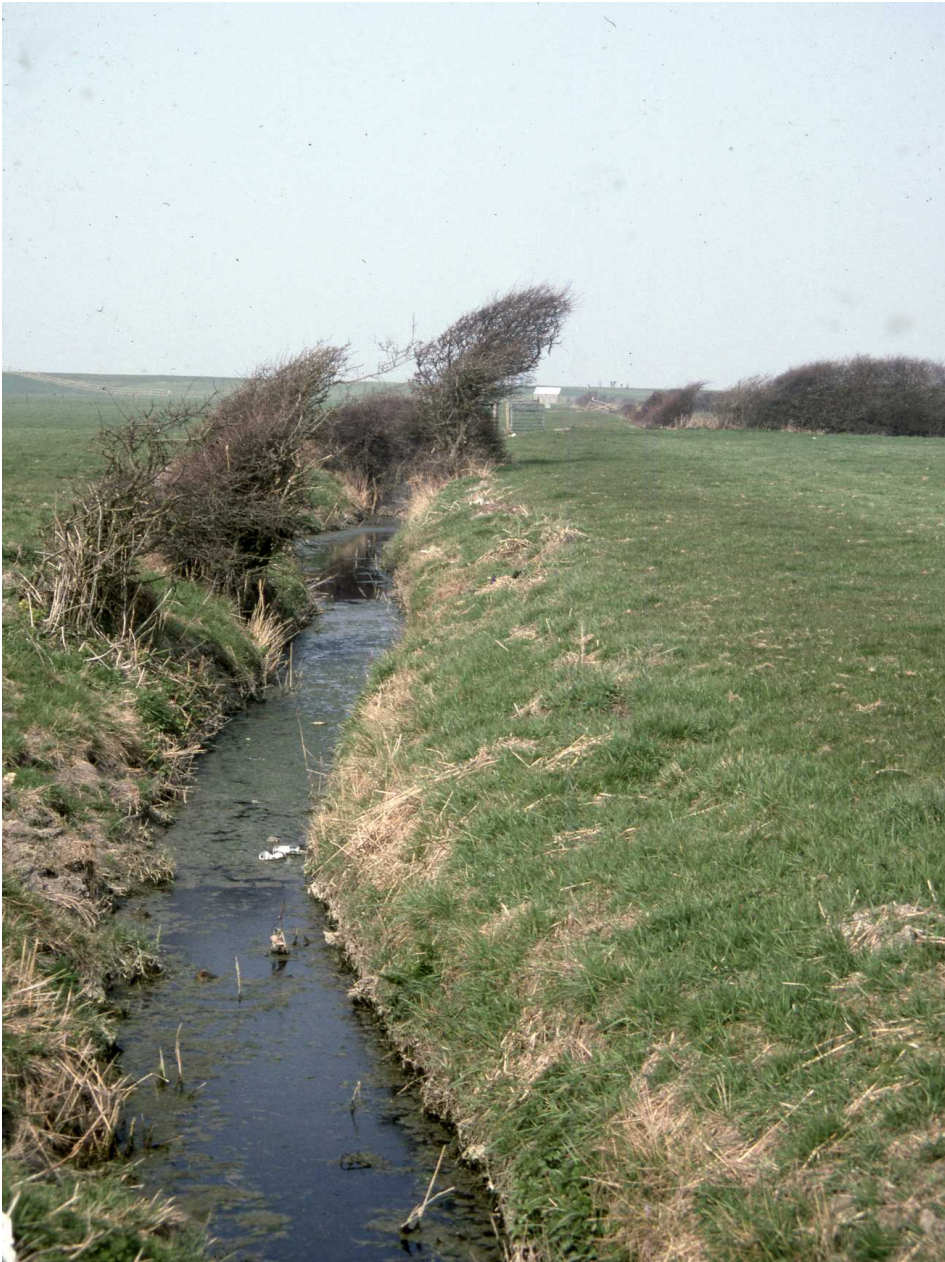
Fig 19: Parallel ditch system at Dowlais farm, Clevedon, marking a possible former sea defence

Some of the potential earlier sea defences (such as the ditch systems at Dowlais Farm, Clevedon) no longer possess any accompanying earth banks, although other origins for these ditches parallel to the modern coast all seem less likely.

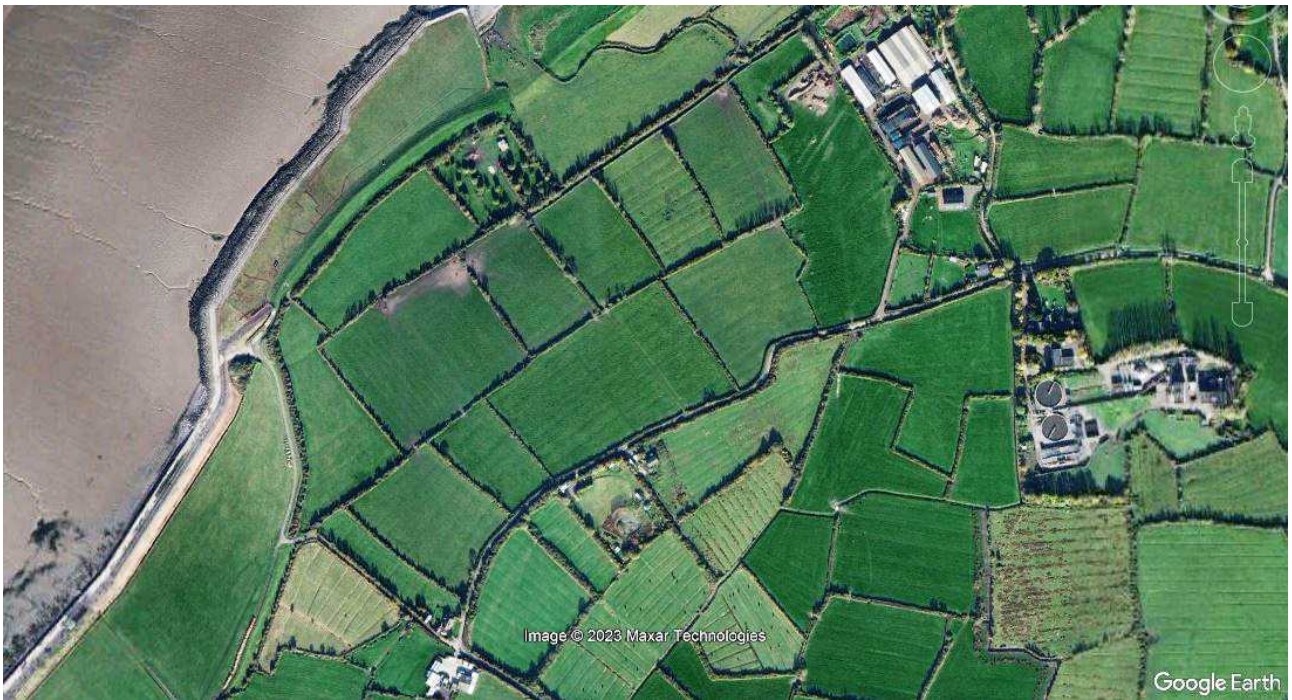
Fig 20: Five landscape lines parallel to the coast at Hook's Ear, Kingston Seymour

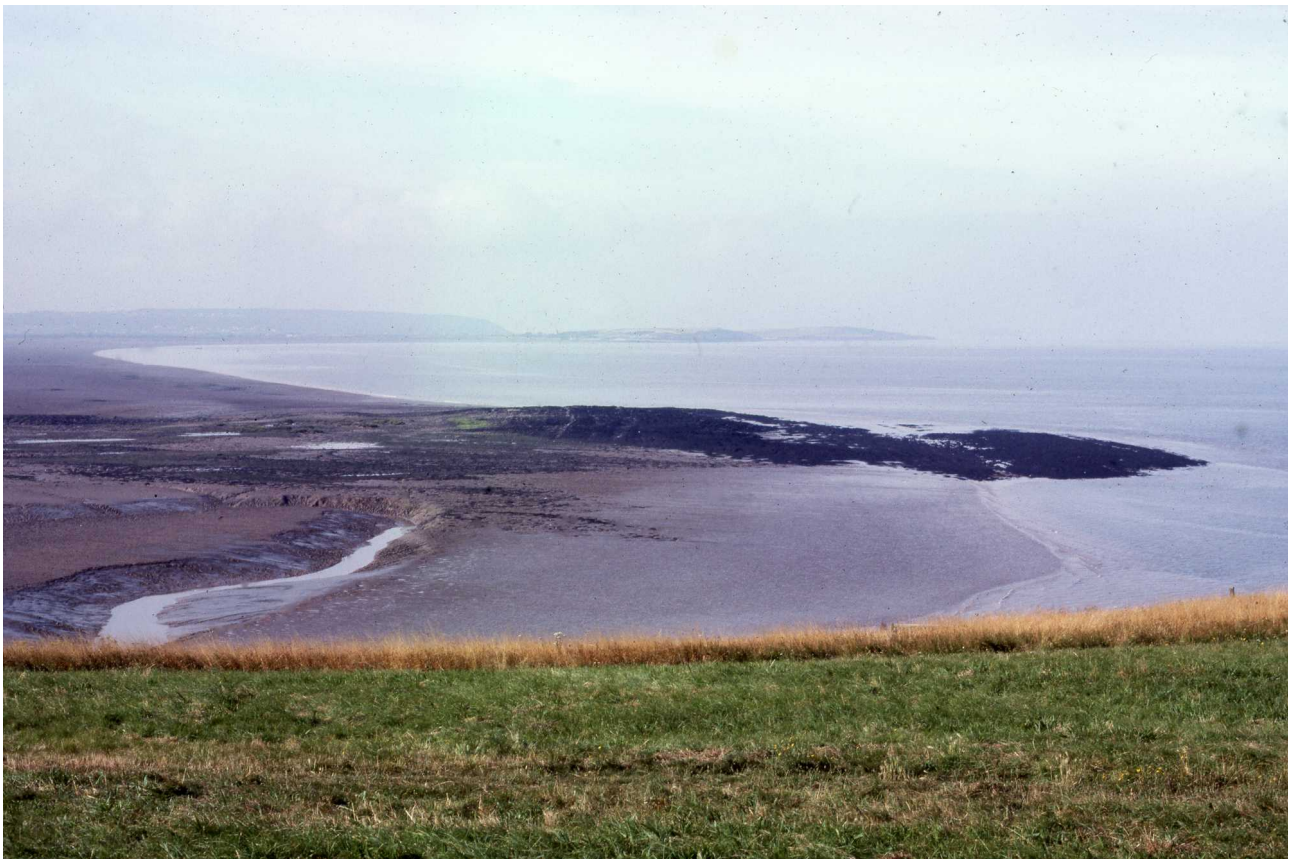
Fig 21: Black Rock, in the intertidal zone at Clevedon Pill: was this rock denuded by the recorded marine incursion of 1667?

Mr Green's story (above) also illustrates the changeable nature of the shoreline in Woodspring Bay: could this have been the episode that unearthed Black Rock?
