YCCCART 2021/Y7

A Second Woodspring Miscellany

**YATTON, CONGRESBURY, CLAVERHAM AND CLEEVE ARCHAEOLOGICAL
RESEARCH TEAM (YCCCART)**

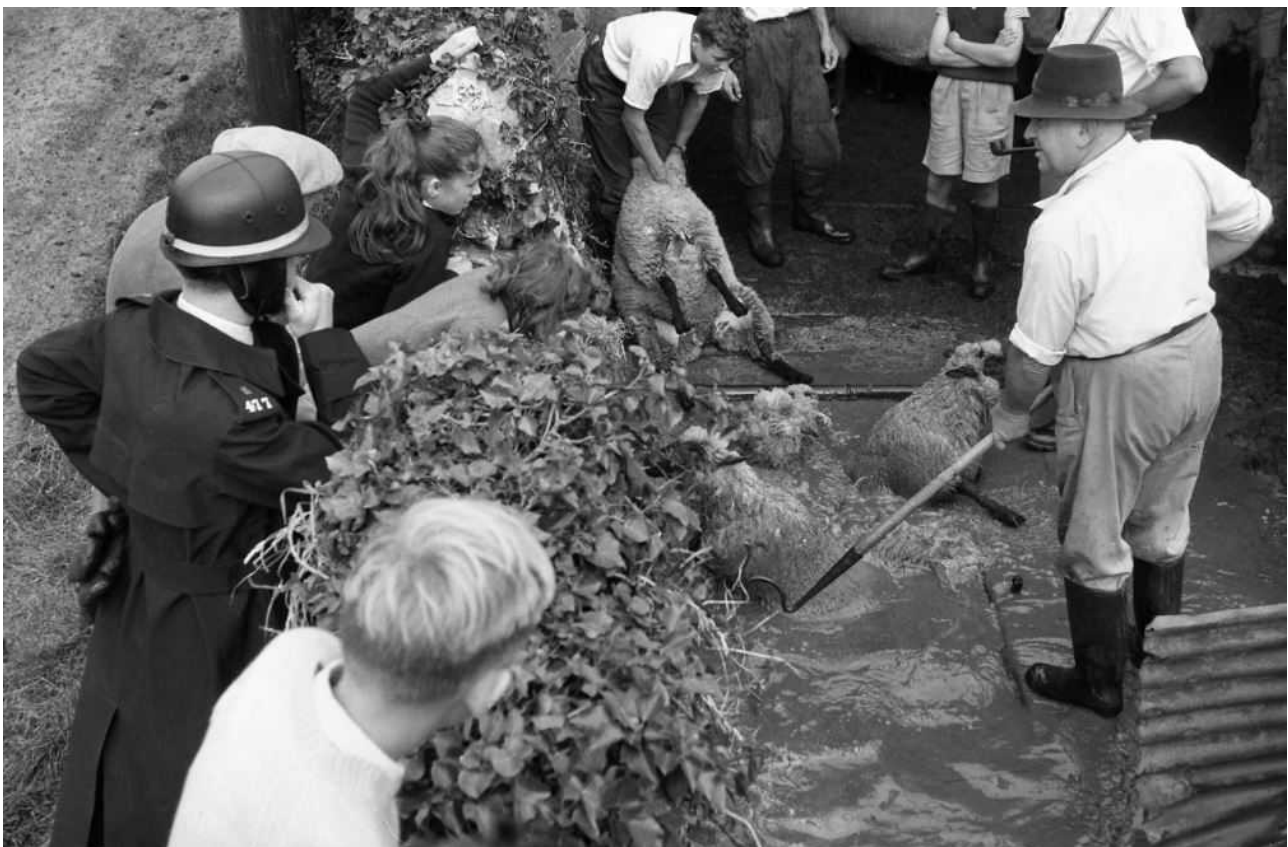
Fig 7: A sheepwash in action

A stream or small river would be temporarily dammed to increase the depth of water, and the sheep basically pushed in.

There they would be kept for a few minutes, occasionally being pushed completely under the water with a special long-handled instrument (see Fig 7 above). This was also an opportunity, when the shell-shocked sheep clambered out, to examine them closely for injuries or flystrike (don't ask), and to deal with it: this is what the lad with the sheep squatting on its haunches is doing in the above illustration.

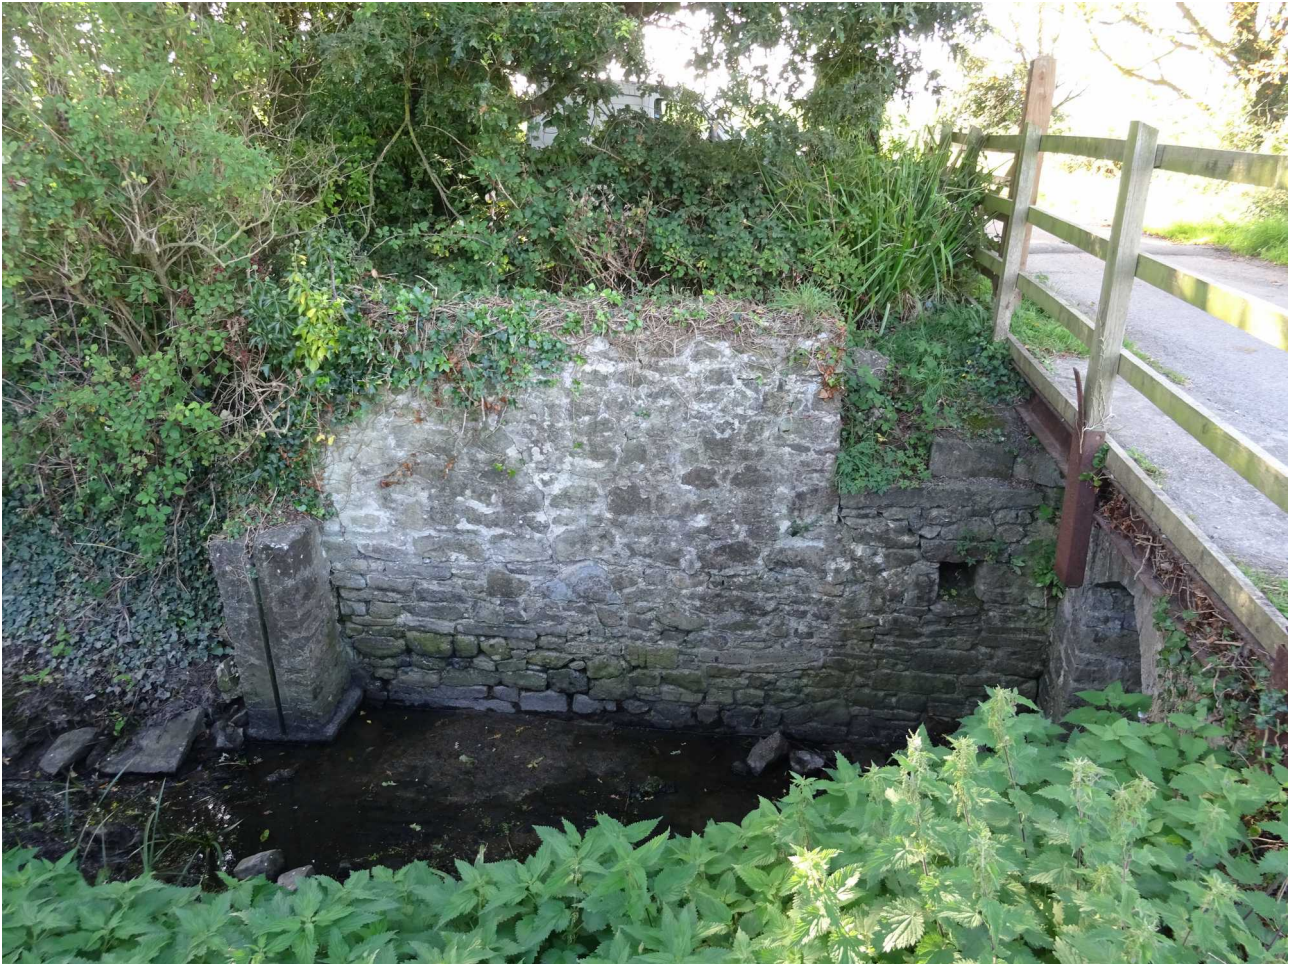
Fig 9: Structures of the sheepwash

In the above figure, the round-headed arch of the bridge can be seen (R), and adjacent to its wall, the platform from which the sheep would be pushed into the dammed stream.

On the other side of the sheepwash (L) can be seen a (later) socket for a sliding hatch or board to temporarily increase the depth of the water: this could be raised from time to time to flush out the dirty water and start again.

The sheep would be brought to the enclosure in small batches (more than one or two in the water at a time are impossible to handle), and pushed into the water from a platform on the south side of the rhyne (see Fig 9 below).

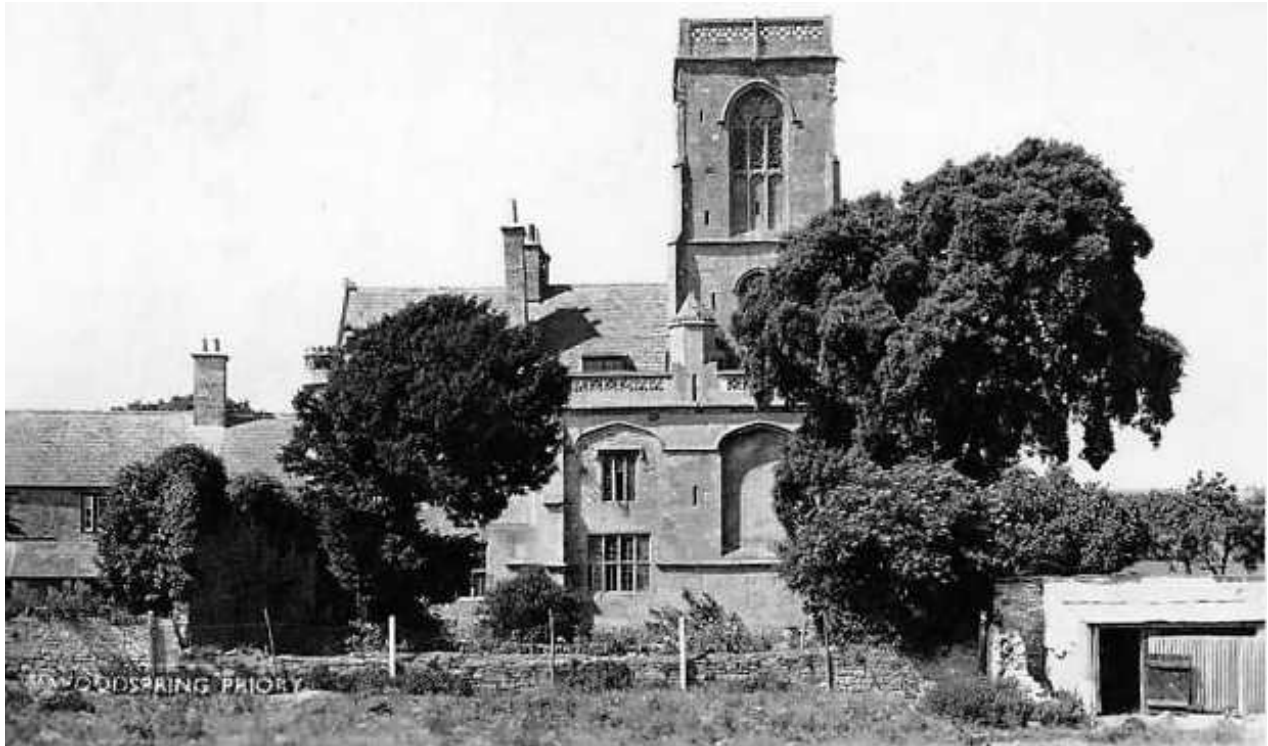
Fig 14: At a slightly later date, the earlier shelter building has been removed, leaving a stub of wall.

On oblique air photographs of 1949, the remains of a concrete floor can be seen in this position.

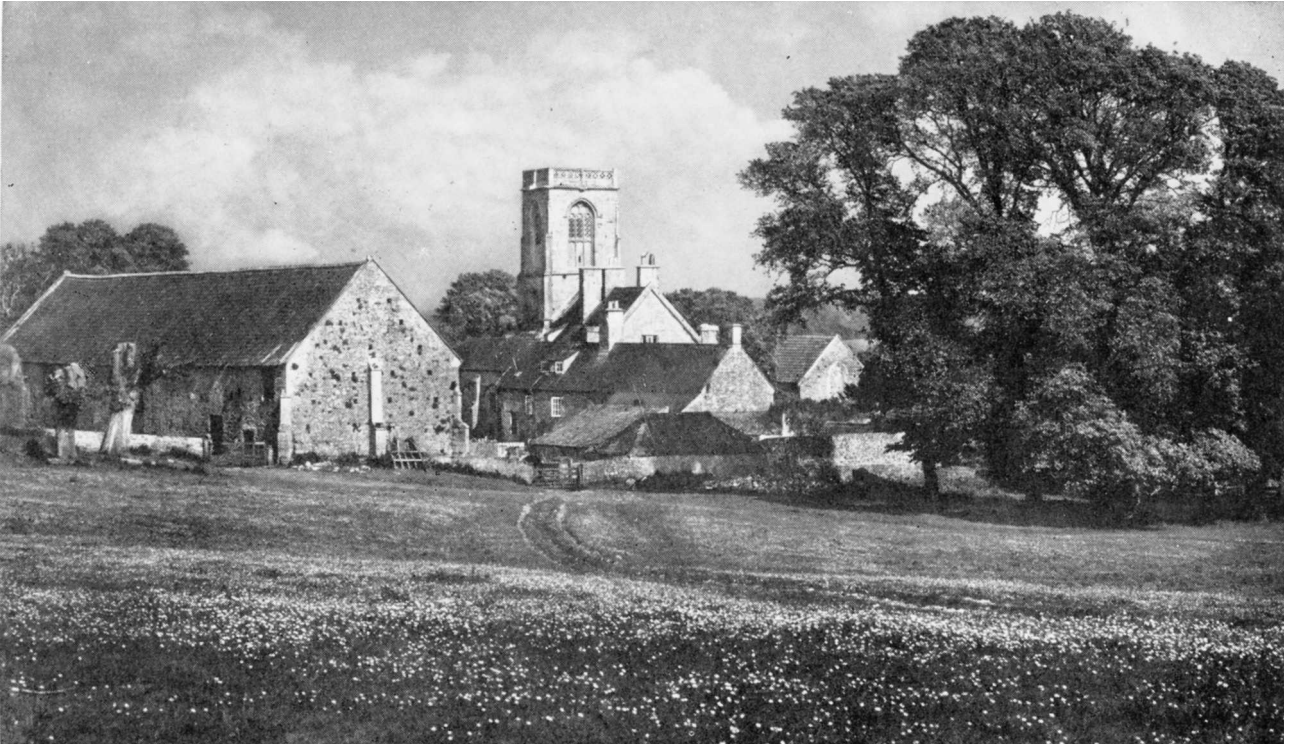
This 1929 view (Fig 15 below) (from Winbolt & Ward 1929) shows the rear of both the barn (which has architectural features never normally remarked on) and the rear outshot on the farmhouse removed by Landmark during renovations in the 1970s and 1980s.

Fig 15: View of Woodspring from the hill, 1929

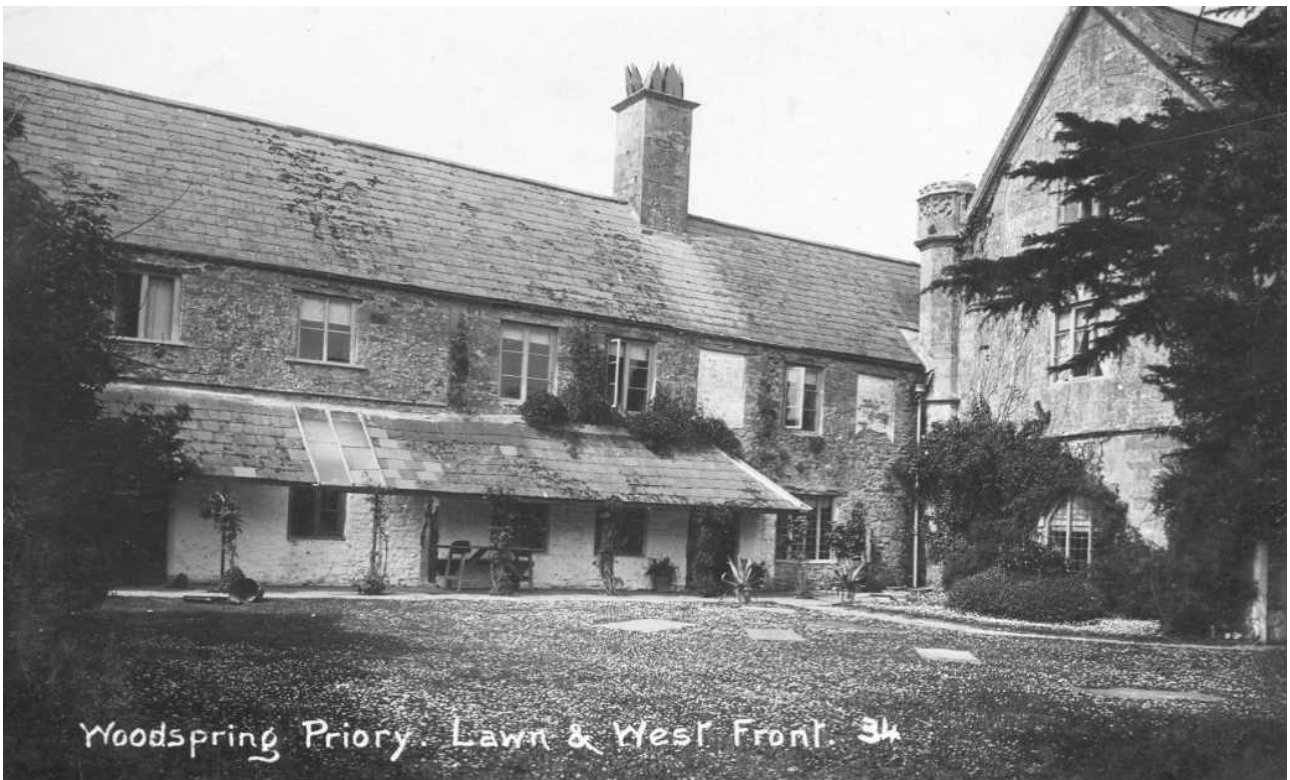
Fig 16: The farmhouse range about the time of WW1

Fig 16 shows the farmhouse, with its Victorian verandah. Significant alterations were made during the conversion of the farmhouse to a holiday let. To be honest, I personally regret the loss of the verandah (but the decision wasn't mine to make).

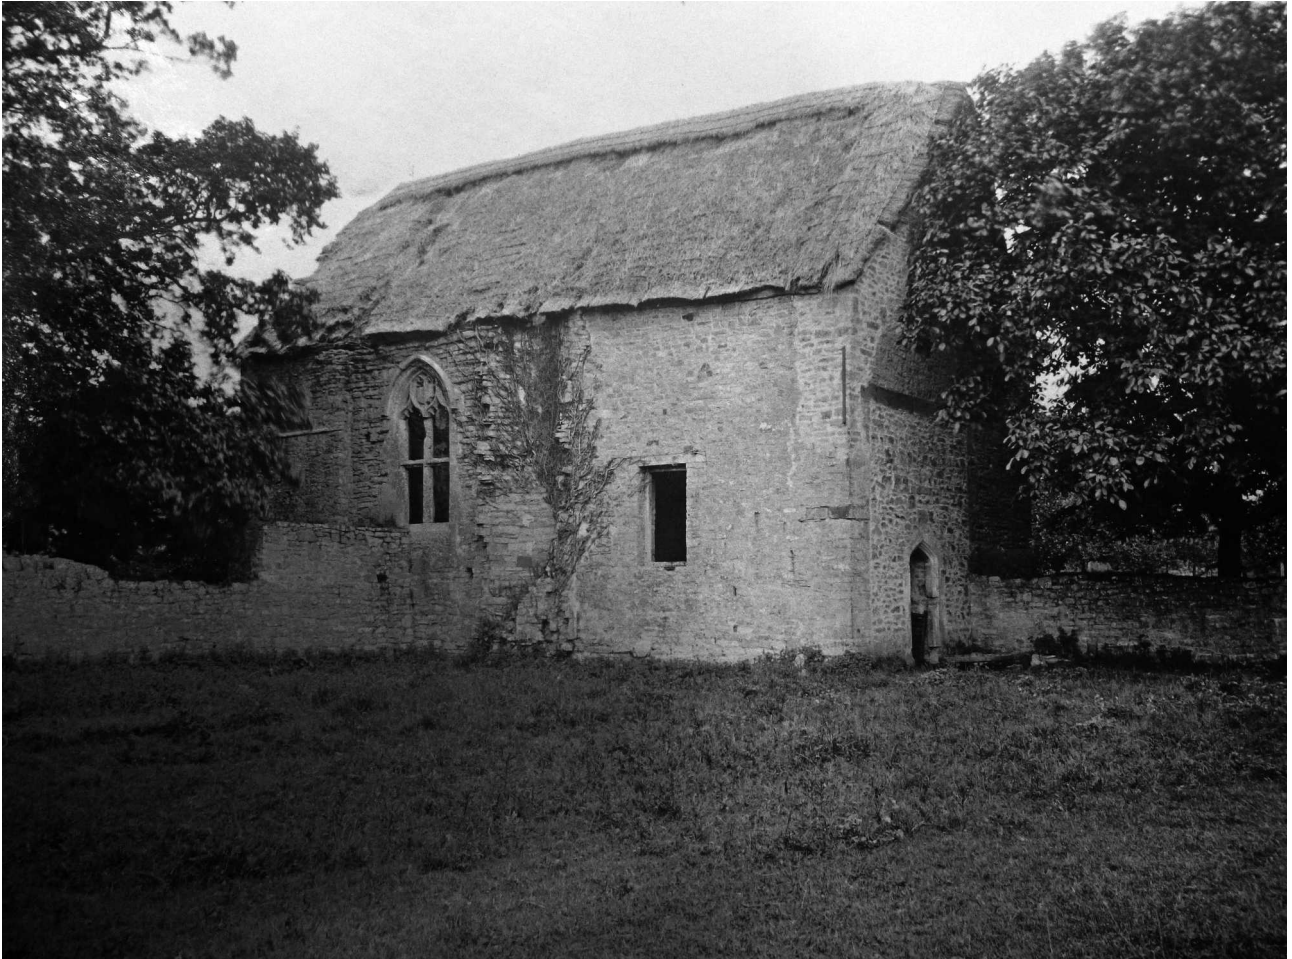
Fig 17: The infirmary (1948)

We know from 19th century accounts that a large hole, topped by a massive wooden lintel, had been made in the east wall for the infirmary to be used as a wagon shed. I had always assumed that the breach had been rebuilt by Landmark, as part of the renovations in the 1970s.

The infill includes what appears to be a genuine medieval stone doorway (there is no figure standing inside the doorway: it's just a pattern of plaster on the interior wall). Further work by Landmark replaced this and the lintel in stone, and the current whereabouts of the door way is unknown. The rectangular opening in the south wall is a 'pitching eye' designed to make loading goods into and out of carts easier. Its outline can

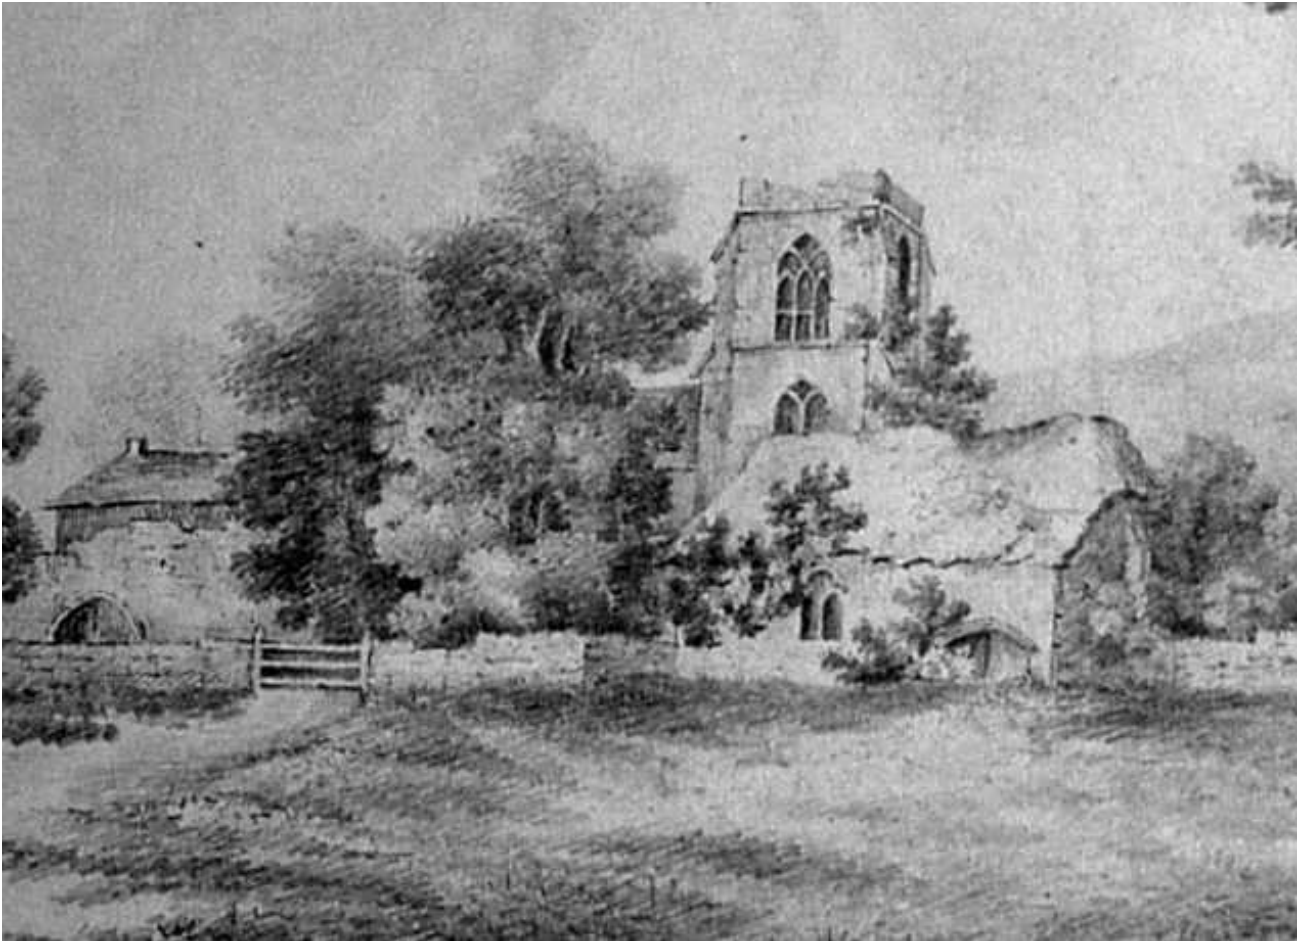
The former presence of this door is confirmed by a drawing of 1818 in the Somerset Archaeological Society's collections (Fig 19) below.

Although this is drawn with typical Georgian misunderstanding of Gothic architecture, it does confirm the main features of the infirmary (oddly, it omits the scar of the spiral stair in the centre of the south wall).

Fig 19: The infirmary and tower in 1818

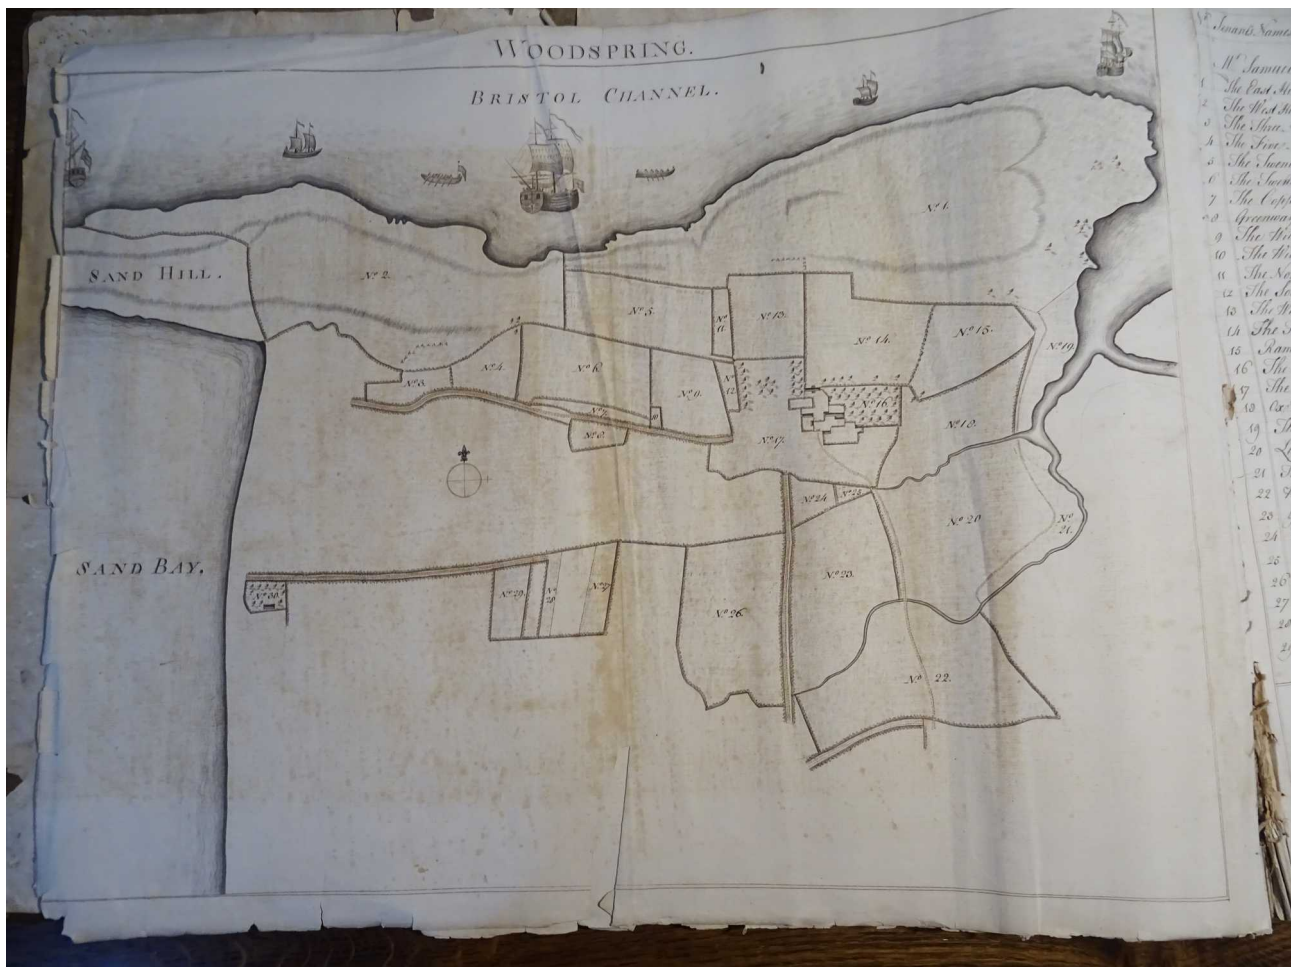
Fig 20: 1768 map of Woodspring (in private hands)

This map is of extraordinary interest. It records the Pigott ownership at the time (which is in almost perfect agreement with the 'lands subject to a modus in lieu of all tithes' discussed above).

It also shows a distinct interest in the maritime environment, with the depiction of several vessels to the north of Sand Hill, and even two rowed pilot boats, presumably from the legendary group at Pill, near Bristol.

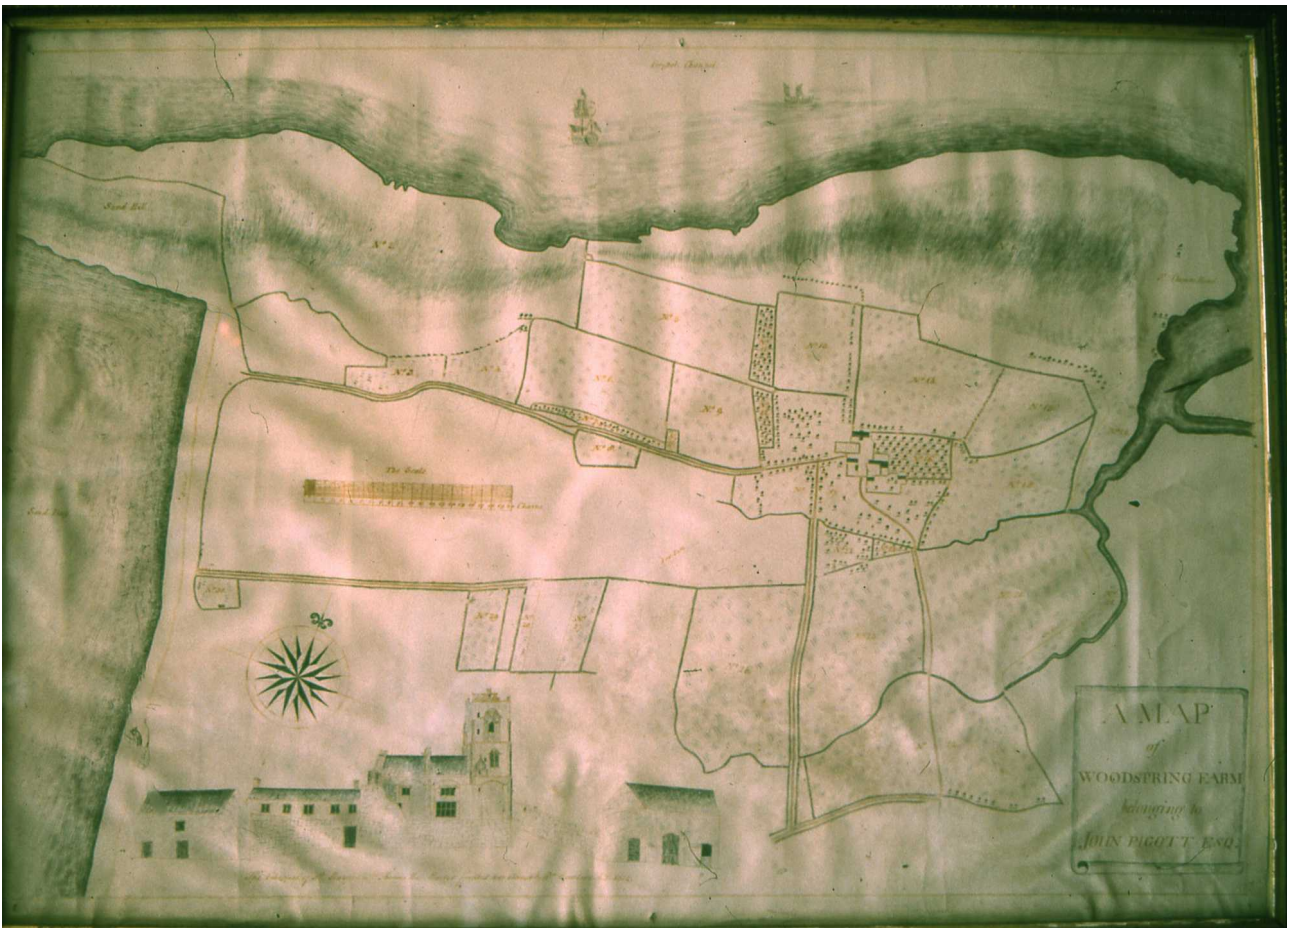
The map displayed at Woodspring has a sketch plan of the buildings at that time, including the 'missing' gatehouse. It shows less interest in the maritime environment - only two vessels are (poorly) illustrated: it has a cartouche on its lower right hand side and a scale bar. The labels 'Sand Hill' and 'Sand Bay' are in lower case.

Fig 22: 'Museum' map at Woodspring Priory

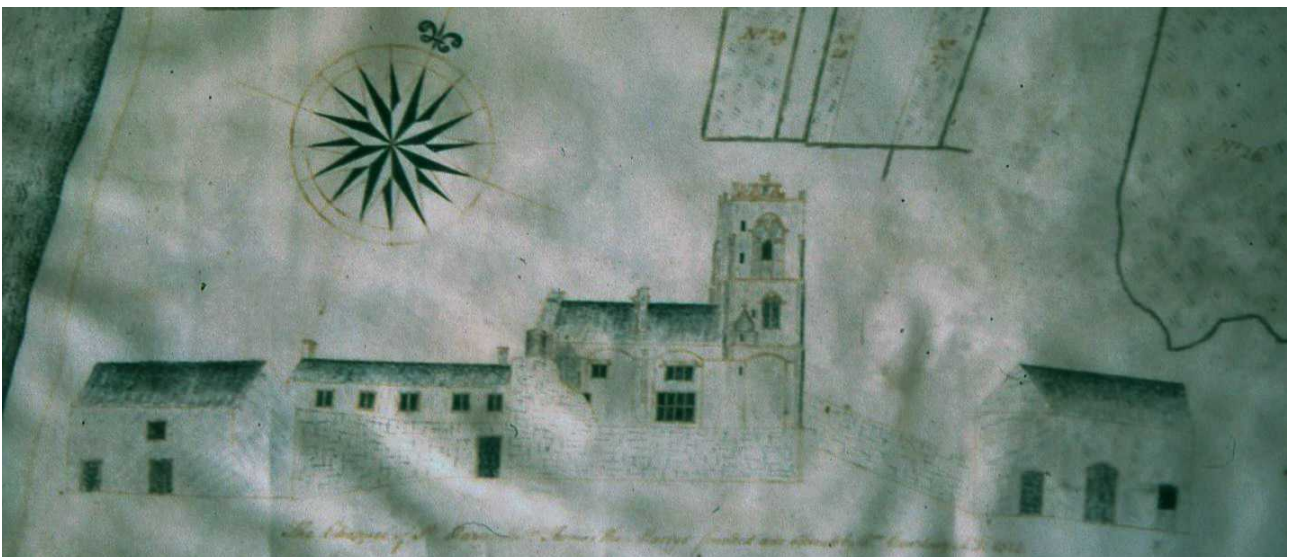
While the buildings are not individually labelled on the 'museum' map (the text under the buildings is 'The Chappel of St Mary and St Thomas the Martyr founded and endowed by Wm Courtenay AD 1212'), they are recognisable (R to L) as the infirmary, the priory church, the farmhouse, and a building now disappeared (although its foundations have been identified in the paddock south of the cloister - YCCART, forthcoming). This is usually taken to be a gatehouse or guesthouse, but details on the map are not able to distinguish these.

Fig 23: The depiction of the buildings on the 'museum' map

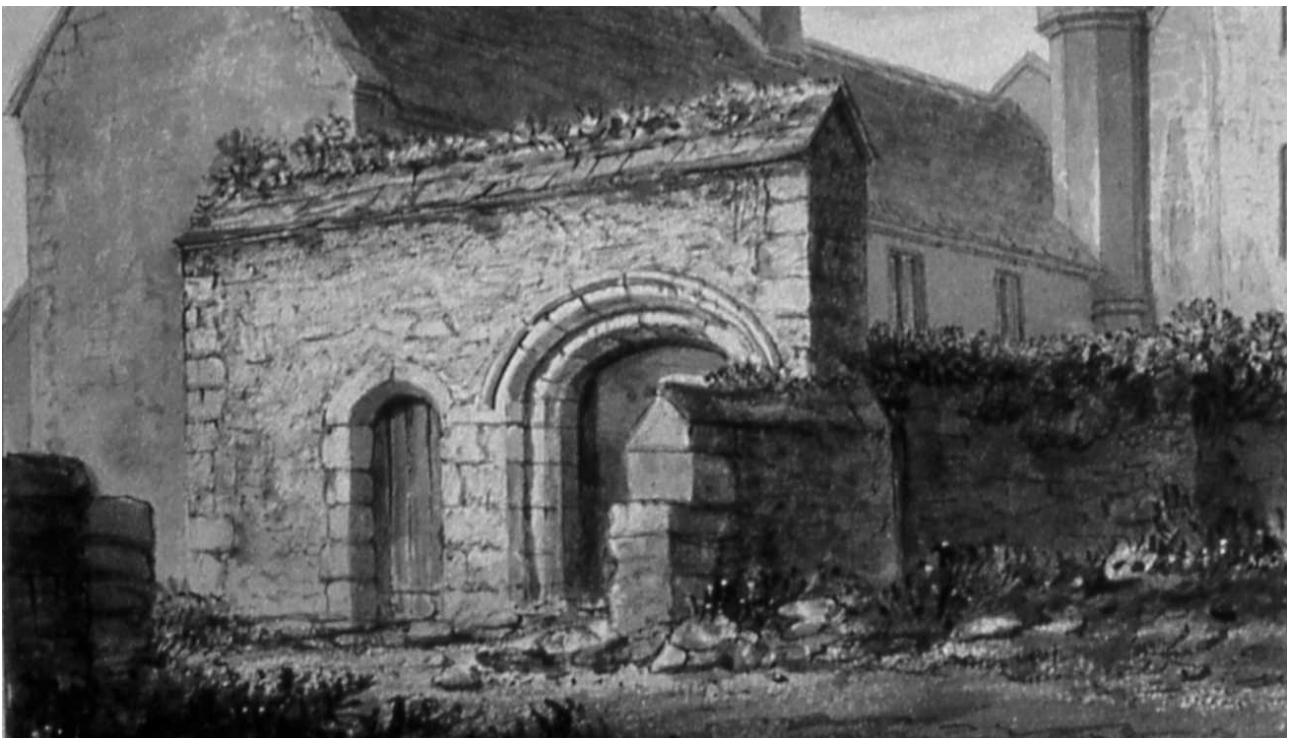
Fig 25: Woodspring gatehouse drawn by J Buckler in 1829

Buckler's drawing of 1829, however, shows the current gatehouse already in place.
