YCCCART 2018/Y9

The Old Stone Crosses of Kingston Seymour

**YATTON, CONGRESBURY, CLAVERHAM AND CLEEVE ARCHAEOLOGICAL
RESEARCH TEAM (YCCCART)**

Kingston Seymour, Old stone crosses, Photographic and documentary study, 2018, Y9, v1

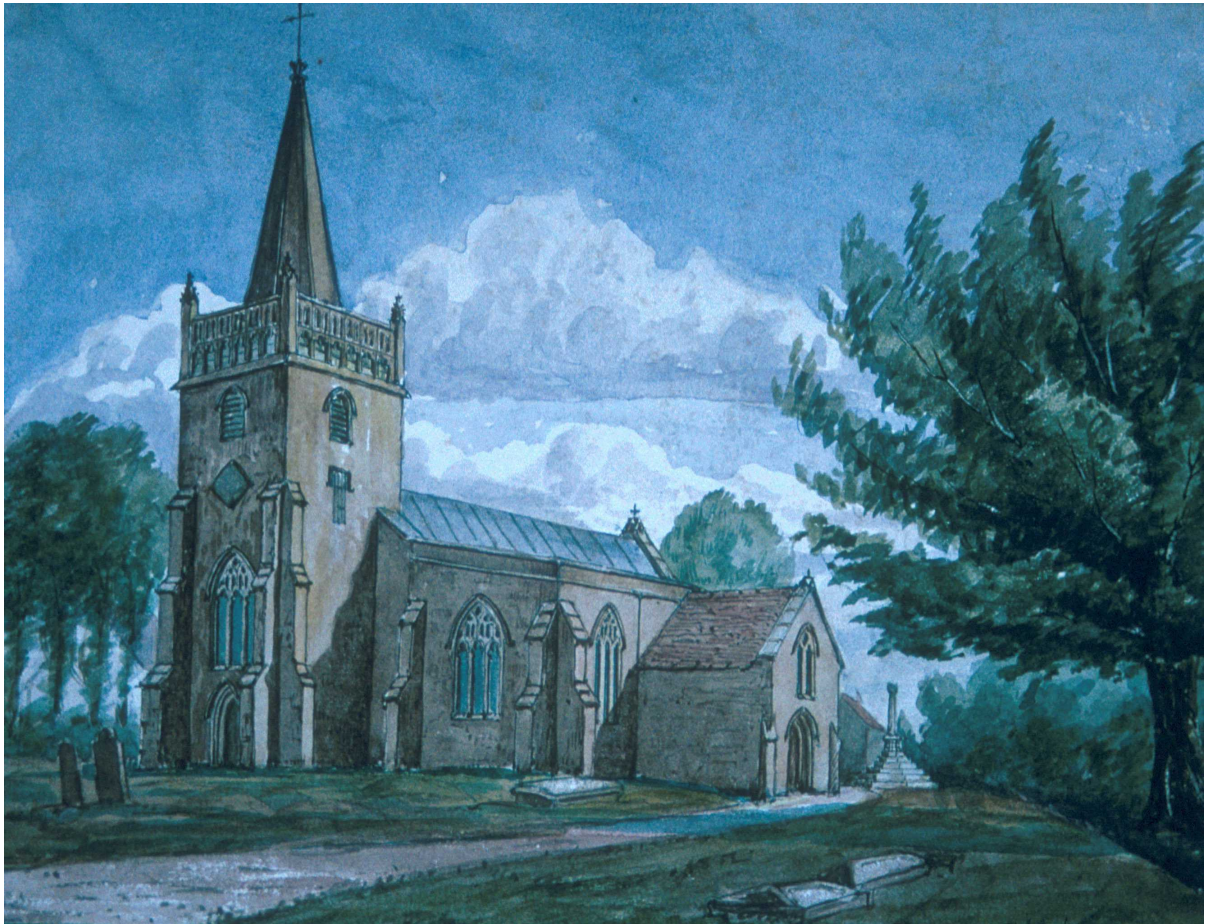
Kingston Seymour church in c1820 (SANHS collections)

The first known depiction of this cross is in the water colour on the cover, dating to about 1820. It shows the cross much as today, with its five octagonal steps and socket, but with a block at the top of the shaft rather than the present cross, which is later in date.

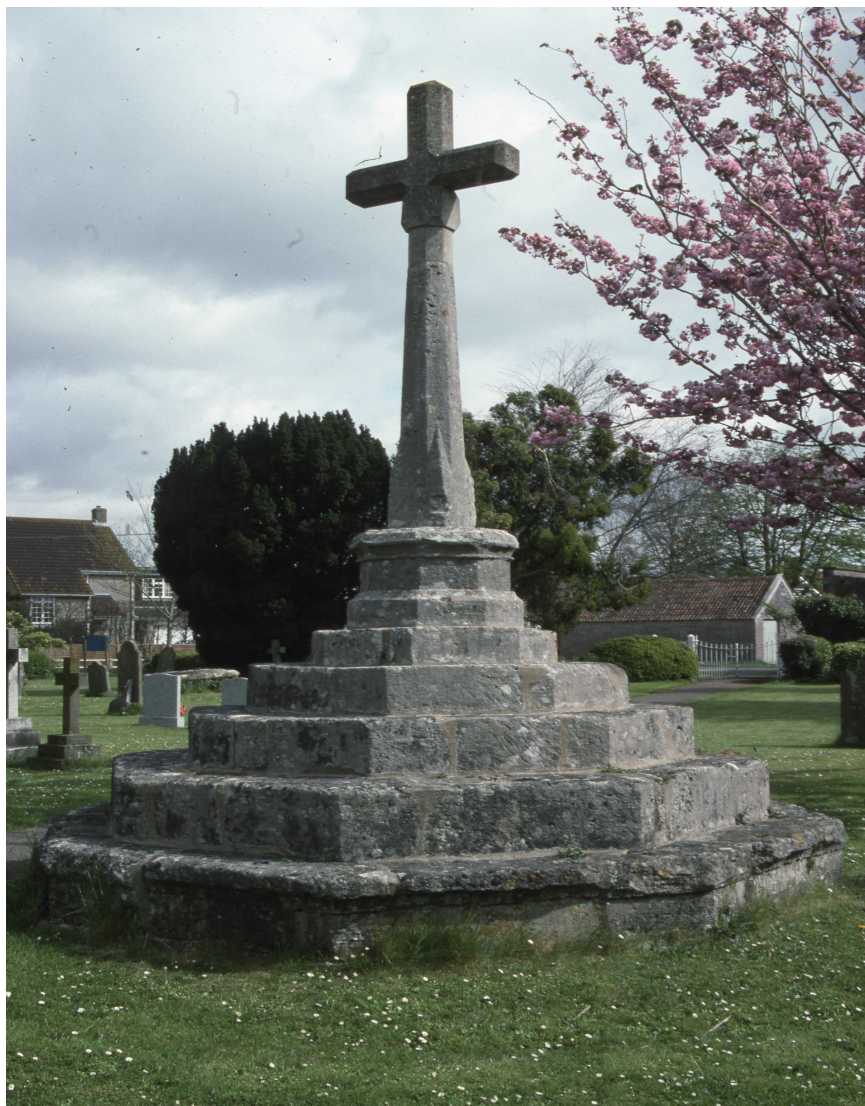
Fig 2: The churchyard cross at Kingston Seymour (1976)

Kingston's churchyard cross, with its octagonal steps, and unusual octagonal socket (most sockets in Somerset, even if on octagonal steps) are square topped with corner broaches to an octagon, like the ones at Yatton and Congresbury.

The closest parallel to this is probably the one on the market cross at Cheddar: both have the offset lower section, and protruding drip at the top, although the fillet under the drip at Kingston is very unusual, and probably means it is late medieval in date.

The Scheduling description (see Appendix 1) describes a stone basement beneath the lowest step, almost certainly necessary (as at Congresbury) in this alluvial area to avoid the cross sinking.

The position of the cross (to the left of the path approaching the door into the church) is most unusual, and often means the cross has been moved, since liturgically, it should be on the right. In this case, and it having a stone base, it may have been necessary to place it on the left for reasons of space - this is a very small churchyard!

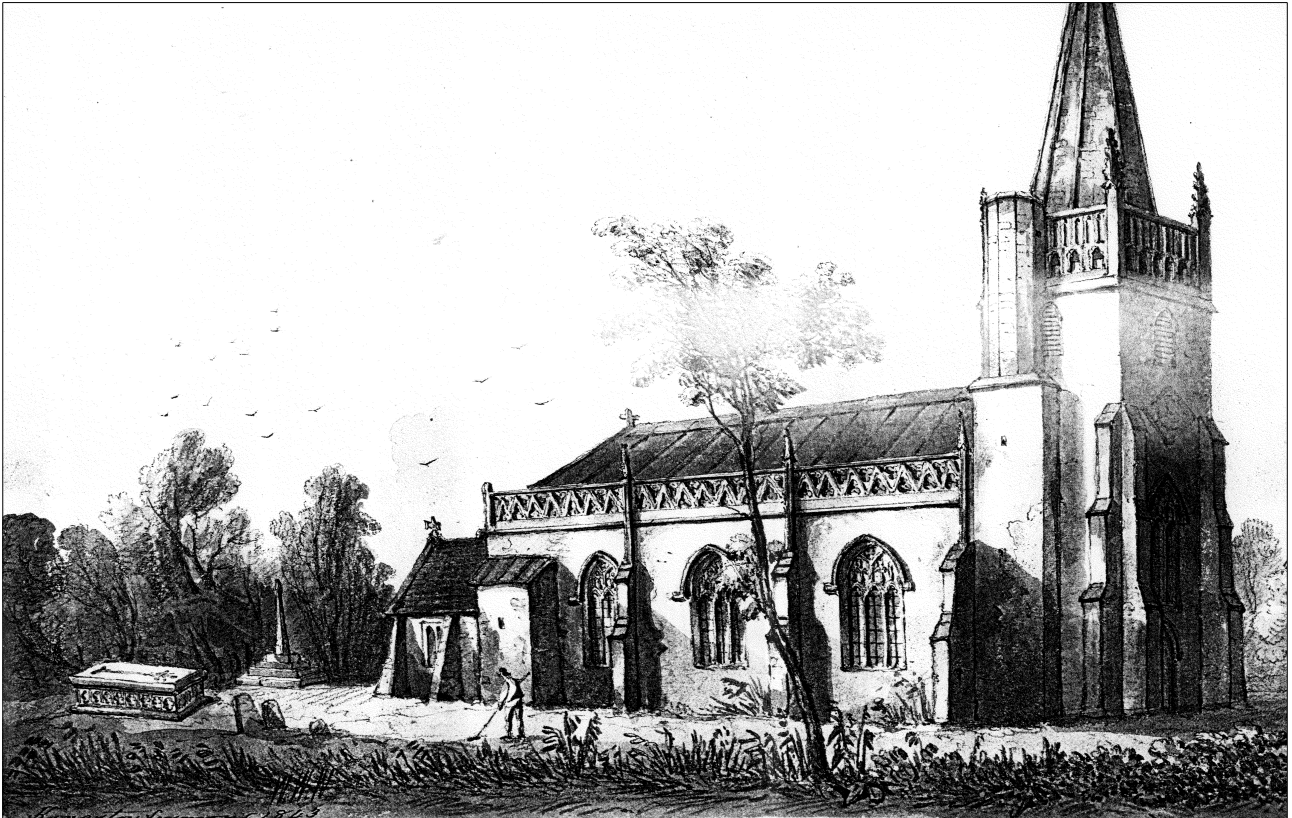
A drawing from the Pigott collection in the SANHS archives also depicts the cross this way.

Fig 3: Kingston churchyard cross in 1843

The drawing could even be an attempt to represent the remains of the original head of the cross, now sadly missing. By the time Charles Pooley arrived in the 1870s, the current cross was in place.

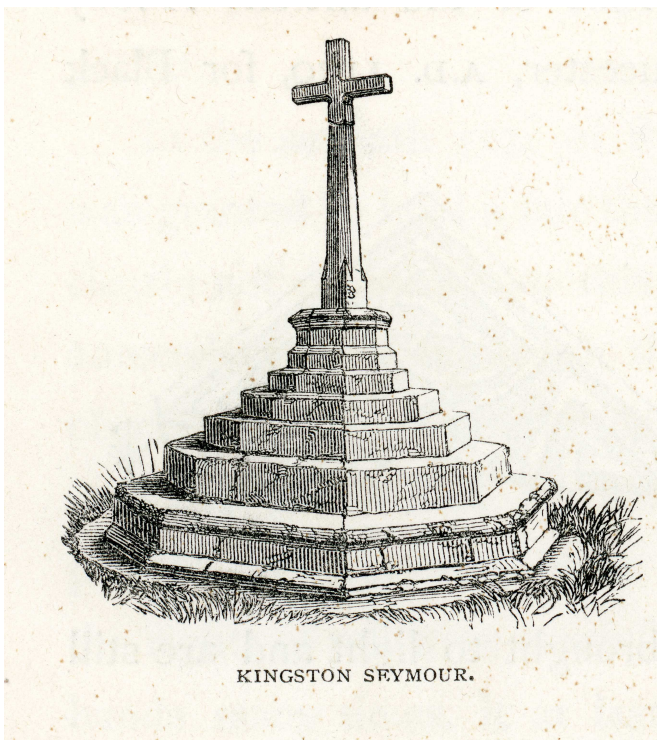
Fig 4: Charles Pooley's illustration of the cross, c 1870

Pooley's drawing clearly shows the cross much as today, and also shows its basement, as referred to above.

'...KINGSTON SEYMOUR.-A restored churchyard Cross of remarkably good proportions, and standing a little to the east of the south porch of the church, nearly opposite the priest's door. Five rows of octagonal steps form the Calvary on which the socket is set. The shaft and stone cross with which it is surmounted, were put up at the instance and after the design of Mr. James Flack,

at the expense of the rector, the Rev. G. Smyth Pigott, in 1863, at which time the Calvary, then much dilapidated, was repaired. The socket is eight-sided, with its upper edge chamfered obliquely, forming a drip, beneath which runs a fillet. Its lower bed is worked with a cant, which gives the appearance of stability. The effect of the high tier of steps and the lofty cross is imposing. The basement is well benched with a drip and a set-off at foot. Fifteenth century...'

If the Calvary (steps) were repaired, then this was a remarkably good and conservative repair for Victorian times.

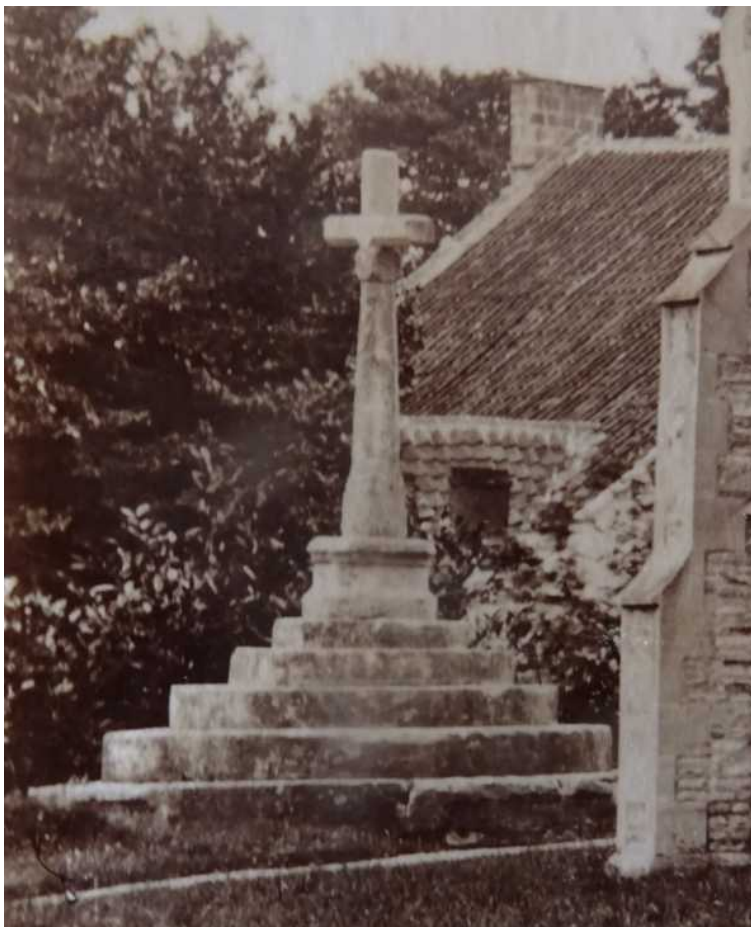
Fig 5: Photograph of the cross in c1900 (Frederick Wood collection in WsM library)

By 1900 (Fig 5), when the Chew Magna solicitor Frederick Wood was carrying out his photographic record all around Somerset (including many crosses), and more importantly, labelling them and keeping them altogether (although he did label Luccombe cross 'Lullington' which nearly had me haring off to the latter to check, before I checked my photos and realised his mistake!).

His photo clearly shows that any scars from the restoration of 40 years before had healed by then.

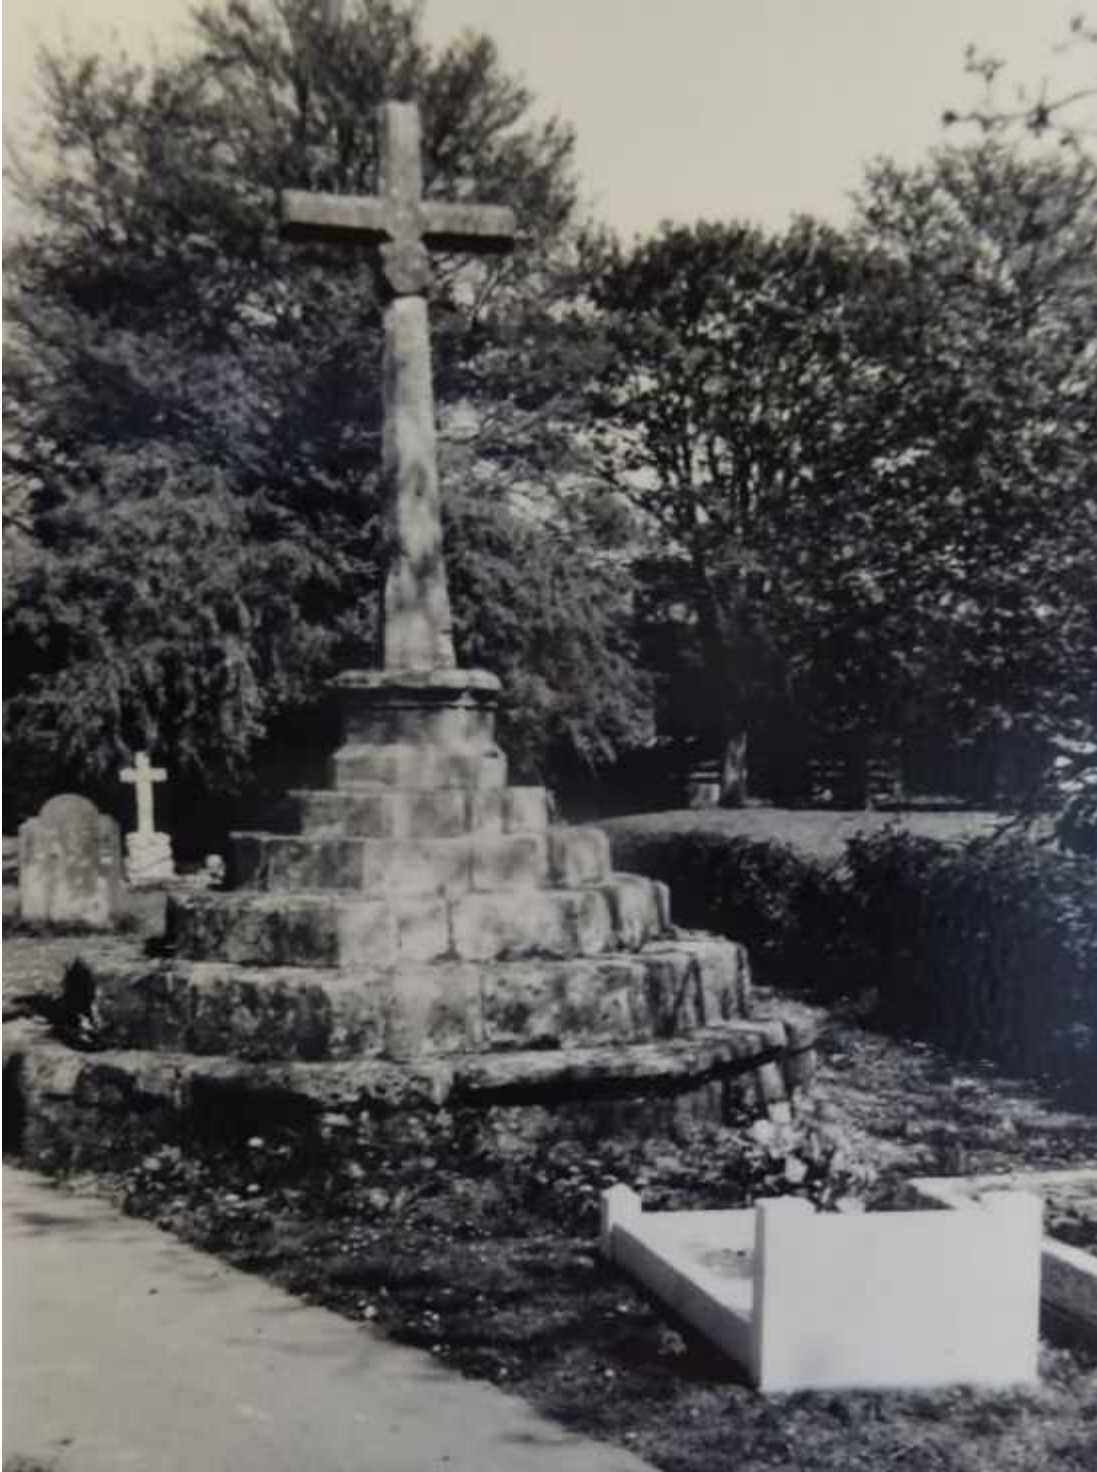
Fig 6: Kingston churchyard cross in c1960

This shows the cross in very much the same condition as today.

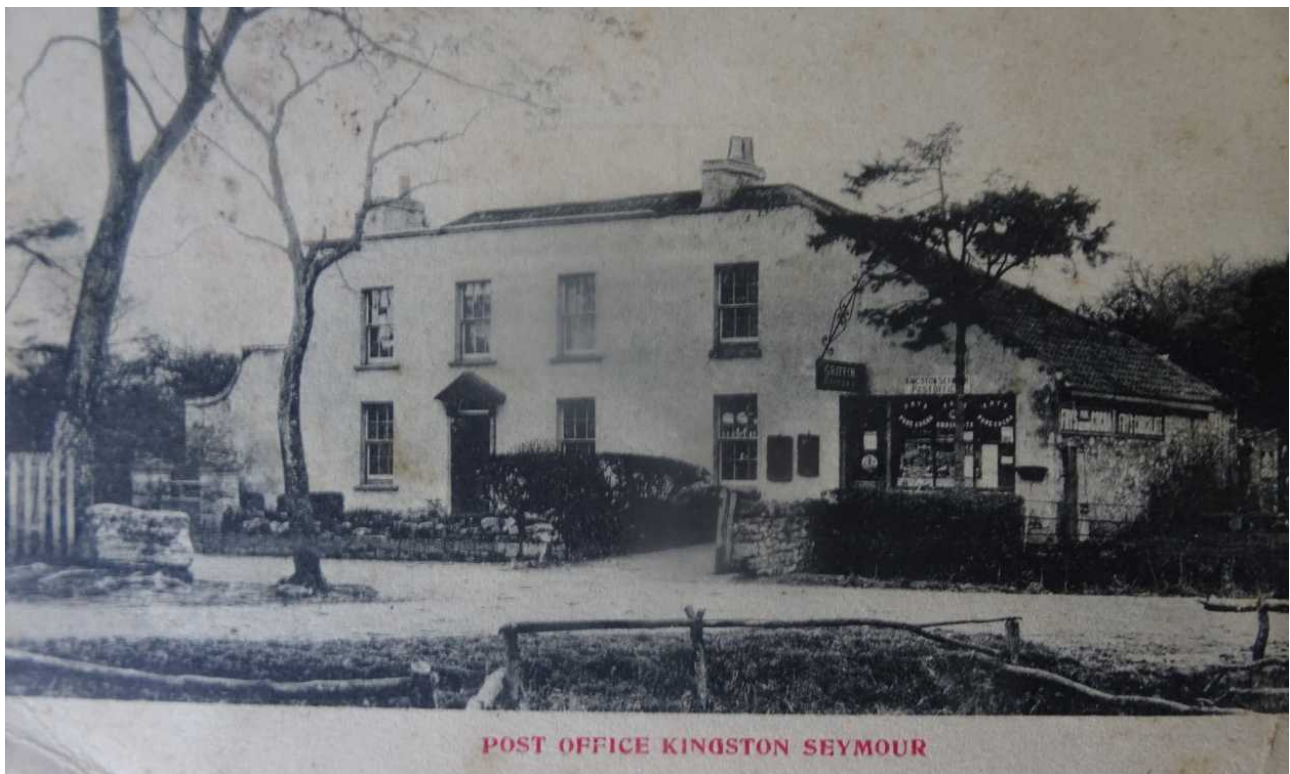
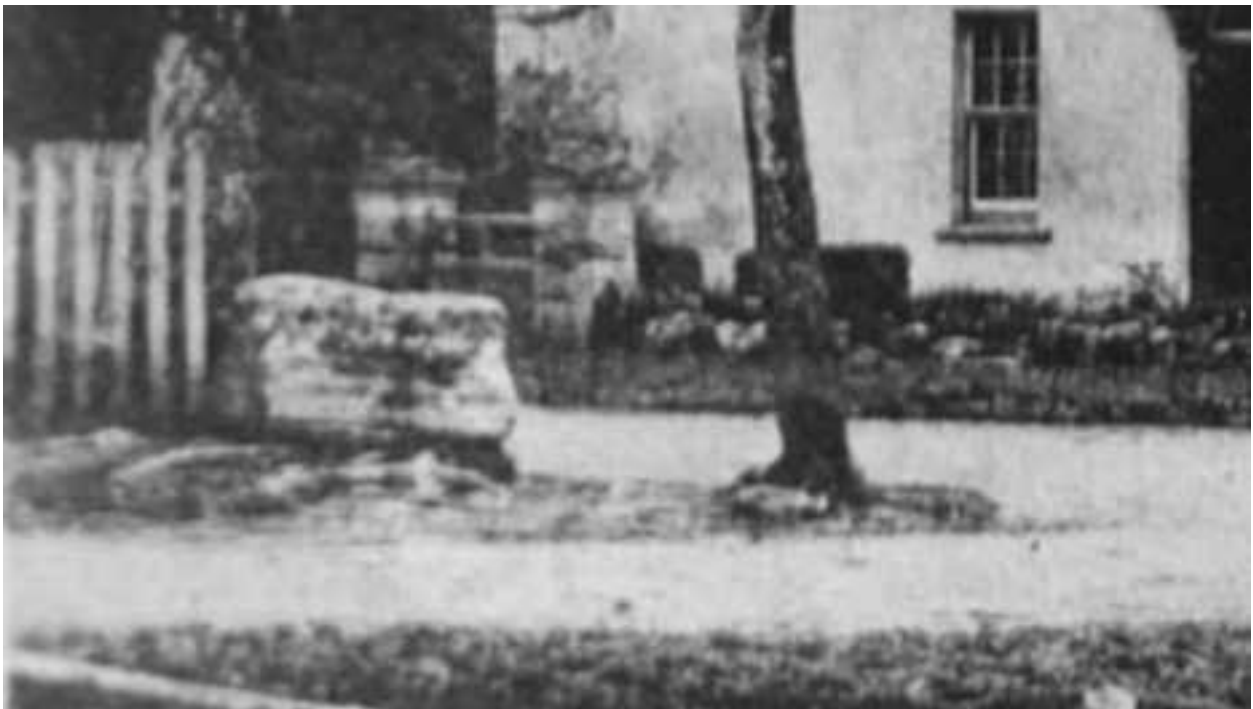
Astonishingly, the socket was photographed and printed as a post card showing the Post Office at Kingston as it was at that time (Fig 8).

This appears to show the cross where depicted on the OS map above, but it seems to be sitting on some rubble, which might be the remains of the base of the original cross, which no longer survive. If so, then the original position of the village cross may have been a little to the SW of the current position of the War Memorial, but clearly, reconstructing it at this point would have meant a traffic hazard (even in the early 1920s), and a space around the Memorial would be required for the Armistice Day ceremonies.

Fig 8: The old cross socket before re-use in the War memorial (pre-1921). I am grateful to Dave Long for finding this image.

Fig 9: Enlargement of above

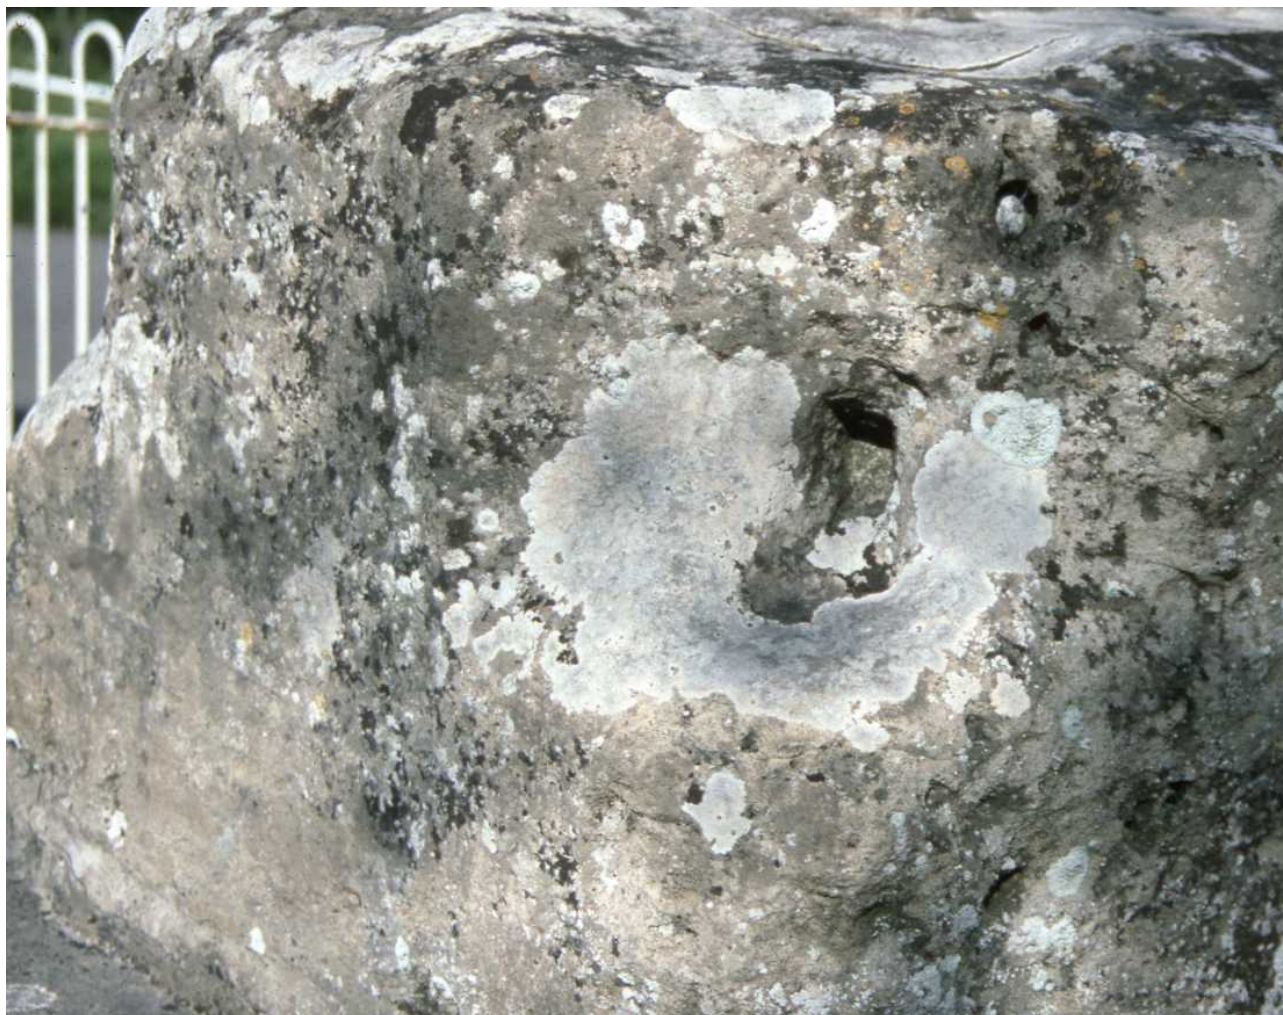
The War Memorial, in its railed enclosure, incorporated the socket of the village cross. Seen close up, the socket has long triangular stops, of which all have a square socket

around 2.5cm across in them. The purpose of these is unclear, but they appear to be ancient on origin, and perhaps have held affixes to the cross. While this is not uncommon in churchyard crosses, it is very rare indeed in village crosses.

Fig 10: The square socket replacing the missing stop-chamfered

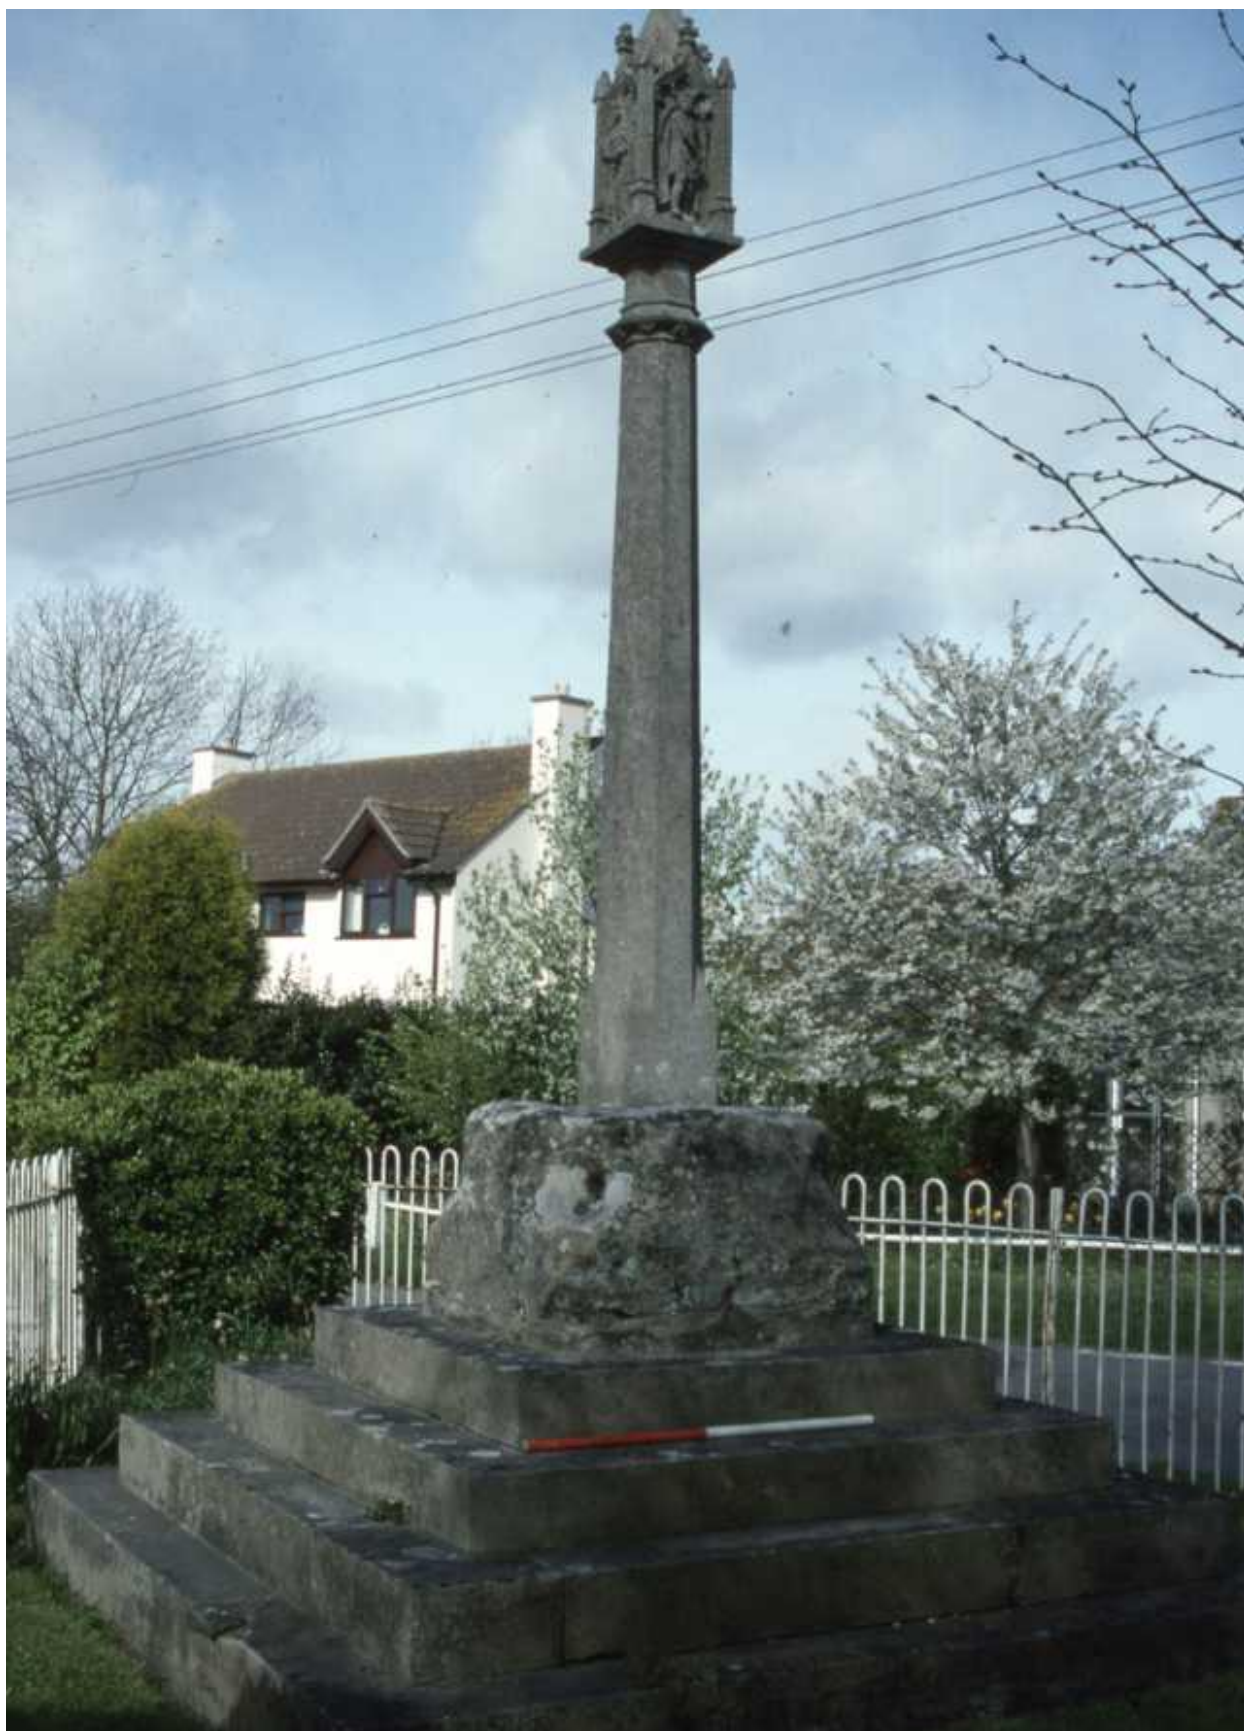
The War Memorial (Fig 11) has four square steps below the re-used socket, a square to octagon shaft with pyramidal stops, and a canopied head with warrior figures in each face, probably depicting the four archangels.

The second step of the cross, facing the main road, bears the lines on its upright face 'IN GLORIOUS MEMORY OF THOSE FROM THIS PARISH WHO GAVE THEIR LIVES FOR THEIR COUNTRY / AND IN HONOUR OF THOSE WHO FOUGHT AND SUFFERED WITH THEM IN THE GREAT WAR 1914-1919.'

Although Historic England's List description (see Appendix 1) describes the monument as 'Late medieval and late nineteenth century/twentieth century' this should clearly be 'late medieval and c1920': how the late 19th century comes into it is unclear. This is not the only war memorial in Somerset accommodating a medieval cross socket: that at Butleigh Hill, near Glastonbury, also does so.

Fig 11: Kingston Seymour War Memorial, incorporating the medieval village cross socket
