YCCART 2019 / Y13

Cheddarford Mills, Charterhouse: a possible early horizontal mill?

**YATTON, CONGRESBURY, CLAVERHAM AND CLEEVE
ARCHAEOLOGICAL RESEARCH TEAM (YCCART)**

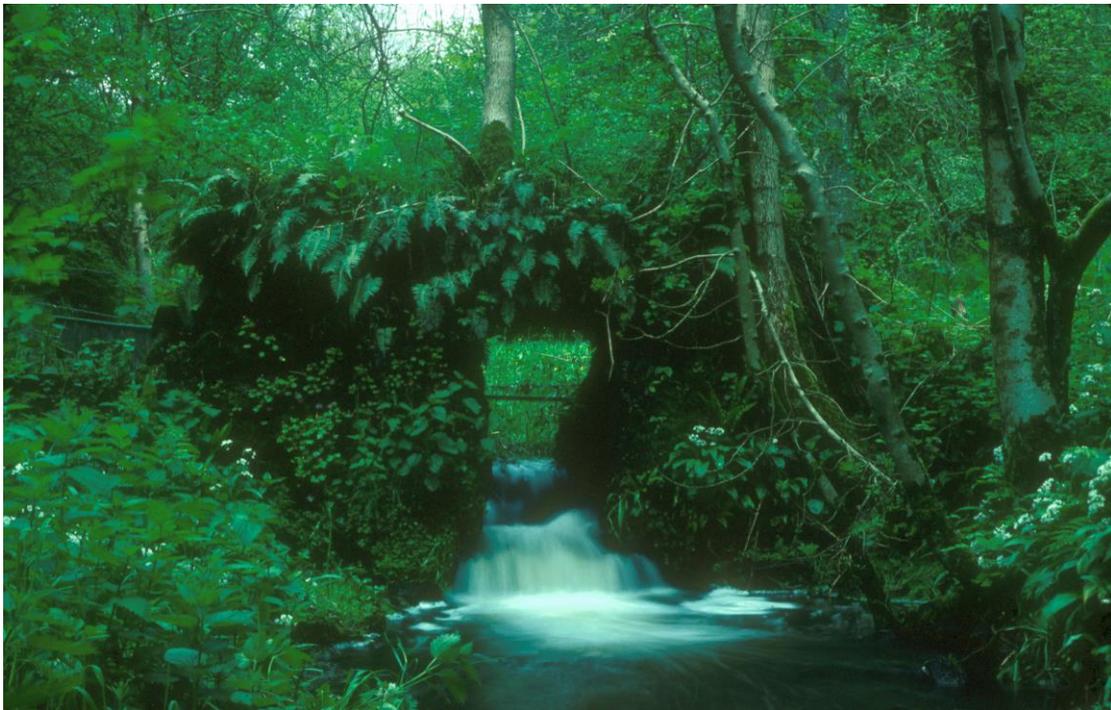
The stream below the mills, running out of a field that includes the stream as water for cattle

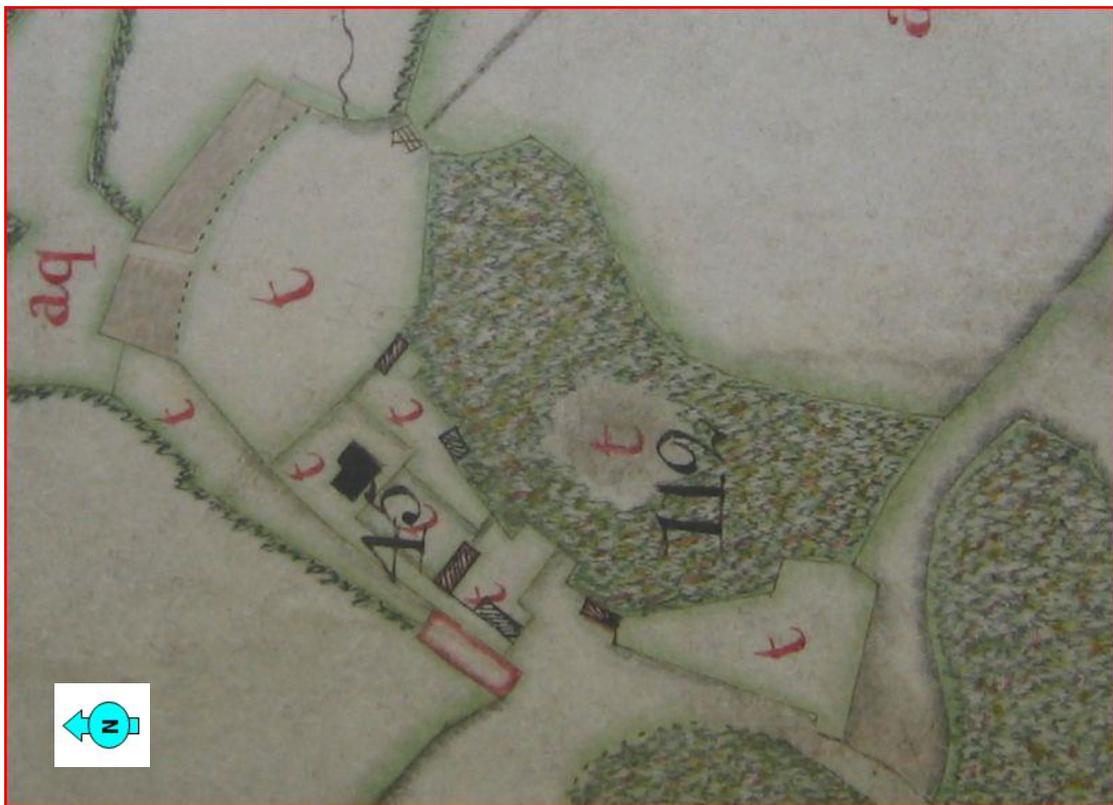
Fig 2: Lower Farm and associated buildings on the 1761 map.

In 1761 (see Fig 2 above), a whole complex of buildings are shown. It is noticeable, however that many of the buildings have black hatching: it is not clear what this signifies here or at other sites on the map. The 1761 map has a number of alterations and these are not always consistent. The attached survey nowhere mentions a mill – south field 't' is simply 'Th'east barn and Rick Yard'.

The building attached to the open southern field marked 't' on the map is on the site of the upper building in the survey below: nothing is marked on the map at the locality of the Lower Mill, probably meaning that it had gone out of use some time between 1699 and 1761, although it was well enough preserved for the Rev Skinner to recognise it as a mill in the 1820s.

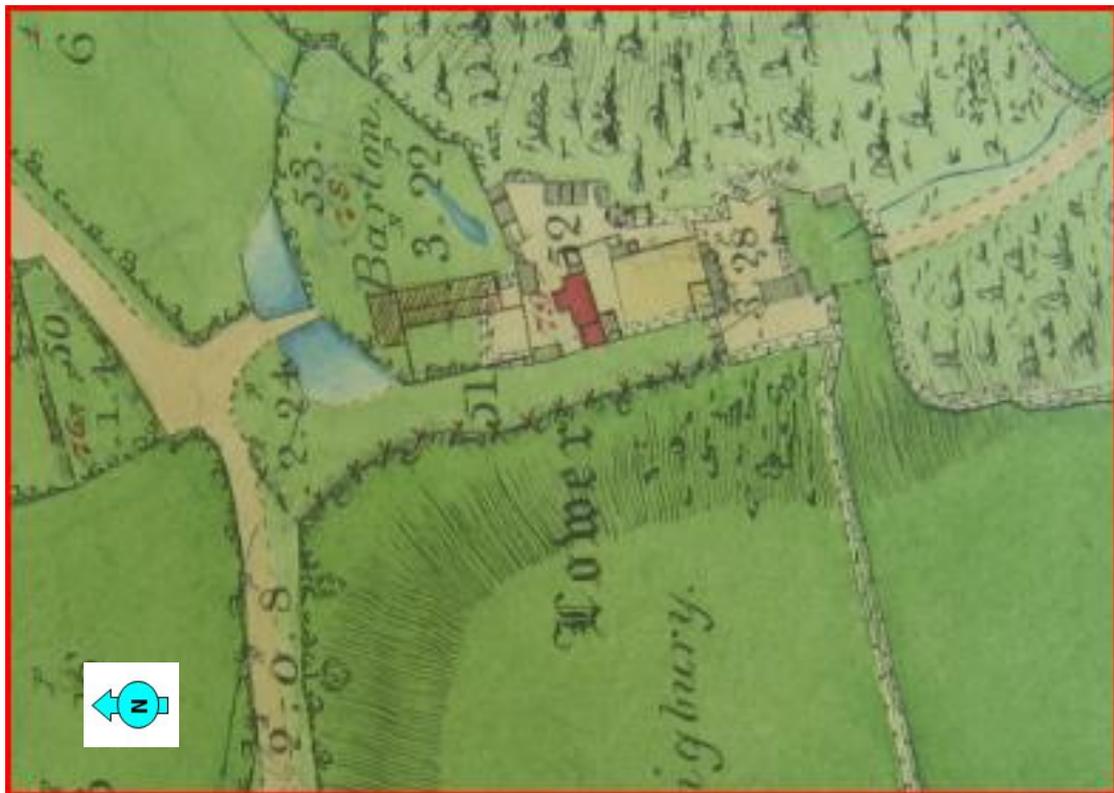
Fig 4: Lower Farm and associated buildings on the 1842 map.

By the 1840s, when the stream was shown running in the leat, there is no indication of anything at the lower site, and the stream appears to have been diverted from the upper mill, since it is now shown emerging from the field south of the house.

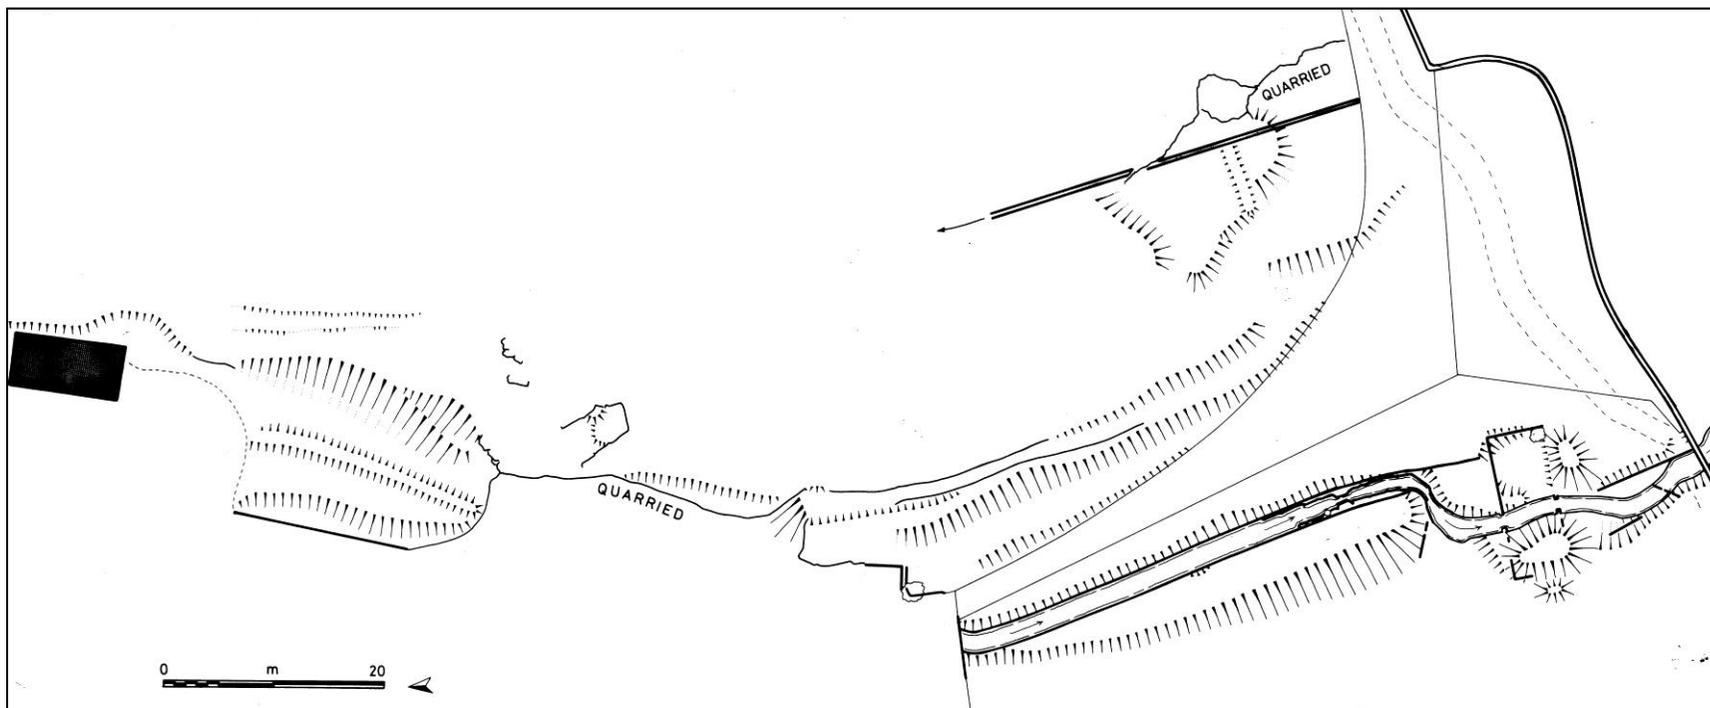
Fig 5: Cheddarford Mills, as surveyed 1988

The survey was carried out by Vince Russett during 1988. The site was quite overgrown, and some of the more subtle earthworks may have been missed, although the major features, such as the mill, the 'Abbots Pool', the leat and others should be reliable.

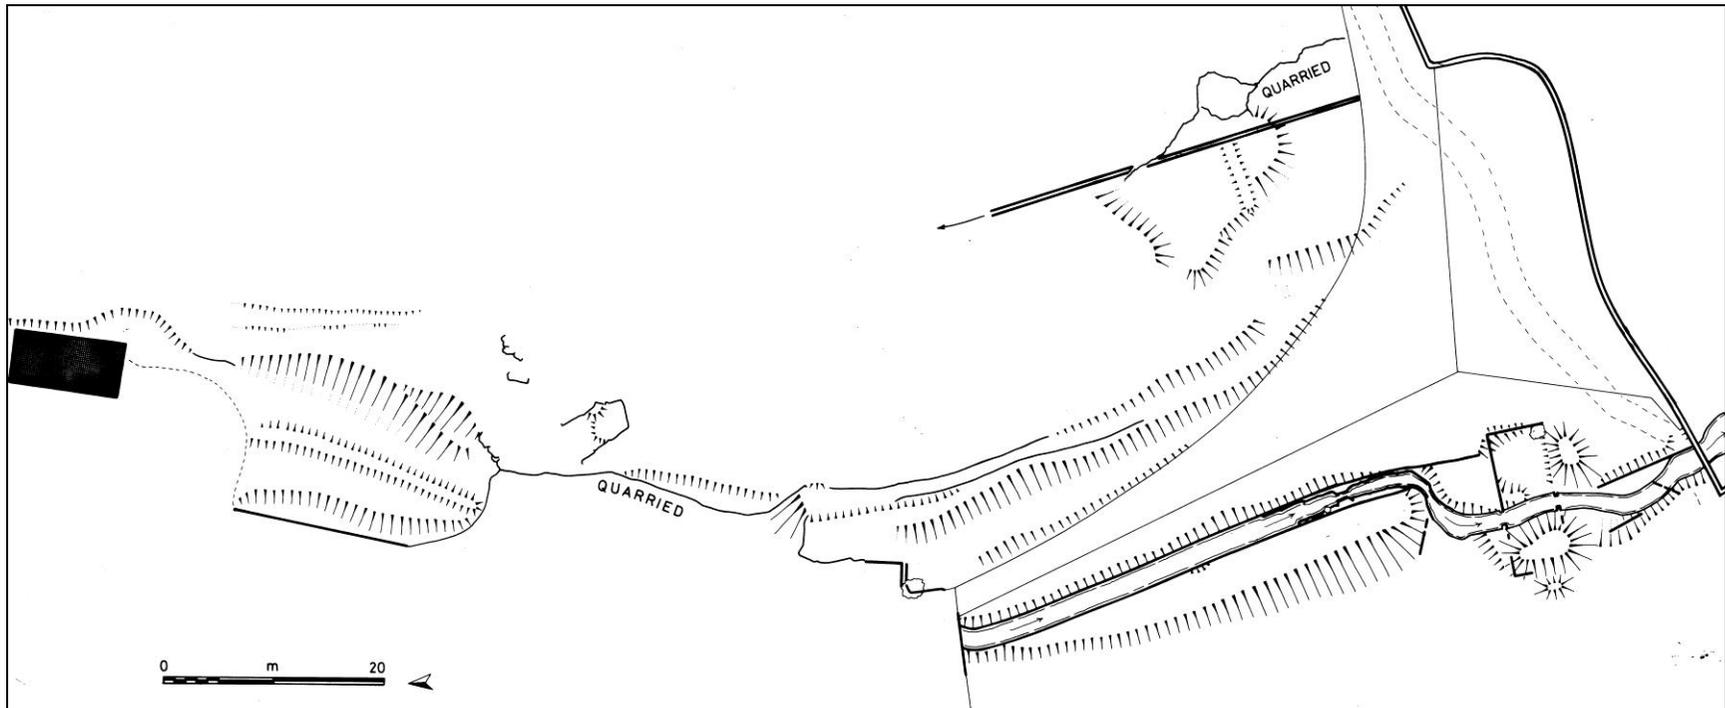
Fig 6: Interpretation of the survey

At the north end of the site, the black rectangle indicates a standing roofed building belonging to Longwood Grange and in use at that date. At A, a section of lynchet on the edge of the wood, with a standing portion of wall at each end, is probably a collapsed wood-edge wall: behind it further up the slope, a short section of small double-lynchet is probably the remains of a former trackway or path. In front (west of) the collapsed wall is a flattish section of ground ending in a lynchet towards the yard, supported by a section of remaining mortared stone wall. Across this flat area runs a low bank of undetermined purpose, but possibly the remains of a former leat to the upper mill.

Between A and B, a section of quarrying (presumably for construction at the farm) has clearly removed any archaeology on and inside the wood edge.

At B, the remaining corner of a stone building can be seen, whose footprint has been replaced by open yard. I was told informally that this damage occurred during the 1968 flood event, and a recognisable fragment of building stood there until that time. Running away through the wood from this point to the south-east is a double lynchet trackway, which seems have been replaced by a later stone-walled track on a slightly different alignment. These are heading towards complex at D (see below). Also at B, just over the fence separating Long Wood Grange from the wood itself, the stream emerges from a stone culvert under the yard. The stone-lined leat is held some metres above the valley floor by a large bank into which the leat was cut. The leat runs about 40m, then the water runs out of a break in the wall into a channel it has carved for itself at C.

At C, a small flat area lies behind the main mill building itself: according to Burgess in the late 1970s (Burgess archive in Axbridge museum), there was a shallow culvert running across this area to a central point at the back of the mill, but this was not visible in 1988. Either it was so overgrown it was missed, or the digging operations at the mill had removed any evidence. The chute by which the water reached the mill wheels is now blocked. The stream now runs through the centre of the mill building, which it has eroded, since stub foundations of the front and back walls of the mill can be clearly seen in both sides of the stream. The original mill was about 14m long and 4m wide: no internal features appear to have survived. The overgrown remains of two spoilheaps can be seen near the mill, one large one on the far side of the current stream, and a slightly small one to its south. It was confirmed at the time that this was the remains of the digging-out operations. Burgess sketched a floor layer support in the mill in the 1970s, level with the culvert, but this was gone by 1988.

The walls of the mill appeared to be of coursed stone with lime and mud mortar, and at the time had been dug out to a depth of about 1.5m.

Downstream from the wall, the foundations of a pair of converging stone footings either side of the stream appear once to have formed a pool, and I was informed that locally, this was known as 'The Abbot's Pool' (source not recorded). They were attached to the mortared stone field wall of a section of a field to the east which had been cleared of wood to give grazing animals access to water. The stream escaped into this area through a small lintelled opening, not dissimilar to the one on the other side of the watering area seen on the cover (although not as photogenic).

Above the mill site at D, a quarried area cut into the hillside was cut off by a stone field wall running towards Lower Farm, of which only the southern end was surveyed. In front of this, an irregular platform with a section of stone wall on it may be a house platform (although not 'The house at the Millgreene Gate' as in Russett 1988: this has been located elsewhere).

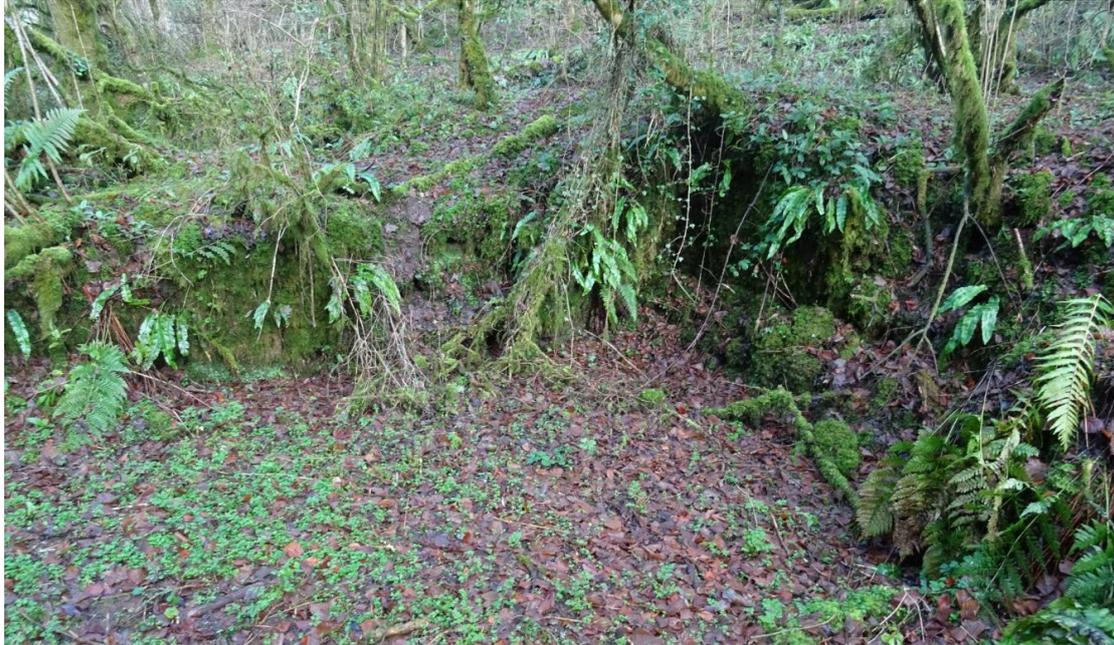
Fig 7: The overgrown remains of the mill, 2018

It is most unfortunate that the inside of the building, where archaeological traces may have survived, was dug out without record: this may have held valuable clues about the origins and development of the mill.
