YCCCART 2019 / Y11

Postmedieval settlement development and change at Charterhouse-on-Mendip 2: Edith Coles' cottage and settlement in Velvet Bottom

YATTON, CONGRESBURY, CLAVERHAM AND CLEEVE ARCHAEOLOGICAL RESEARCH TEAM (YCCCART)

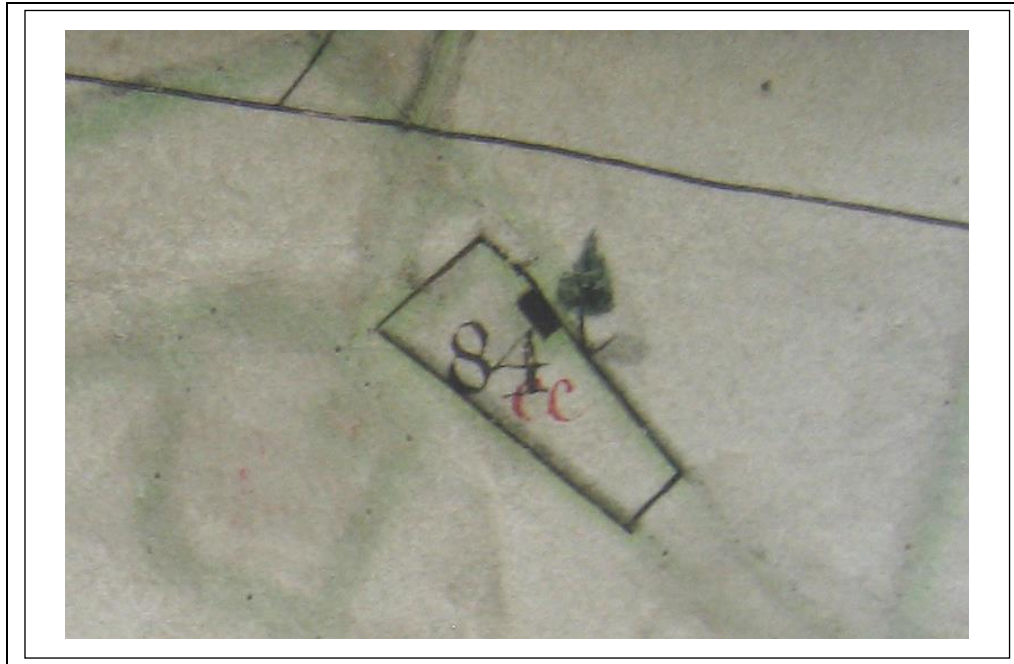
Fig 3: The site in ?1809: note the erasures on the map. Map reproduced courtesy of the Somerset Record Office.

The modified plan of ?1809 shows a very different layout: only the central of the three buildings survives, now in a much reduced enclosure: the former buildings and enclosures can be seen to have been erased from the original map, but traces of red ink confirm all three were buildings in 1761.

The survey attached to the map gives the details of occupancy as *'Late Edey Coles Cottage and Garden'* and an area of 2 roods and 13 perches.

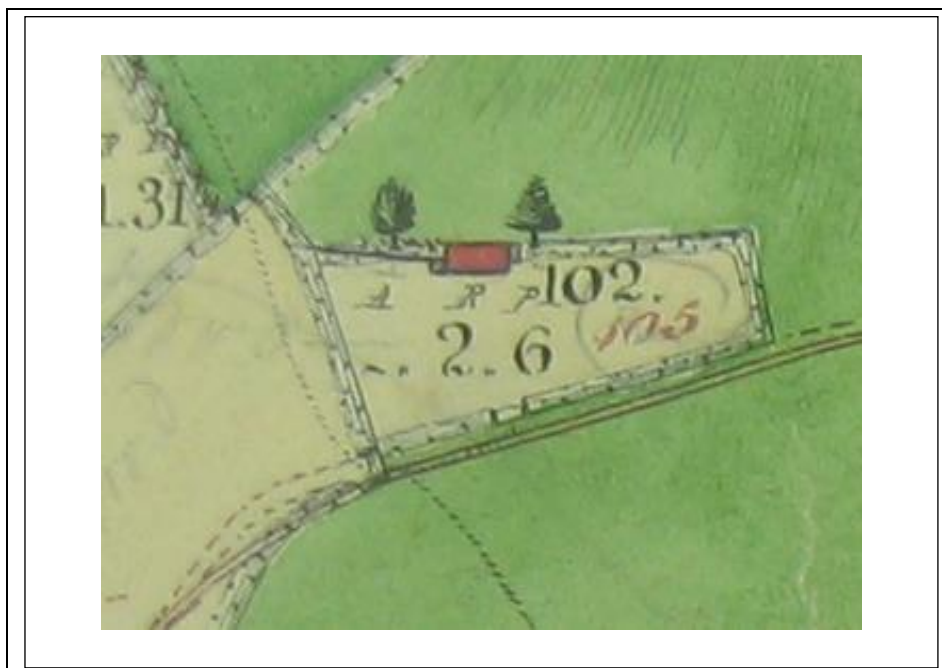
Fig 4: The site in 1842. Map reproduced courtesy of the Somerset Record Office. Map rotated from true north about 45 degrees counter-clockwise.

The site was again mapped in 1842 (Fig 4). By this time, tiny extensions can be seen to each end of the surviving building. The slighter earthworks at the eastern end of the building may represent one extension, but no trace of the

second is visible in the survey. A smaller walled enclosure is shown (although according to the details on the map only 7 perches smaller (about 25m²) at 2

roods 6 perches, as against the 2 roods 13 perches of 1761). The shape of this enclosure cannot be seen on the ground, either.

Incidentally, both trees shown on the survey are ancient: the yew stump is depicted as a tree in 1761 (Fig 2 above), and the current huge sycamore at the site was depicted in 1842 (Fig 4).

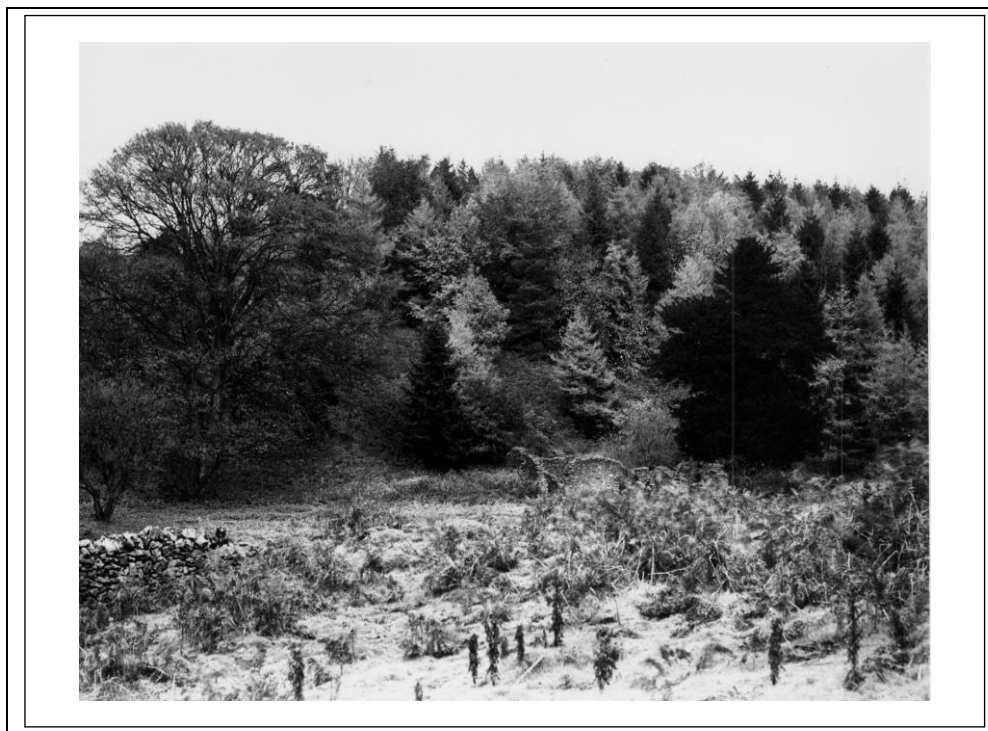
Fig 5: The site in 1919, from the Evens collection. Reproduced courtesy of Bristol City Museum and Art Gallery

The 1919 photograph (supplemented by a smaller photograph of 1914 from the Shovel collection in the Somerset Record Office) shows the building had clearly been in ruins for many years: the large sycamore currently growing at the site is already a mature tree at that date.

The photograph shows walls still standing to a height of about 1.5m, and the possibility of a door in the centre of the SW face of the building.

Both buildings seem to have lost their front walls, despite that of building A being clear in the 1919 photograph (Fig 5 above). This has presumably been lost during widening of the track for vehicles: little enough of building B survives at all, and that which does is probably because the building was constructed in a hollow into the hillside.

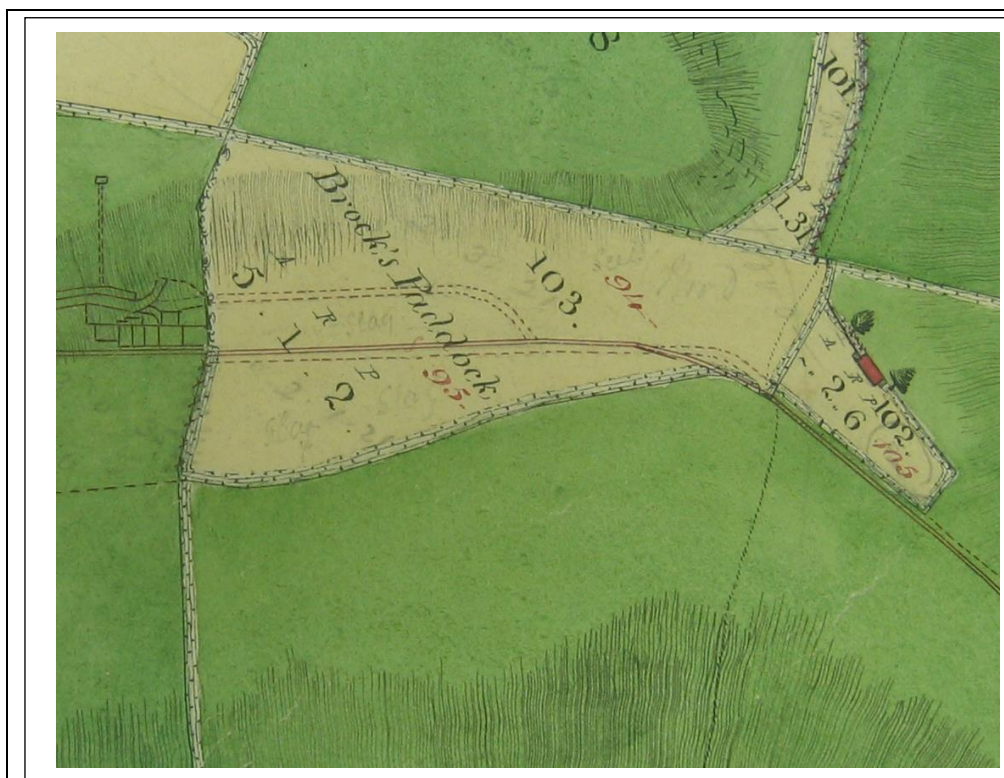
Fig 6: The wider area in 1761. Map reproduced courtesy of the Somerset Record Office.

Fig 7: The wider area in 1842. Map reproduced courtesy of the Somerset Record Office.

The wider changes between 1761 and 1842 (Figs 6 and 7 above) are plain, though. The original field called Brock's paddock seems to have lost its northern boundary (although this survives as an earthwork bank on the ground), and has expanded to a 5 acre site taking in a section of the whole of what is now Velvet Bottom. If the map can be believed, this paddock was being cultivated in 1842. Its southern edge seems to survive as the current wall of Velvet Bottom, putting the site of the third building in the field on the southern side of Velvet Bottom. No trace of this building or its small enclosure can now be seen on the ground. It has probably been completely dismantled as an easy source of walling stone for the new wall along the south side of Velvet Bottom.
