YCCCART 2018/Y5

The Old Stone Crosses of Wick St Lawrence

**YATTON, CONGRESBURY, CLAVERHAM AND CLEEVE ARCHAEOLOGICAL
RESEARCH TEAM (YCCCART)**

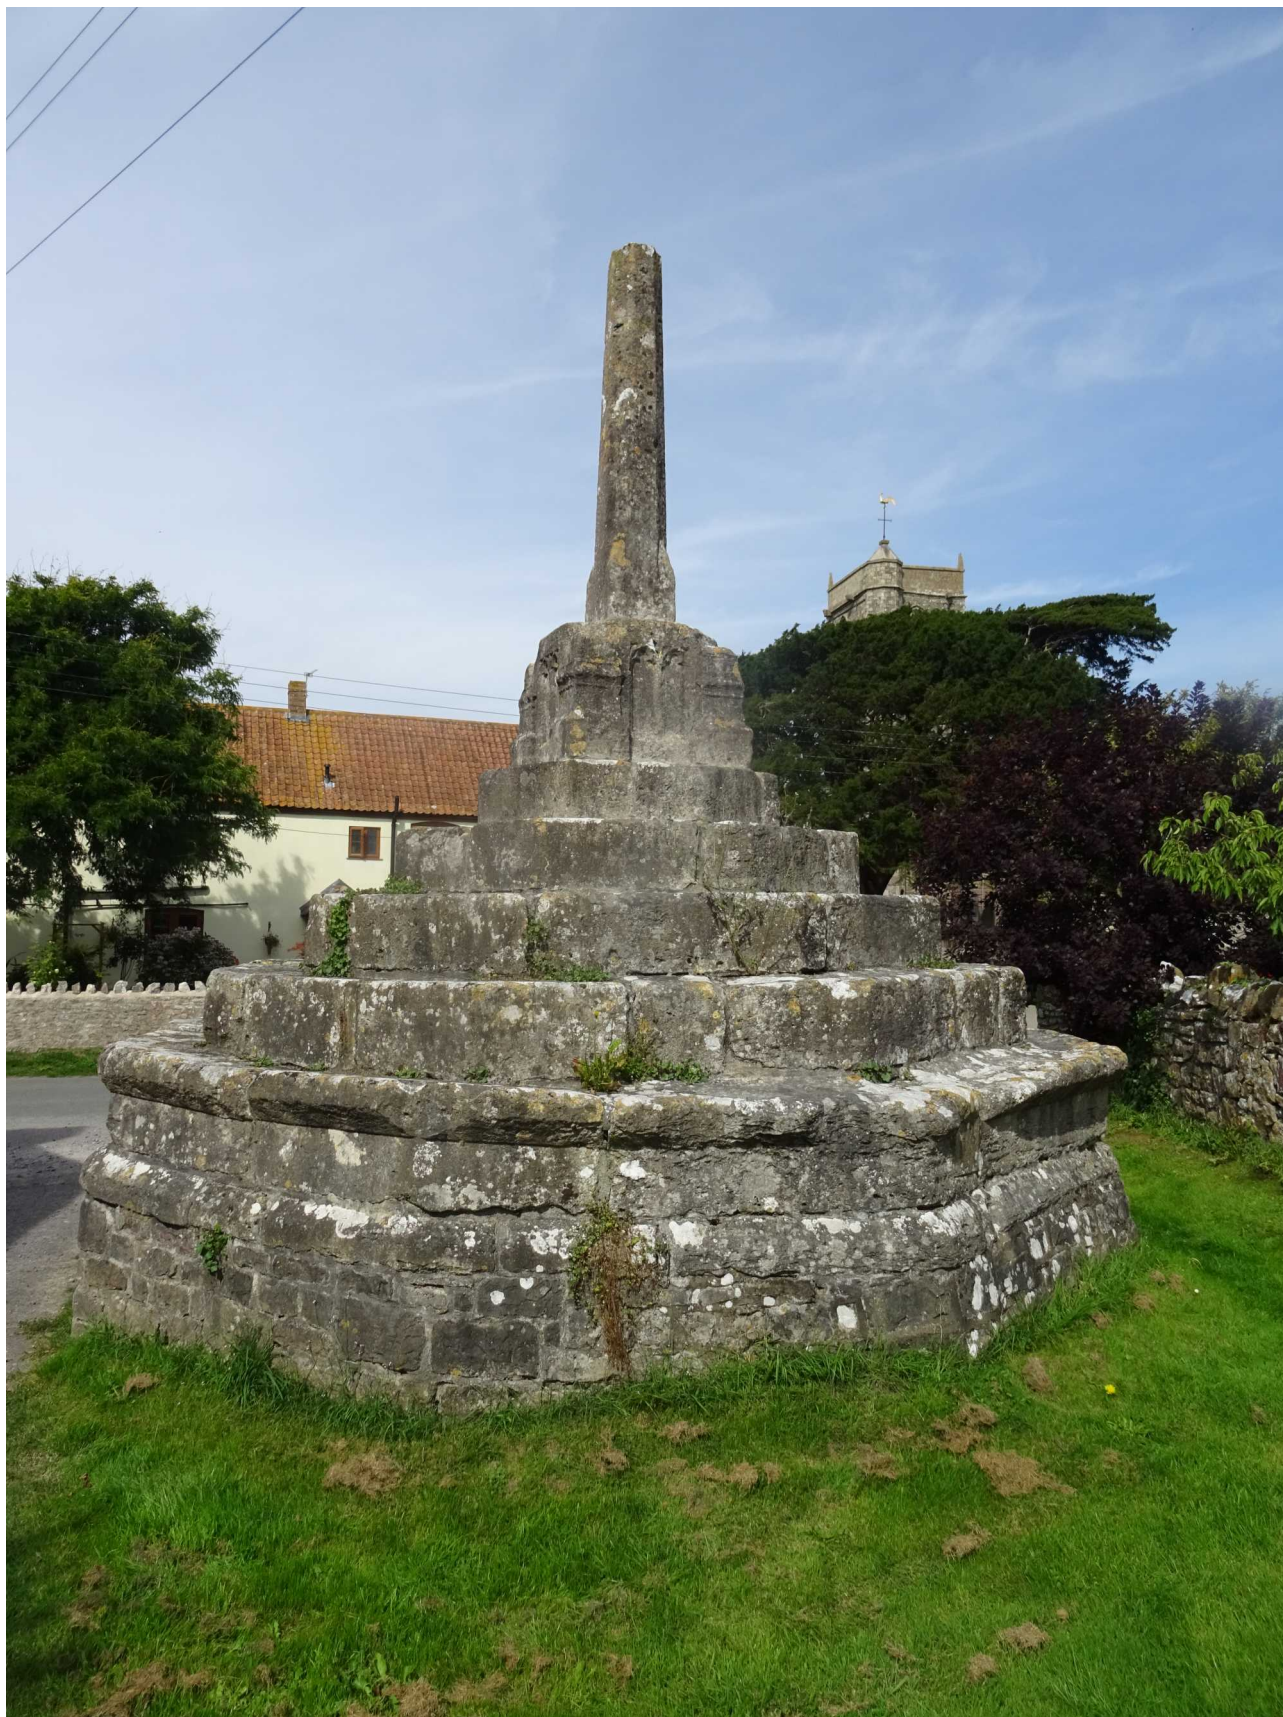
Fig 3: Village cross, 2016

The village cross at Wick is very tall, largely due to the basement below the first step, which means that the cross is not accessible without a ladder or removable steps (Fig 3). The basement is also mortared, and in a local roughly coursed and squared Carboniferous limestone, whereas the rest of the cross is in an Oolitic freestone.

The origin of this basement is, to say the least, a mystery. The Buckler drawing of 1827 (see below) appears not to show this base, with the grass growing up to the bottom of the first step proper: similarly, Pooley's drawing of c1870 does not show it either, although the drawing in Pooley may be a simplified copy of Buckler's plan, and so may not be independent evidence. He does show an apparent loose scatter of stones to one side of the cross, however, which Buckler does not. The earliest photographs, however, of around 1900, do show the basement clearly. If Pooley's drawing is a copy of Buckler's (and Pooley admits some of his other illustrations are), then the restoration of 1865 (see below) may be a key: at this date, perhaps the soil around a previously covered basement was dug away, or (perhaps less likely) the cross was re-erected on a new basement. Either way, the intention may have been to dissuade children from gathering on the cross, a constant fret by Victorian churchmen.

Either way, this cross is probably late medieval. Its socket is very similar to the two identical ones at Dundry and Burrington, with the exception that Wick's cross has blank trefoil-headed panels, whereas the other two feature a small shield in each. All three are of Douling stone (even Dundry) and have probably been ordered from a central masons yard, probably at Wells.

The shaft has a little graffiti on its north face, but otherwise, the monument is in good condition.

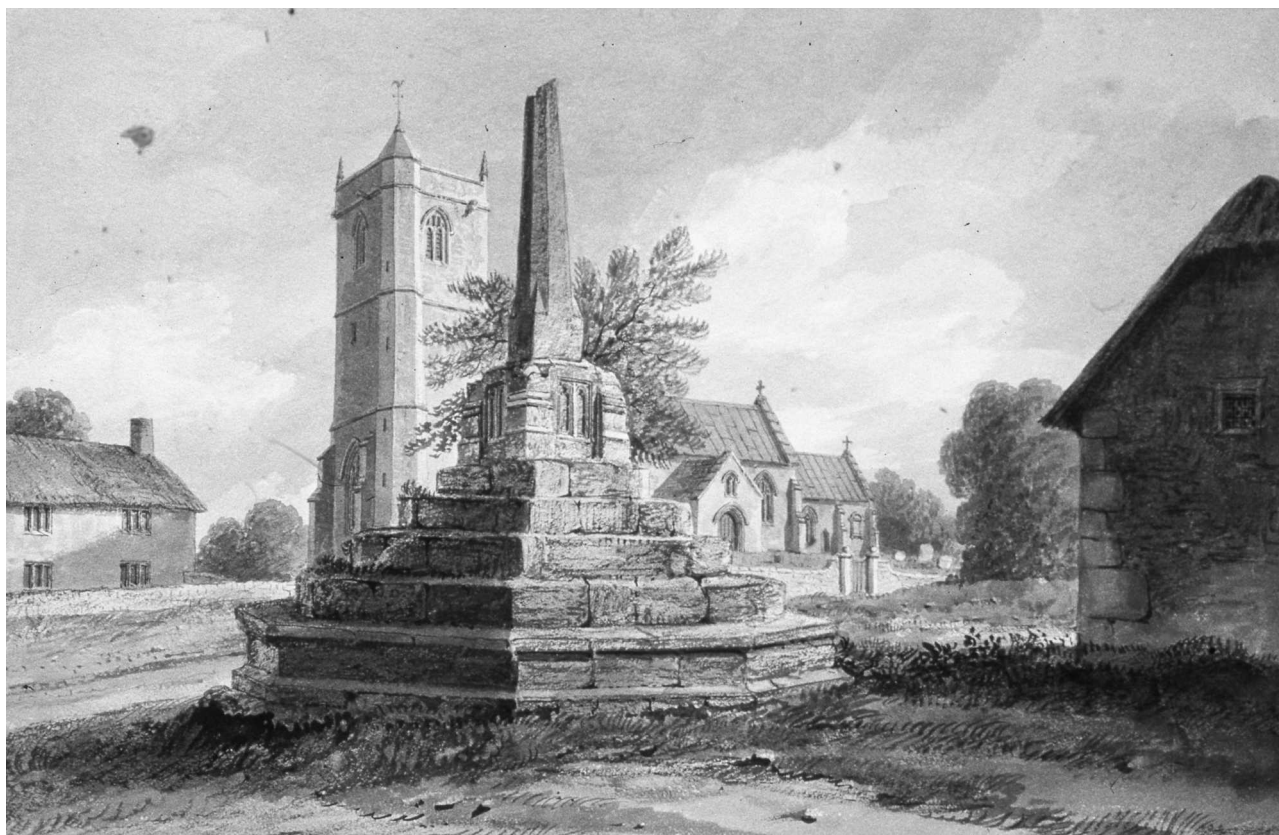
Fig 5: Buckler's drawing of Wick village cross in 1827 (SANHS collections)

This shows the cross (Fig 5) in more or less its present condition (with the exception of the basement - see above). In particular, the head of the cross is missing. The top of the shaft was not squared off, as today.

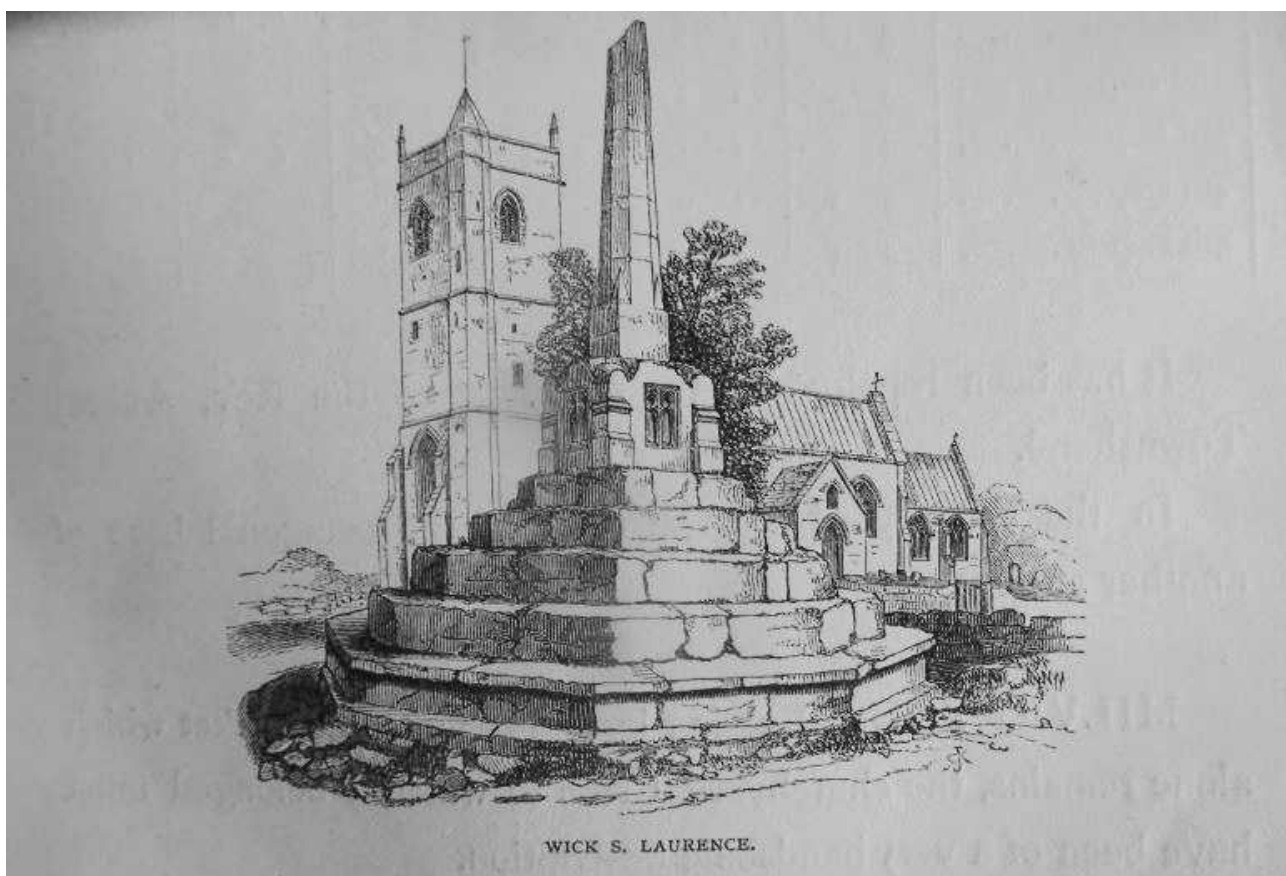
Fig 6: Pooley's drawing of Wick village cross, 1877

WICK S. LAURENCE.- This conspicuous and handsome Cross stands in an open space in the village at the back of some poor cottages and nearly opposite the church; it is an excellent example of the group of Crosses belonging to late Fifteenth century. Its ample Calvary of five octagonal steps, massive square socket with buttressed angles, horizontal mouldings and panelled sides, relieved by pairs of trefoil-headed flat arches, divided by a mullion, as in Dundry Cross, and the delicately fluted tapering octagonal shaft, all point to the Perpendicular period as that of its erection. The basement is well splayed and recessed, the slabs forming the bench making a deep weather-drip. Walling has been necessary to level the work. The shaft is fixed with lead into the mortise. It has been repaired at the sole cost of the Rev. Aubrey Townshend.

Steps		Socket						Shaft			
	Each face		Height		Height		Square at base		Height		Square at base	
	ft.	in.	ft.	in.	ft.	in.	ft.	in.	ft.	in.	ft.	in.
Basement	5	10	2	0	3	1	2	4	6	8	1	2
2nd step	5	0	1	1								
3rd step	4	2	1	1								
4th step	3	1	1	0								
5th step	2	1	1	0

His comment that 'walling has been necessary to level the work' presumably applies to the basement, but really takes us no further.

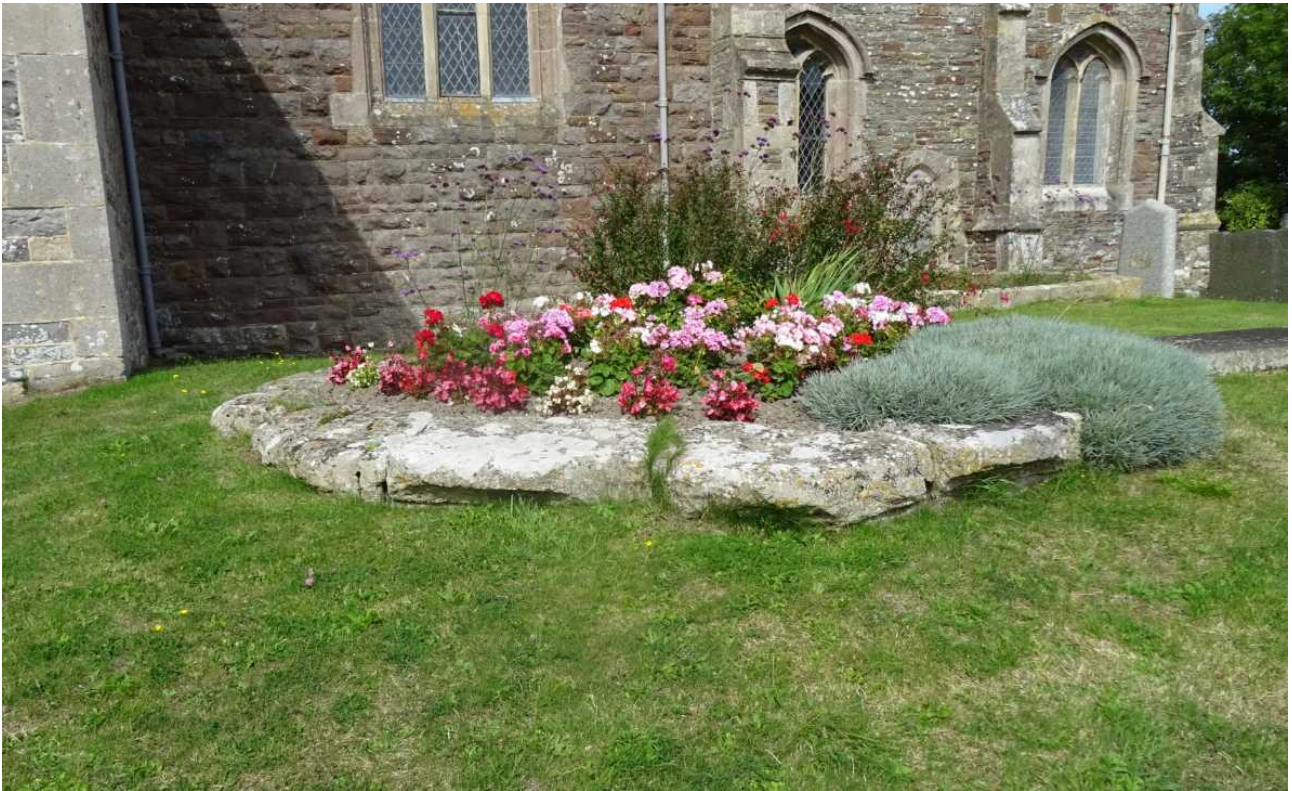
Fig 10: Wick churchyard cross, 2016

The cross is an octagon of worked stones forming an octagonal flower bed today (Fig 10).

The stones seem very large for such an apparently small cross, and have benching on them. The possibility must be entertained that this is simply a flowerbed made up with worked stones, potentially from the churchyard cross, although the apparent mound they stand on adds some credence to this being the site of the cross.

The Historic England Scheduling document refers to 'Probing around the base of the calvary suggests there is stone c 0.1m beneath the surface to a width of 0.5m from the base of the calvary indicating the presence of another calvary step or substructure below ground' (<https://historicengland.org.uk/listing/the-list/list-entry/1016198>), which is also encouraging and tending to view this as the original site.
