## Prestow Wood Limekilns and Quarries

Visit Record for attn. North Somerset HER Vince Russett 2023-05-25

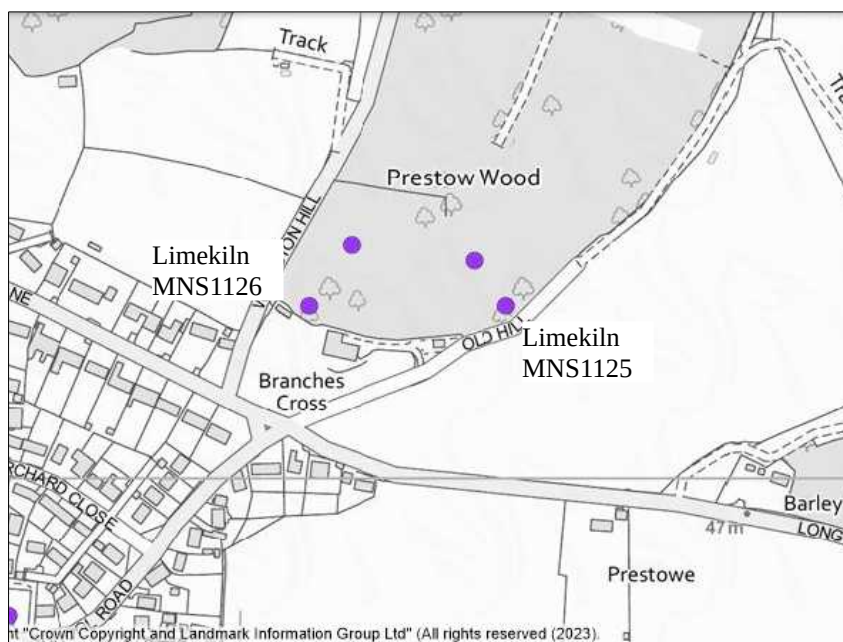
Fig 1: Limekilns at Prestow Wood, Wrington  
MNS1125 ST 4761363131  
MNS1126 ST 4745963131

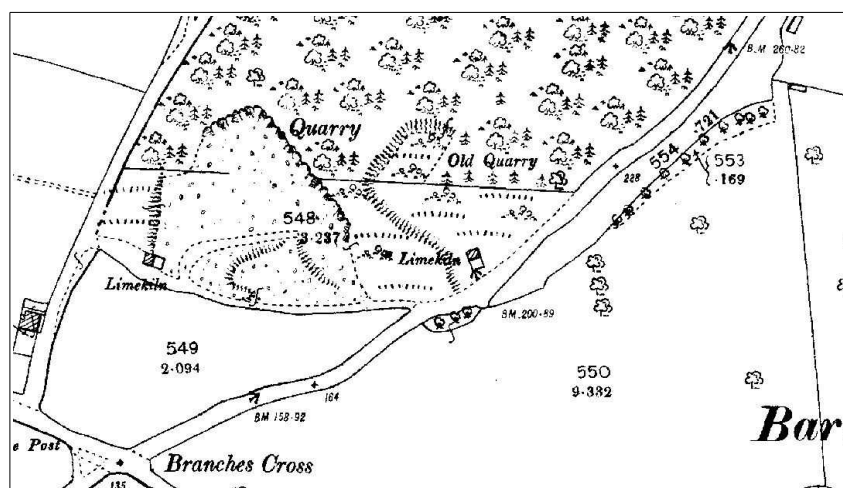
Fig 2: Kilns in c1885

The eastern quarry is potentially older than the western (it is recorded on the Wrington TM of 1840, whereas the western is not), but both are relatively close to roads for importing of fuel (probably coal) and export of lime.

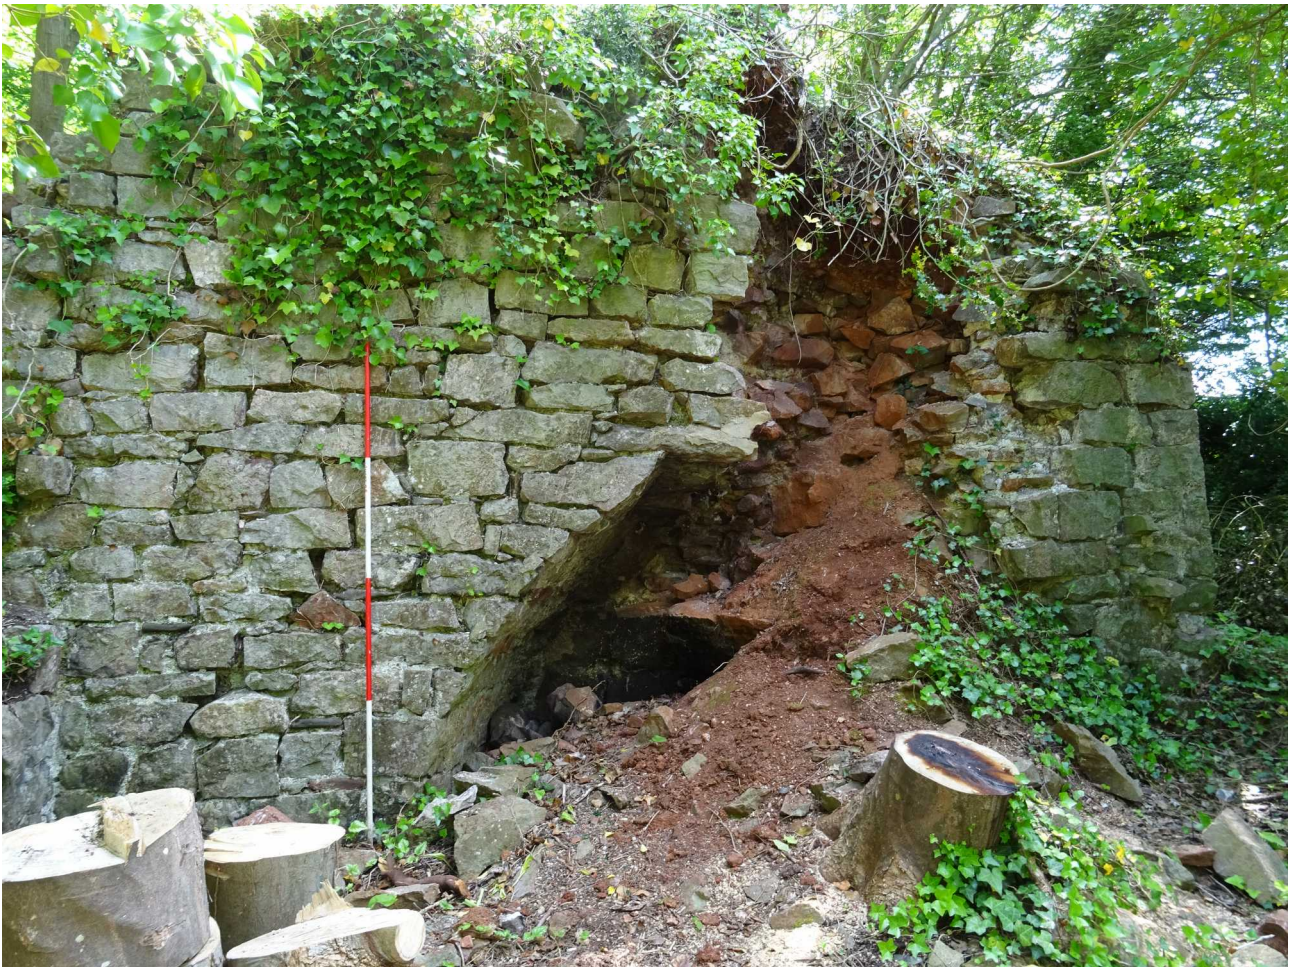
The majority of the structure (Fig 3 below) is intact, although a section above the 'vestibule' (front delivery area) has collapsed, revealing the severely heat affected interior. The southern side of the vestibule has also begun to collapse and some emergency attention should be given to this ASAP.

Otherwise, the kiln, consisting of the kiln, with its combustion chamber substantially intact, and a few corners lost, is in reasonable condition. The rear ramp for access by wheelbarrows to the combustion chamber is very worn down but still visible (a good example surviving on Mendip is at Fig 4), and the low bases of the walls to the working area in front of the kiln (oddly shown at its rear on the OS plan) are still be seen, as are some protruding stones from the kiln that once tied them in.

*Fig 3: Front view of MNS1126*

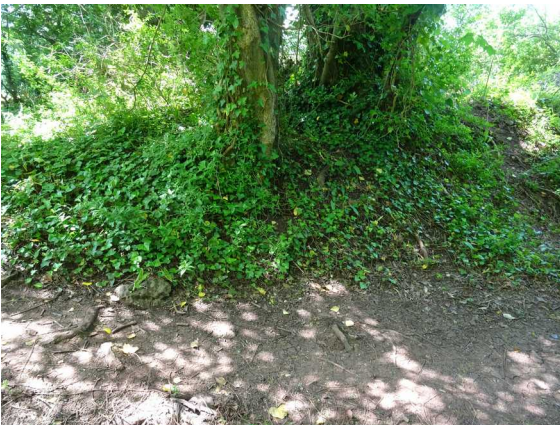
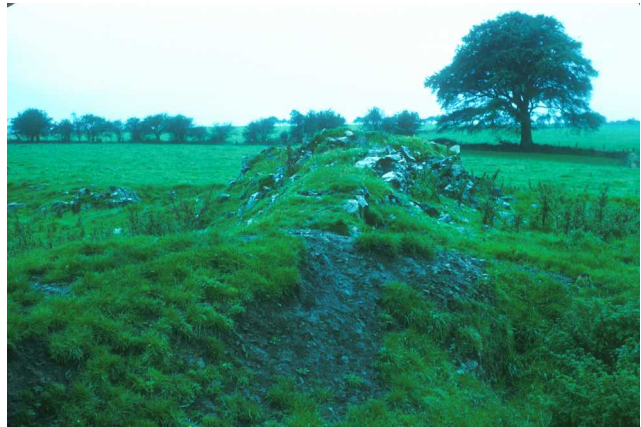
*Fig 4: Left: earthwork of ramp, MNS1126 Right: Surviving ramp at Charterhouse-on-Mendip*

It would be useful to do two very small evaluations to see how well the ramp and the working area walls survive, and if there is any future in replacing at least part of them as an educational feature.

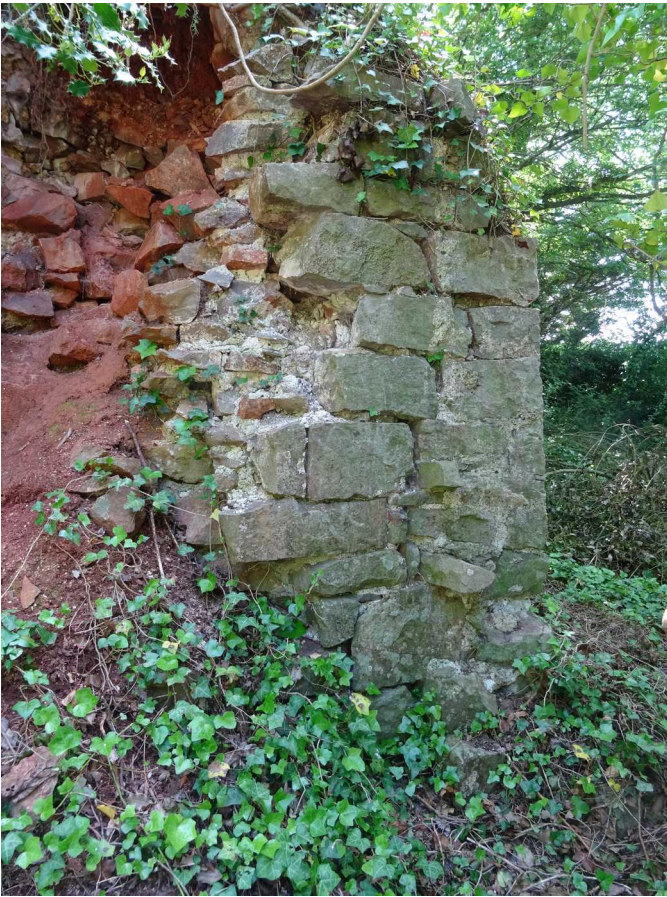
*Fig 5: The walls on the south (right) side of the kiln, with keying stones for the walls of the working area attached (now gone, but footings visible)*

Note that the front wall of the kiln, however, is not well-keyed into the front, and they have split apart.

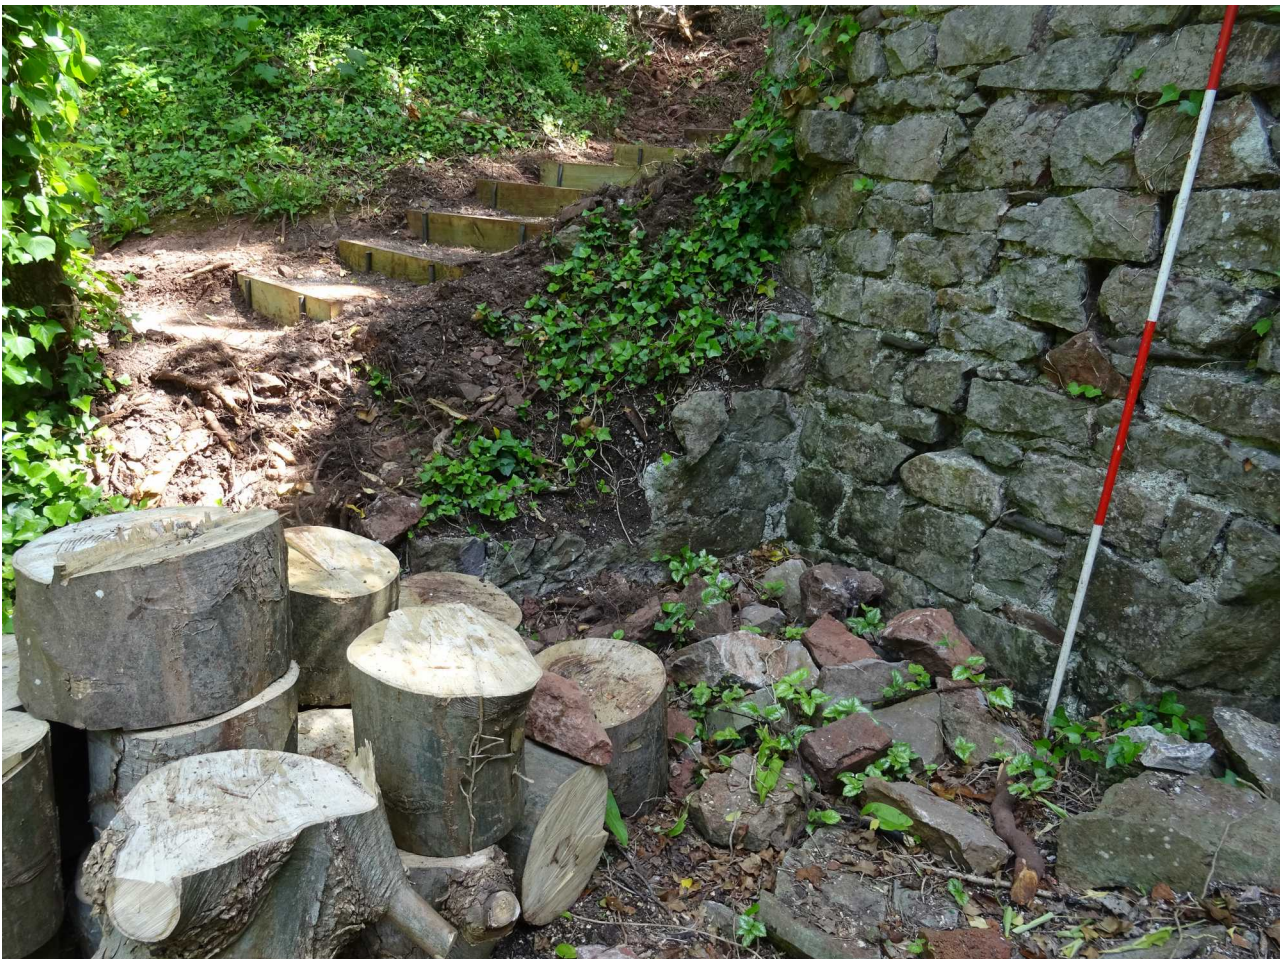
The left side of the kiln has a better-preserved section of the working area walls (see Fig 6 below).

*Fig 6: MNS1126: Left cheek wall of working area and front face of kiln*

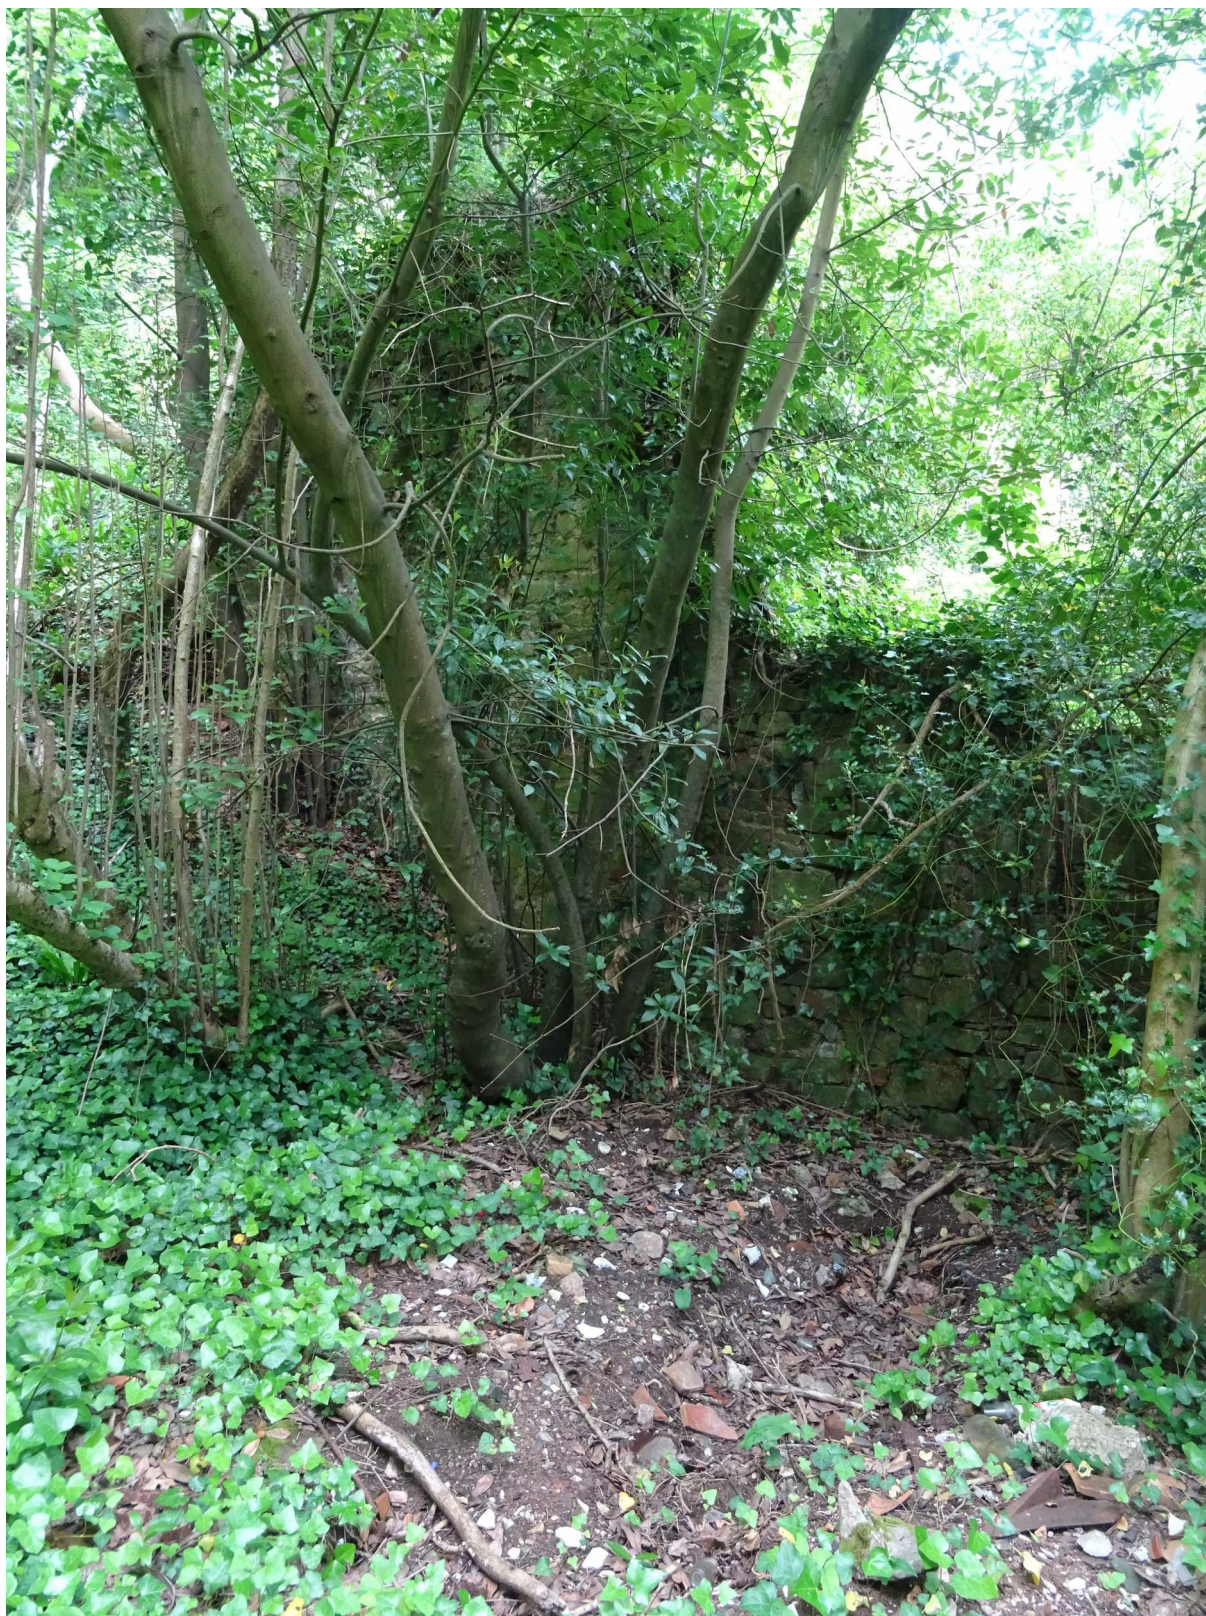
*Fig 7: Left side and wall of working area, eastern kiln*

The kiln is built against the rock, with entrance for charging the kiln at a high level, and exit for unloading at a lower level, hence the 'double-height' of the kiln and presumably its deeper combustion chamber and higher capacity.

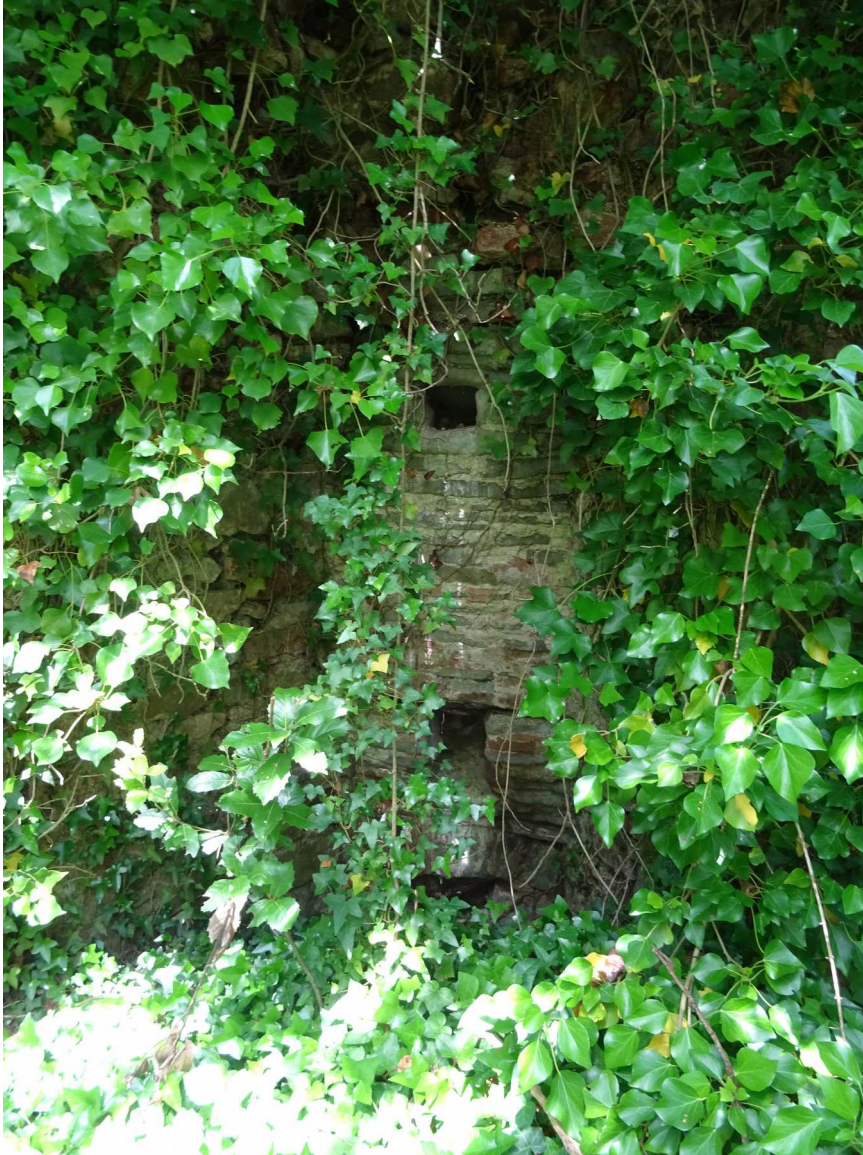
*Fig 8: Front of kiln, heavily overgrown*

This kiln appears to be also quite well-preserved, but it requires a structural engineers assessment before any work begins.
