**The Old Stone Crosses of Wroughton**

**YATTON, CONGRESBURY, CLAVERHAM AND CLEEVE ARCHAEOLOGICAL  
RESEARCH TEAM (YCCART)**

### Wrington 1: the Village Cross in Broad Street ST4696762797

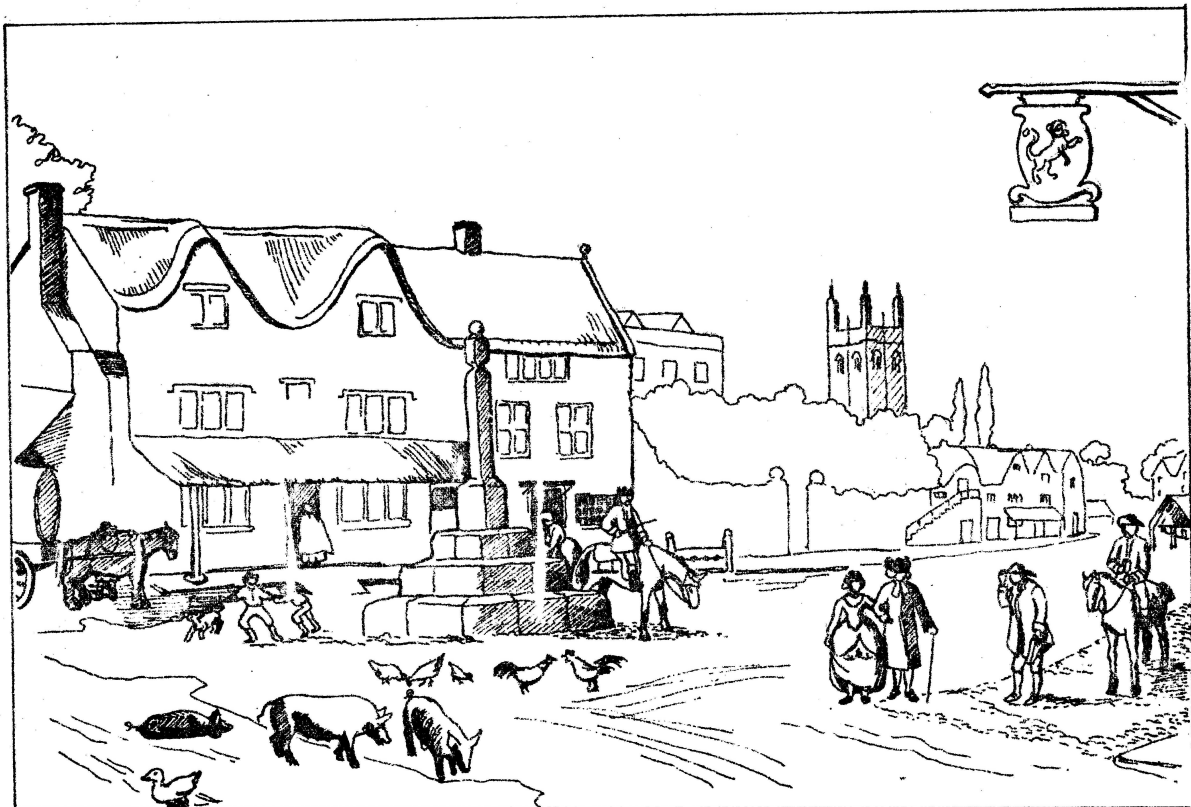
**BROAD STREET, WROUGHTON**

*From an 18th century painting.  
Property of Miss D. Wood, Wroughton.*

Broad Street, Wroughton 18th century scene, with village cross central (after Neale 1969)

Judging by the drawing (report cover), the village / market cross at Wrington had hexagonal steps, a similar hexagonal socket with a chamfered top, and a tall shaft with (apparently) a tall head with ball top, probably of post-medieval date. Judging by the figures around it, the whole cross was about 6m high.

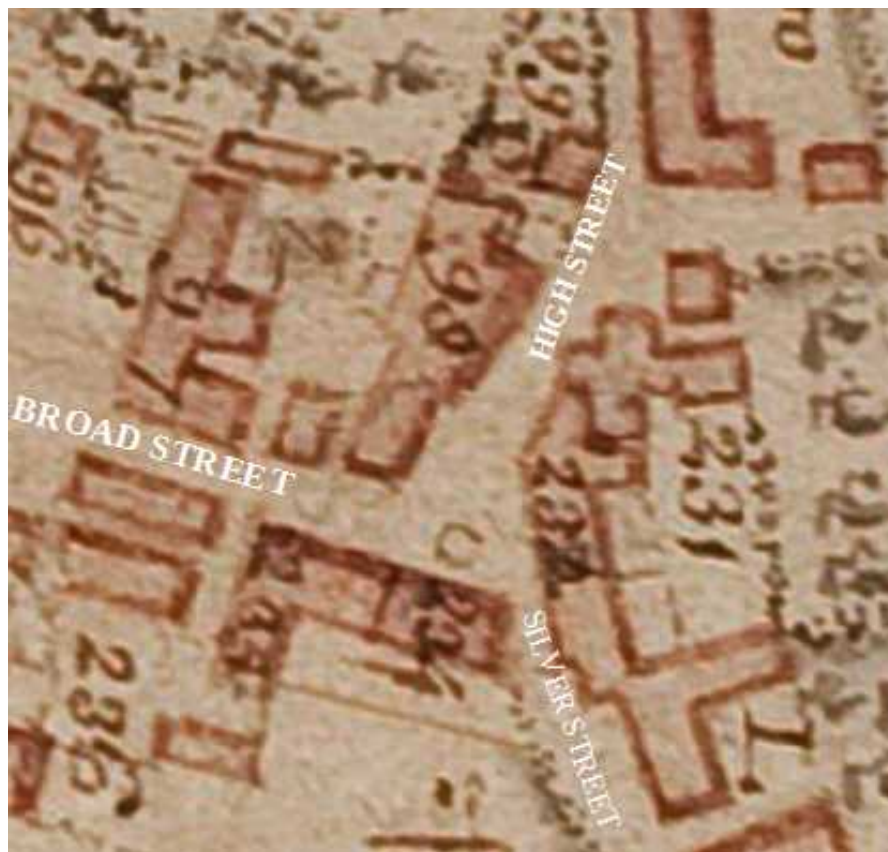
Fig 3: Site of the village/market cross in 1738

The 1738 map of Wrington shows a circle at the supposed site at the east end of Broad Street: Fig 3 (below).

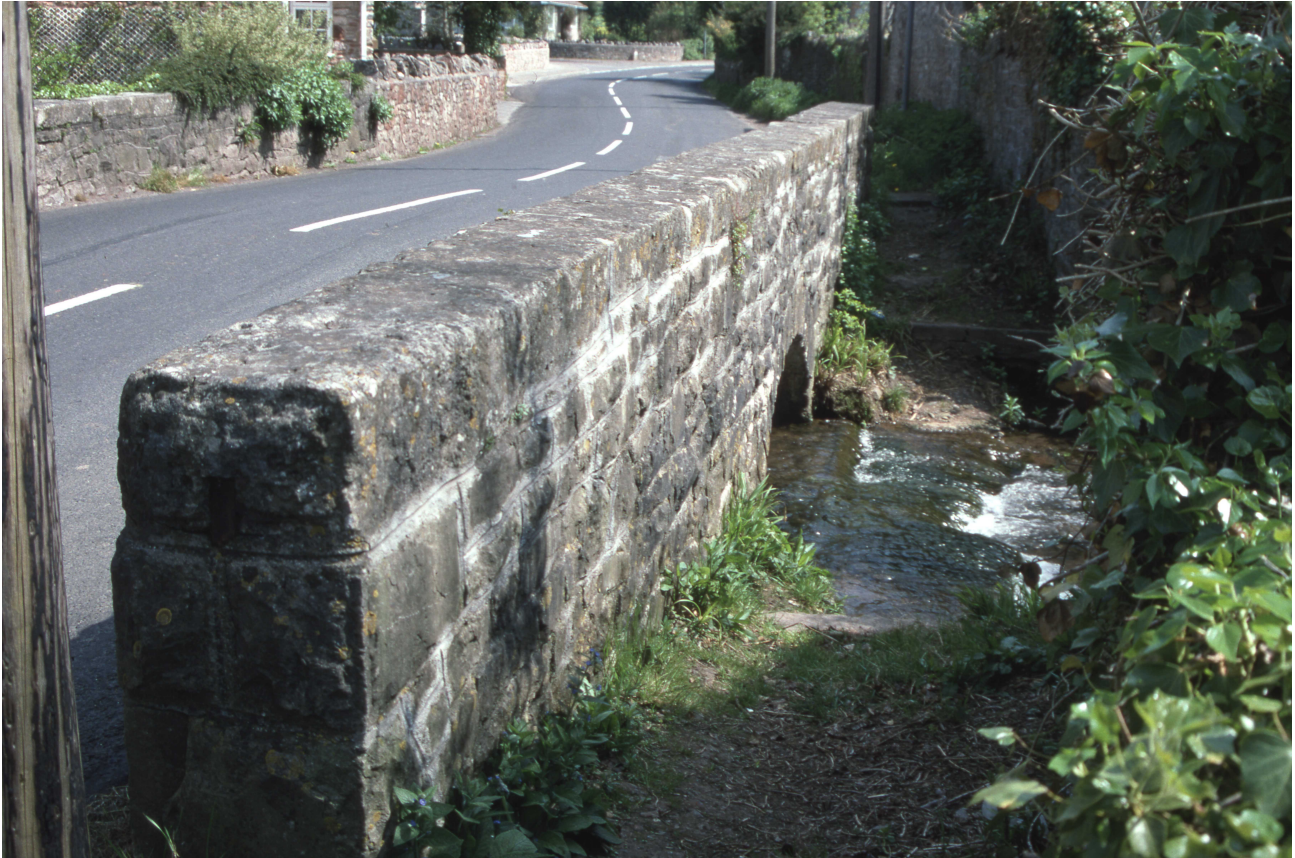
The bridge in question seems to have been Silver Street bridge (Fig 4) at ST 47146265.

*Fig 4: Silver Street bridge (1994), reputed to have been built with the stones of the village cross*

It is just possible that elements of Wrington village cross survive under the tarmac: this should be borne in mind when any road repairs are proposed in the area.

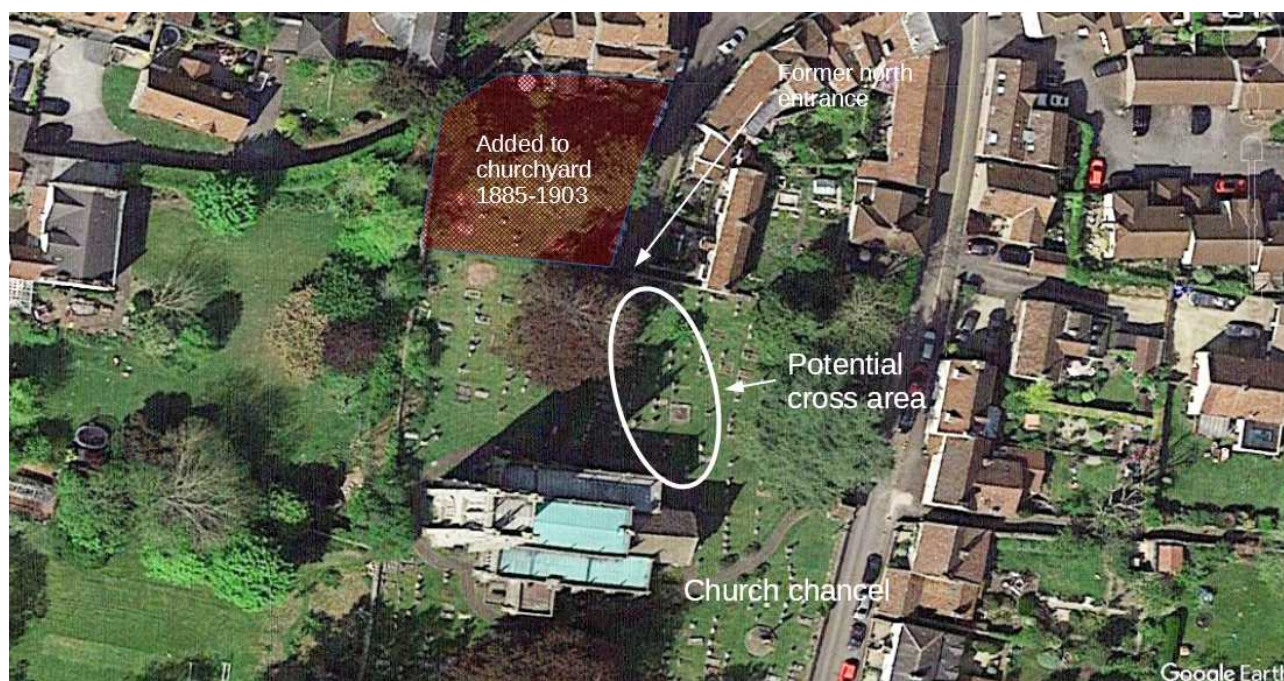
Although the churchyard has been extended (between 1885 and 1903: OS plans). the area between the 'north of the chancel' and the 'north entrance of the churchyard' (from The Triangle) is small: if the cross had a solid stone basement, as did Congresbury village cross, for example, (YCCCART 2016), this could perhaps be found by geophysical survey.

Fig 5: Potential site of churchyard cross, Wrington

In any event, there are several graves with dates varying from 1770 to 1810, which narrows down the space where the cross could possibly have stood. Unfortunately, the crop marks which might have betrayed the position of the cross, which were beginning to develop, have now been obliterated by rain which followed a hot and dry June (2023).

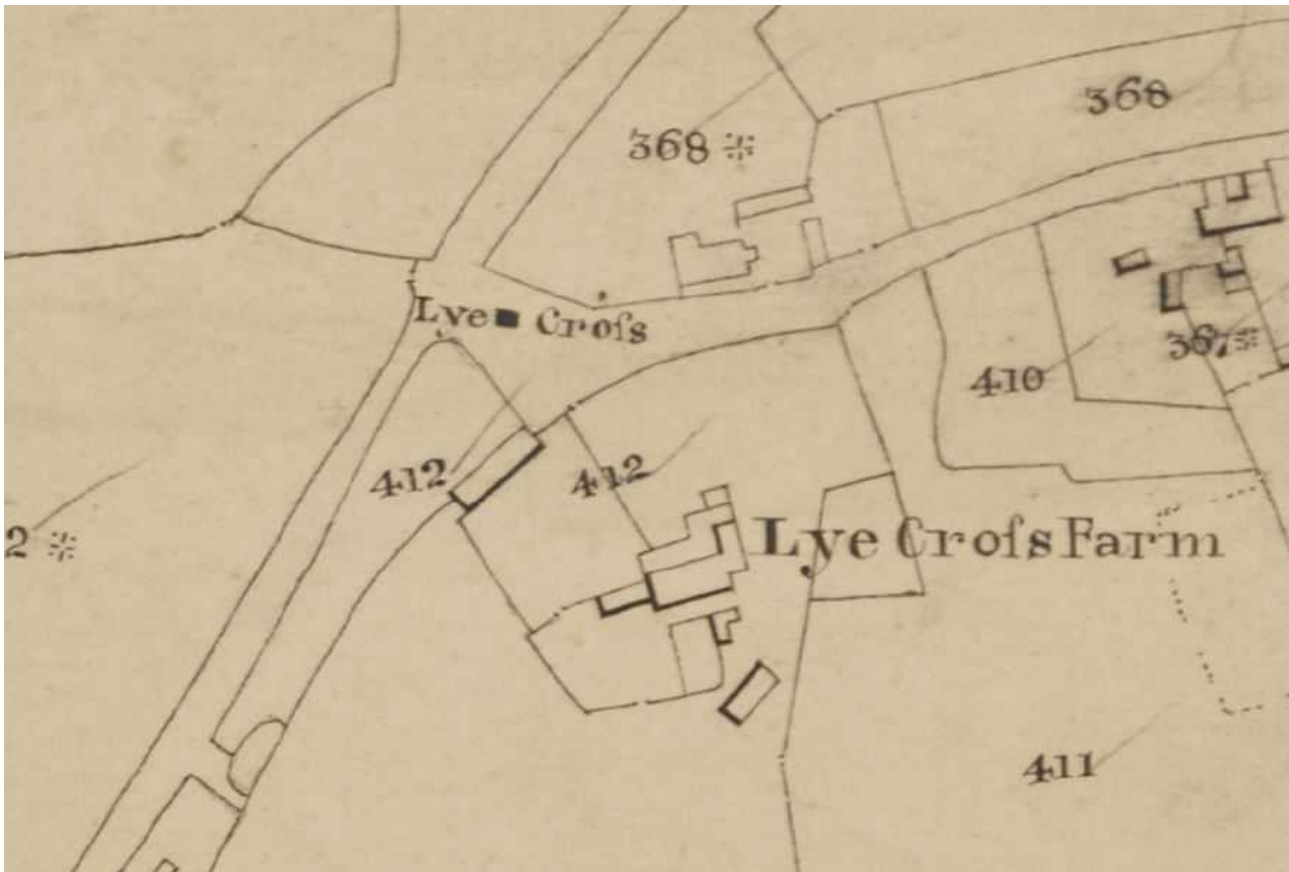
The only other reference to this cross is, unusually, on the Wrington Tithe Map. Tithe maps do not often feature crosses (Dundry churchyard is one of the few other exceptions in North Somerset), but the Wrington map (1840) features (alongside anachronistically long 's' text) the structure seen in Fig 7.

It clearly lies in the centre of the road junction, agreeing with the image in Figure 6.

*Fig 7: Lye Cross beside the A38 at Redhill*

Elements of the structure may survive under the tarmac: this should be borne in mind when any road works are proposed in the area.
