YCCART 2010/Y17

The Old Stone Crosses of Yatton: historical and photographic study
YATTON, CONGRESBURY, CLAVERHAM AND CLEEVE ARCHAEOLOGICAL
RESEARCH TEAM (YCCART)

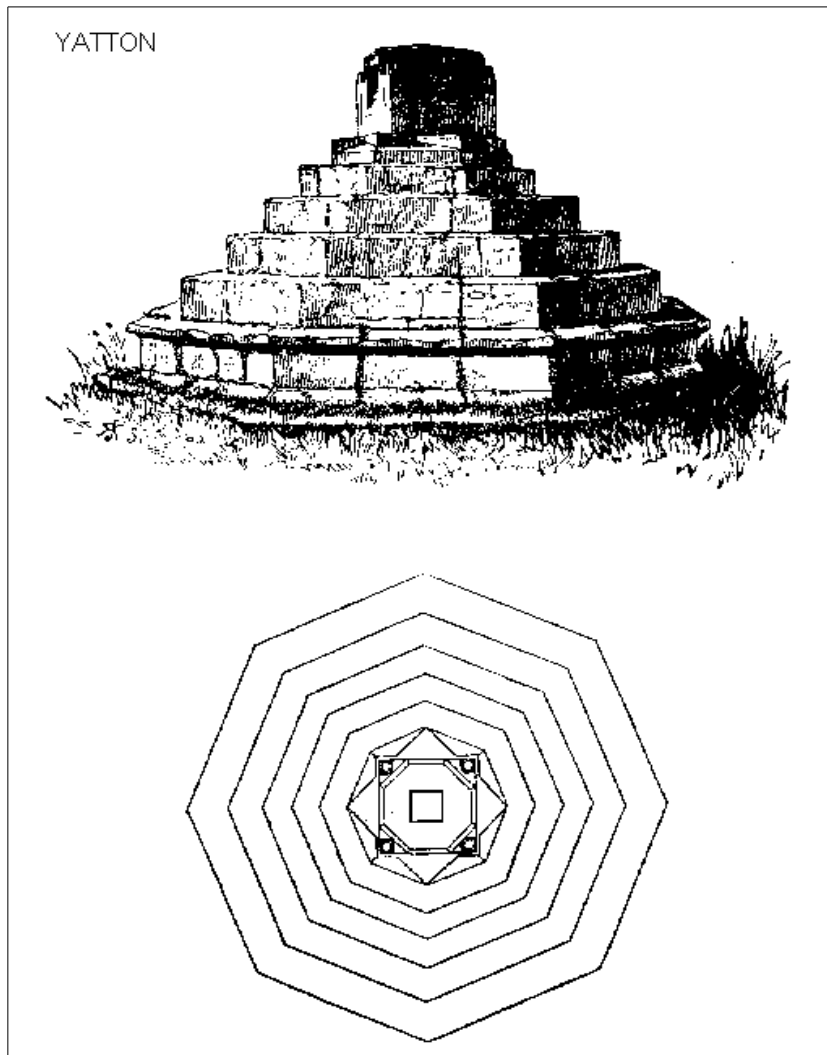
Fig 3: Depiction of the cross and plan in Pooley 1877

YATTON.-There are few remains of Crosses in Somersetshire that present proportions so grand as these. By the construction, and style of ornamentation, of the socket, its massiveness, and the lofty Calvary of six steps, it may well be supposed that the structure, when entire, was one of no ordinary beauty.

In plan it is octagonal. It is erected in the churchyard, opposite the south porch of the church, and covers a large area of ground. The socket is remarkable for the manner in which it is constructed. Its sides are set to correspond with the direction of the church, which is north, east and south-west. In its upper bed it is a true octagon, the alternate sides being worked, by slopes of double curves, into lesser octagons, which die away into square angle shafts by means of small broaches. On the north and west faces are oblong recesses, into which panels were evidently at one time fitted; on the south and east the panels remain in place. They measure 16 in. by 15 in., and are decorated with carved figures of angels robed, holding scrolls crosswise. A broken stump of the shaft is left in the mortise. The plinth, or top step, on which the socket rests, is effectively cut with sharp nosings, that form triangular tables similar to those of the crosses of Wraxall and Dundry. Of the six steps forming the lower stage, the basement only has an overhanging drip, and a convex set-off on the ground-line. It is no less than sixty-eight feet and eight inches in circumference.

Steps Each face		Height		Width		Socket Height		Square at base	
	ft.	in.	ft.	in.	ft.	in.	ft.	in.	ft.	in.
Basement	8	7	1	8	1	5	2	9	3	5
2nd step	5	9	1	3	1	1				
3rd step	5	0	1	2½	1	0				
4th step	4	0	1	0	1	1½				
5th step	3	2	1	0	0	10½				
6th step	2	4	1	0

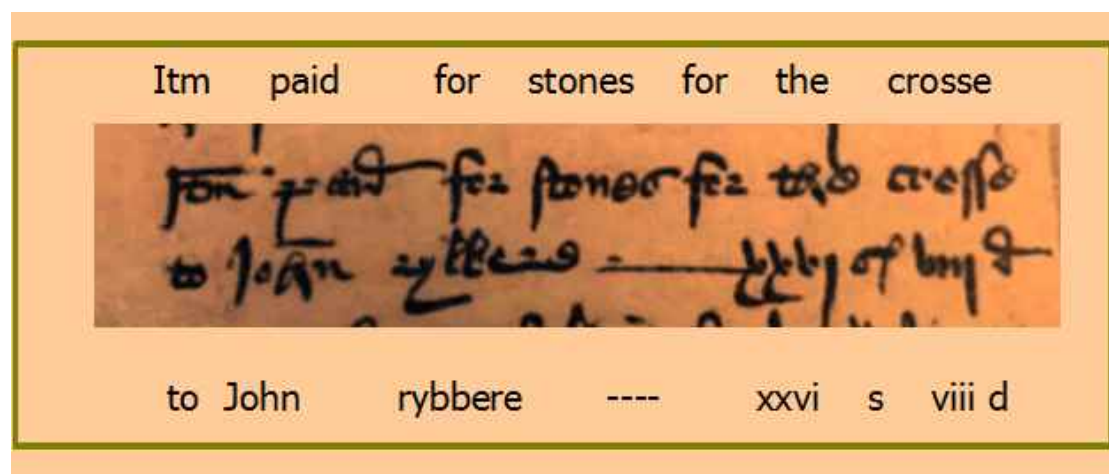
Fig 4: Item from Yatton churchwardens accounts 1525-6

The example above shows a typical entry in the accounts for 'stones for the crosse'

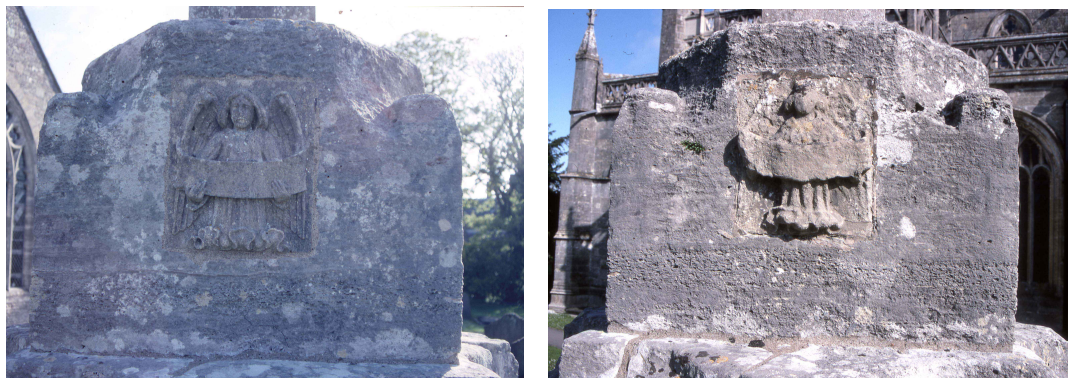
Fig 5: Inset carvings on W (1919) and S (medieval) sides of socket

These carvings of angels may well have been painted, and may even have had lettering on the scrolls: similar figures on the broadly contemporary Refectory at Congresbury bear the Latin tag 'LAUS DEO' (Praise God). It is noticeable that a 'gyltar' (applier of gold leaf) was paid 20 shillings at the time of the erection of the cross, but it is not specified for what he was paid. A further medieval inset and 1919 example survive on the E and N sides of the socket.

The missing two plaques in the socket, representing angels holding scrolls, were replaced with new at the same time.

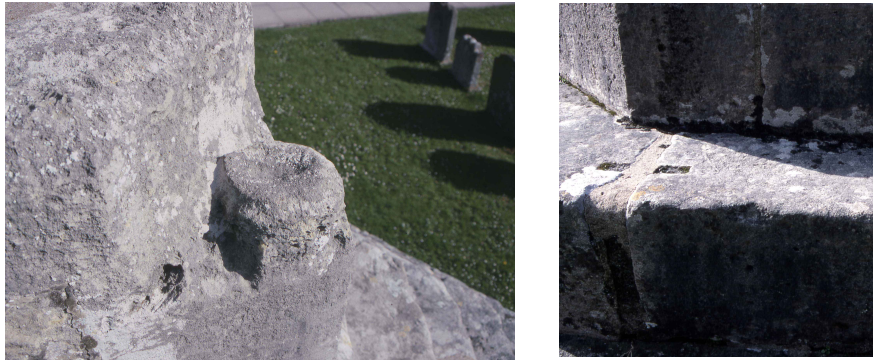
The dowel on the socket may once have held a carved figure. These dowels are known on other Somerset crosses, but no original figures survive. A restored example at Charlton Mackerell show this results in an over-cluttered monument, to 21st century eyes.

Fig 6: Dowelled feature on socket and cramp socket on step

The socket holding the shaft has unusual broaches. They begin as traditional rounded fittings, but each becomes a cylindrical feature at the top, with a recognisable shallow dowel hole in the top face of all four. These may therefore once have held figures. There are no dowels or other metal fittings in the cross. Two stones of the first step on the side closest the church have the scars of former iron cramps, although these have been removed, and their sites backfilled with cement.

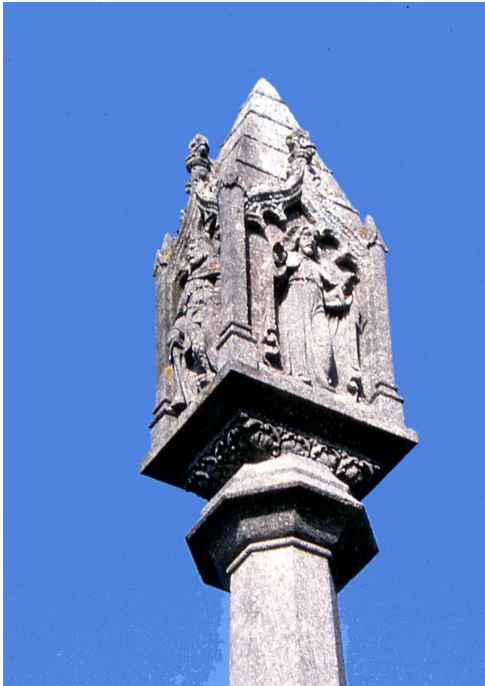
Fig 8: Head of 1919 from below

The cross, which is a Scheduled Monument, was restored and a new shaft and head added, in 1919, with the benefit of a faculty (SHC D\D/cf/1919/172).

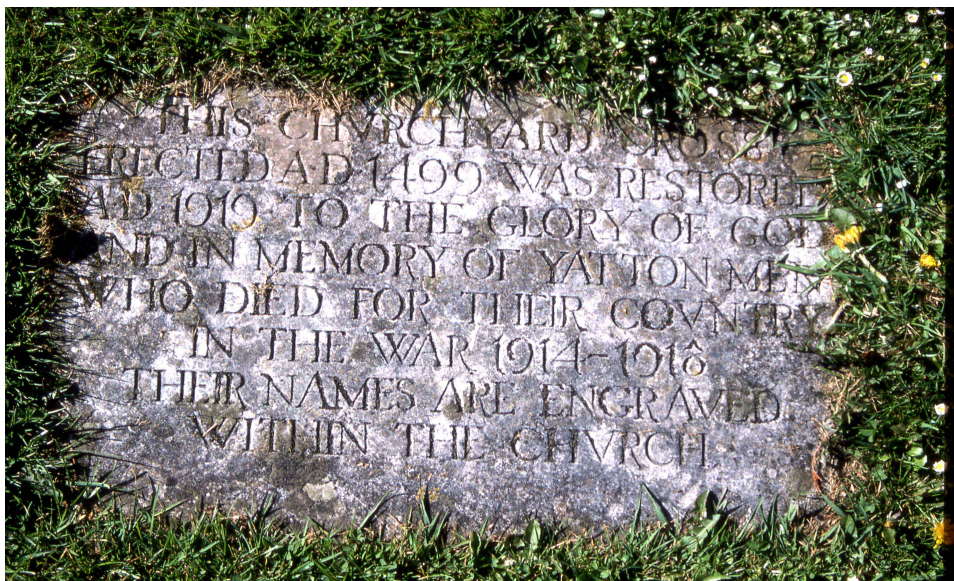
Fig 9: Plaque of 1919, set in the turf to N of the cross

This was intended for a war memorial, and is commemorated by a rectangular stone plaque, set into the ground below the cross on the side facing the church, bearing the incuse inscription:

'THIS CHVRCHYARD CROSS / ERECTED AD 1499 WAS RESTORED / AD 1919 TO THE GLORY OF GOD / AND IN MEMORY OF YATTON MEN / WHO DIED FOR THEIR COVNTY / IN THE WAR OF 1914 - 1918 / THEIR NAMES ARE ENGRAVED / WITHIN THE CHVRCH'.

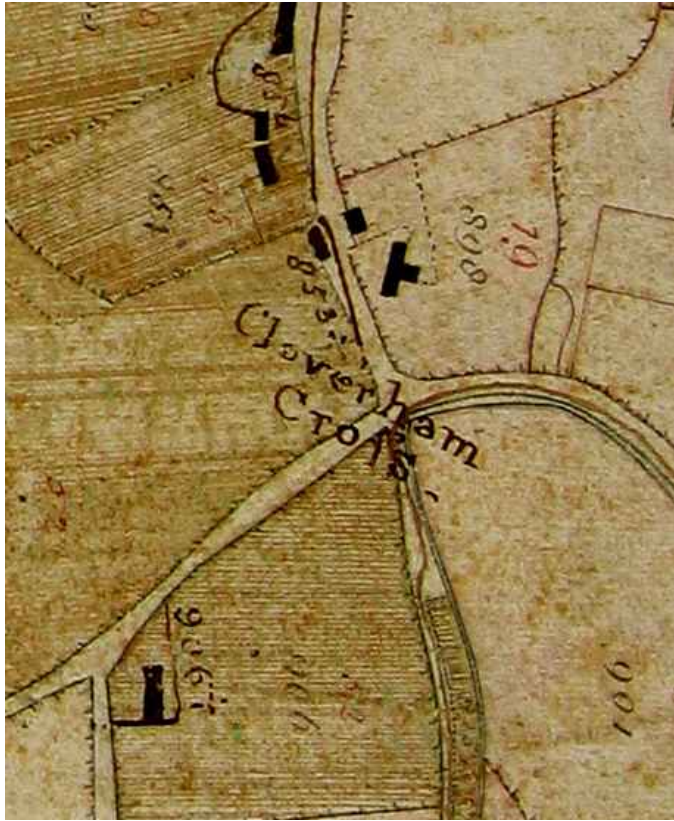
Fig 10: The depiction of Claverham Cross on the 1800 map

The map, which has been recorded by YCCART, shows a cross-roads named 'Claverham Cross', which is probably the name of the cross-roads itself, and does not indicate the former existence of a cross in itself.

A local story had it that stones from this cross had been built into the gable wall of 6-8 High Street at Claverham (the building in enclosure 18 / 898 in Figure 10 above), but I personally saw this building undergo very extensive rebuilding in 1997, and saw no evidence of such.
