**Observations on wall repairs at Woodspring Priory, Kewstoke, North Somerset**

**YATTON, CONGRESBURY, CLAVERHAM AND CLEEVE ARCHAEOLOGICAL  
RESEARCH TEAM (YCCCART)**

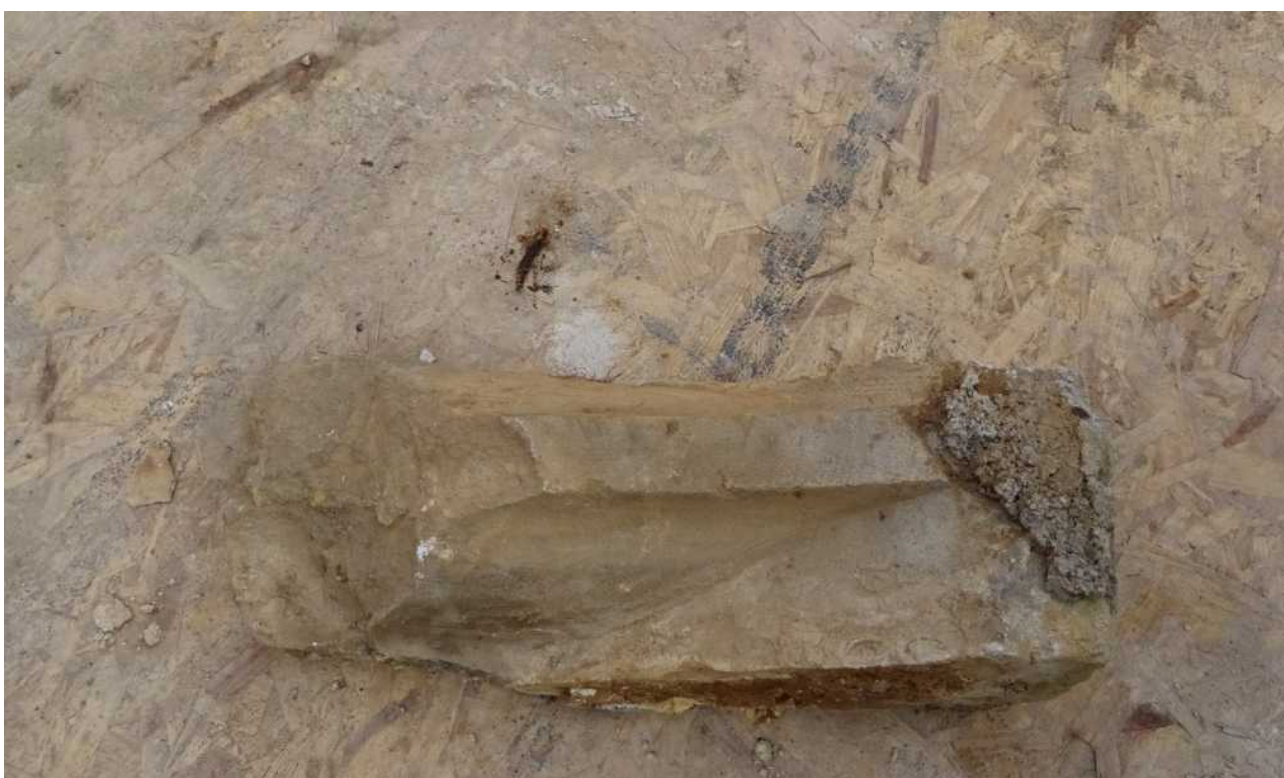
*Fig 11: Section of ovolo-moulded widow column, with sloping sill (approximately 45cm long)*

Several small pieces of previously worked Dundry freestone were recovered: a fragment of door upright with a *cyma reversa* moulding 30cm in length; two other fragments with similar moulding, also approx 30cm long (none fitting together); a complex fragment of what appears to be part of a carved widow (see Fig 11 above), a flat section of stone with a rebate in one side (possibly a column base? (see Fig 12), and finally, at the base of the wall a corner of a Tudor freestone fireplace (see Fig 13, and discussed below).

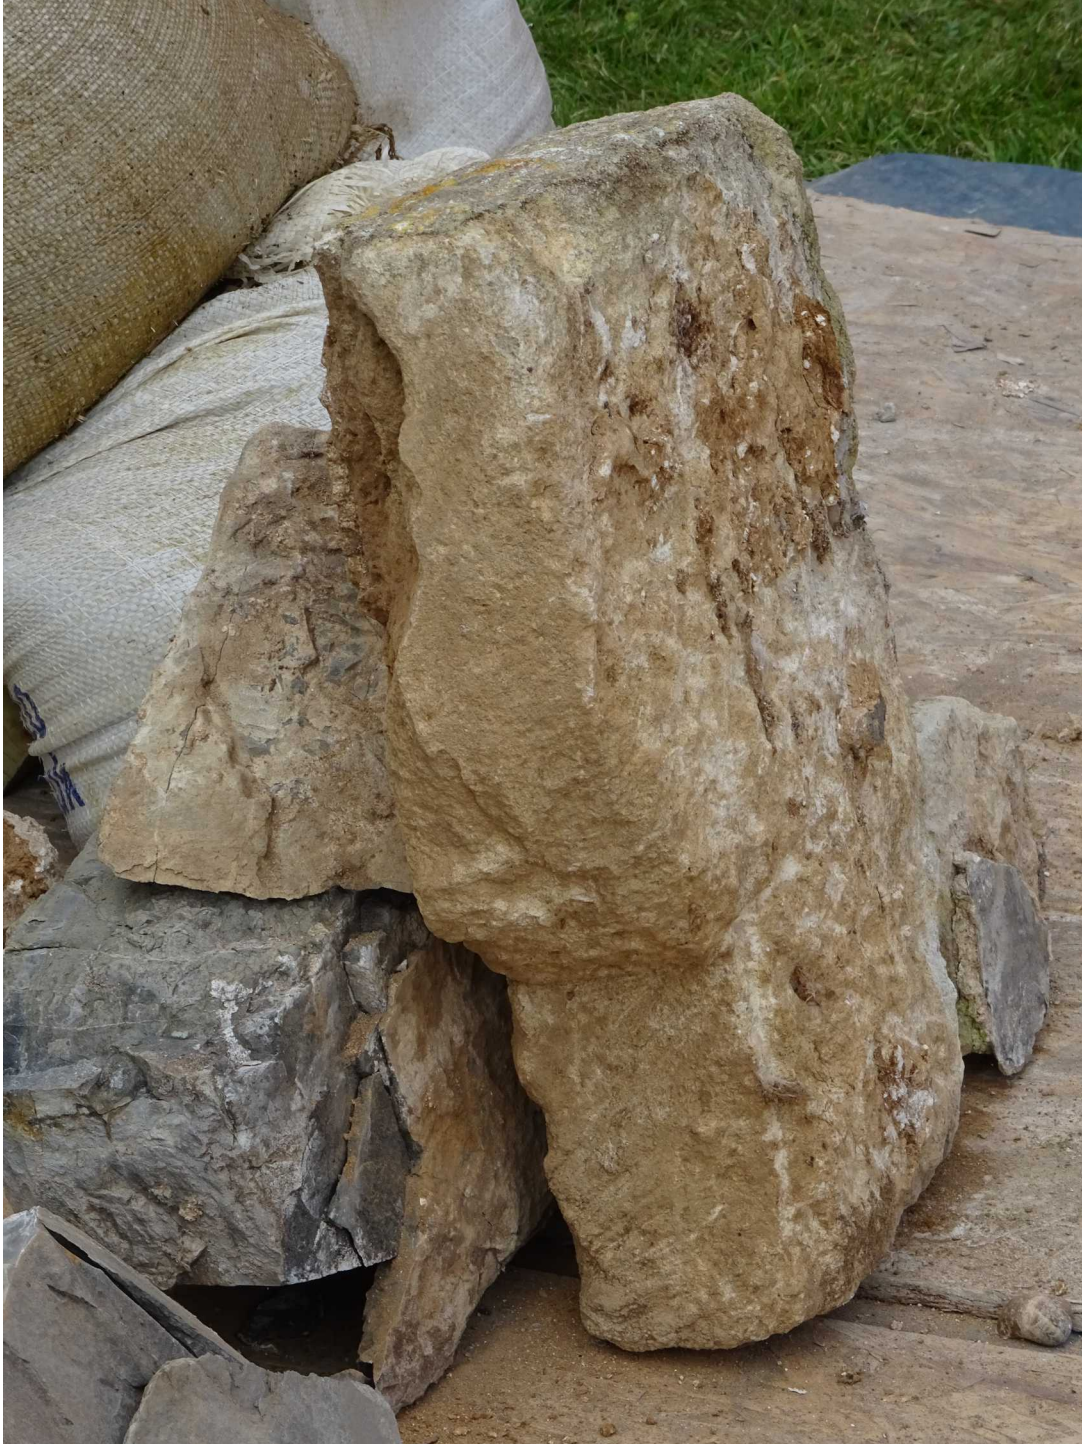
Fig 12: Freestone block with rebate: possibly a column base or plain corbel: re-used in wall as quoin. Length 45cm.

Apart from the stone in Fig 11 and this stone, all other freestone was either undecorated quoin, or used as fill in the centre of the wall.

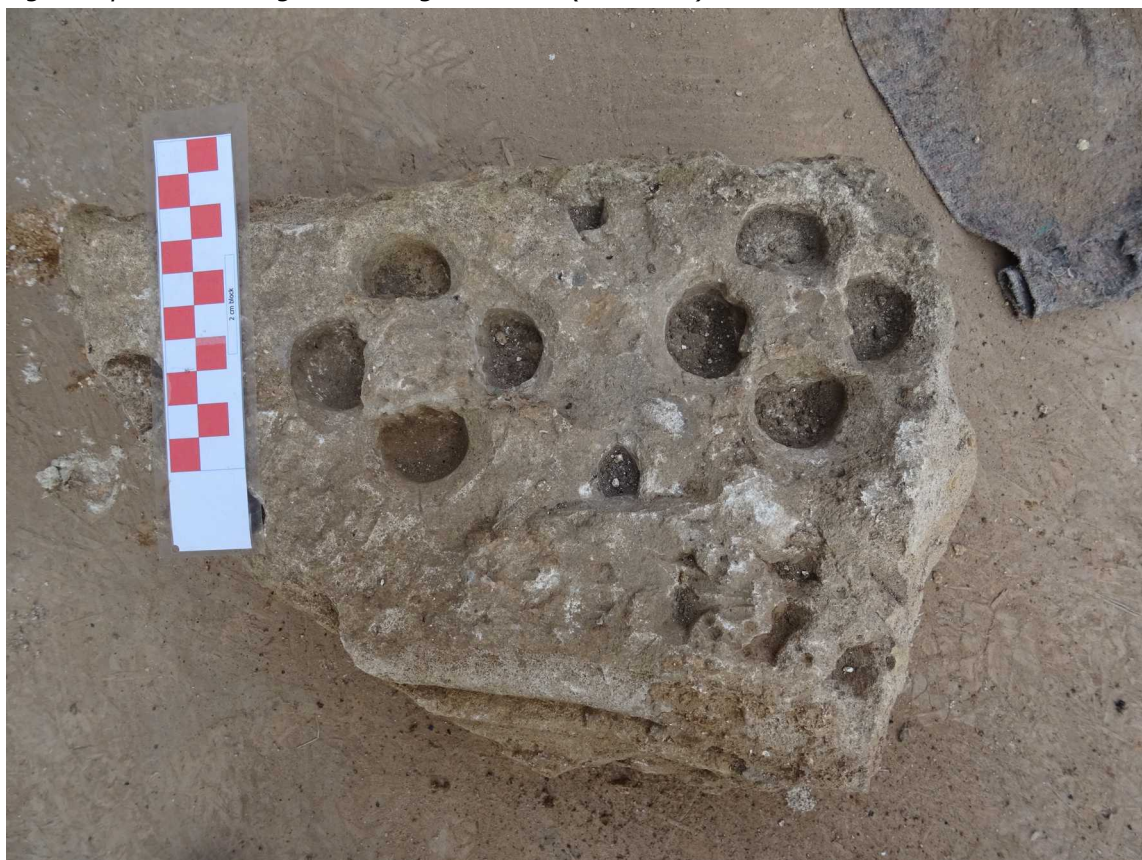
*Fig 15: Two complete quatrefoils, with evidence for other structures in their centres.*
