Observations on wall repairs at Woodspring Priory, Kewstoke, North Somerset

**YATTON, CONGRESBURY, CLAVERHAM AND CLEEVE ARCHAEOLOGICAL
RESEARCH TEAM (YCCCART)**

Collapsed section of wall on east side of cloister, Woodspring Priory

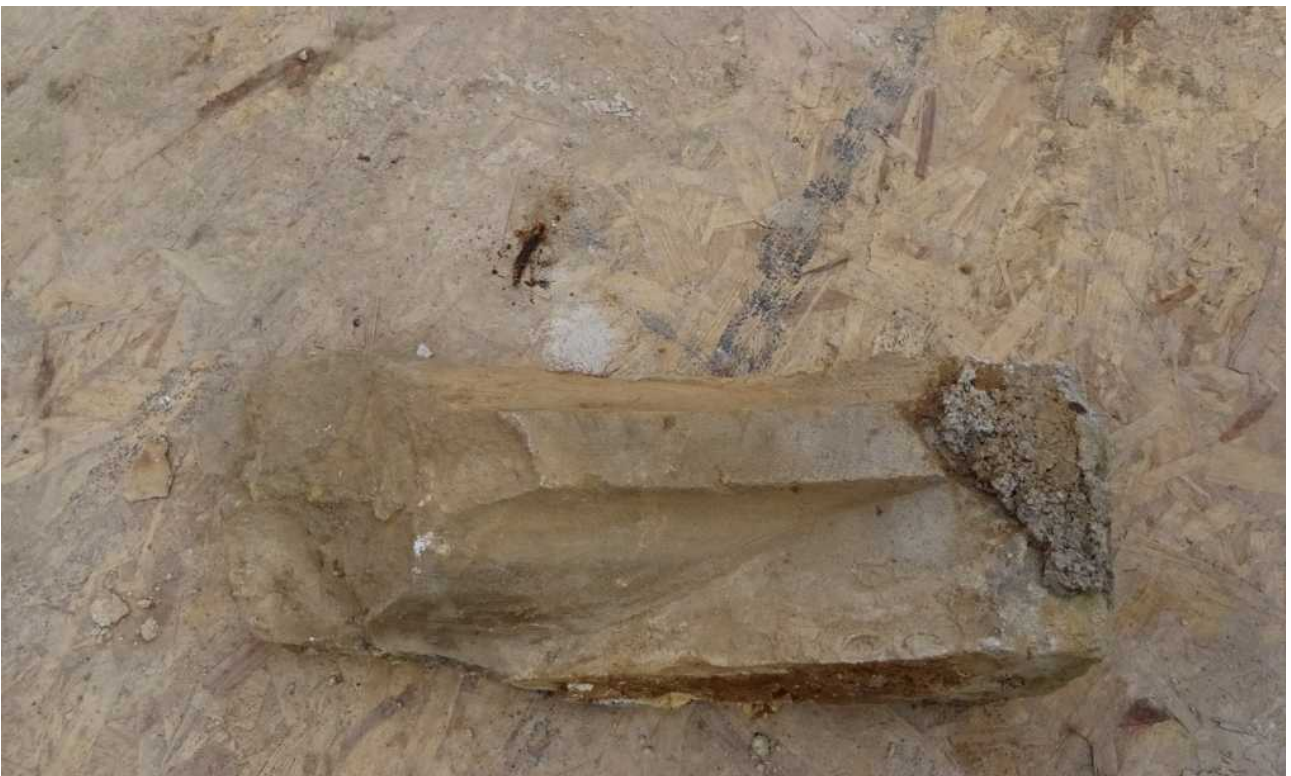
Fig 11: Section of ovolo-moulded widow column, with sloping sill (approximately 45cm long)

Apart from the stone in Fig 11 and this stone, all other freestone was either undecorated quoin, or used as fill in the centre of the wall.

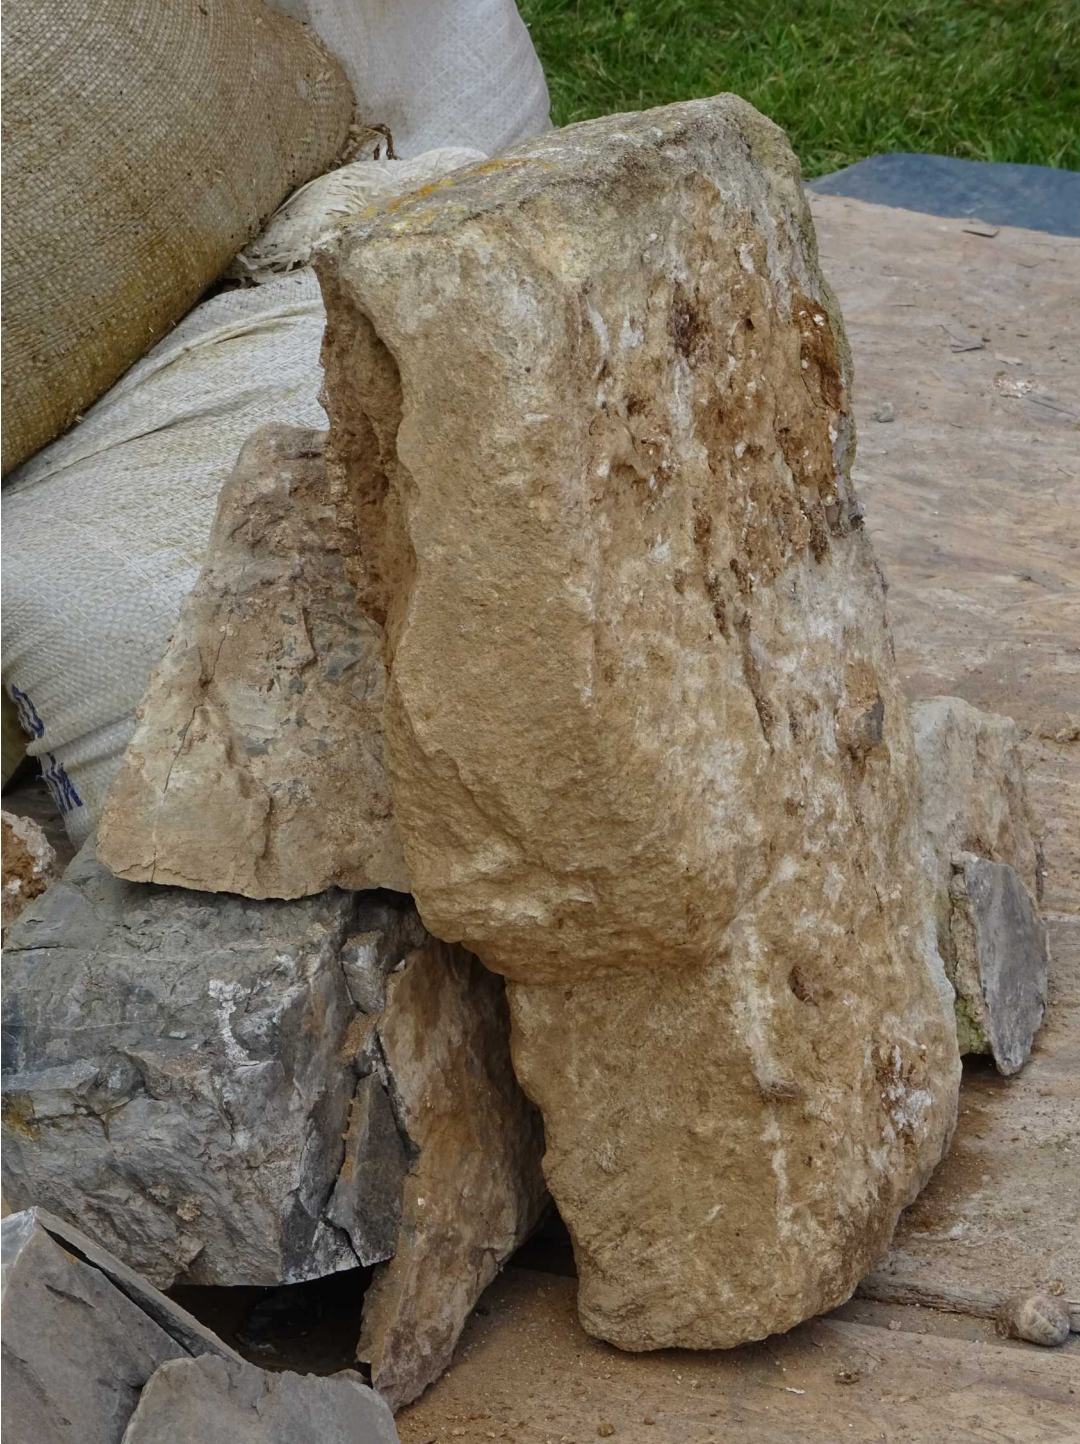
Fig 12: Freestone block with rebate: possibly a column base or plain corbel: re-used in wall as quoin. Length 45cm.

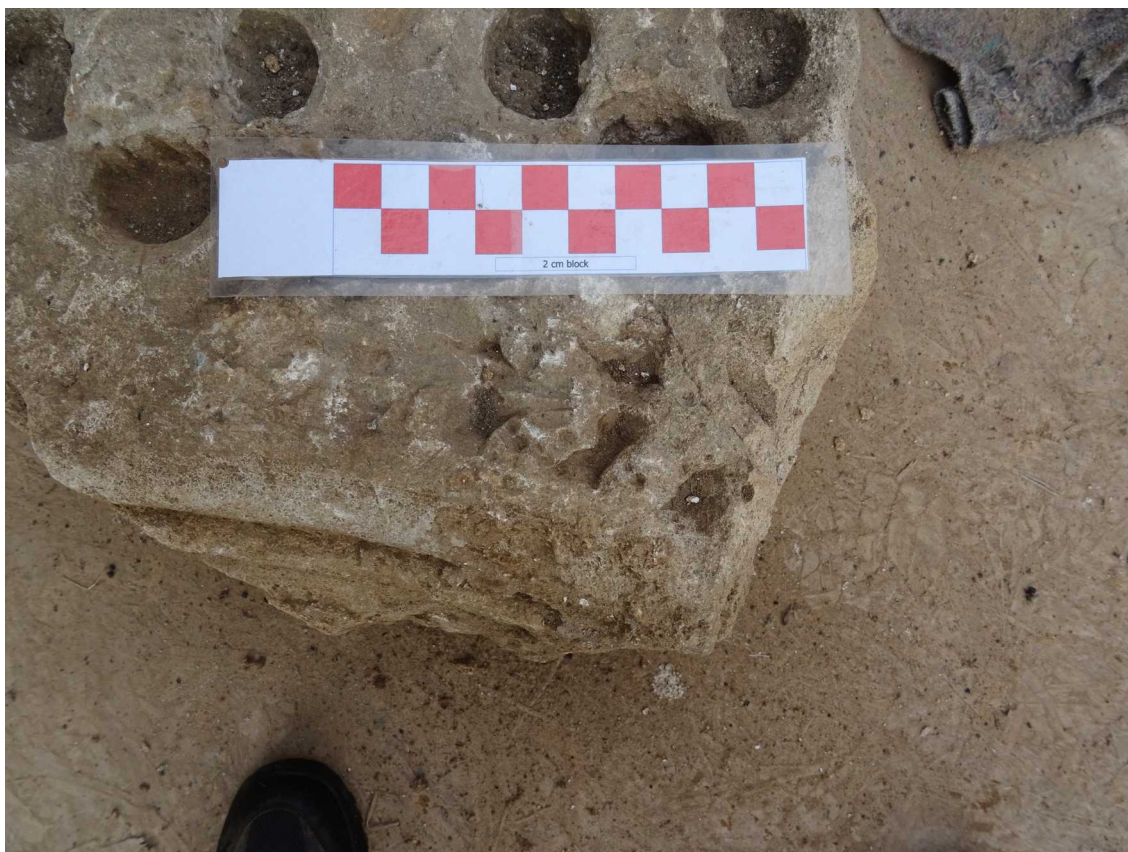
The stone is very worn, and may have been exposed to the weather, or even adapted for a different use subsequent to being a fireplace, as its back has been chiselled hollow (see Fig 17), possibly for use as a surface drain.

The stone is a maximum of 58cm across, 43cm high and 28cm deep. Some mortar is retained in the photographs, because (ironically) this was concrete hard and was deliberately not removed for fear of damaging the stone further.

Fig 14: Spandrel carving at lower right of stone (2cm scale)

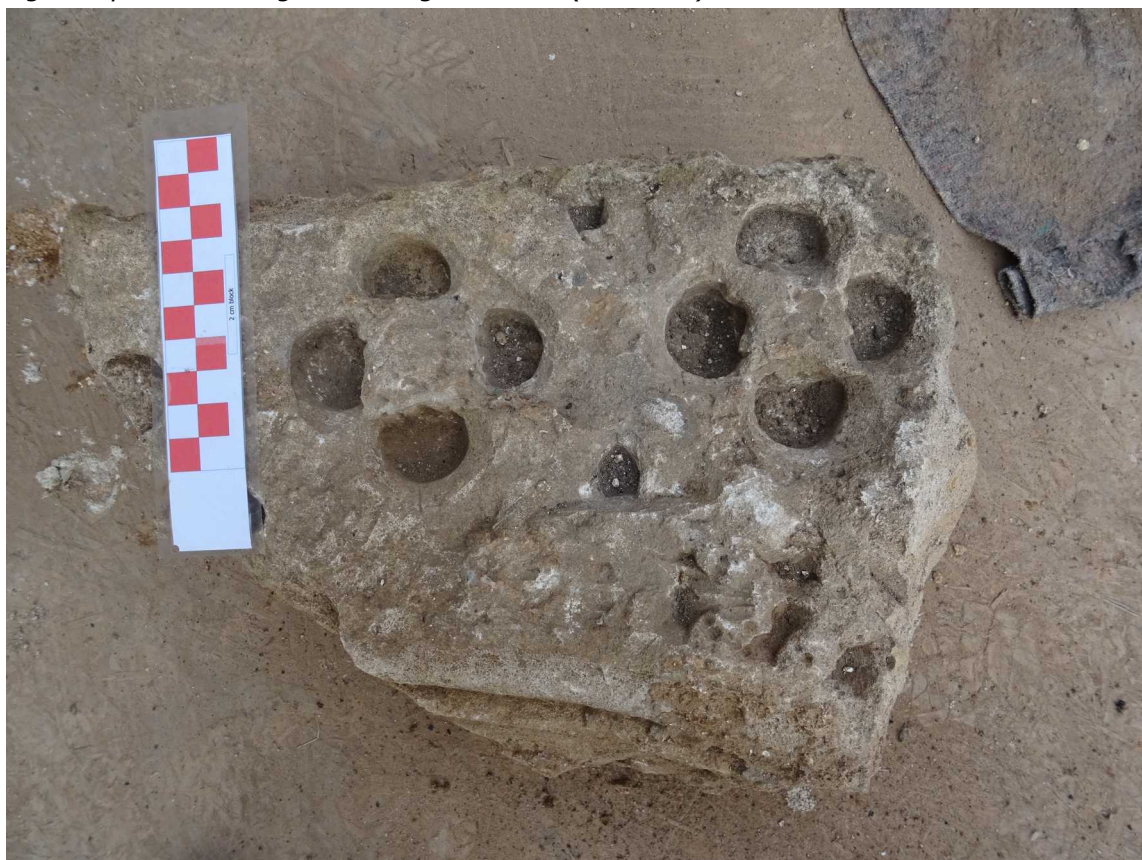
Fig 15: Two complete quatrefoils, with evidence for other structures in their centres.

The quatrefoils have deep hollows with flared rims: could these have held affixes? There seems from the faint marks on the lower edge of the face, some attempt to either mutilate the stone, or possibly, to prepare it for plastering over.

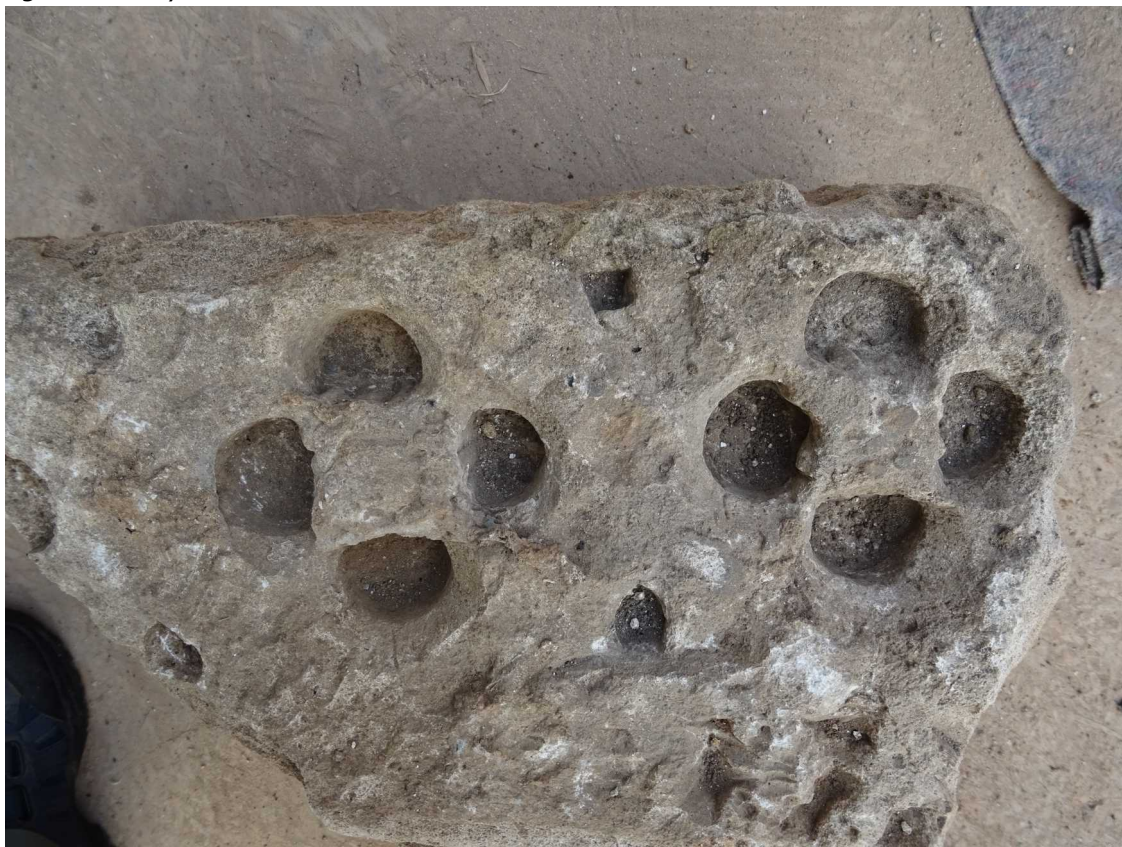
Fig 18: Close-up of quatrefoils and damage to face of stone

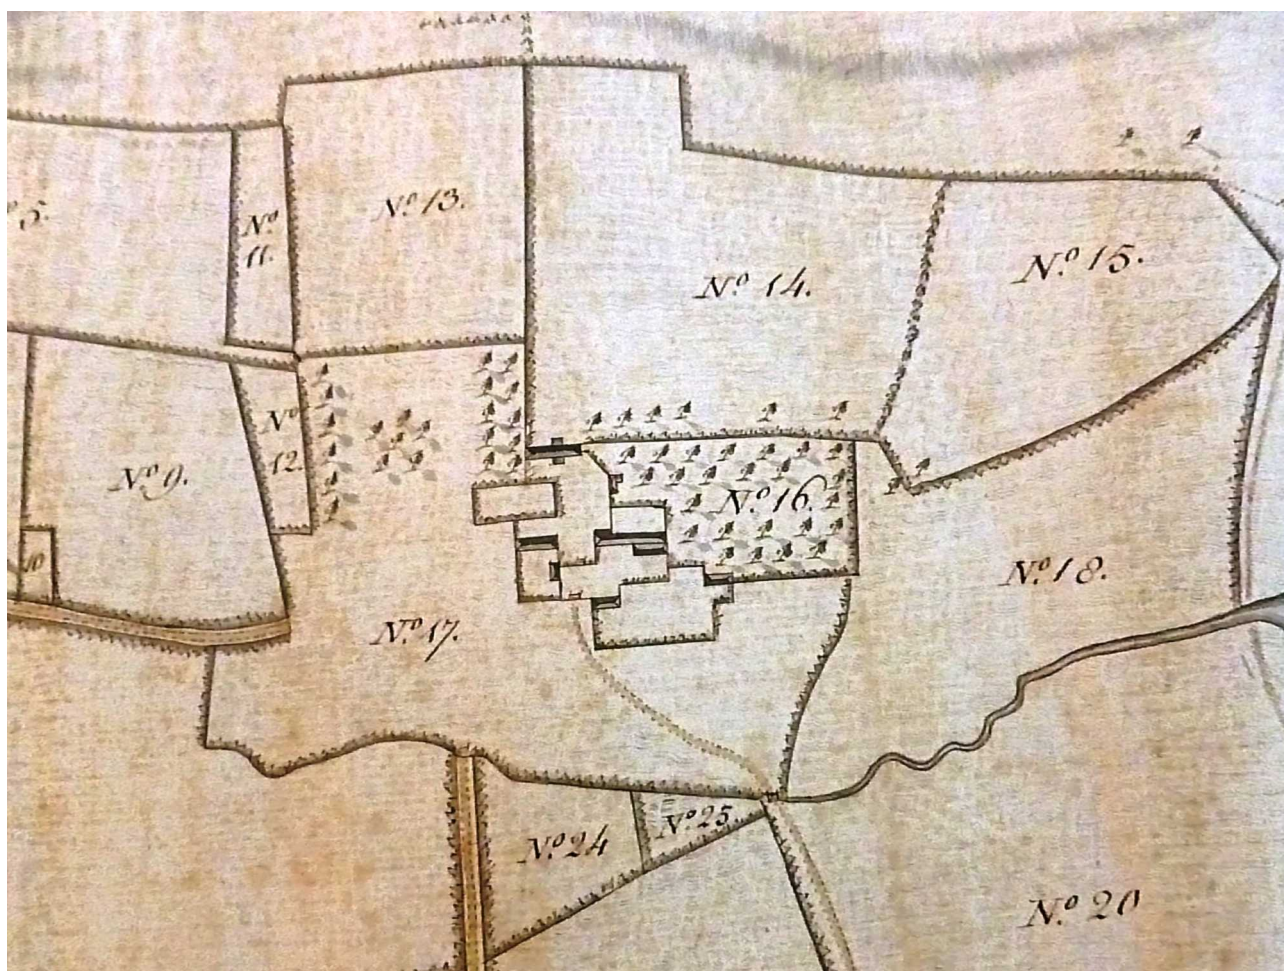
The surviving walls at Woodspring clearly have long and complicated histories, as the map of 1768 shows (Fig 22 below)

A moment's inspection shows immediately that (for example) the E-W wall running from the infirmary building to the external wall on the west, along the south of both the cloister and the garden, butts up to both the infirmary building and to the external wall (and it also contains fragments of re-used carved freestone. There is also insufficient room for the stair in the south-west corner of the cloister to be complete.

Fig 22: 1768 Pigott map of Woodspring, showing very different wall-lines to those present today.
