YCCCART 2022/Y11

**Watching brief for Landmark Trust on wall repairs at Woodspring Priory
2021-2022 Reports: PART 1 Introduction and walls 1 - 7**

**YATTON, CONGRESBURY, CLAVERHAM AND CLEEVE ARCHAEOLOGICAL
RESEARCH TEAM (YCCCART)**

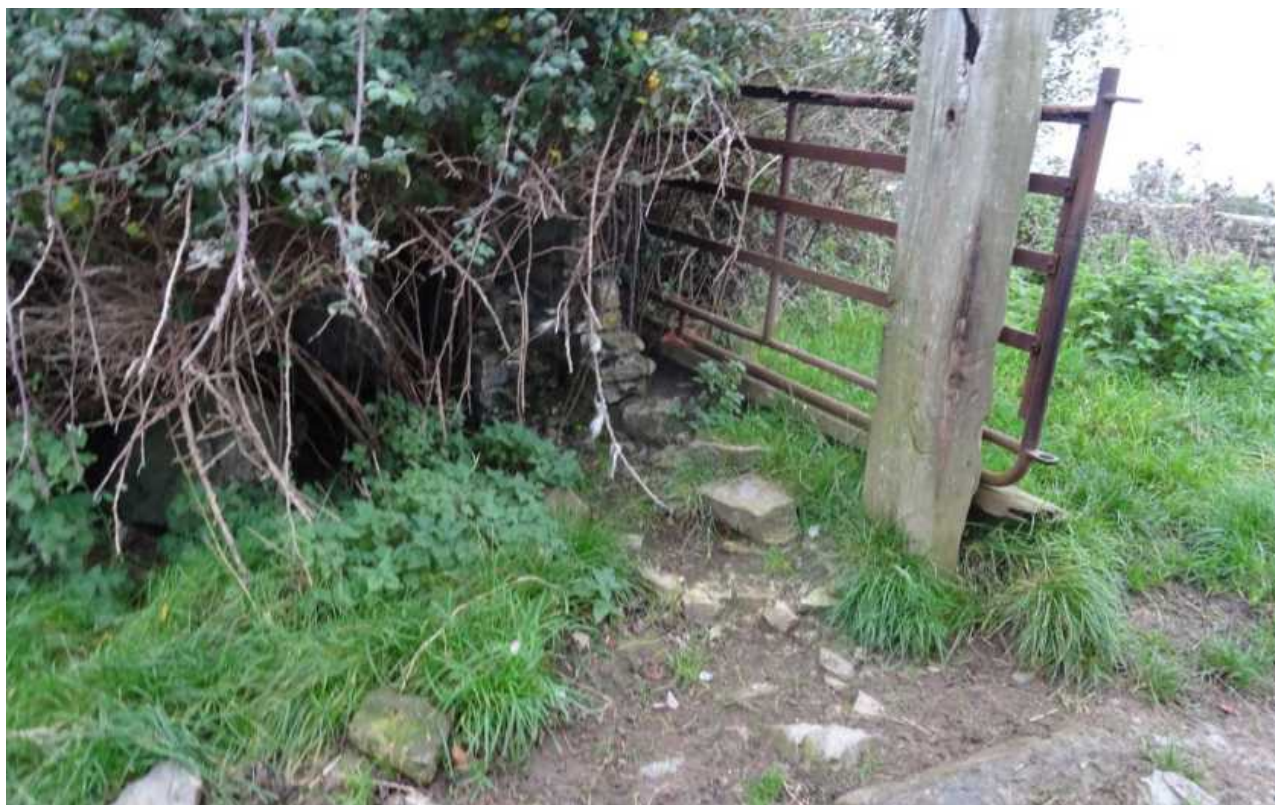
The wall also once extended further north than today: an extension can be seen in the gateway some 15m north of the walls current end (Fig 20). This may relate to a known rearrangement of the field walls around the site between maps of 1768 and 1840 (Figs 40 & 56).

Fig 20: Gateway in field to north, showing former continuation of wall 4 to north of wall 3

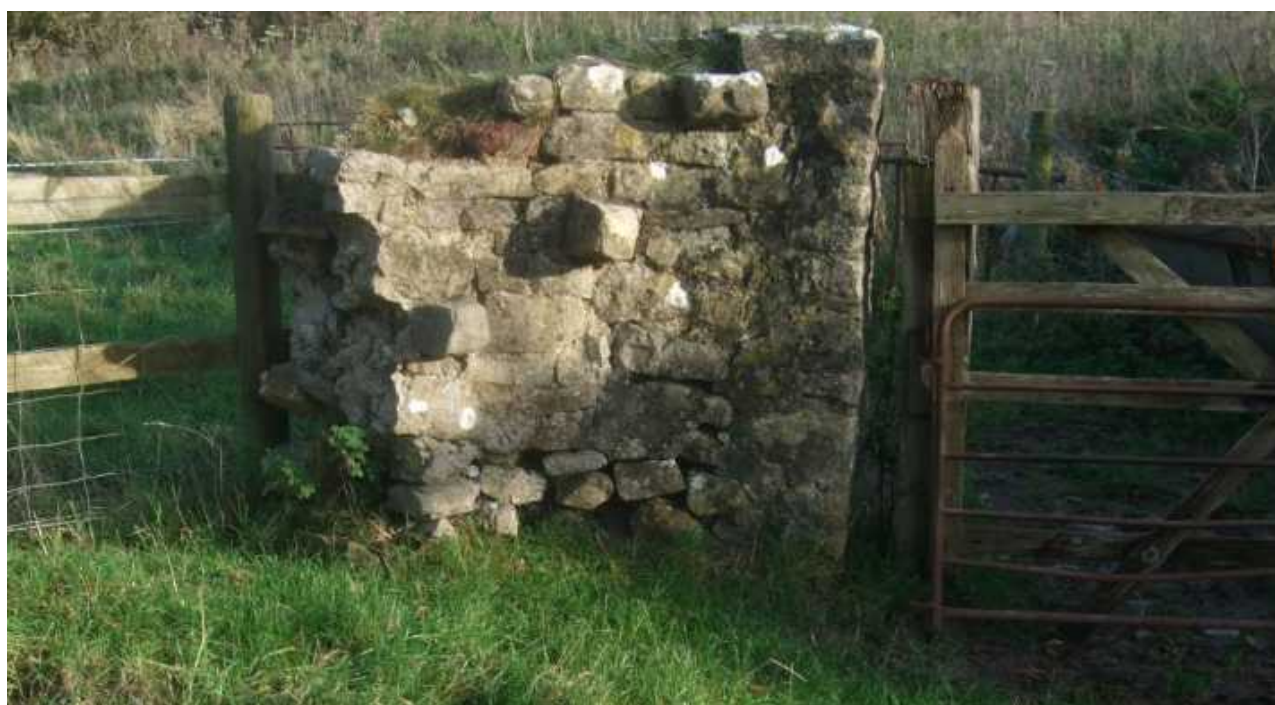
At the southern end of the wall, a series of integral through-steps next to the gate (Fig 21) may imply a way to cross the wall while the gate remained shut, possibly as a means of stock control. These are integral to the original wall.

Fig 21: South end of Wall 4, showing through-steps by gate (2011)

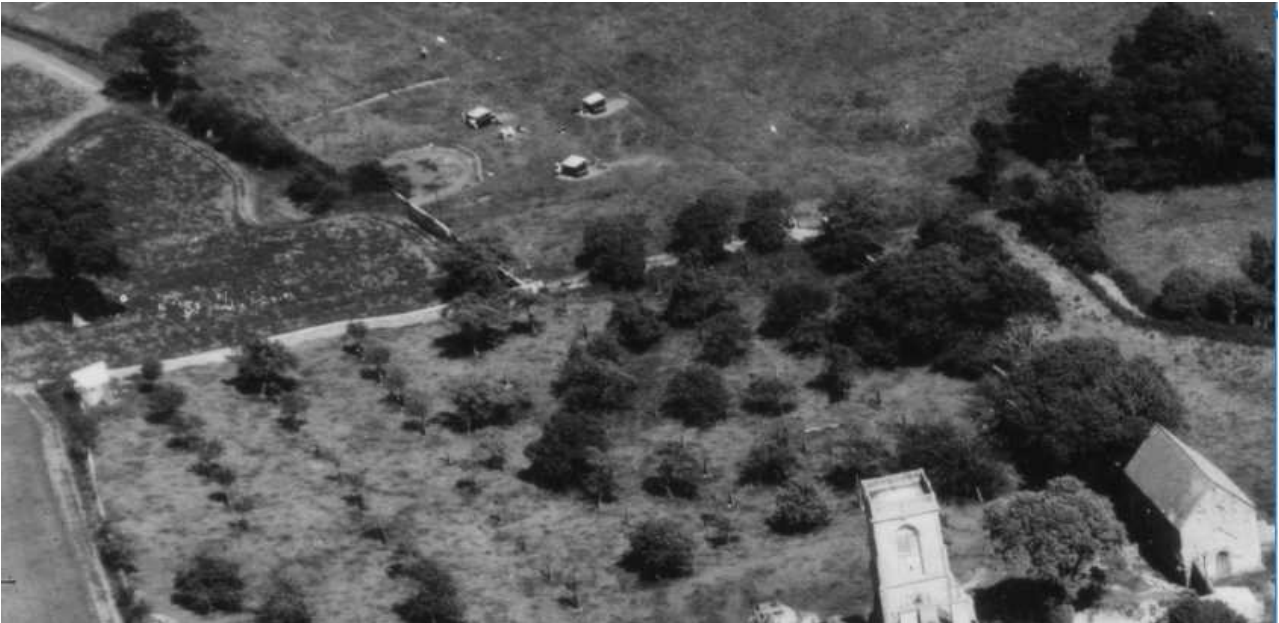
A further significant section of wall 4 towards its southern end had been reduced to foundations at an unknown date: air photographs of 1949 (Cambridge University CE003) (Fig 22) show the line as already ragged, but not as reduced as at present. This may be one of several possible alterations during WW2 (such as the new gateway in wall 19 - see below) and perhaps are responses to wartime agricultural conditions.

Fig 22: Wall 4 in 1949: note the northern section appears freshly repaired at that date

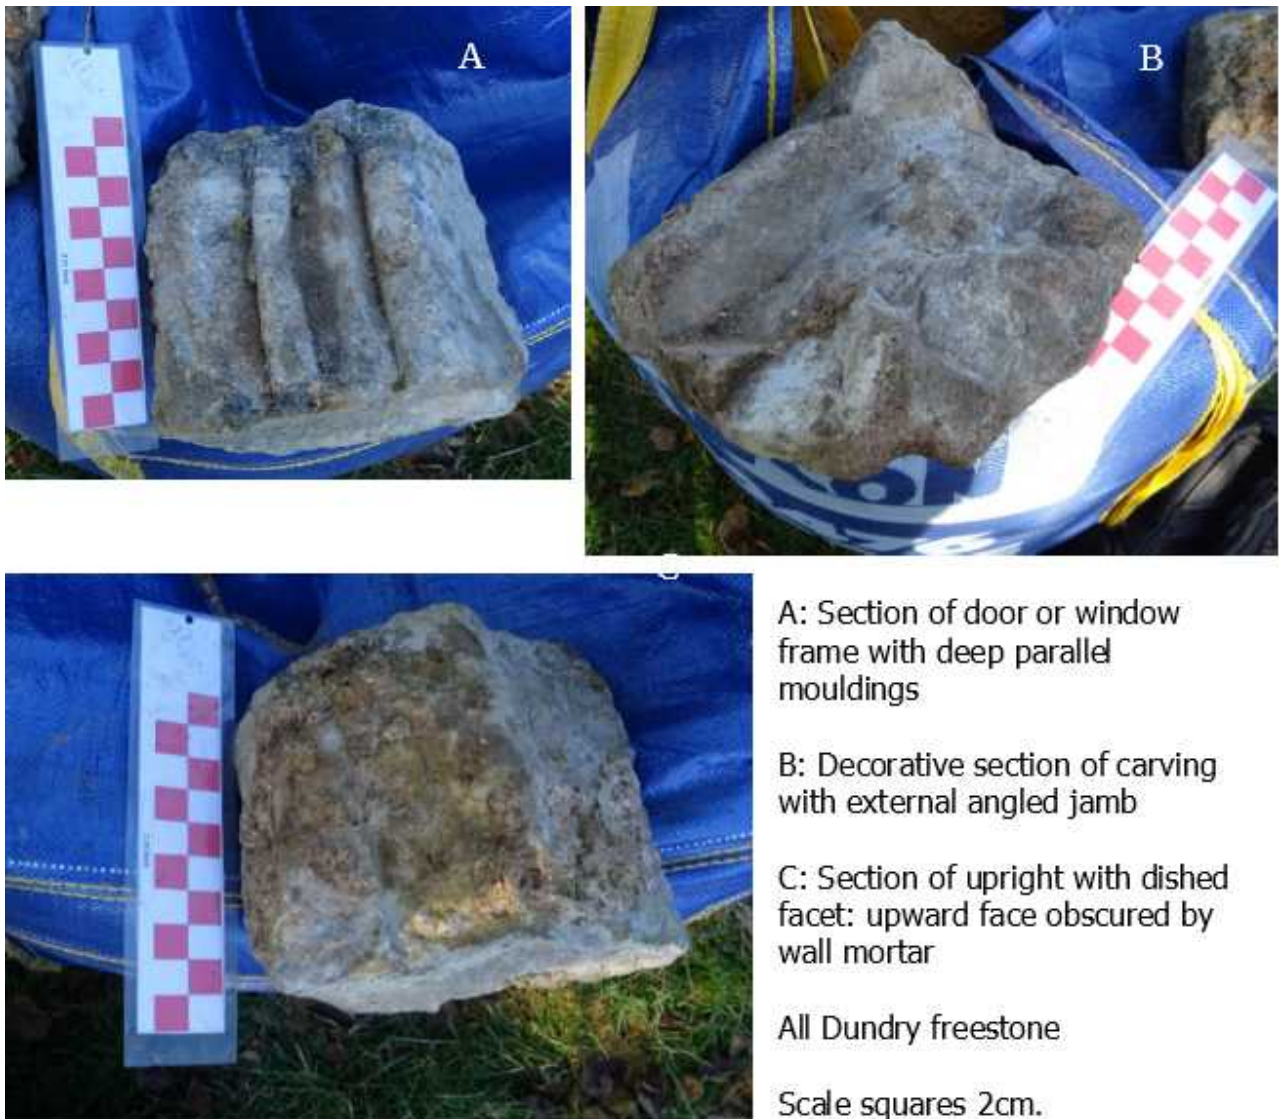
Unfortunately, work began on the collapsed area in Fig 23 before recording began, but in recompense, the area yielded several worked freestone fragments (Fig 24).

Fig 24: Freestone carvings recovered from Wall 4 repair

All carved stones were returned to the wall after recording.

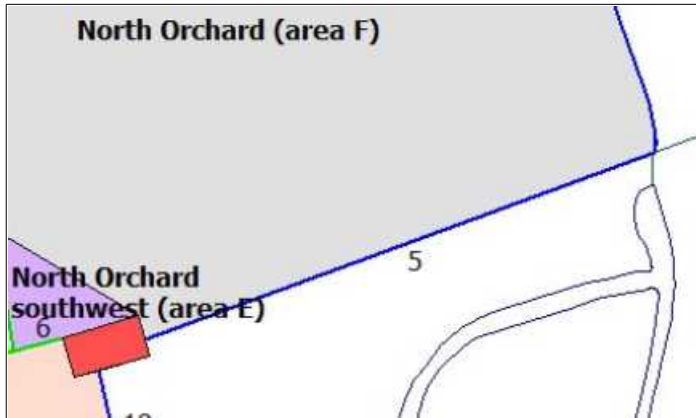
Fig 29: Wall 5, forming the southern boundary of the orchard (area F) from its junction with wall 4, to the (1970s) entrance stile against the infirmary

Wall 5 was in better condition than walls 1-4, with no major collapses. Apart from a field gate into the orchard, and a recent entrance stile immediately adjacent to the infirmary (and probably dating to the 1970s), there were no openings in the wall, although one or more underdrains were noted taking any excess water from the orchard out into the outer fields.

Apart from the repair of one very minor collapse, this response to the wall was largely repointing of areas where surface mortars had weathered out.

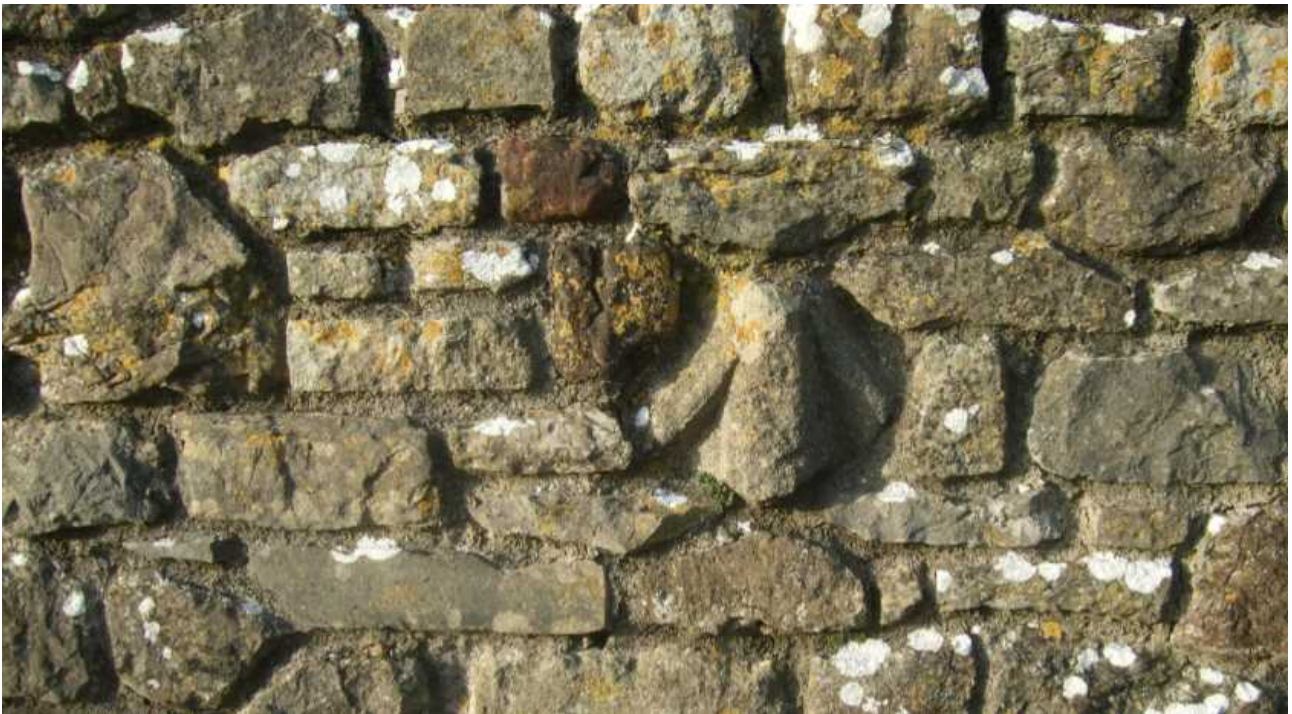
A few pieces of worked freestone also occur in this wall, and are visible on the surface.

Fig 32: Example of a carved freestone fragment visible in wall 5

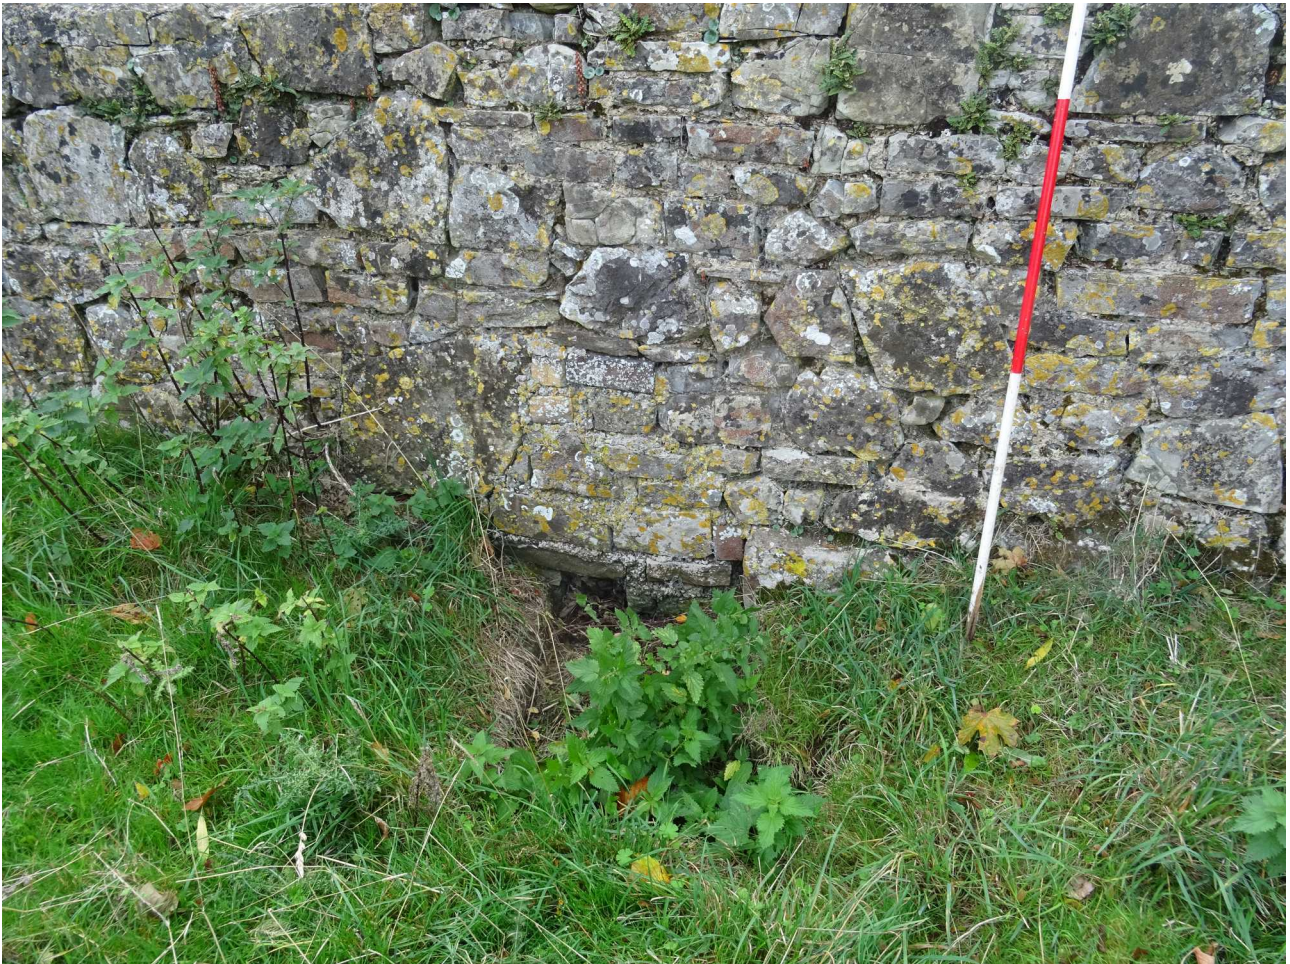
Fig 34: Drain hole from orchard under wall 5 (one of at least three present)

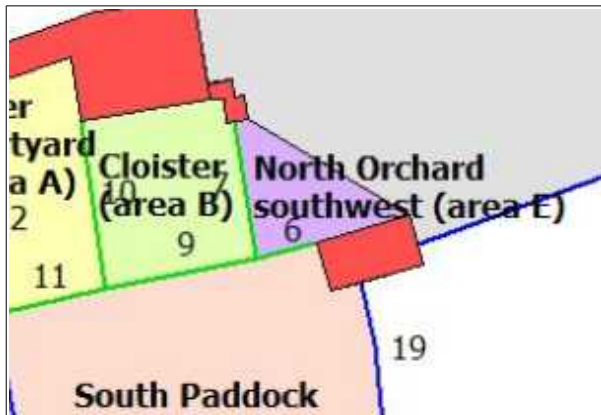
Fig 35: Wall 6, running between the infirmary and the junction of the east cloister wall and south wall 9

This wall is clearly, from its stratigraphic relationships to its surrounds, a different, much less organised structure, also indicated by its absence from the 1768 map of Woodspring (see below), later than others in the vicinity.

Its structure is also compromised by being re-used to support 20th century agricultural buildings (specifically a pig sty recorded in early 20th century post card illustrations -YCCCART 2nd miscellany).

Most of the works to this wall were limited to repointing.

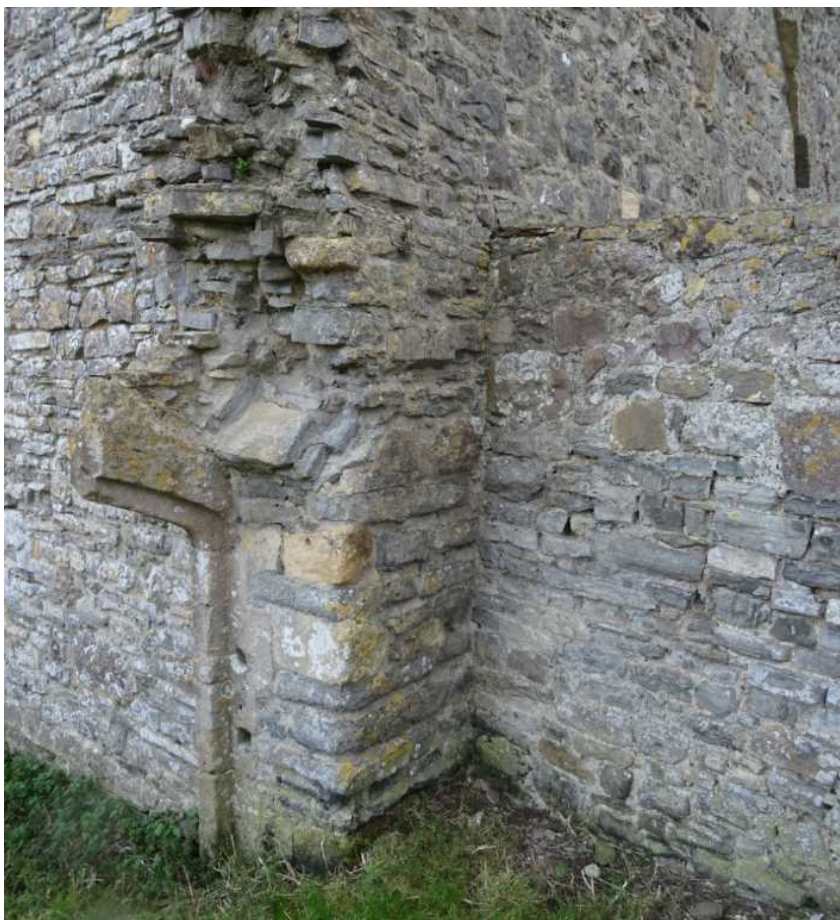
Fig 36: Relationship of wall 6 and the infirmary building

The wall has been constructed against the west gable of the infirmary (Fig 36).

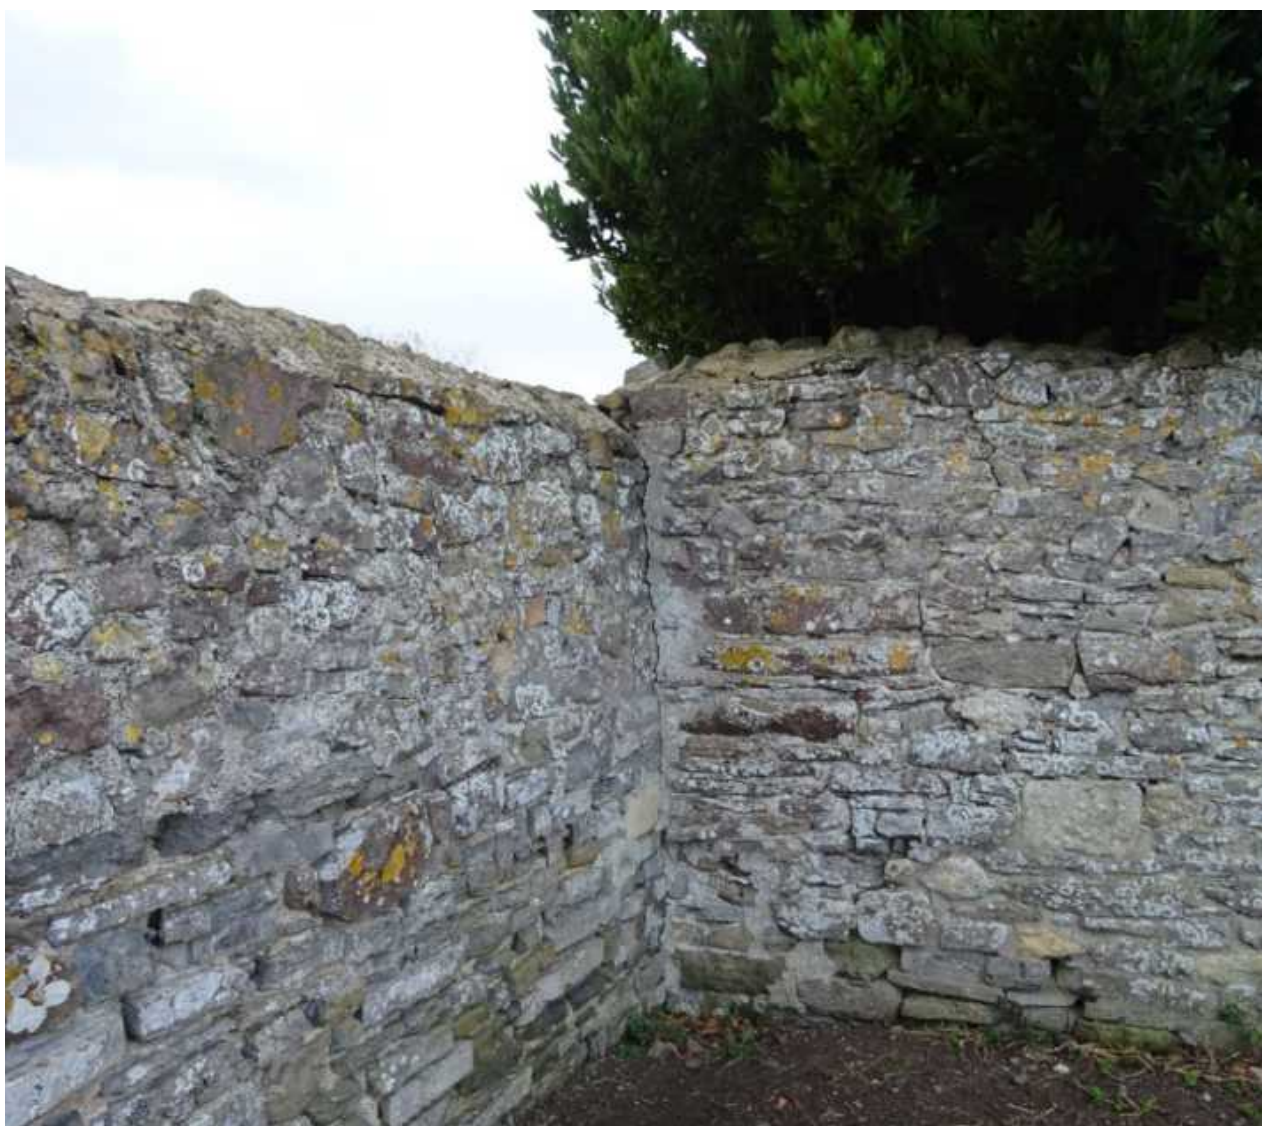
Wall 6 appears to be of one build with wall 9 (see below), but neither appear to be original priory features. Although not itself early, Wall 6 is obviously earlier than the southern end of wall 7 (see below).

Fig 37: Butt joint of wall 7 (right) against north side of wall 6 (2021)

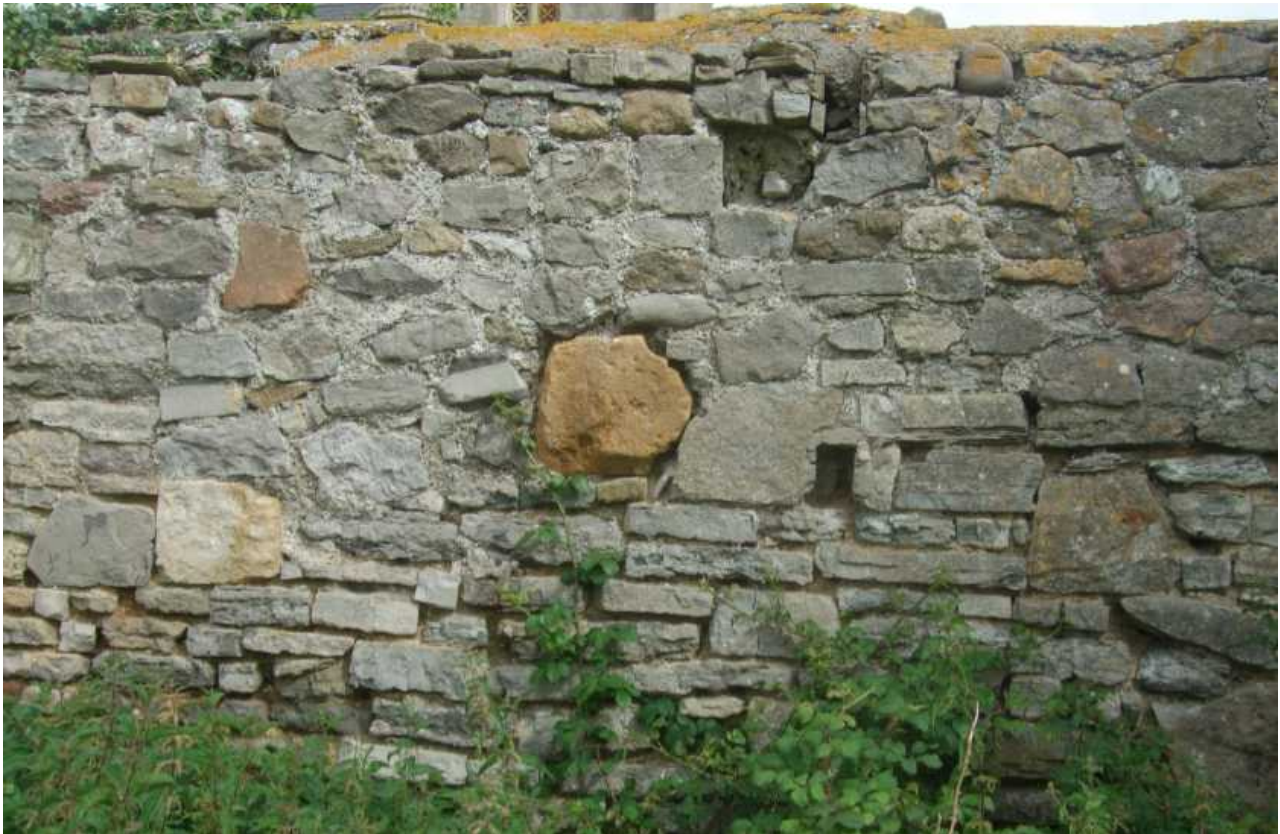
Fig 38: South side of wall 6, showing re-used freestone block and a socket (possibly two) for insertion of 20th century wooden structural members (2012)

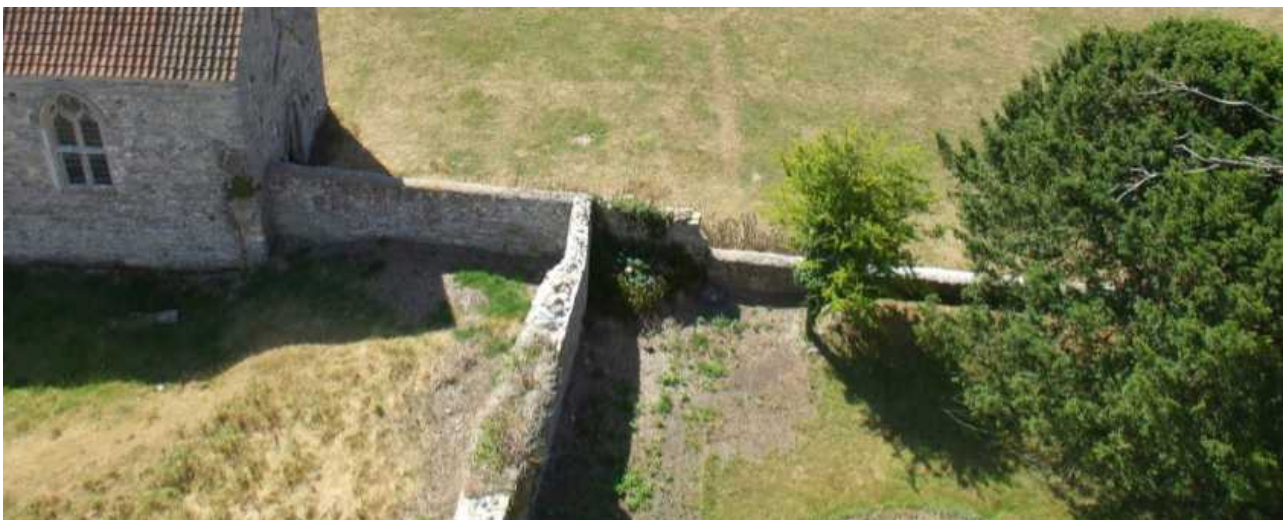
Fig 43: South end of wall 7 from church tower (2013)

At the southern end of wall 7, a section of the wall is not only much thinner in build (see Fig 43 above), but, like the repaired wall described above, has clearly been constructed to make good the gap between the southern end of the medieval section of wall 7, and the later wall 6 (see Fig 37 above).

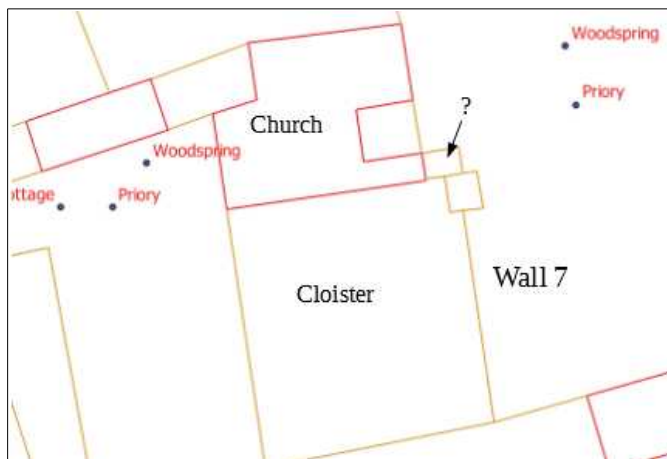
Fig 46: Wall 7 from OS digital data (2009)

The detail shown in Fig 46 appears to show the church tower as unroofed (something not true since the 1820s).

It also shows an apparently spurious building (Marked '?' in Fig 46). This is not a modern error, but has been in place since at least the 1885 Epoch 1 OS plans. It is possible that a small temporary outbuilding was marked here at some point, but if so, there is no trace of it on the walls or ground in the vicinity.

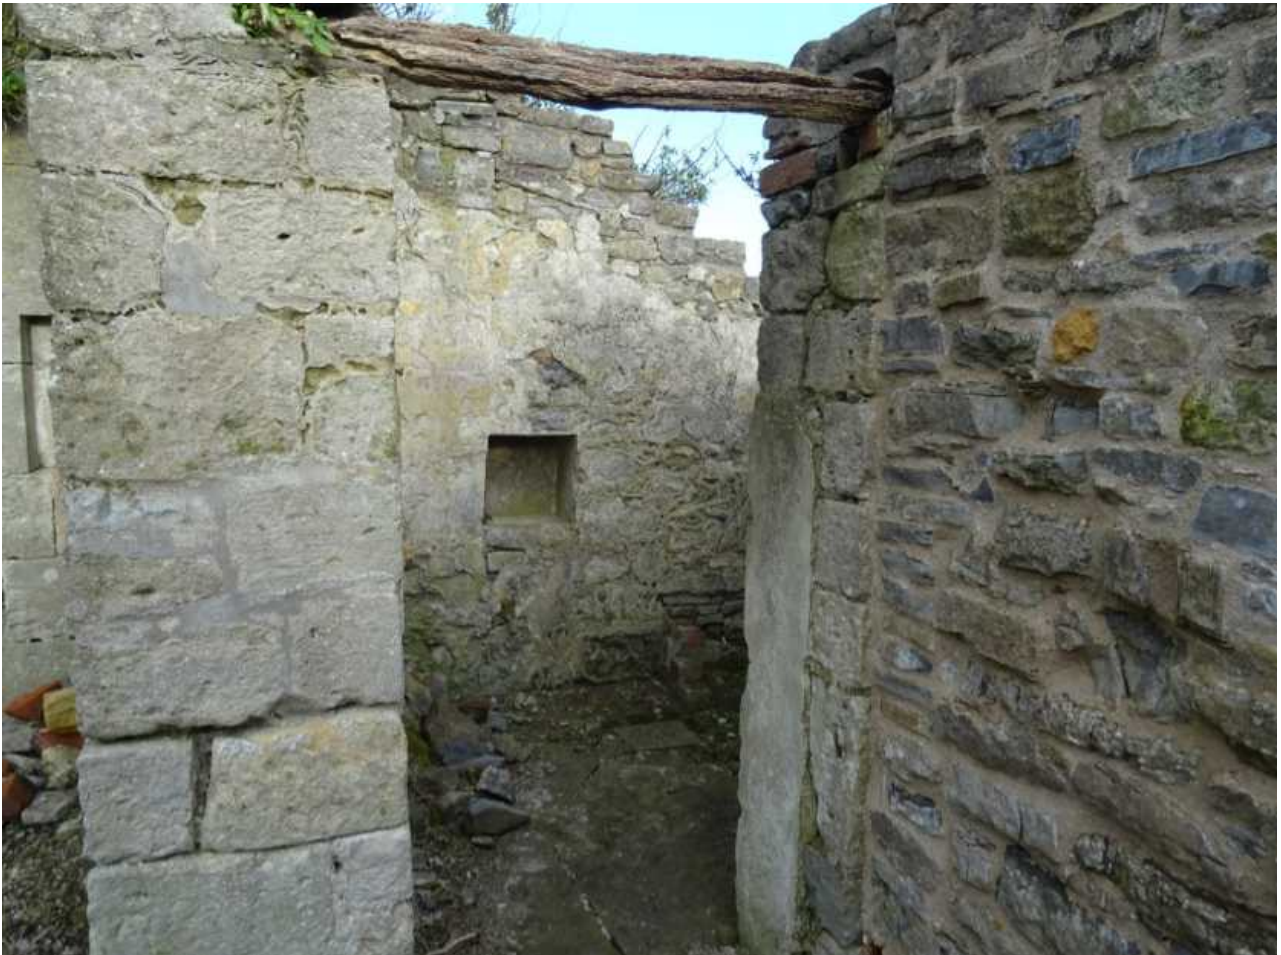
The structure in Fig 47 has a door into the area that would have been the east walk of the cloister, and is close to the blocked doorway in the former north aisle of the cloister, which should represent a ritual Victorine entrance to activities in the church. Although the structure clearly butts against chancel 1b, defined by Tomalin and Crook as 'the 15th century chancel', it could, of course, have replaced an earlier structure elsewhere.

Otherwise, with its internal plastering, 'lamp niche' and evidence of a possible bench seat, it might be a garden room, relating to the 16th century great house or later farm: this would at least be consistent with its stratigraphic relationship to the chancel. The walls do seem rather solid and thicker than most on the site, but this might simply be due to easy availability of stone.

Fig 47: Thicker-walled structure at the northern end of wall 7, butted against the remaining chancel wall

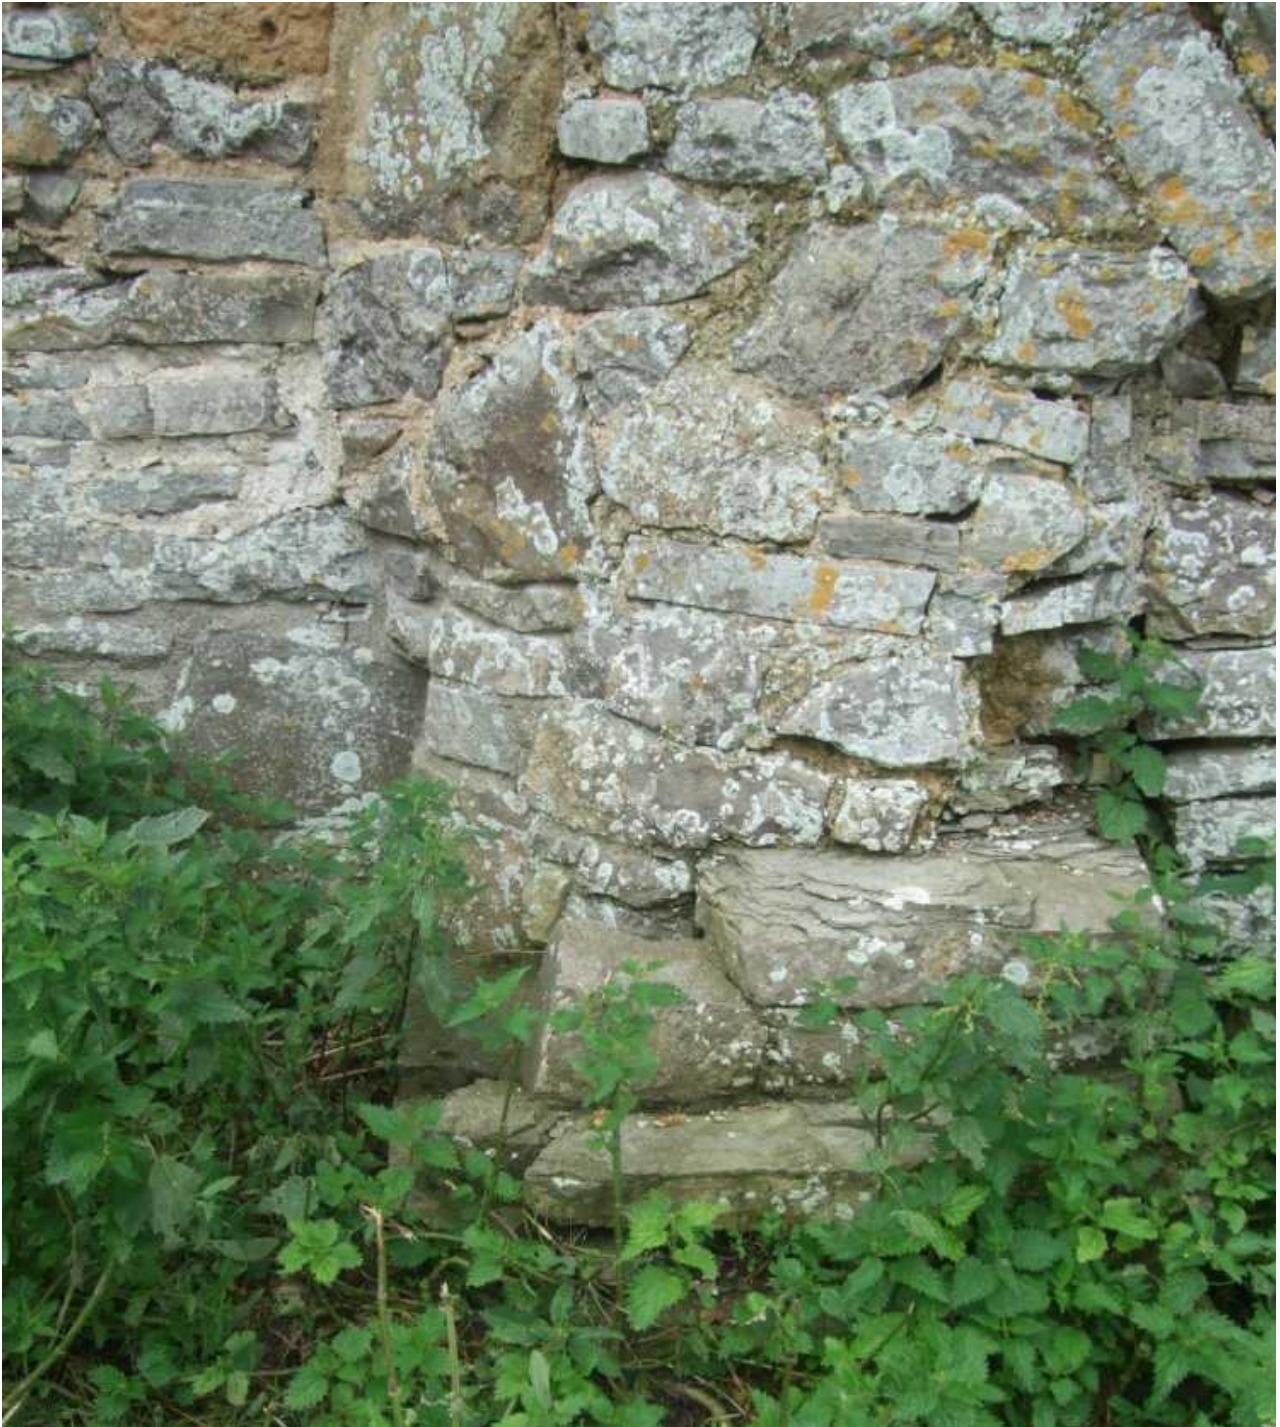
The southern end of the 'old' section of wall 7 at its terminal, curves in towards the east cloister walk (see Fig 48 below), and the southern section of wall 7 springs from this.

Notable in Fig 48 below is the junction of the 'old' and the 'infill' sections of wall 7, but also a group of stones lower down in the 'old' section which are firmly embedded in wall 7. Despite their initial resemblance to a horse-mounting block, they are too low to serve this function: are these stones the last remaining stump of the north wall of the slype (see Paul map Fig 3 - 1885)? Unfortunately, digging over this area has prevented any clear indications on resistivity surveys (Russett 2020).

Fig 48: Junction of curved terminal to 'old' section of wall 7, and infill wall between it and wall 6

The southern 'infill' wall even has a broken firebrick incorporated into its structure, emphasising its later date.

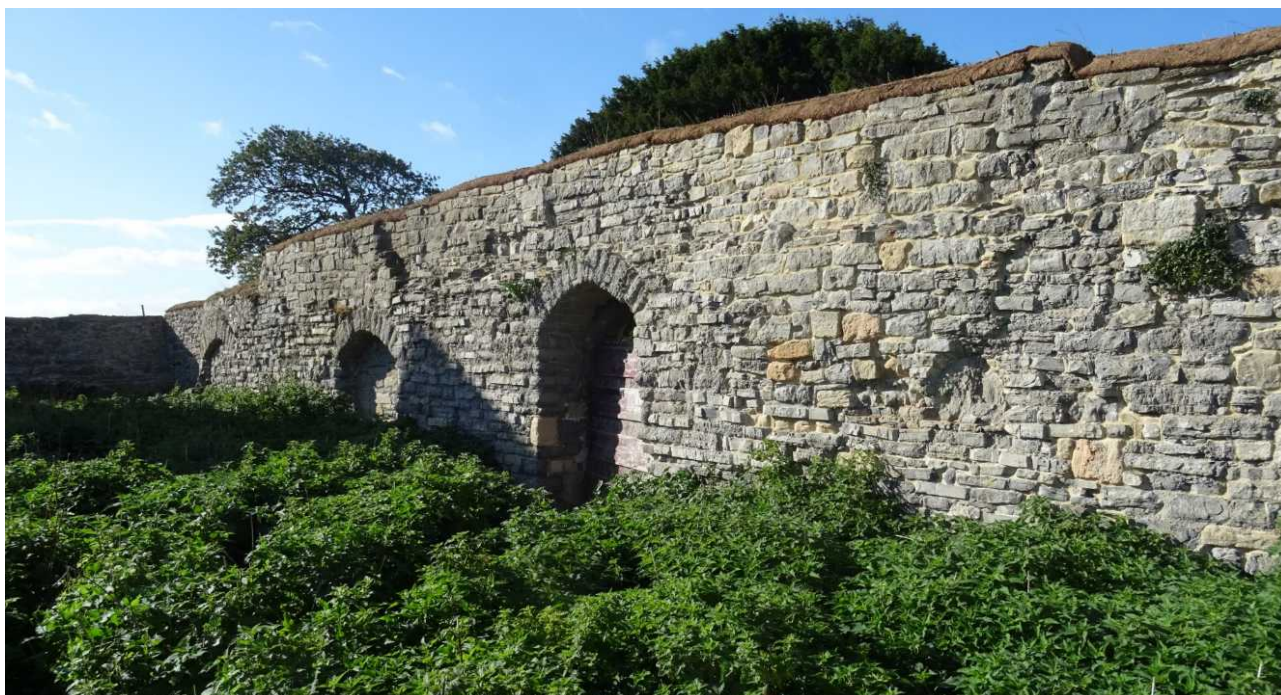
Fig 49: The upper stage of wall 7, clearly later, is thinner than the lower

Wall 7 above the level of the door arches (Fig 49) is clearly of a later construction than the doors and their surrounds.

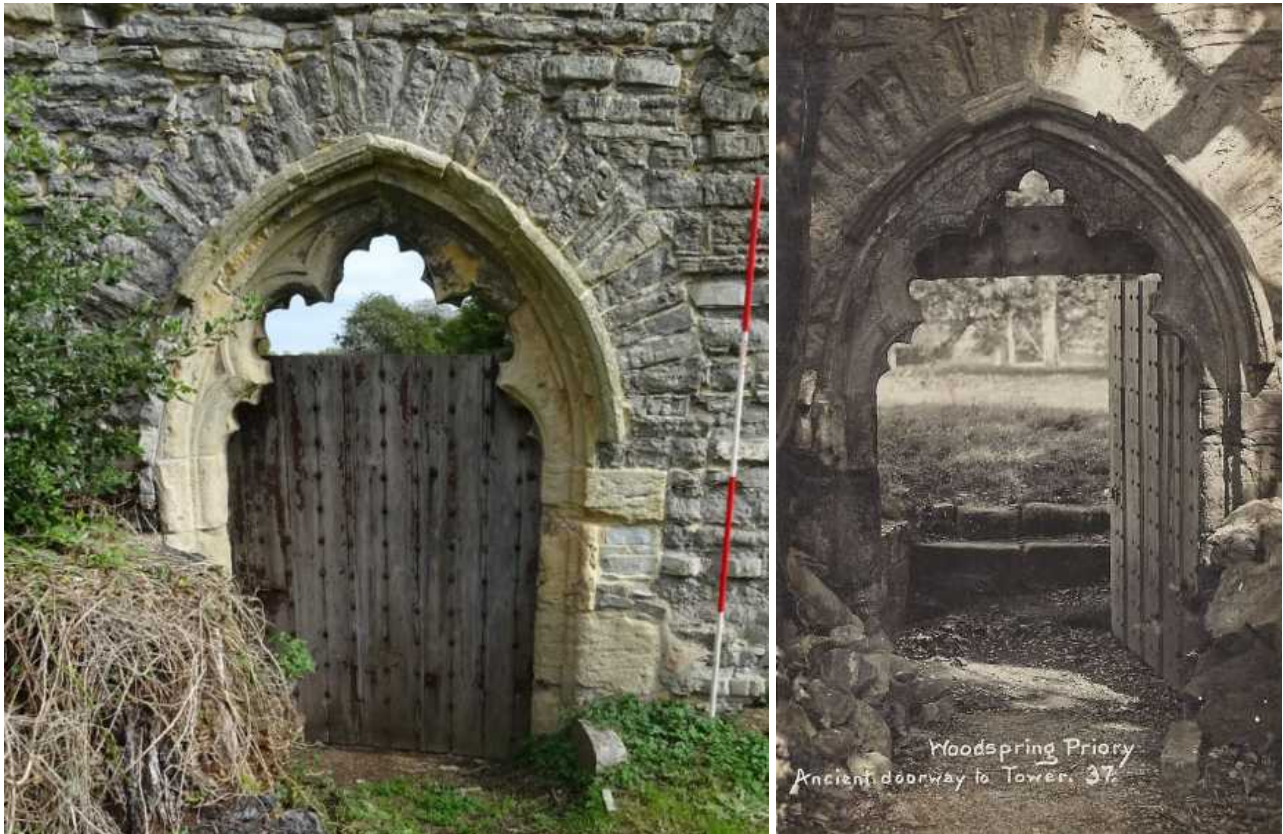
The three entranceways in wall 7 are all different, with only that to the north including a carved freestone structure, with drop tracery, and dating to around 1300, and thus almost certainly re-used in this context (Tomalin and Crook 2007).

Fig 50: Northern doorway in wall 7: left from west (2022), right from east c1910

The view into the garden in c1910 shows garden features (a sunken path) no longer visible today. The same door seems to have survived.

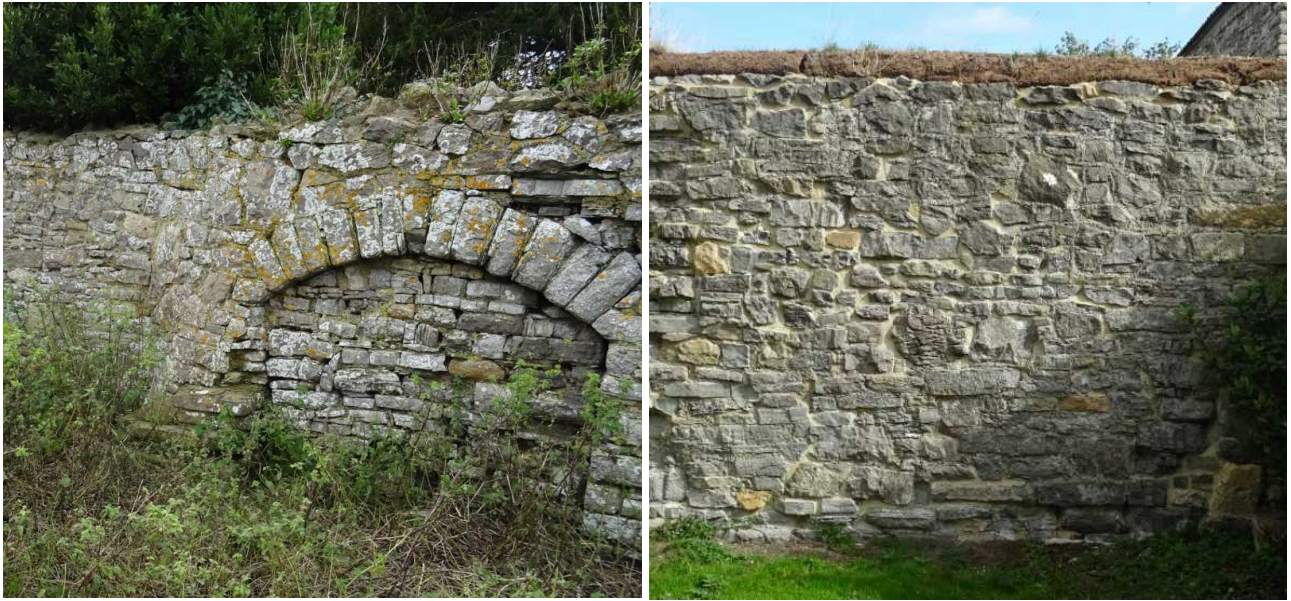
The southern and central apertures have no surviving frames, that to the south being not even evident today on the inner side of the wall.

Fig 52: Southern opening to wall 7: (left) from east; (right) from west
