PART 2: Walls 9 - 19 and endrefs

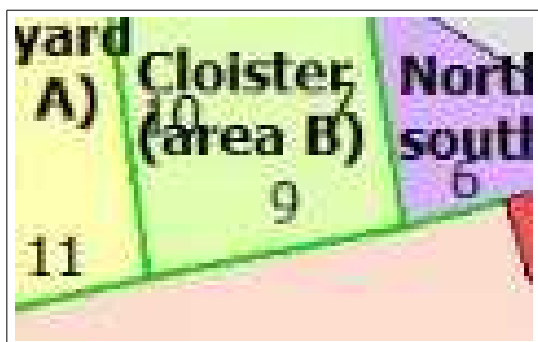
Fig 53: Wall at the southern side of the cloister, probably coeval with wall 6

Wall 9, often said to be the south wall of the cloister, cannot be so. It probably derives from a building first recorded on the Kewstoke Tithe Map of 1840, and in its current form, cuts the former spiral stair at the southern end of wall 10.

Before repairs in 2022, wall 9 was lacking any major defects, but required repointing to replace lost surface mortar.

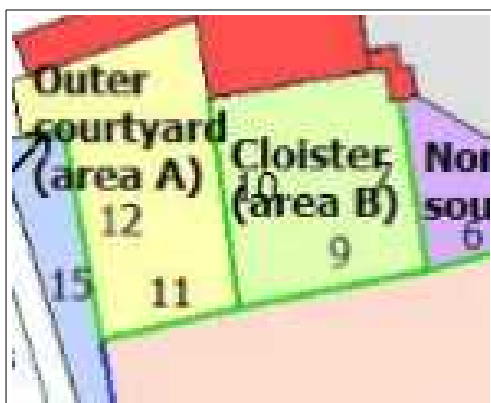
Fig 59: West cloister wall 10 (centre), specifically Listed in its own right and largely medieval in origin

Wall 10 (uniformly c4.0m high) is clearly the medieval surviving structure of the external west wall of the cloister, possibly dating (see below) to the later 15th/16th century stage of development at the Priory. Unlike any walls so far described (with the exception of parts of wall 7) this medieval origin is demonstrable.

Most of the works to this wall consisted of the stabilisation of the top of the wall (where the bats were) and the repointing of the rest of the faces. This was accomplished from scaffolding during March and April 2022.

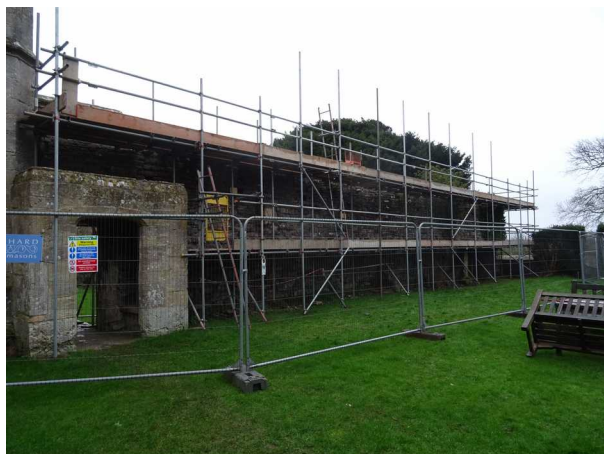
Fig 63: External and internal scaffolding, wall 10, March - April 2022

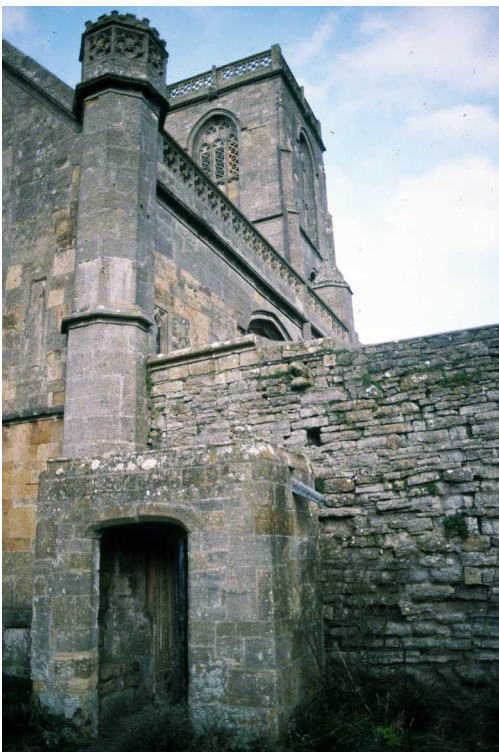
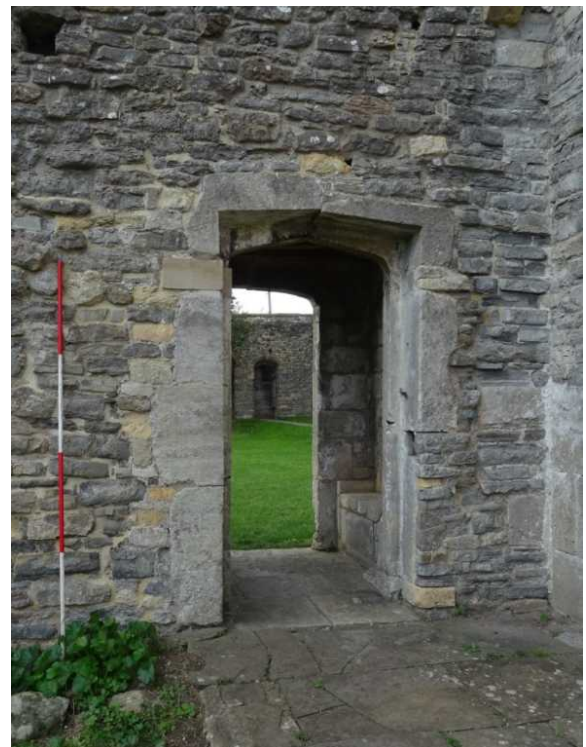
At the northern end of wall 10, the doorway and porch constructed in the wall were in reasonable condition, and needed little repair.

Fig 65: Porch (1989) and opposing doorway (2022) set into wall 10

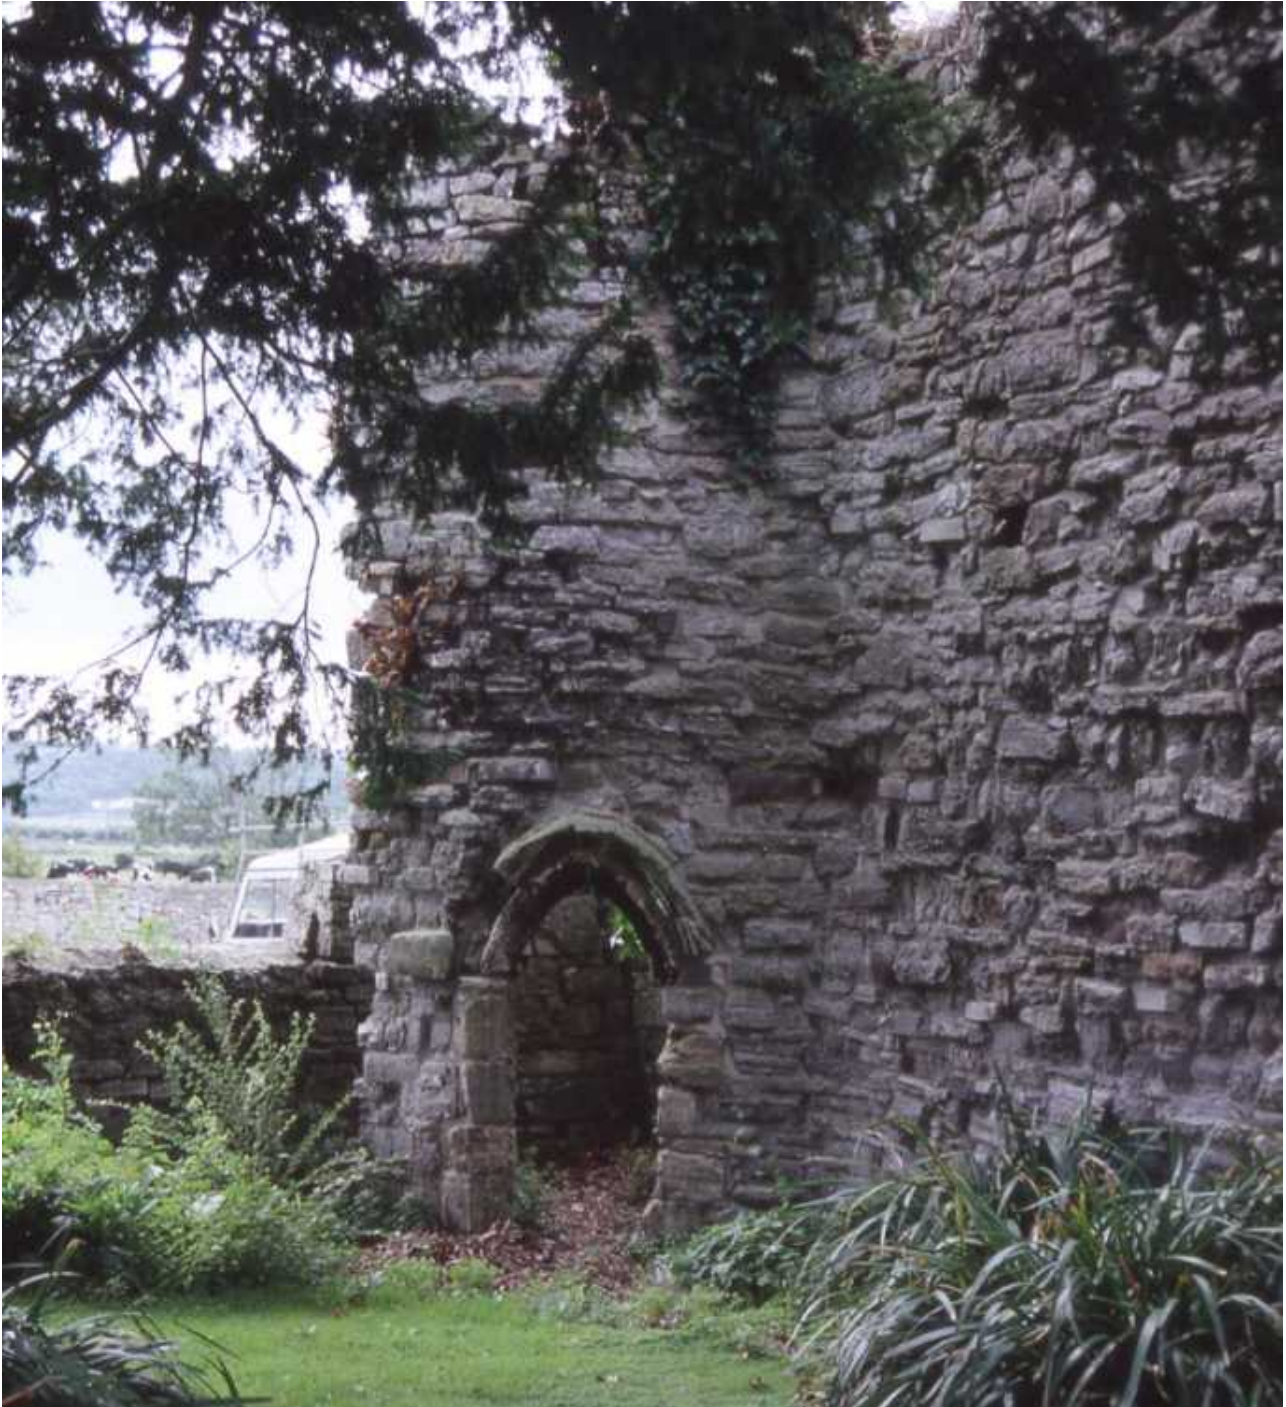
of stone treads. Wall 10 meets with wall 9 (above) and 11 (below) at this point, and it is very clear that the junction leaves no room for the full circular structure of the stairwell (Fig 69 below).

Fig 67: External wall of stairway and entry door at south end of wall 10, 1992

The north part of the interior of the stairway survives, and was comprehensively repointed, with the rest of wall 10 in March and April 2022.

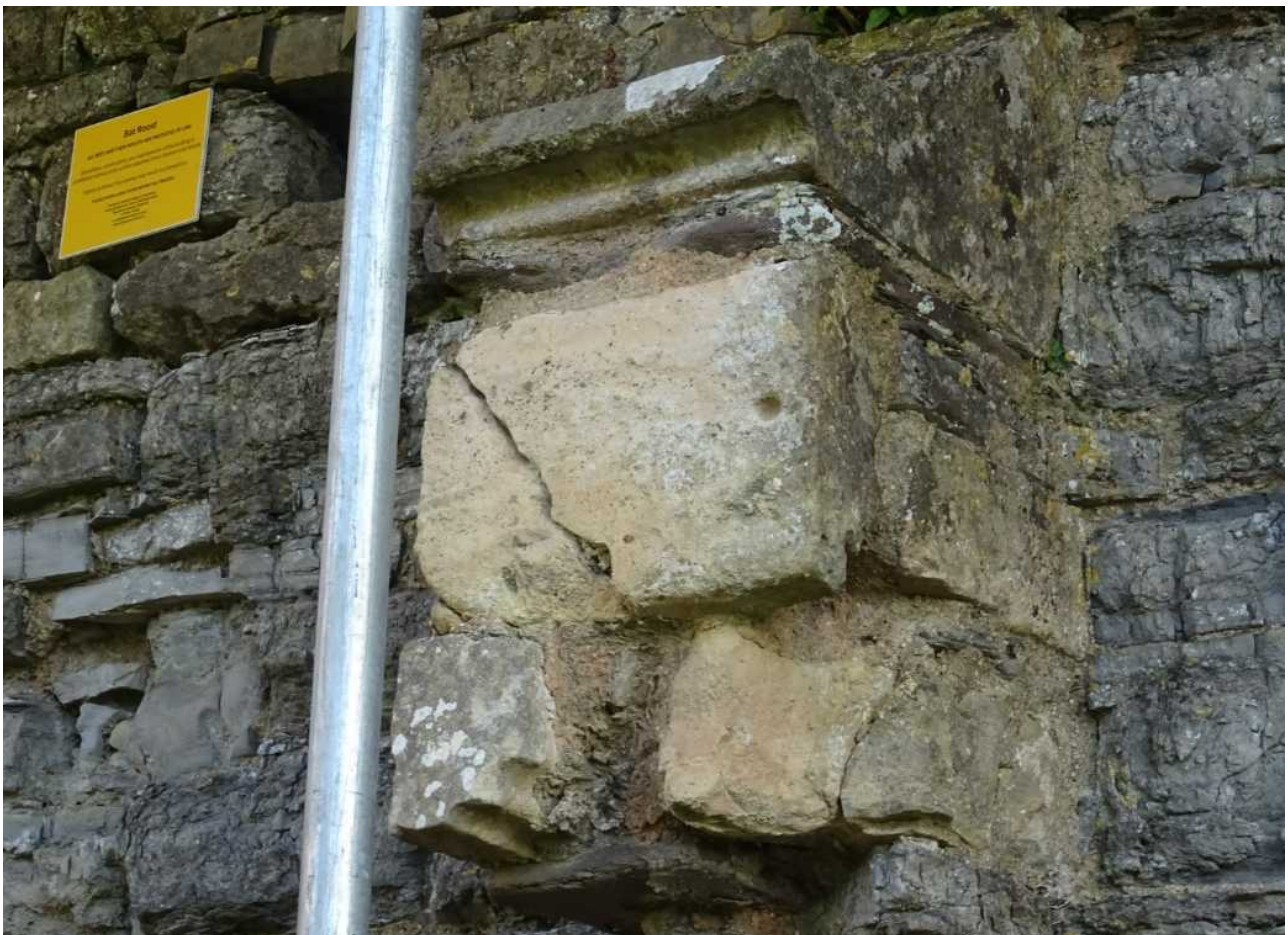
There is good reason to suppose the buttresses are contemporary with the wall: they share a(n applied) stringcourse with the wall (as does the chapter house wall in wall 7), at least some appear to be set into the wall, and despite some re-used worked stone in some (see Fig 70 below). This re-used stone, incidentally, appears to be set with the same mortar as used in the construction of walls 1-4, meaning this is potentially a post-medieval repair, and not original.

Fig 70: Re-used carved freestone in northern buttress, wall 10 (2022)

On the exterior of the west cloister wall, there was little damage requiring rebuilding (except at the very top): the buttresses (Figs 60 and 61 above) are in various states of decrepitude, and were repointed as is.

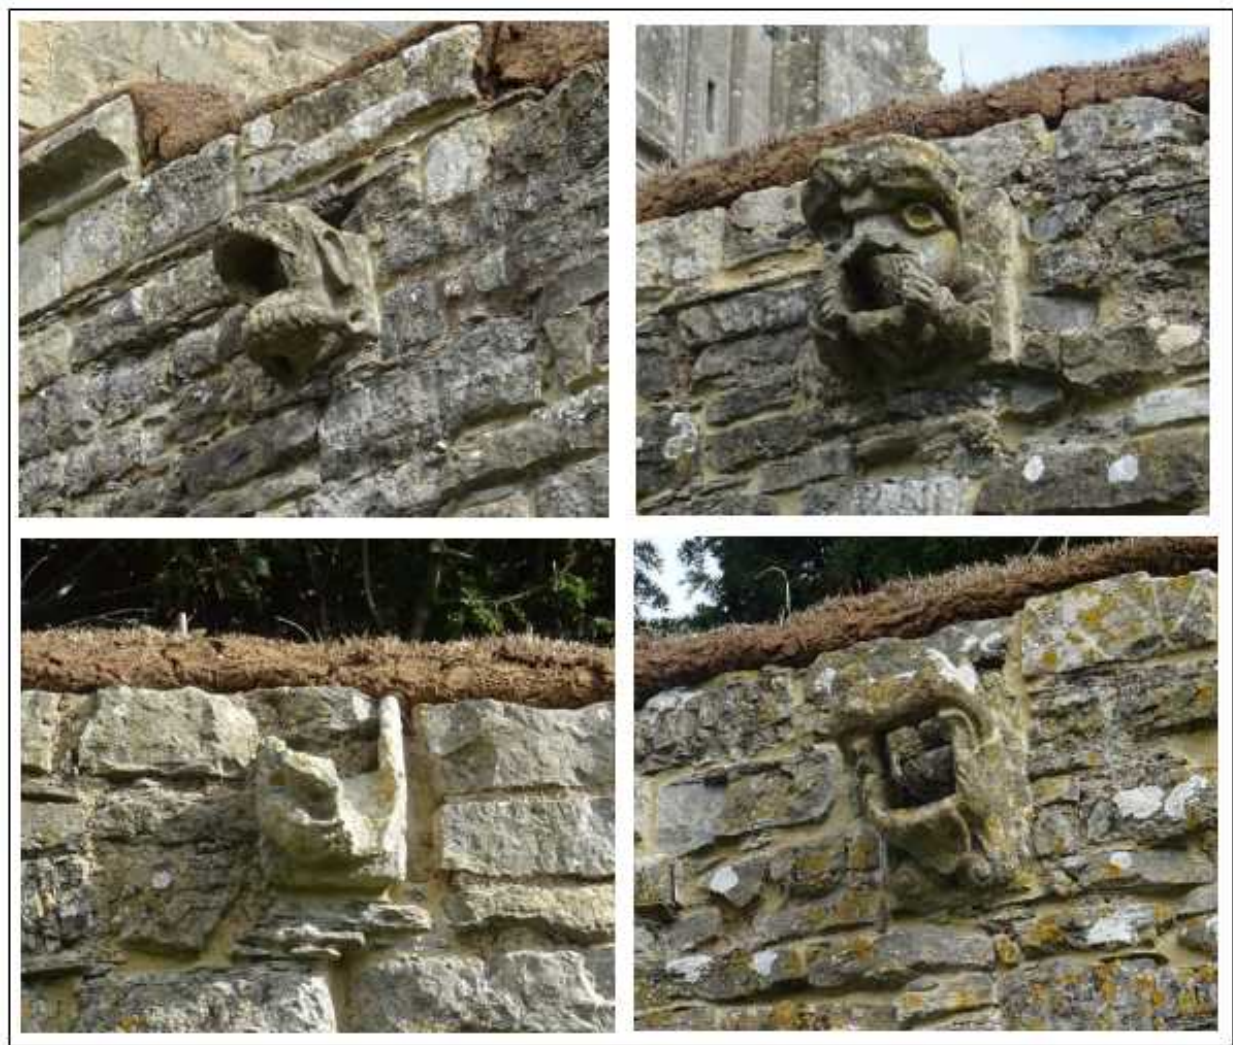
Along and just below the top of the wall, a series of freestone grotesque gargoyles survive (also in various states of disrepair) (see below). These were presumably for the dispersal

Fig 71: Gargoyles (clockwise from north to south) in wall 10 exterior (2022)

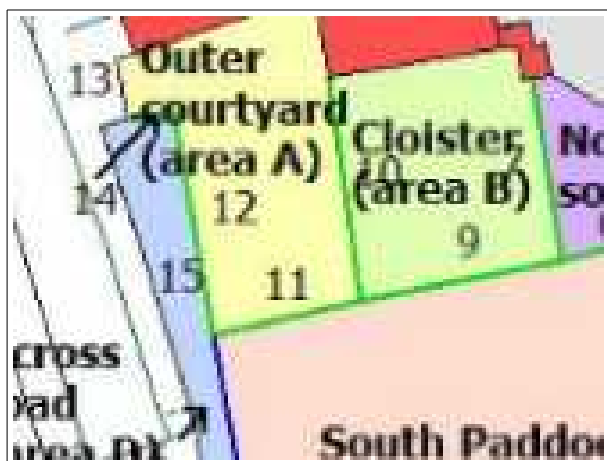
Fig 72: Wall 11 at the southern end of the old farmhouse garden ('Outer Courtyard'), and post-Dissolution in origin.

Wall 11, along with walls 6 and 9, clearly post-dates the priory: it includes some re-used freestone within its structure, as well as the gate leading from the garden out into the southern paddock.

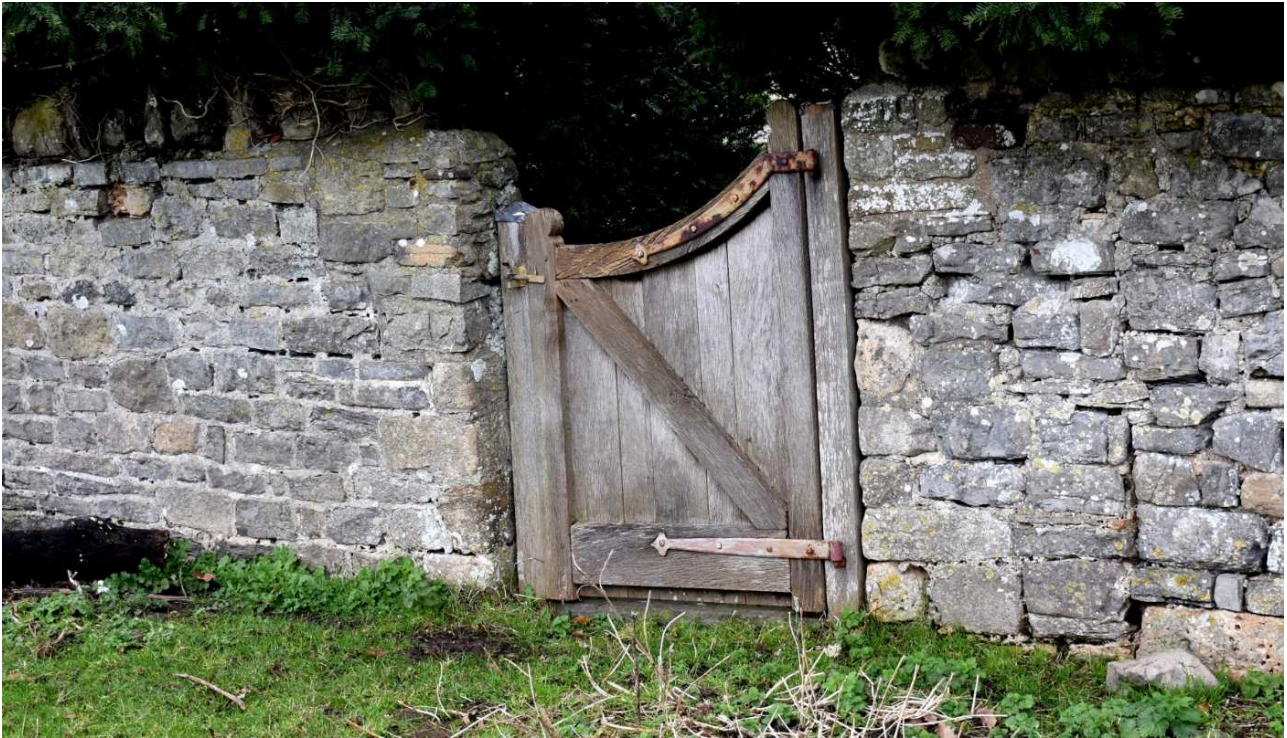
The gate between the garden and the southern paddock seems to have once been wider (Fig 74), perhaps marking a change between farmyard and domestic garden. Like several of the walls, it does not appear on the 1768 map of Woodspring (Fig 40 above), or even the Tithe Map of 1840 (Fig 41), but there are no obvious traces of a predecessor between the two plots.

Fig 74: Current gate in wall 11, with clear evidence of filling in of a former wider gateway to its east

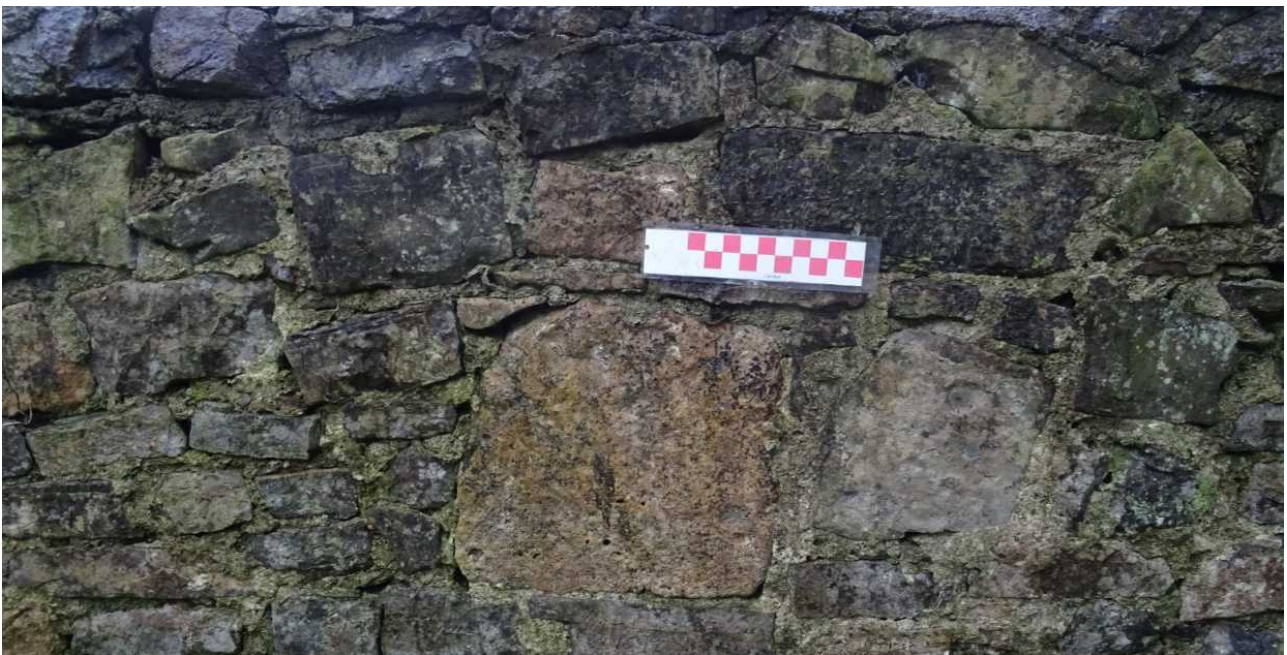
The wall contains several fragments of re-used freestone (Fig 75 below), presumably due to its easy availability at the time of construction.

Fig 75: Re-used freestone (probably a column section) in wall 11 (from north 2022)(scale square 2cm)

Although repointed during frosty weather (on one occasion, the south face of the wall (in the sun) at 7° C was workable, while the north, at 2° C, was not), the repointing has taken and has not been subject to frost damage.

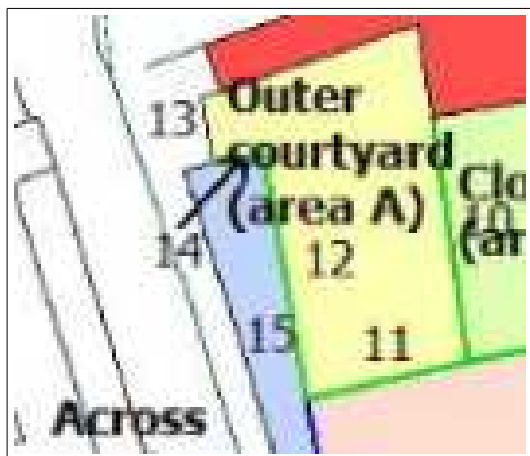
Fig 77: Wall 12/15, on the west side of the farmhouse garden, against the overgrown verge of the lane, from the junction with wall 11 to that of wall 14.

This undergrowth had rooted into the top of the wall, reducing the mortar there to little more than dark brown dust, from which the stones could be lifted by hand. Apart from this necessary 'gardening', the wall was in reasonably good shape, having clearly been repointed more recently than some other walls in the complex, and repairs in 2022 were

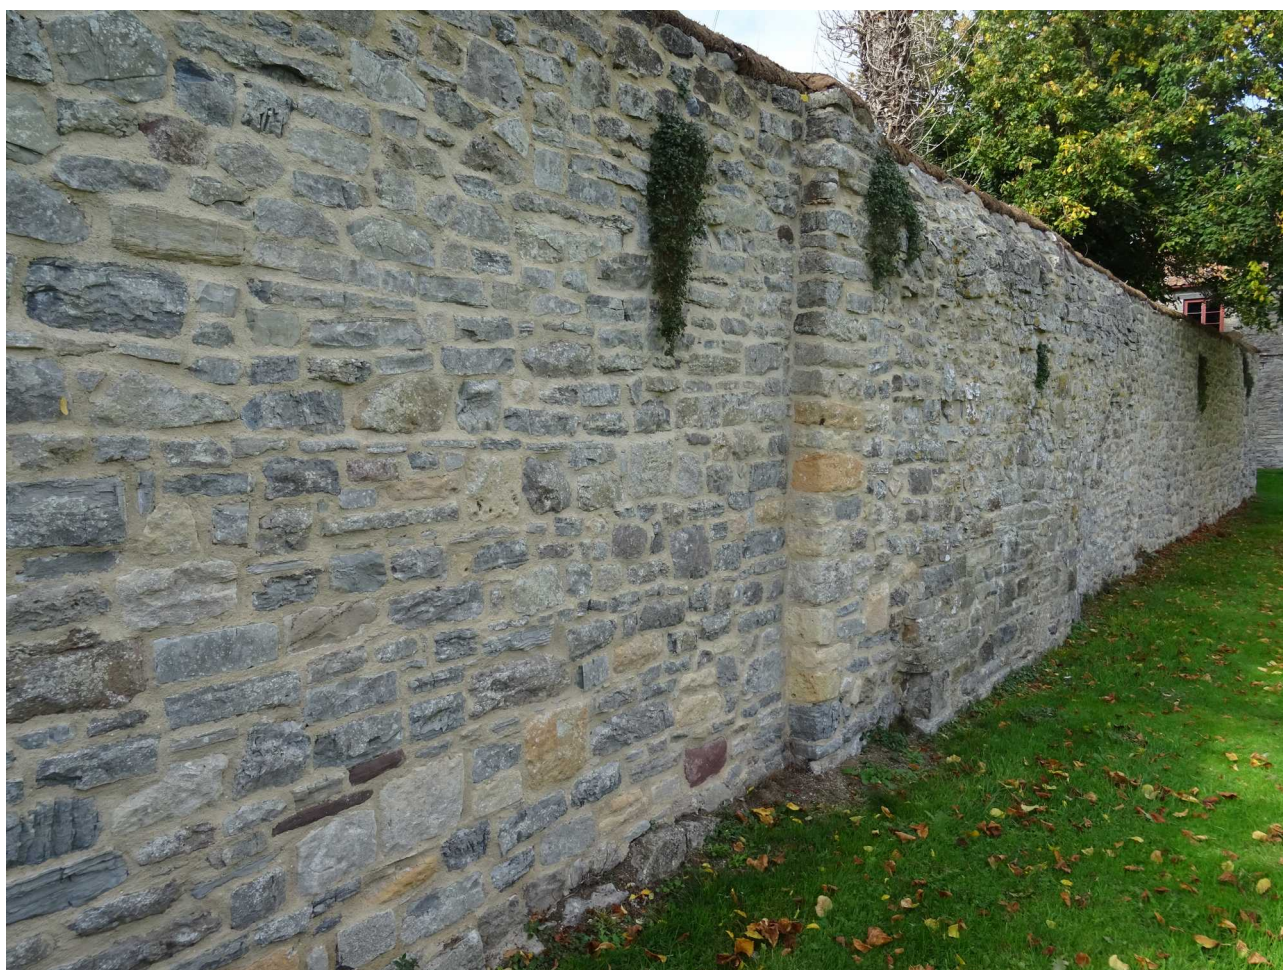
Fig 79: Thickening of wall 12/15 on its eastern side (after repairs, 2022)

While this appears as if it might be the butt end of a pre-existing structure incorporated into the wall, there is no evidence on the west side of the wall, or in geophysical surveys of the plot, that such a structure existed, and there is no explanation for this anomaly. Wall 12/15 shares the tendency of some of the structures to have more carefully squared and coursed stone at the base of the wall, with upper structure more irregularly shaped and coursed: this may reflect older structures surviving near the base of the walls. Only

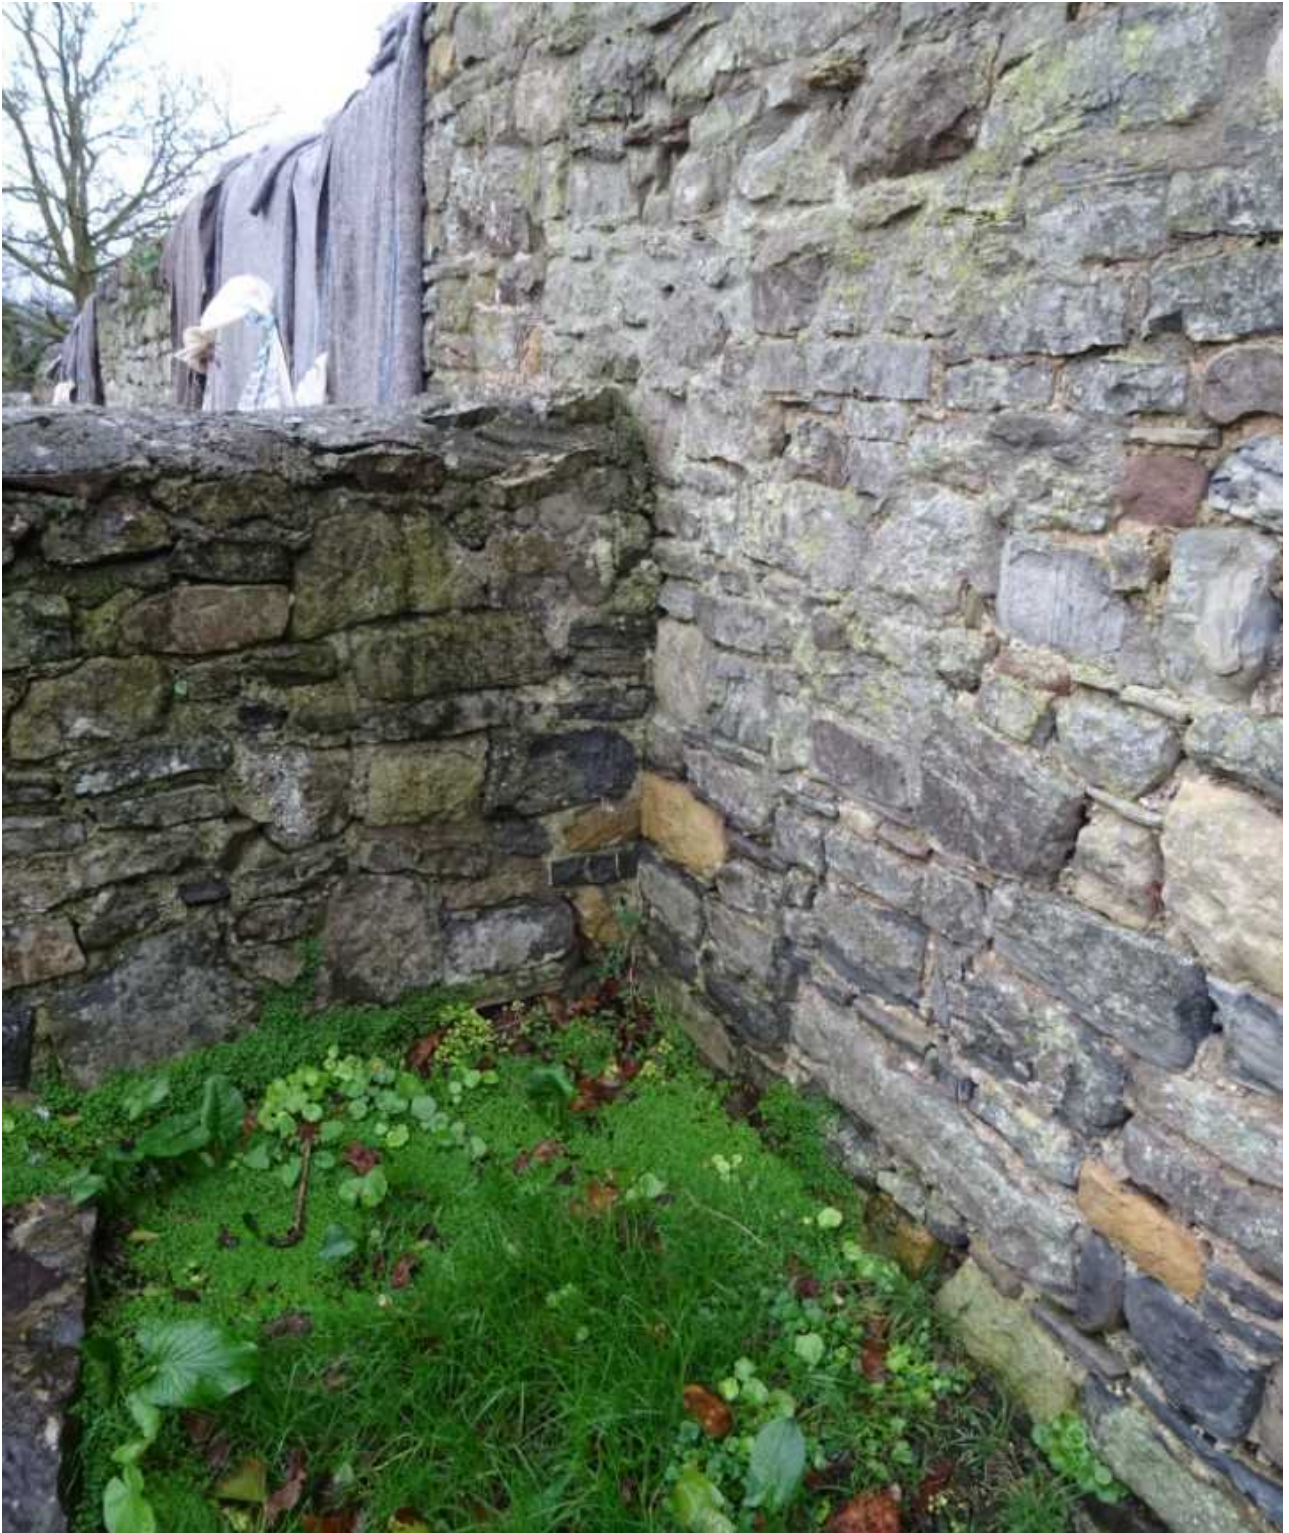
Fig 80: Wall 12/15 junction with wall 11, indicating more regular basal courses and potentially less regular courses above (the same can be seen on the cover illustration)

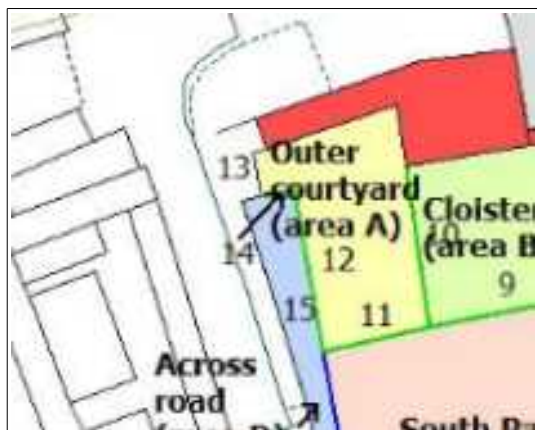
Fig 82: Wall/structure 13, current entrance gate to the farmhouse complex.

It is immediately obvious that the wall and the entrances are fairly crudely constructed, compared to the rest of the core of the site: the round-headed vehicular access arch to the south in particular is anomalous, the round arch apparently not fitting with the largely Perpendicular nature of the rest of the site, although similar can be seen elsewhere (e.g Maxstoke in Warwickshire). In addition, it is also clear that the south pillar of this opening is now nearly 10 degrees out of vertical: this may be due to initial sloppy building, but cracks in the adjacent wall (see below) imply this is at least partly due to settlement, and some drastic moves are described to prevent further movement.

Repairs to this structure were largely limited to clearance of vegetation and repointing: its position in the complex probably implies that it has been maintained reasonably well.

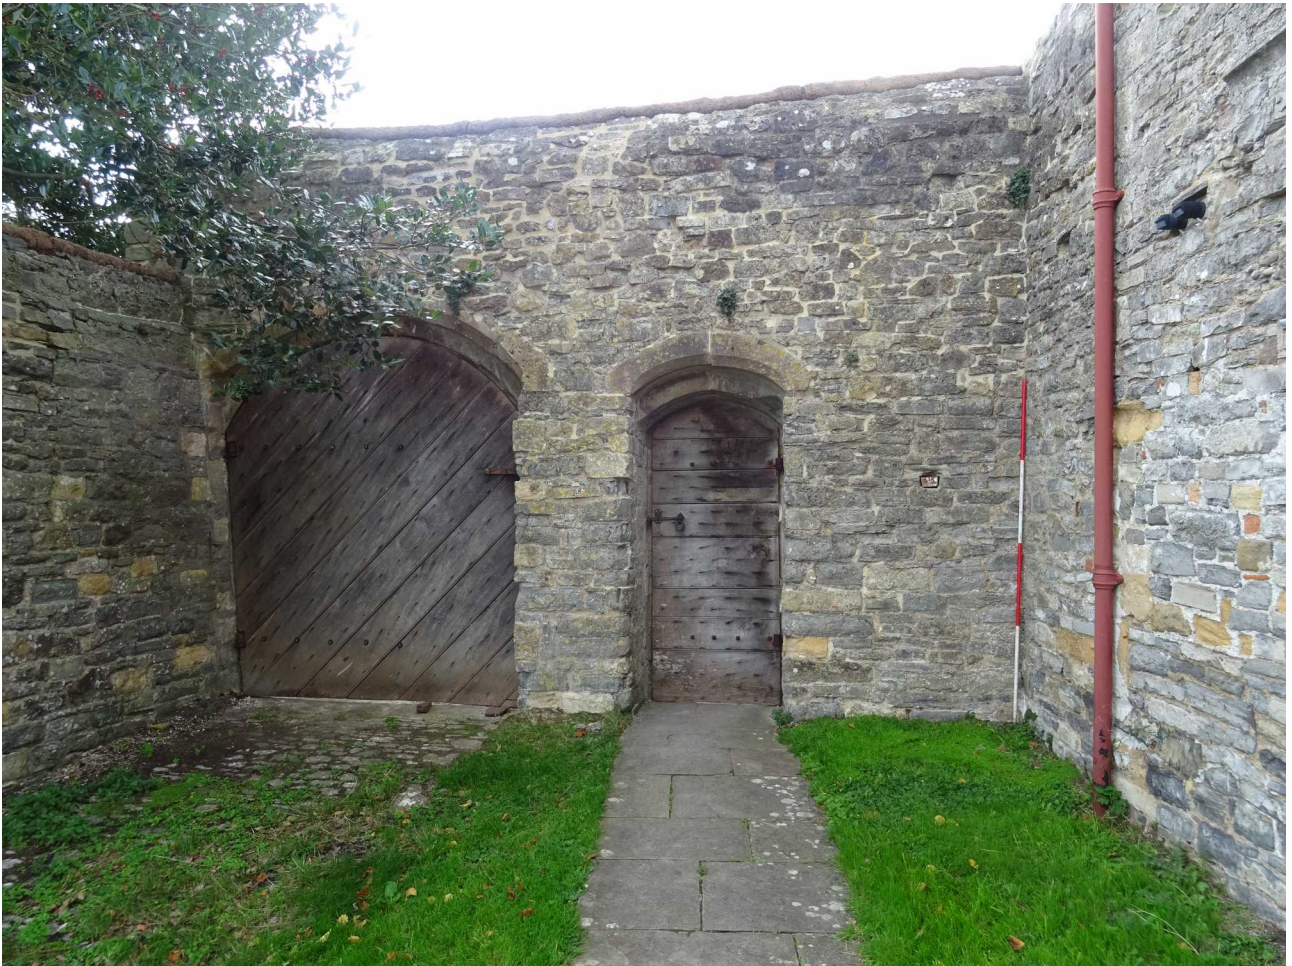
Fig 88: East (inside) of wall 13 after repointing, 2022 (note the absence of freestone jambs to either opening)

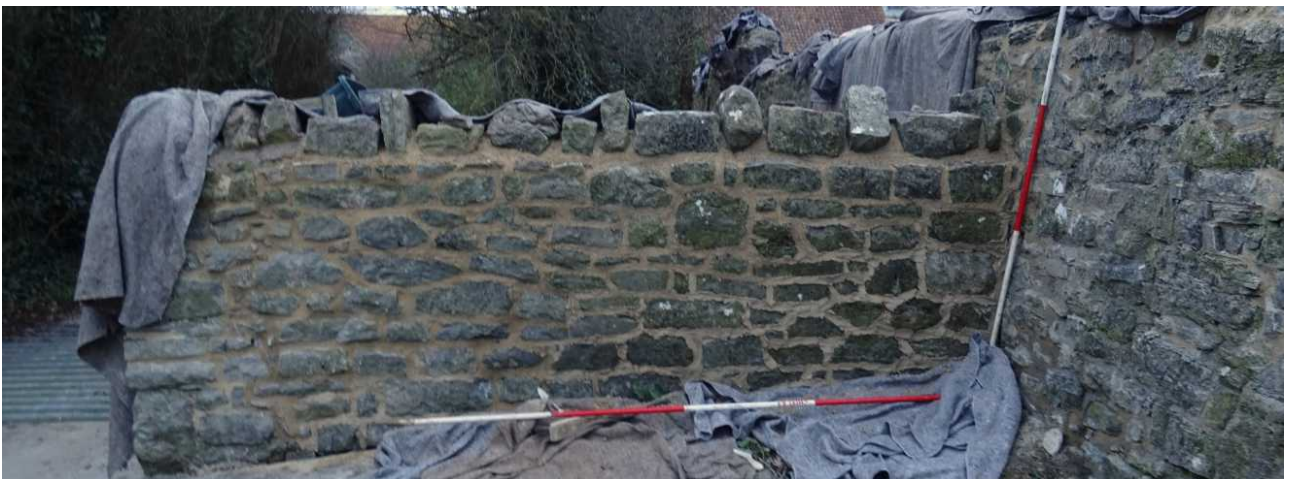
Fig 90: Wall 16 under repair, 2022

Repair here was limited to clearance of vegetation and repointing.

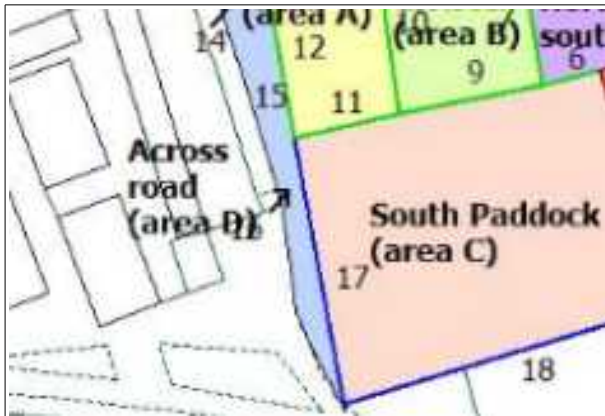
Fig 91: Wall 17, running between wall 11 to the north and wall 18 to the south, and including the gate into the south paddock

They have been subject to multiple repairs and repointings.

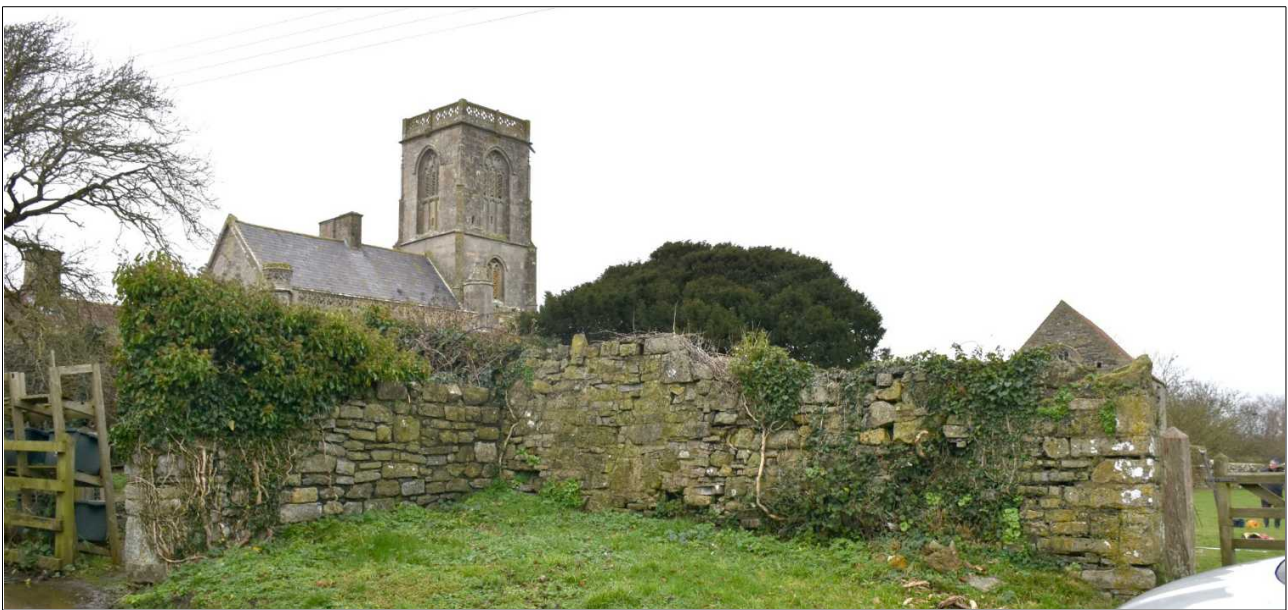
Fig 92: Wall 17 north of field gate (and wall 16) (2020)

Wall 17, joins seamlessly to wall 12/15, but immediately loses height south of the junction with wall 11 (and the farmhouse garden) to about 1.8m. It is clearly a mortared field wall of roughly coursed squared Lias and Carboniferous limestone, although worked freestone blocks are incorporated into its structure. Paul's 'small window', which should be in the northern half of wall 17 above the gate, is no longer evident.

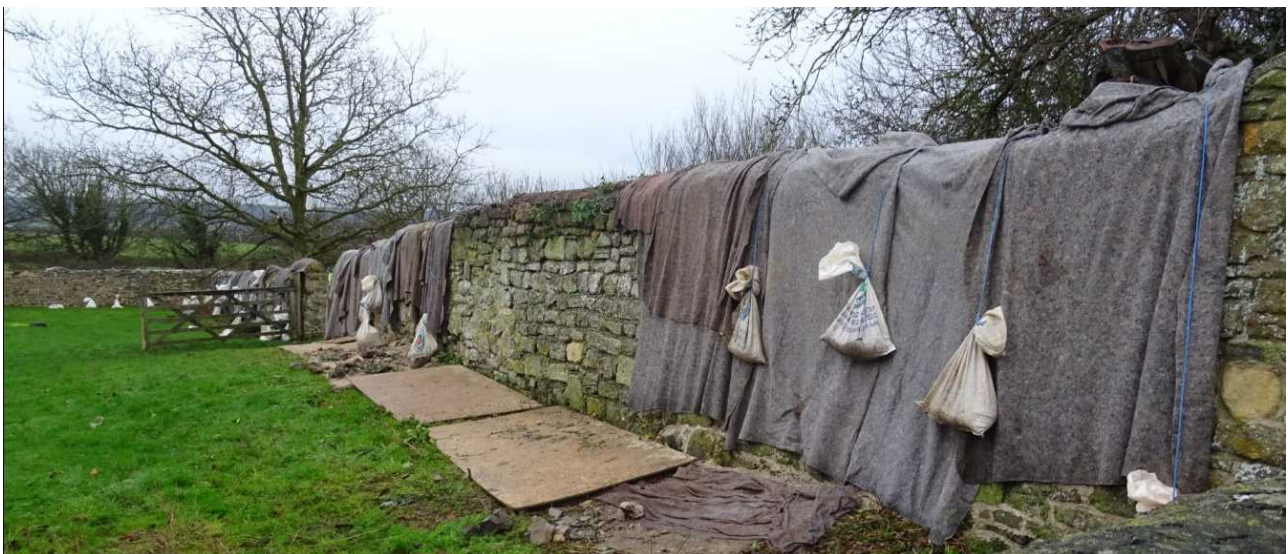
Fig 93: Wall 17 under repair and frost protection (2022)

Apart from this collapse, and a few areas missing large amounts of surface mortar, repair was largely limited to heavy repointing of both sides of the wall, and foundation levels were not reached in repairs.

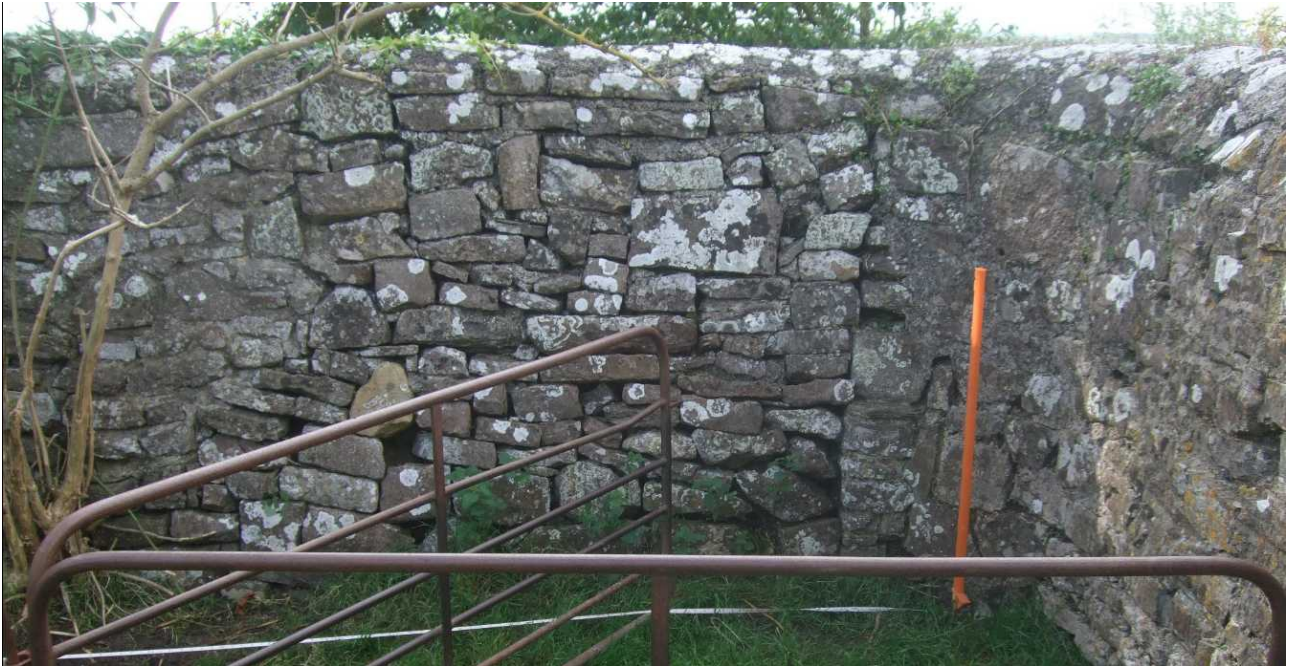
Wall 17 terminates at its southern end with a rounded corner leading into wall 18.

Fig 96: South end corner of wall 17, with break between 17 and wall 18 (2012)

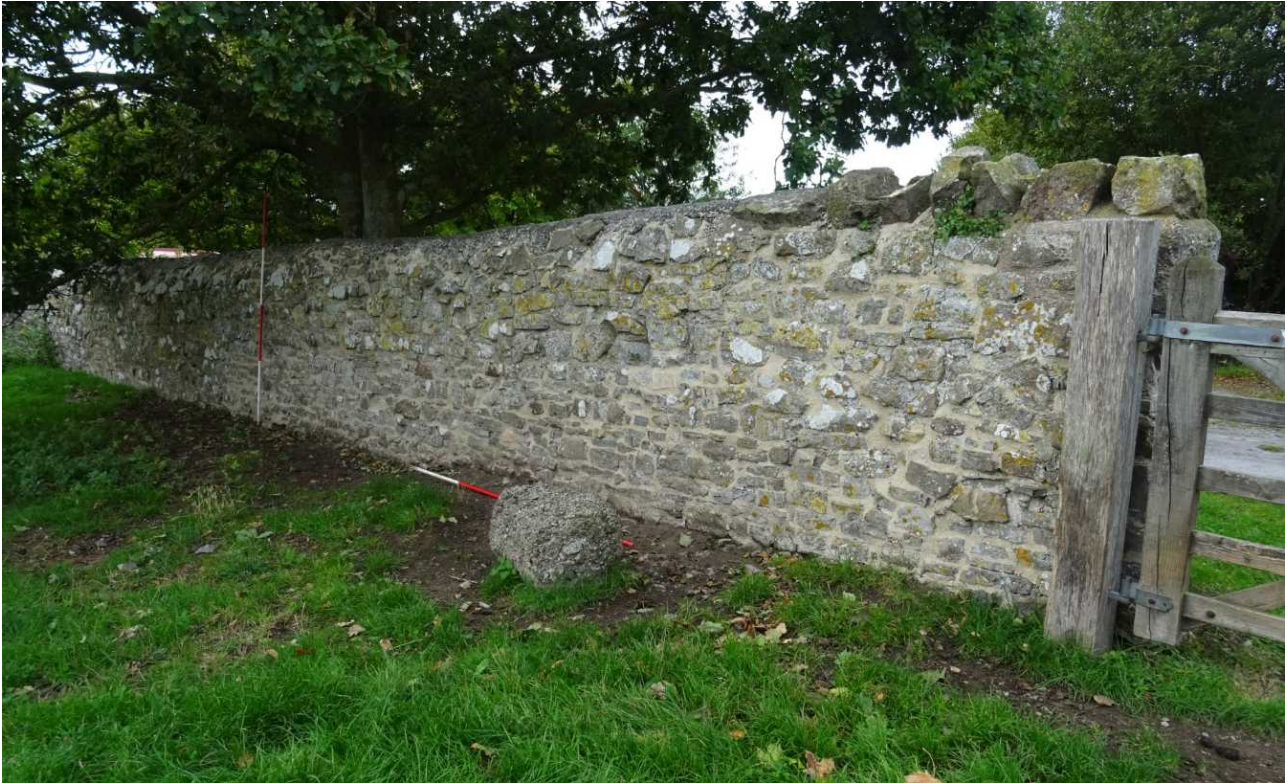
Fig 98: Wall 17 south of gate repointed 2022

The interior of both walls 17 and 18 was almost entirely mortar-free, in effect held up by gravity only (see wall 18 below). Early photographs show that overgrown and slightly neglected is a common historical state of these walls (Fig 99 below).

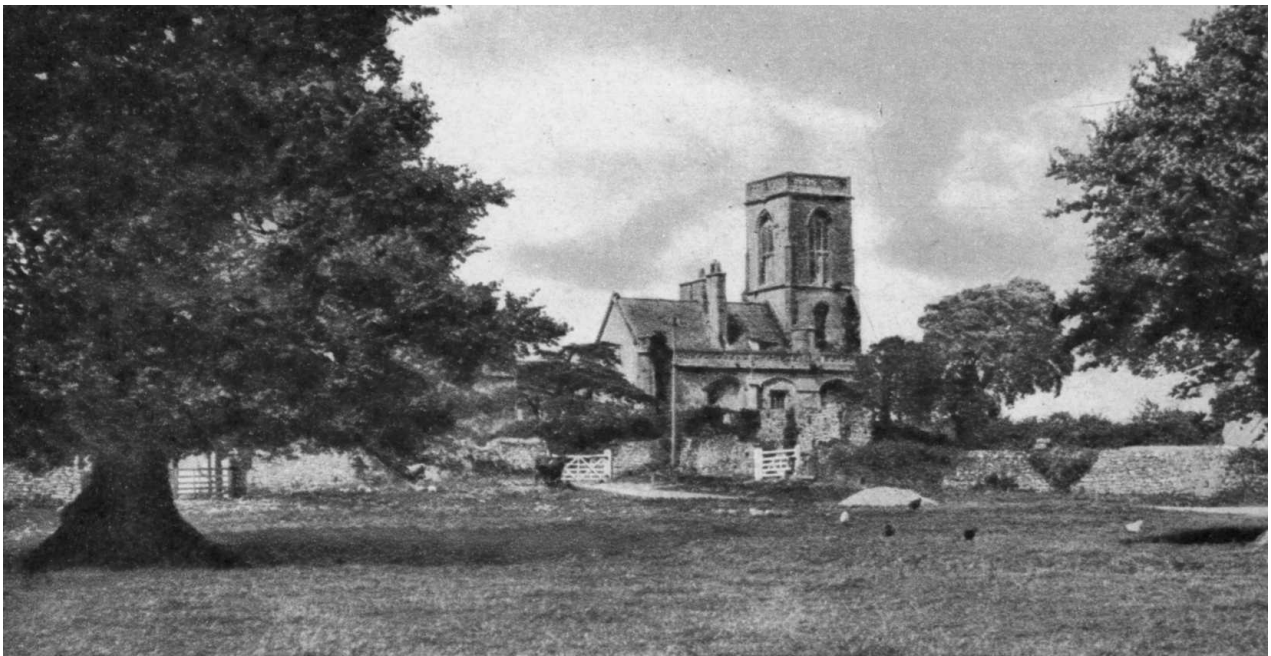
Fig 99: Wall 17 (including white gate) in 1934 (Fraser 1934)

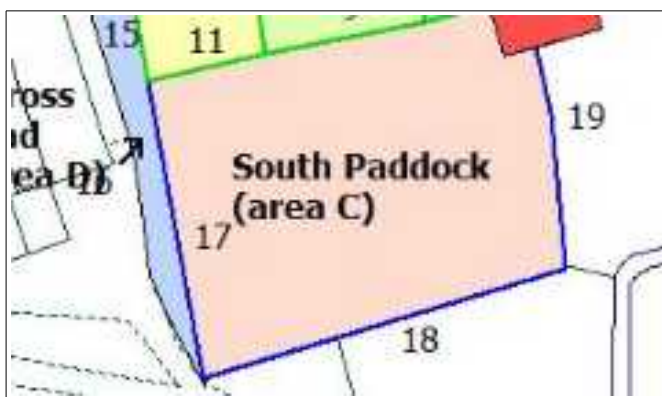
Wall 18: (Fig 100) (Rebuilding and repairs in 2020-2022)

Fig 100: Wall 18 forms the southern edge of the south paddock, joining wall 17 at its west end and 19 at its east.

Collapses in this wall were the earliest repairs carried out in this set of works, many before the main campaign in late 2021-2022. There were at one point some very surprising results (Fig 115).

Wall 18 seems to have been particularly prone to collapses (possibly due to its structure), and most of the repair works in 2020-22 were rebuilds of such. This was followed by large-scale repointing of most of the north face of wall 18, and much of the south face.

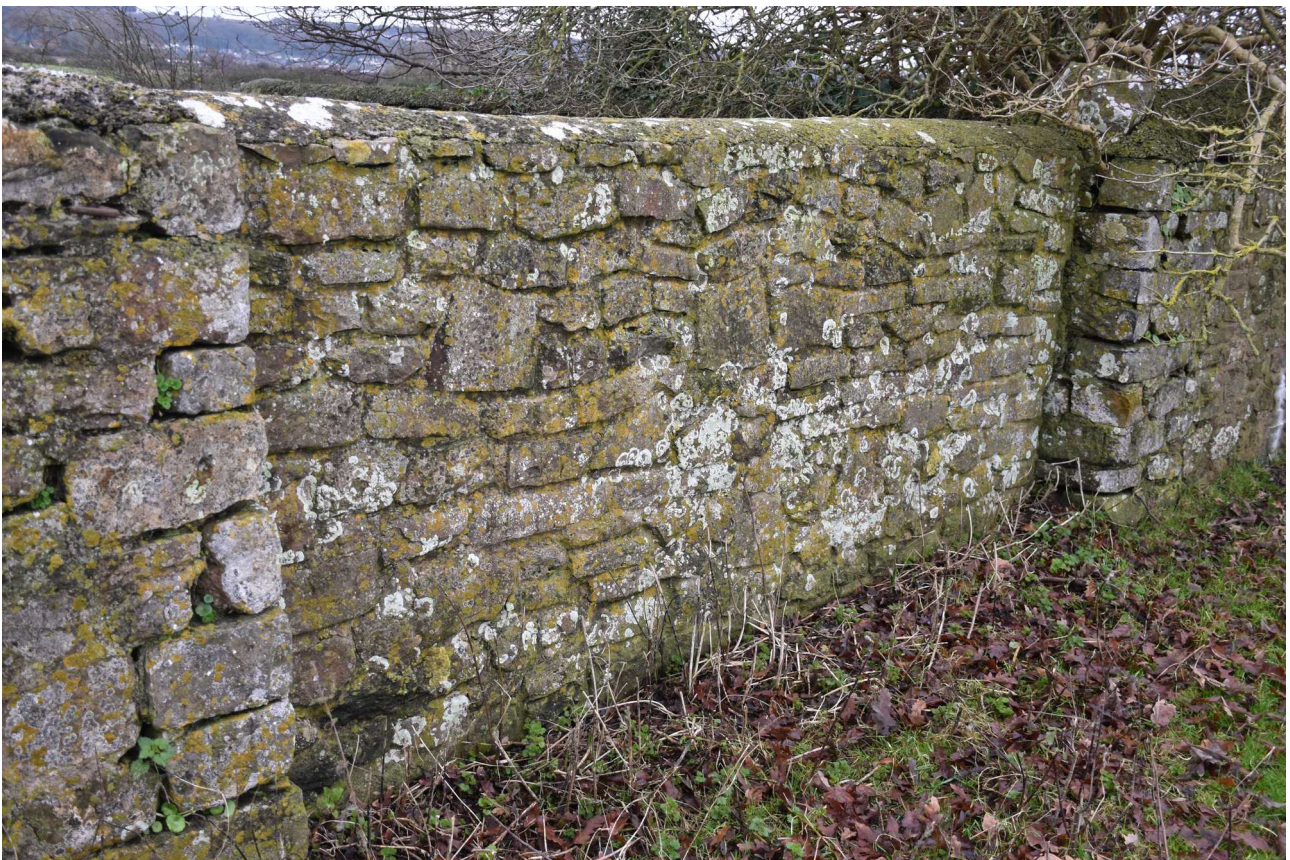
Fig 103: Blocked gateway between the paddock and land to the south, in wall 18, 2020

probable blocked gateway at the very western end of wall 18 against wall 17.

These 'tapered' gateways, wider at the top than the bottom are very unusual in northern Somerset: there is another in the field to the south of the paddock.

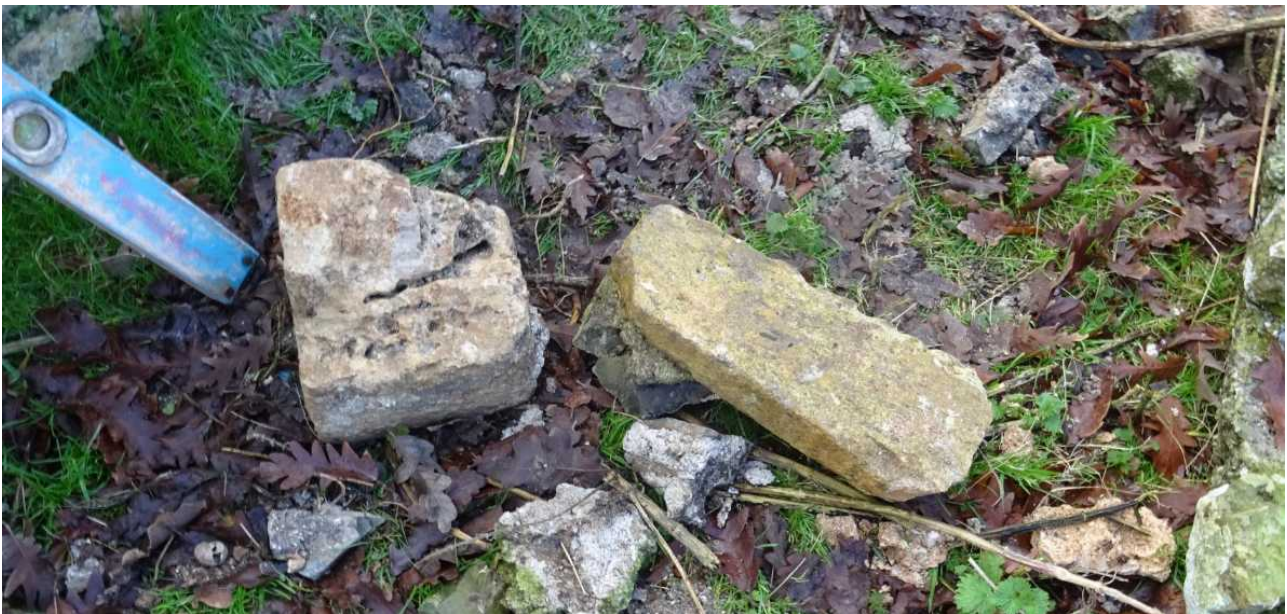
Fig 110: Freestone blocks from collapse ii (2020)

The cuboid block above is probably a building block: the wedge-shaped item (c80cm long) is probably too thin to be a vouissoir, and is perhaps a (tiny) stair tread or similar.

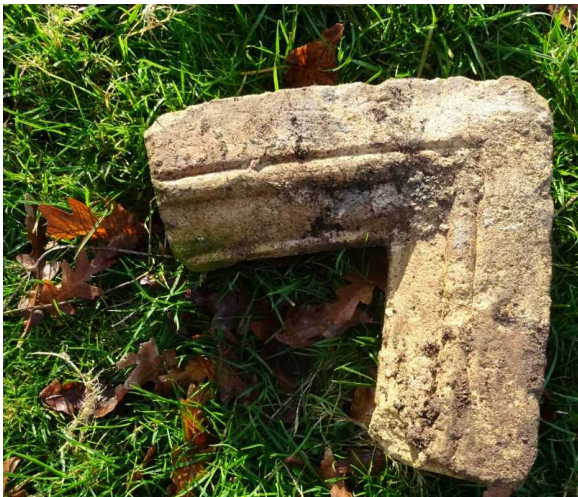
Fig 112: Part of freestone tracery from collapse iii (from the moss growth, parts of this have been exposed at the surface for some time) (c50cm high)
