PART 2: Walls 9 - 19 and endrefs

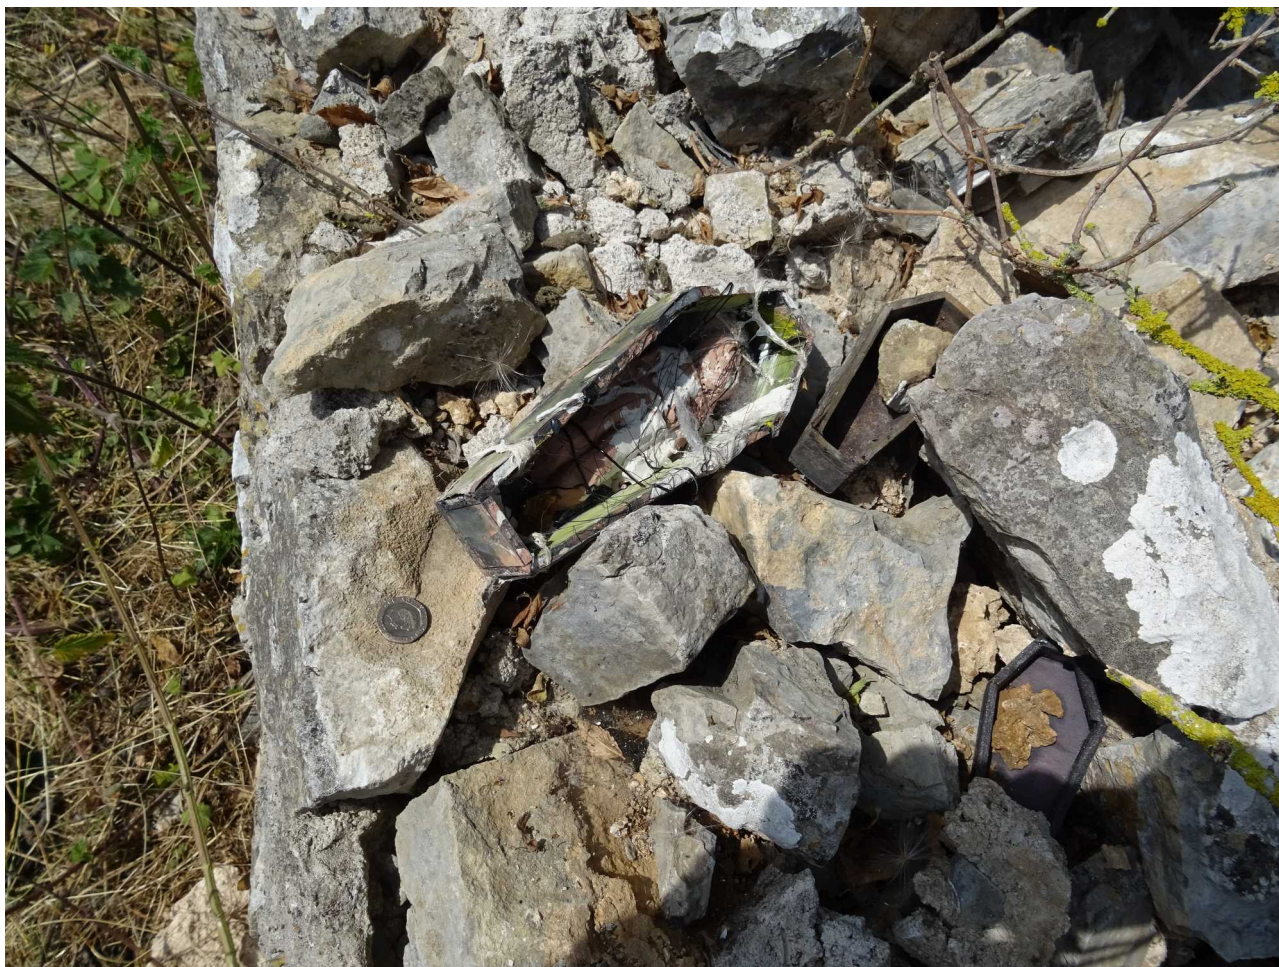
Fig 115: A somewhat unexpected find from wall 18 in 2018

A visit to check on potential crop marks in the hot summer of 2018 revealed 12 tiny coffins, containing fabric and clay doll 'bodies', buried in the fabric of wall 18 where it had collapsed.

These were, on routine inspection, of modern construction, the coffins of painted plastic insulating board, and the fabric and 'bodies' also modern. This odd find had clearly been inserted into the wall *after* the collapse. Their construction must have been time-consuming, and their origin remains mysterious, although they may have been a conscious imitation of Edinburgh's famous miniature coffins (see Fortean Times). They were kept on the site, as they clearly reflect some modern attitudes to Scheduled Monuments, but sadly, have since disappeared.

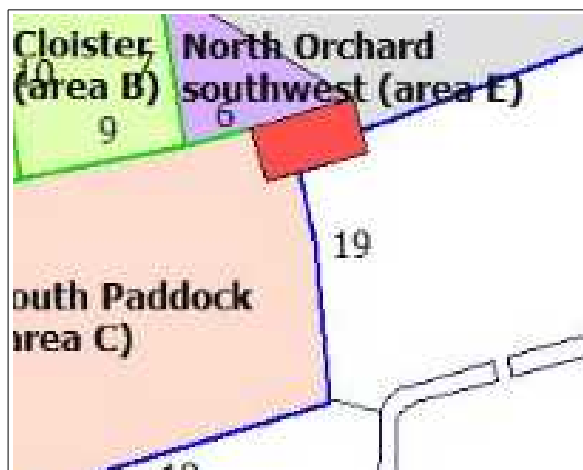
Wall 19: (Fig 116) (works of repair and repointing largely in late 2021 and early 2022)

Fig 116: Wall 19 forms the eastern side of the south paddock, from its junction with wall 18 in the south, to where it butts against the infirmary.

Wall 19 now runs straight (with only a small kink in its line) but until 1807-1840, the wall turned through two right angles to meet the infirmary at its eastern end (Figs 118 and 121). This may be a reflection of the former existence of an infirmary chapel to the SE of the building.

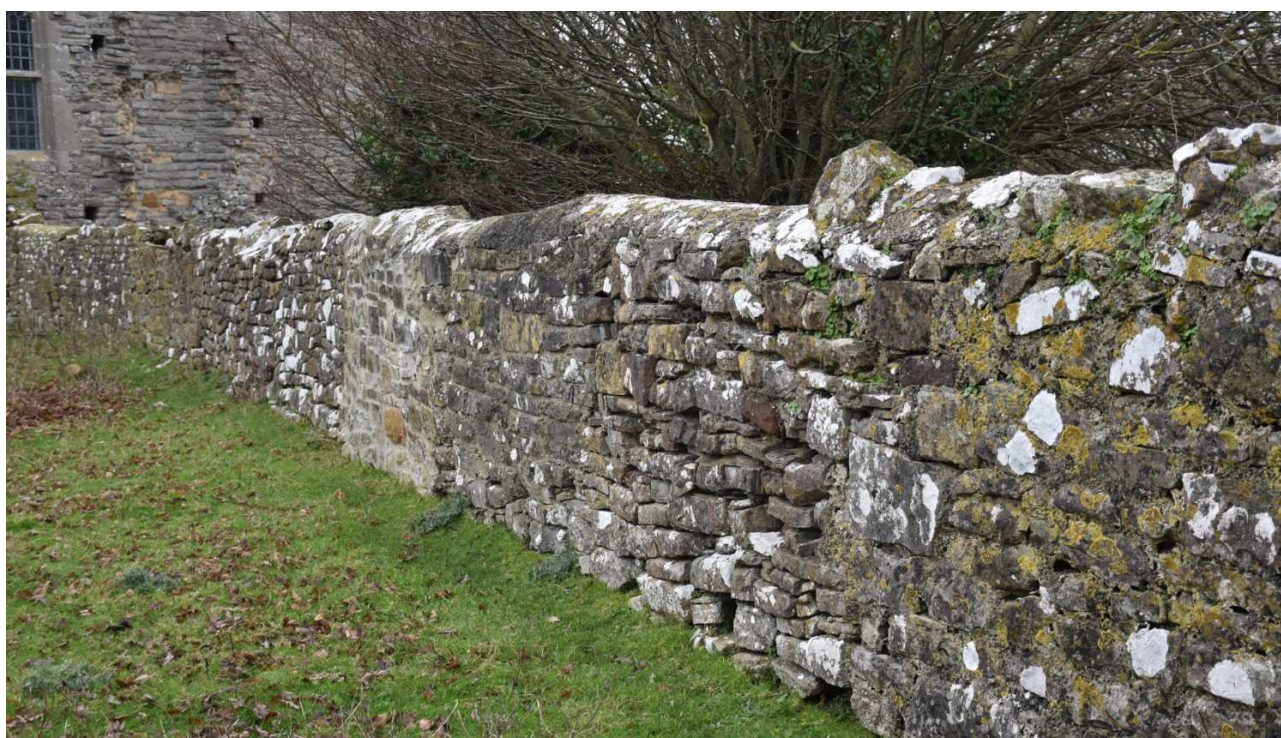
Fig 117: Wall 19 from SW before works (except one repointing episode in centre) (2020)

Wall 19 was, on the whole, in good condition, with the exception of a partial collapse in its centre, and the rather parlous condition of the last 3m against the infirmary.

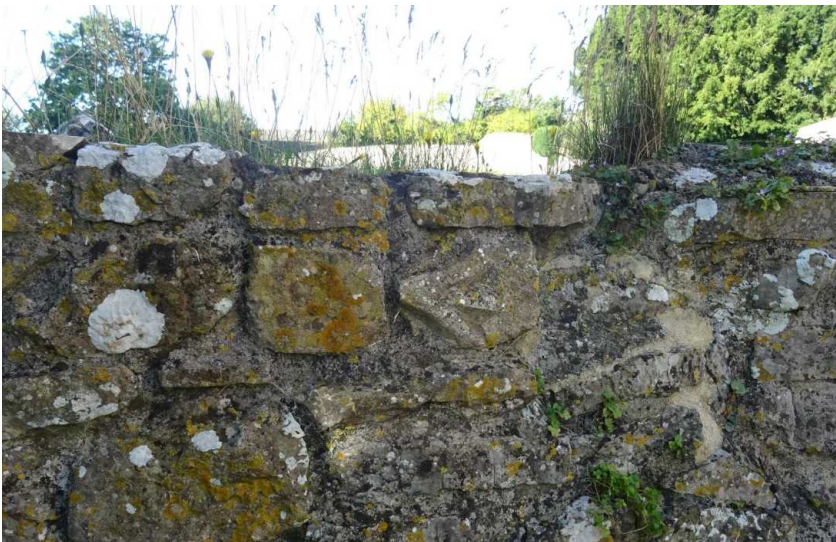
Fig 119: Small fragment (c30cm long) of worked freestone in top of wall 19

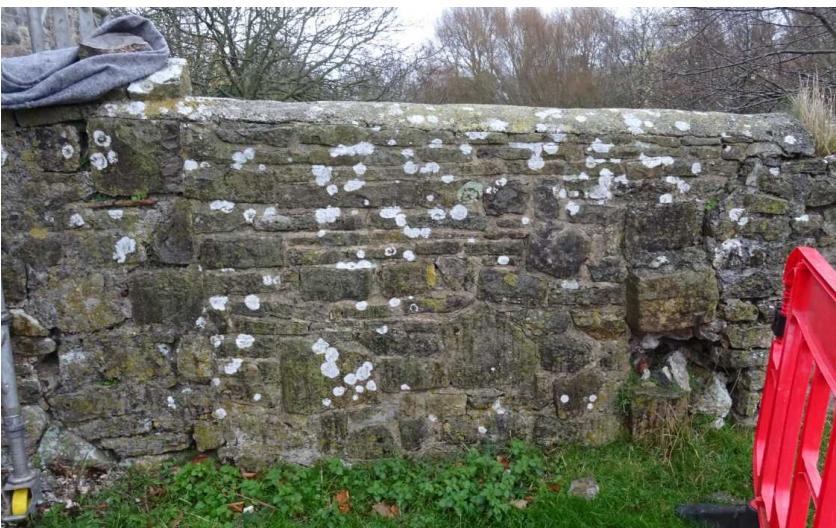
The wall has also been altered since its re-routing: an opening close to the infirmary was carefully constructed with large quoinstones, giving access between the paddock and the field to its east (Fig 120).

The date of this opening in the wall is not clear: none of the maps (1840 or 1885) show a gap at this site: it is, however, clearly visible on air photographs of 1949, and may perhaps be another war time alteration from WW2.

Fig 120: Former opening in wall 19, close to the infirmary

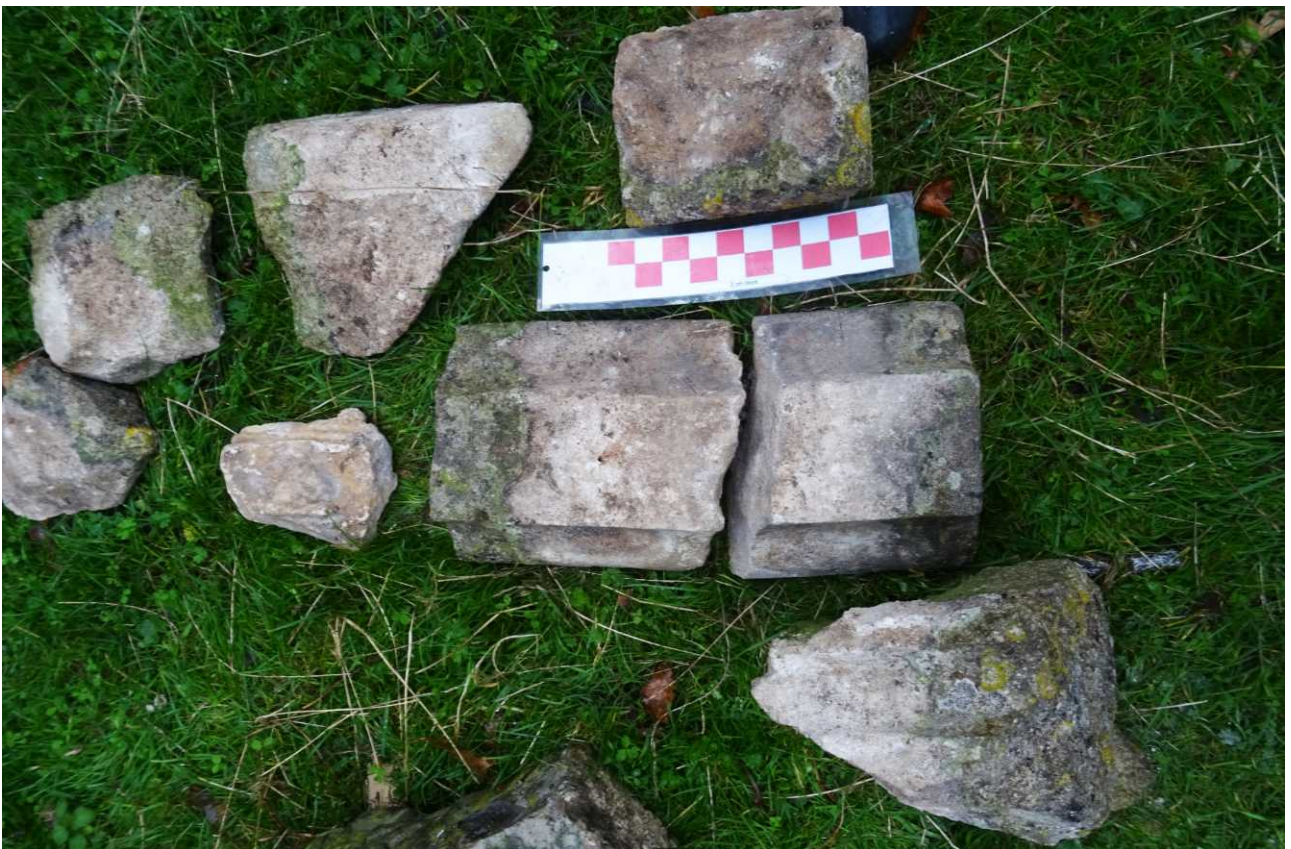
Fig 122: Worked freestone recovered from wall 19 repairs by infirmary (scale 2cm squares)

A number of fragments of carved freestone (largely Dundry stone) were uncovered from the works (Fig 122 above), including some carved, but highly weathered sections.

This section of wall was taken down to the first sound area, largely level with the adjacent wall, and rebuilt.

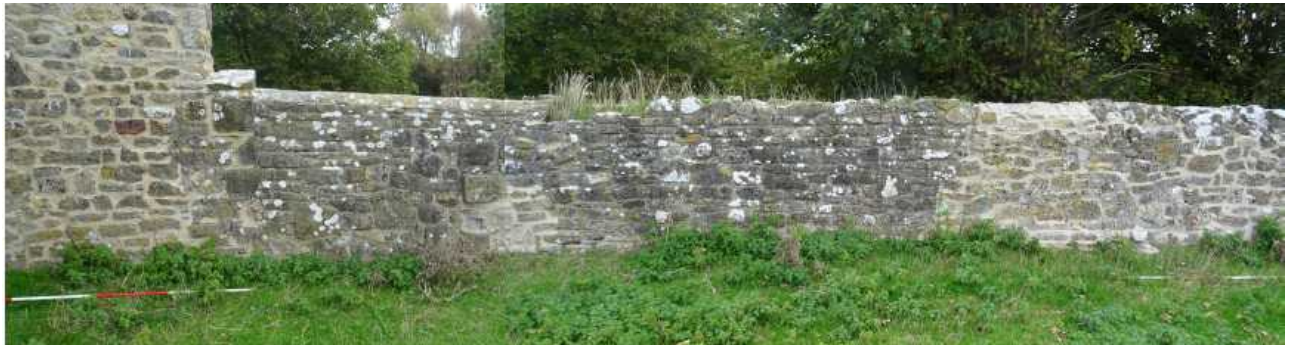
Fig 127: Interior (west) of wall 19 after rebuild and repointing (2022)
