YCCCART 2016/Y5 North Somerset HER 2016-014

The TW stones of Cleeve and Congresbury: recording and historical study

YATTON, CONGRESBURY, CLAVERHAM AND CLEEVE ARCHAEOLOGICAL RESEARCH TEAM (YCCCART)

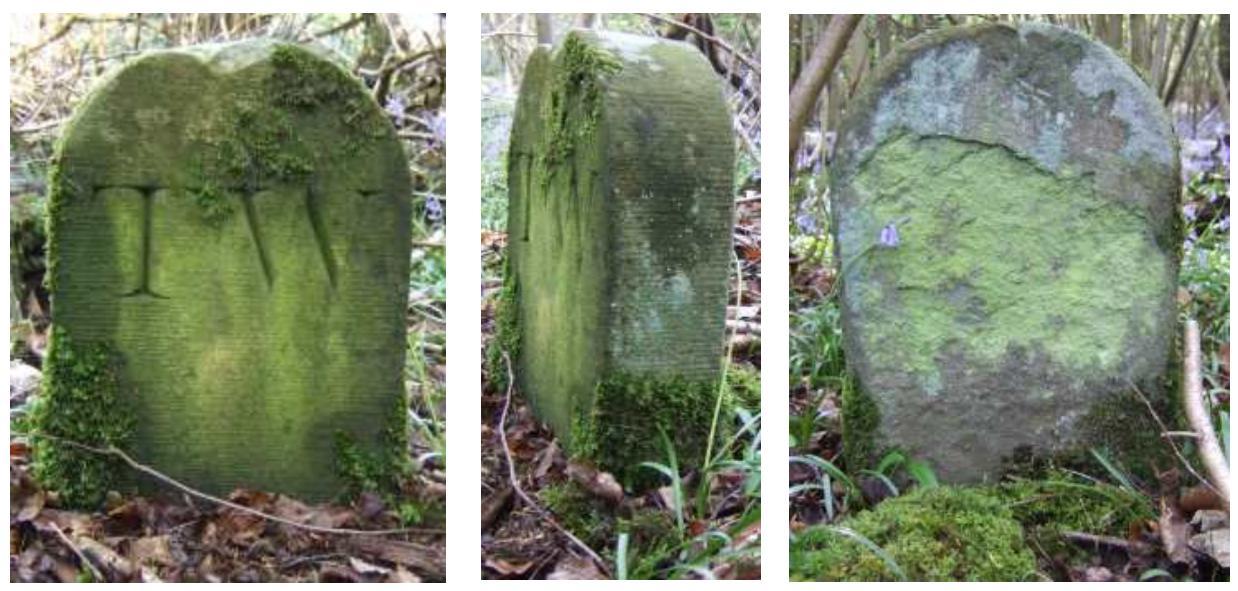
The stones are all carved from the Pennant Sandstone. Only the upper section of the stone is worked, to a flat back and face with a rounded top, horizontal milling all down the face of the worked section, and horizontal milling down each side and over the top as well (see photographs). The length of the section worked is remarkably similar in all cases, and it looks from field evidence as if c450mm of this (about 18 inches) was intended to show above ground. The mean width (of the worked section) is 317mm (SD 13.9), which means the stones are probably intended to be 12 inches wide. Thickness is 98-120mm (mean 107mm, SD 6.5), meaning they are probably intended to be 4 inches thick.

Fig 3: A typical TW stone: face, side view and back of stone 16 at Cleeve Hall

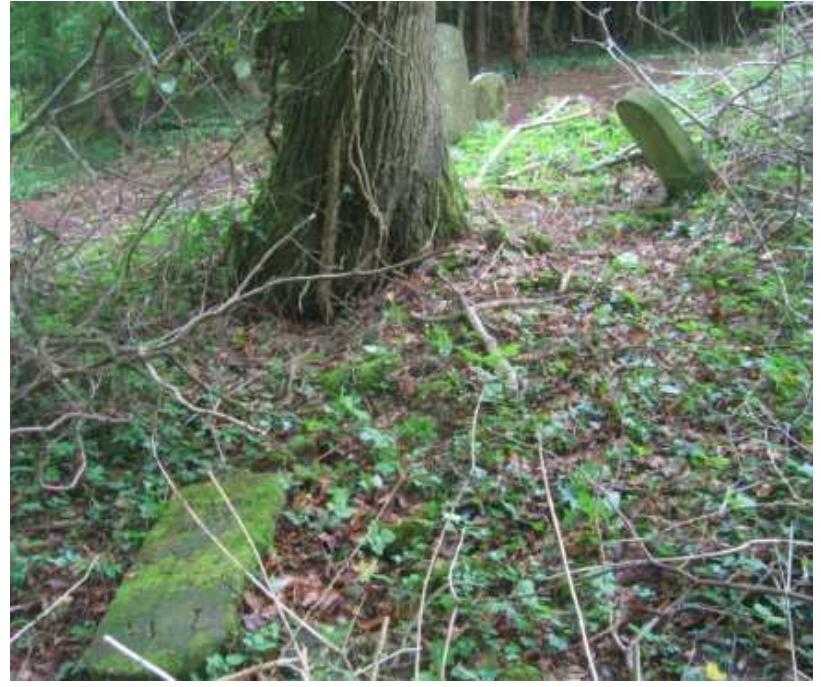
Fig 5: Stones 1, 2 and 3 at Woolmers, 2005

One (standing by Boundary Stone 15 in the background) is probably in its original position: the second (seen leaning in the upper right corner of the photograph) may be. Either way, the second cannot be very deeply buried in the ground (quite a lot of its unworked lower section can be seen) and it must be at real risk of falling.

The third, in the foreground, is already supine on the ground, and may have

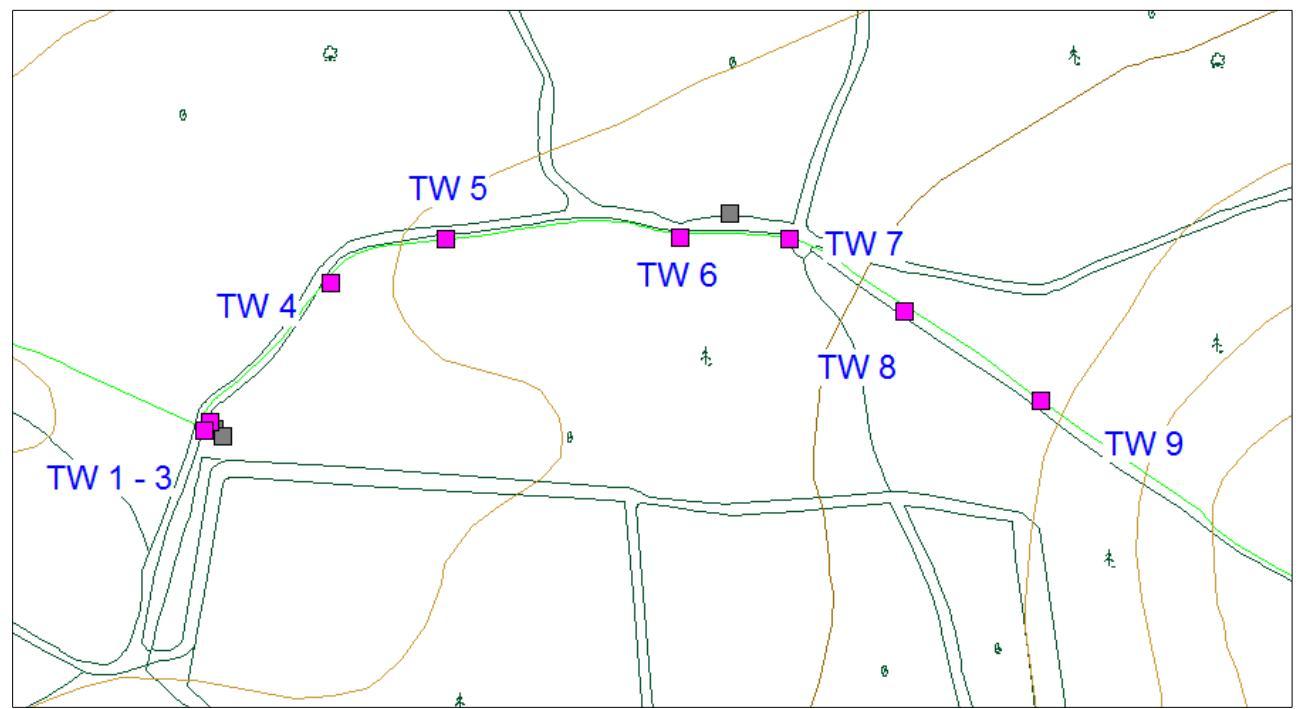
been moved to this position at some point. When recorded in 2005, stones 4 - 9, all at Woolmers, were standing, mostly (apart from a little shaling of the face of stone 9) in good condition.

Fig 6: TW stones at Woolmers, 2005. Details of individual stones are in Appendix 1.

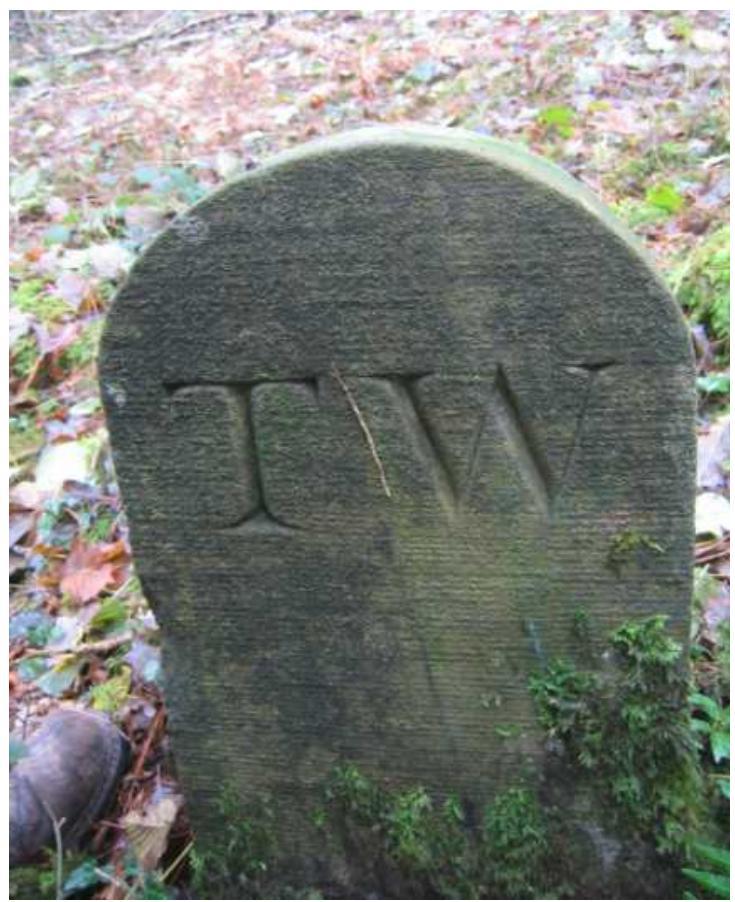
The well-preserved stone 8 shows the original milling face decoration of the stone.

Pennant Sandstone, as well as being subject to shaling in layers, is quite variable in its resistance to weathering. This stone (left) also shows the irregularities that make it clear it was hand-tooled: (the bottom serif of the T, and the lower points of the W aren't on the same line, for example).

Fig 7: Stone 8 at Woolmers showing preserved details of carving

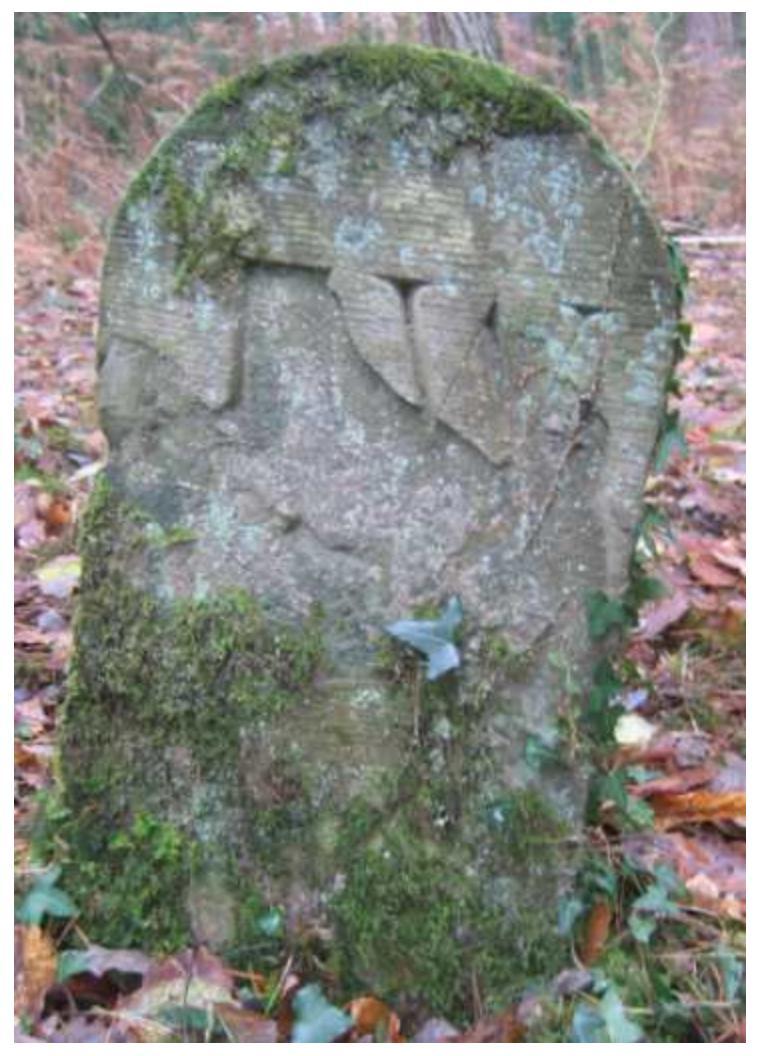
The face of Stone 9 is also quite revealing.

The shaling of the surface has removed the lowest part of the W, but the edge of it has largely followed the straight lines of the carved T, probably after stress fractures caused during the carving.

As with most of the weathered stones, however, it is clear from the suite of lichen growth on the old surface and the new that this shaling probably happened many years ago.

Fig 8: Stone 9 at Woolmers showing typical shaling damage

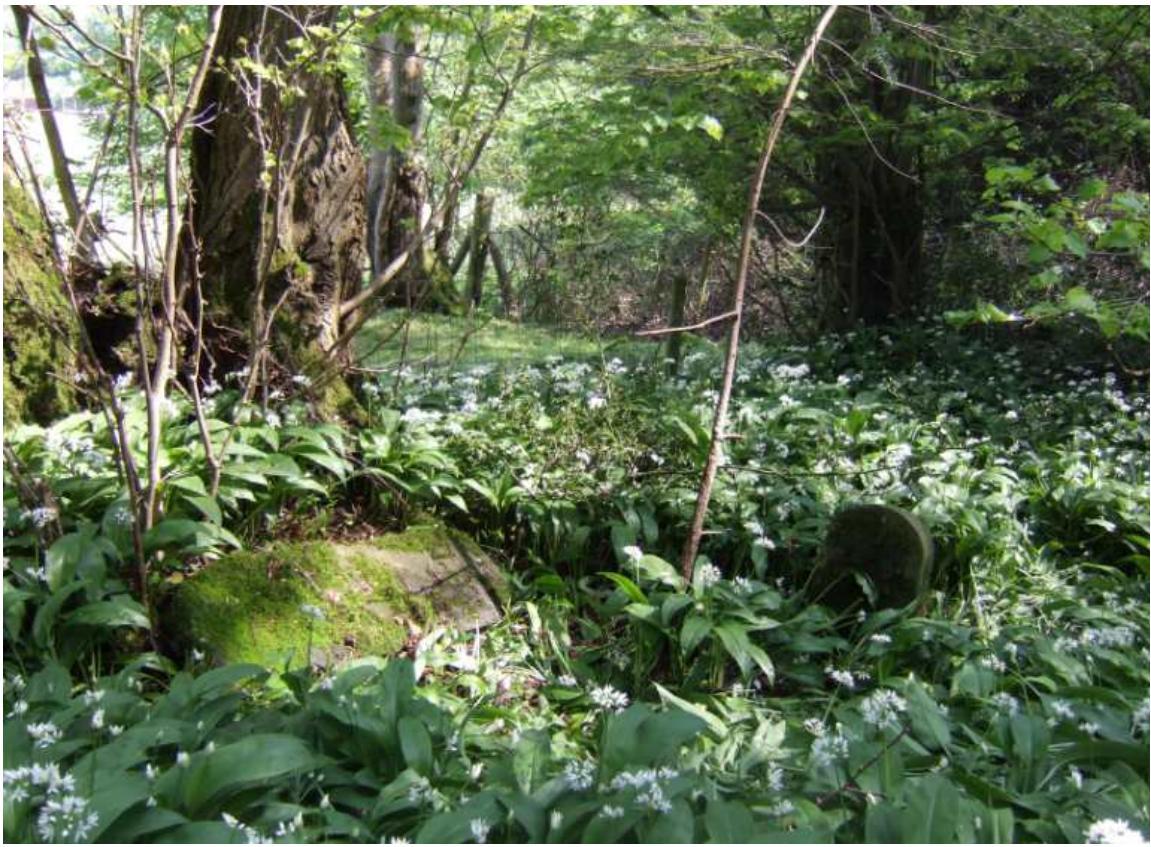
Fig 10: Stones 11 (supine) and 12 (standing) are close together: Stone 11, lying on the roots of a tree, has clearly been moved at some time

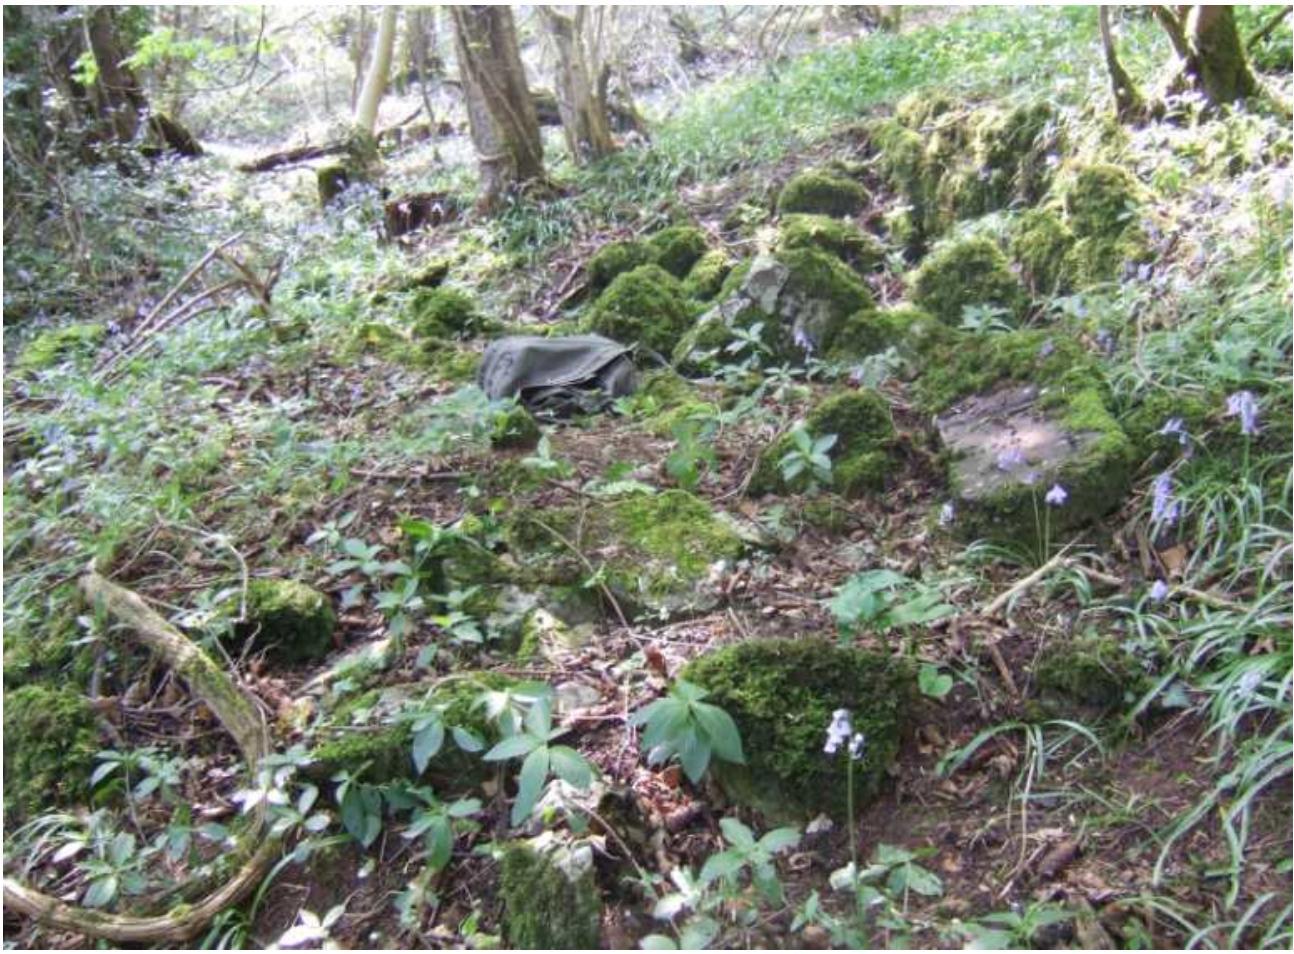
Fig 11: Stone 13 (centre right) lying among rocks close to the woodland edge

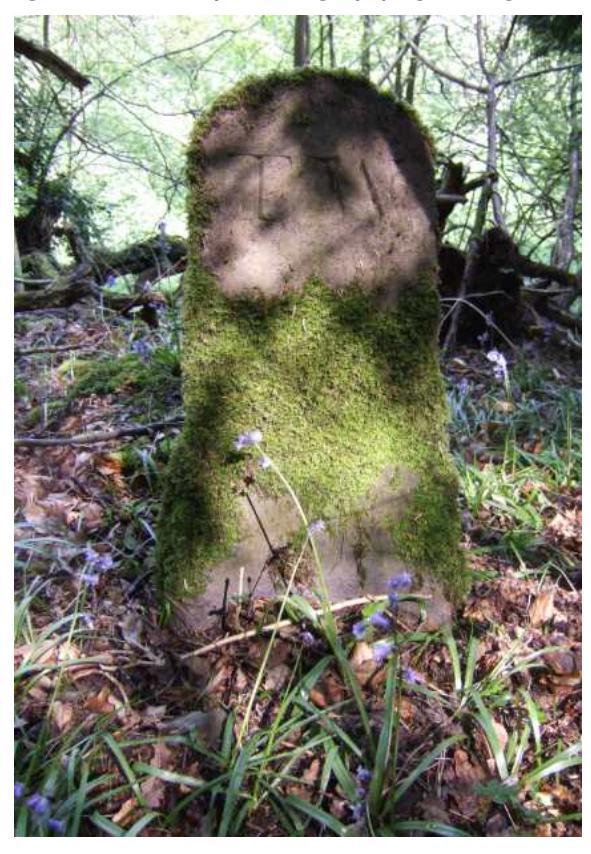
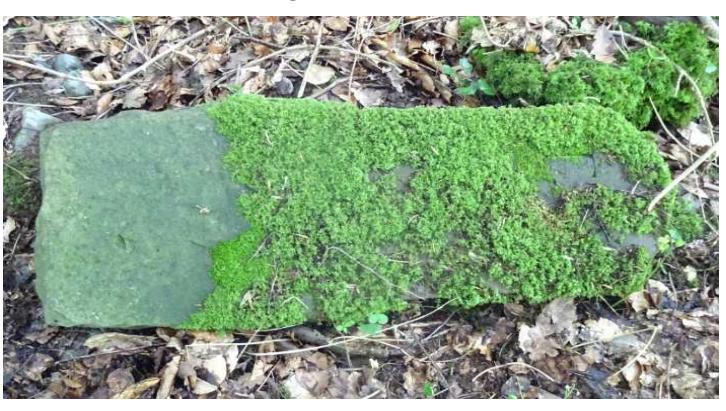
Fig 12 & 13: Stone 18 standing in 2005 (left), supine by 2016 (above)

Some stones, like 18, shown left, appear to be only buried at a shallow depth in the ground and probably moved. This photograph (left) shows a great length of unworked stone, presumably initially buried, showing in 2005: by 2016, this had led to the stones collapse.

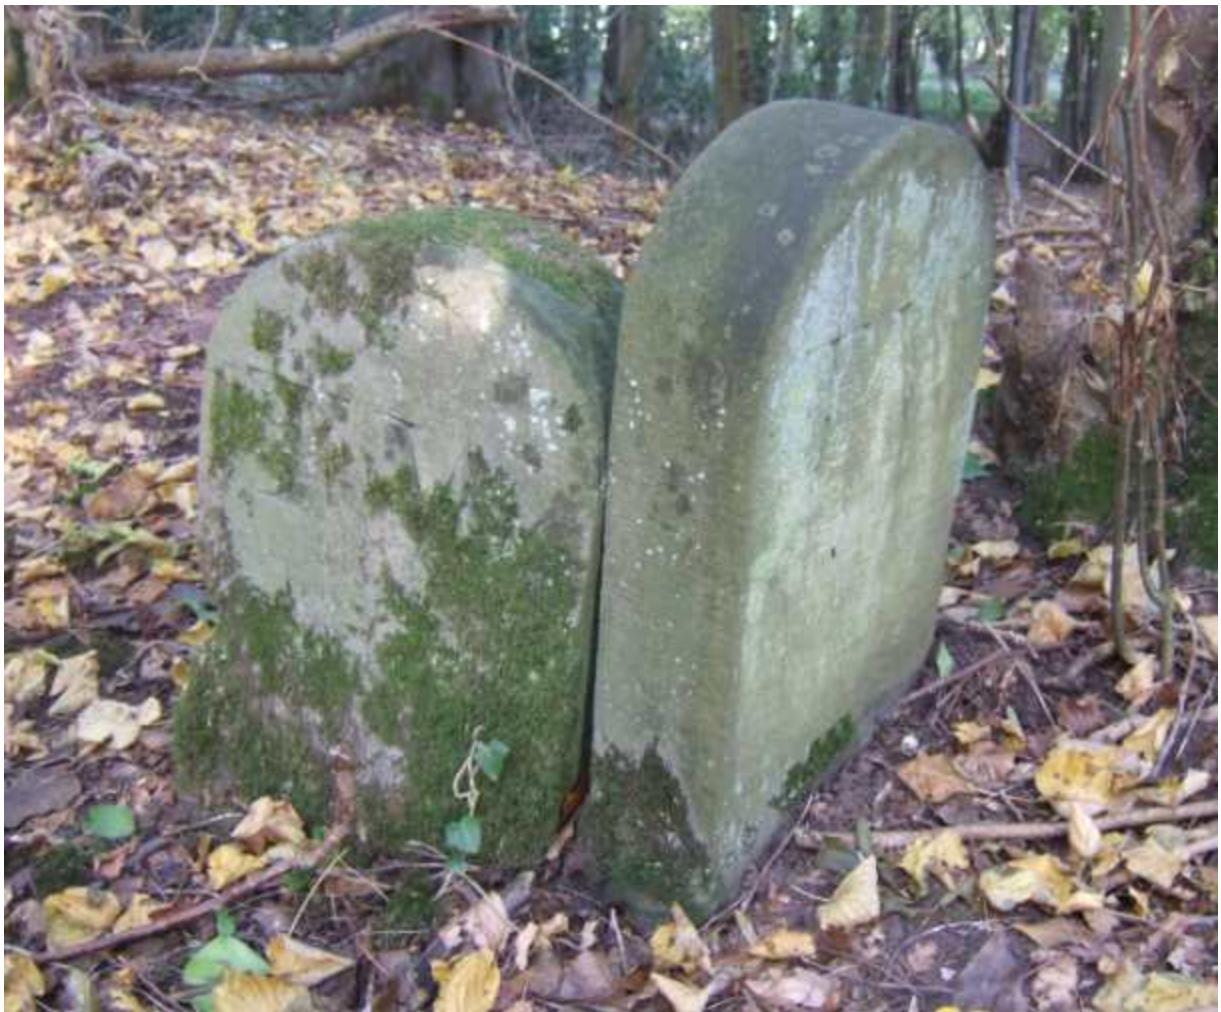
Fig 14: Stones 20 and 21 at Bickley

These two stones were at first thought to have been moved, but from the 1821 map and survey, it can be seen that they stand on the corner of a plot held by one Lydia Nash under Thomas Biddulph. Again, both face away from the outside into the wood, and these two facts mean that at least one of them is in the original position: would he really have put up two right next to each other? It is also noticeable that immediately behind the stones begins an area of quarrying, some recorded by YCCCART in the past.

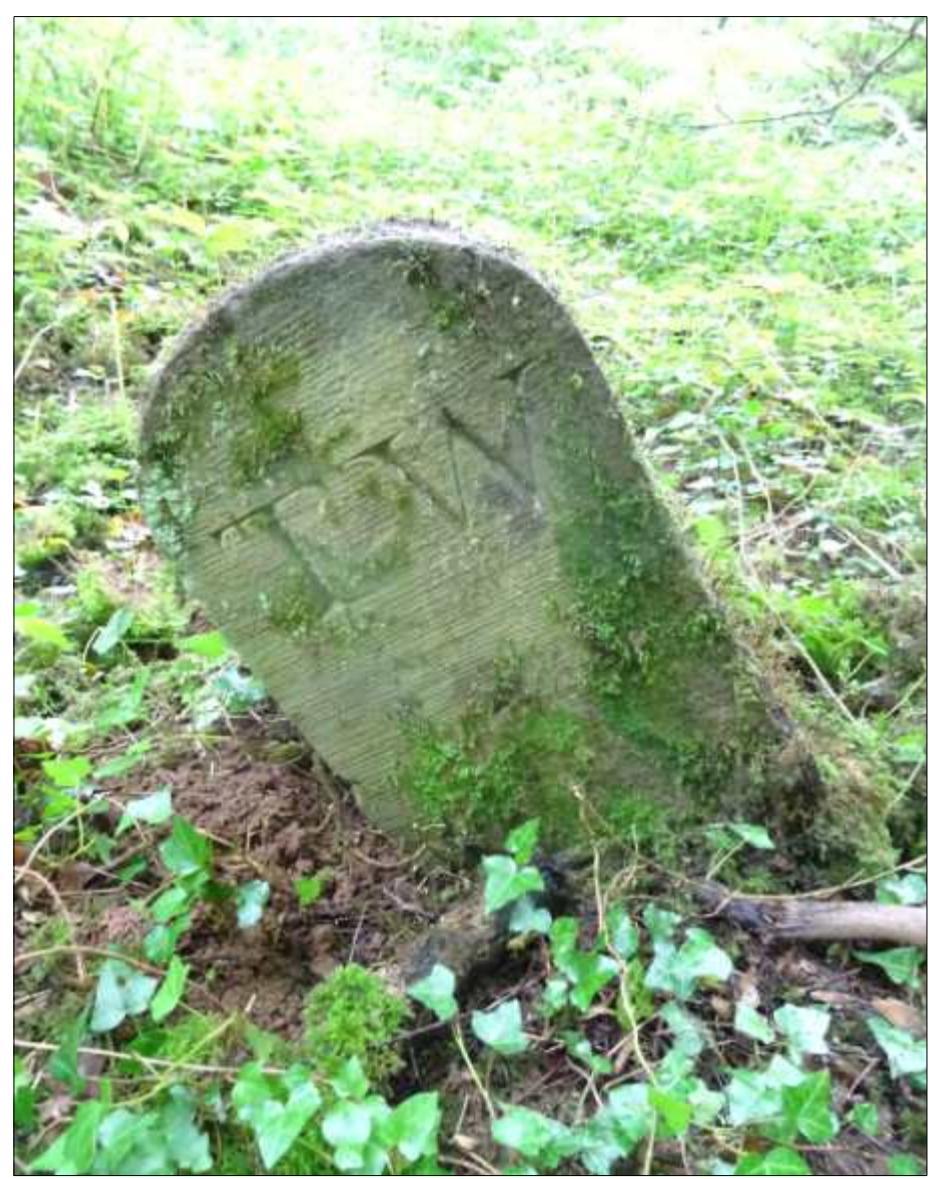
Fig 16: Stone 23 at the foot of the slope: photograph brightened post capture

Stone 23 has a feature not seen elsewhere: a rounded end 77mm slot in its upper shoulder. This slot appears to also have a rounded base.

Its purpose is unclear. In its original position, it would have been unsuitable as a mortise for a fitting such as a wooden railing (and it seems inconceivable that such would be needed here).

A second possibility is that this was a sharpening aperture for some narrow bladed tool. The stone is quite close to a main track past Woolmers, and so would be easily accessible.

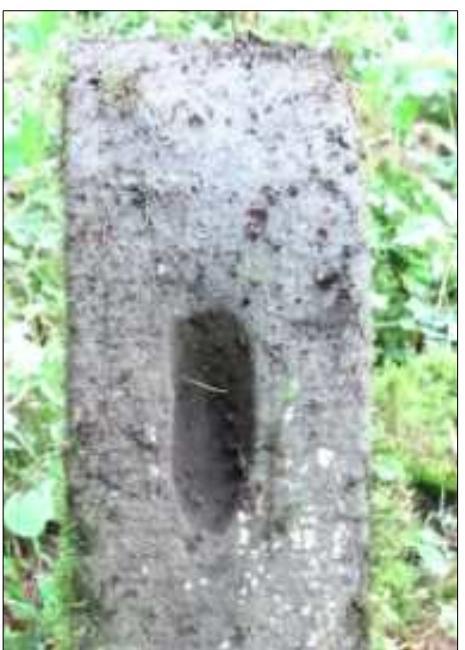
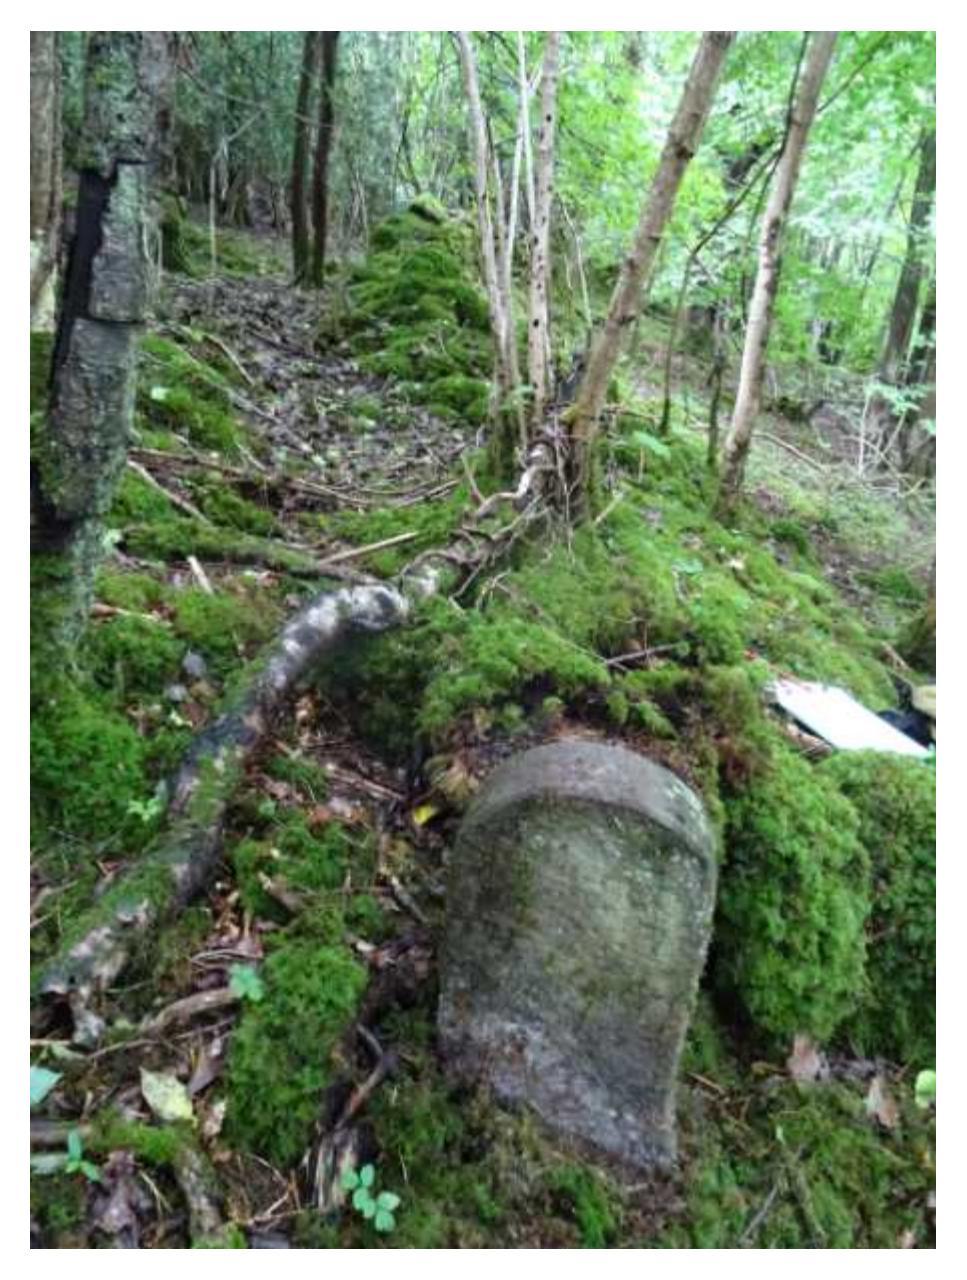
Fig 17: The slot in the shoulder of Stone 23

The stone at the top of the slope (25) shows one of the unexpected properties of these stones: its inscription face is close to the end of a large but heavily tumbled stone wall at the top of the slope down to Woolmers.

Fig 18: Stone 25 at the end of the tumbled stone wall at the top of the slope down to Woolmers: note the inscription faces into the wall
